DIVISION OF
ENVIRONMENTAL QUALITY

RE: Inspection conducted on July 31, 2023
AFIN 60-01071
Permit Number 0266-S1

**Division of Environmental Quality
Office of Land Resources
Class 1 Landfill Inspection Form**

Site Name	City of Little Rock Class 1 Landfill	County	Pulaski	AFIN	60-01071
Facility Address	10803 Ironton Cutoff, Little Rock, AR 72206	Phone #	501-888-4493	Permit #	0266-S1
Permittee Address	10803 Ironton Cutoff, Little Rock, AR 72206	Email Address	ncharles@littlerock.gov	PDS #	127024
Date	7/31/2023	Entry Time	0938	Exit Time	1225

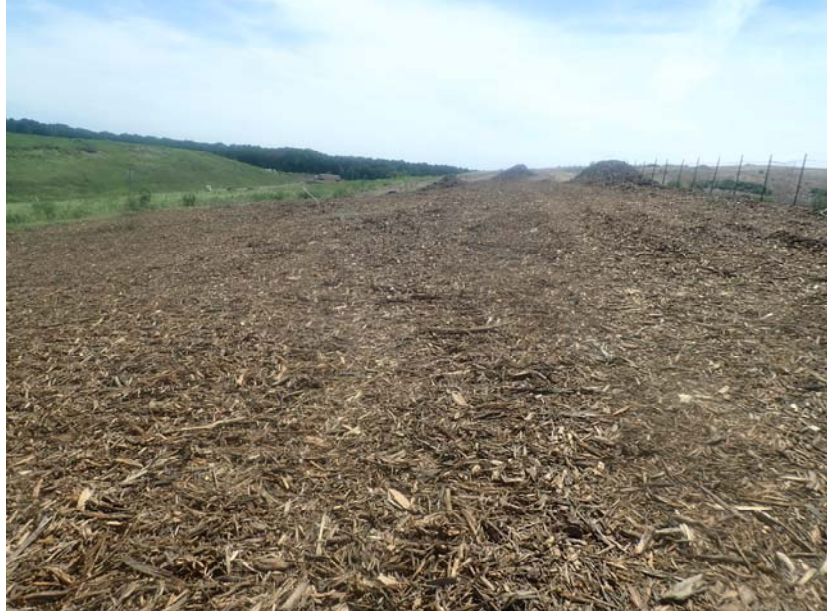
Location	City of Little Rock Class 1			Permit	0266-S1	AFIN	60-01071
Photographer	Kim Davenport		<i>KD</i>	Witness	N/A		
Photo #	1	Of	14	Date	7/31/2023	Time	1114
Description	Alternate daily cover (ADC) was observed on the exterior slope of Cell 9, above Cell 2, without approval.

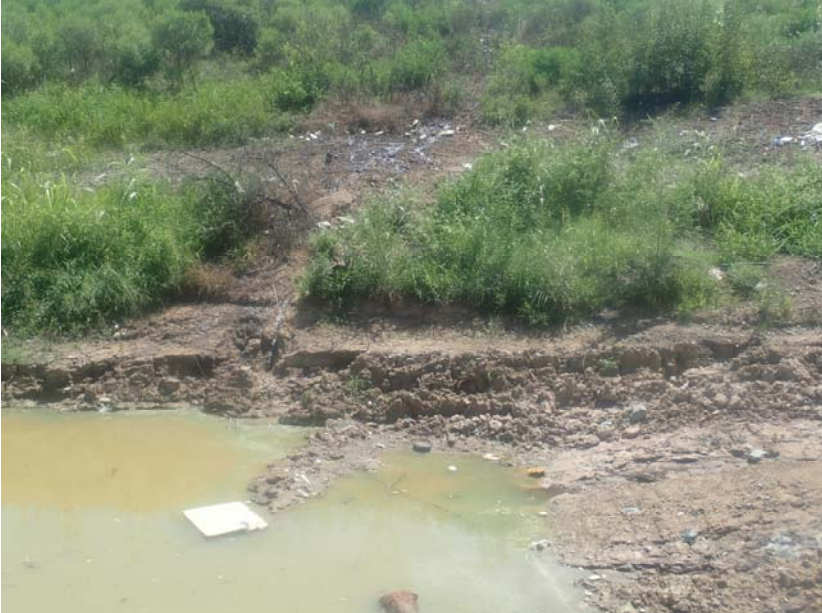
Regulation	Item Description	Comments
X	411(a)	Operations in Accordance with Permit Documents	The last approved Operating Plan (OP) is dated 1996 and requires updating. (Refer to Doc #3716, dated July 26, 1996.) An OP (Doc #60665) was submitted in 2011 but has never been approved and is now also out of date. Alternate daily cover (ADC) was observed on the exterior slope of Cell 9, above Cell 2, without approval. (Refer to Doc #s 31984 & 83935 & Photo #1.) In addition, vegetation was observed growing through the sand layer of Cell 5W at the unused south end. This sand layer is part of the bottom liner. (Refer to DOC #79083 and Photo #13.)
	411(c)	Smallest Practical Area, Unloading Supervised, Single Working Face	
	411(b)	Operations by Licensed On-site Personnel at All Times	
X	411(g)	Litter Control Provisions Maintained	Litter was observed entering and surrounding the unlined stormwater collection area, located northwest of Cell 5, and in the unused south portion of Cell 5W, with no litter controls in place. (Refer to Photos #2 - #4.)

Regulation	Item Description	Comments
	413(a)(b)(c)	Satisfactory Daily/Alternate/Intermediate Cover	
X	419(a)(5)	Cause Discharge/Leachate Leaving Landfill	Leachate was observed running into the unlined area referenced as the stormwater pond. (Refer to Photos #3 & #6.)
	411(f)(3)	Depositing Waste in Standing Water Prohibited

X	411(o)	Erosion or Other Cover Defects Resulting in Exposed Refuse	Erosion with exposed waste was observed on the west slope of Cell 2, the north slope of Cell 1, the west slope of Cell 5E, the south exterior wall of Cell 5W. (Refer to Photos #3 & #5-#10.) Cover defects resulting in exposed waste in ADC was observed across active Cell 5W and the south end of Cell 5W. (Refer to Photos #4, #12.)
X	309(c)	Overfill/Off Lined Area	Partially buried waste was observed in the truck cleanout area, located north of the fueling station, which is off the lined area and is not permitted for waste disposal. (Refer to Photo #14.)

Location	City of Little Rock Class 1			Permit	0266-S1	AFIN	60-01071
Photographer	Kim Davenport		<i>KD</i>	Witness	N/A		
Photo #	3	Of	14	Date	7/31/2023	Time	1148
Description	Litter and exposed solid waste observed on the west slope of Cell 2.

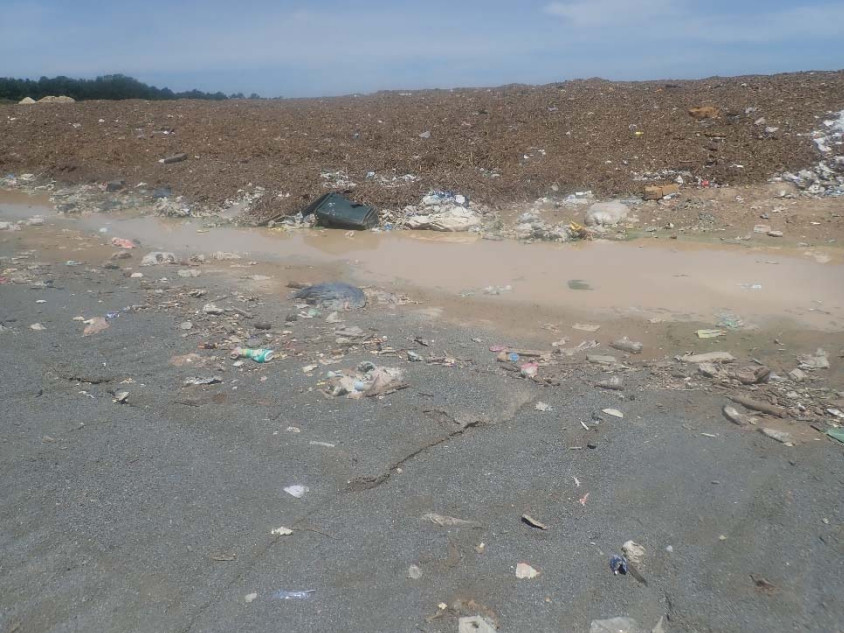
Location	City of Little Rock Class 1			Permit	0266-S1	AFIN	60-01071
Photographer	Kim Davenport		<i>KD</i>	Witness	N/A		
Photo #	4	Of	14	Date	7/31/2023	Time	1205
Description	Litter was observed (foreground) and exposed waste observed at the south end of Cell 5W.

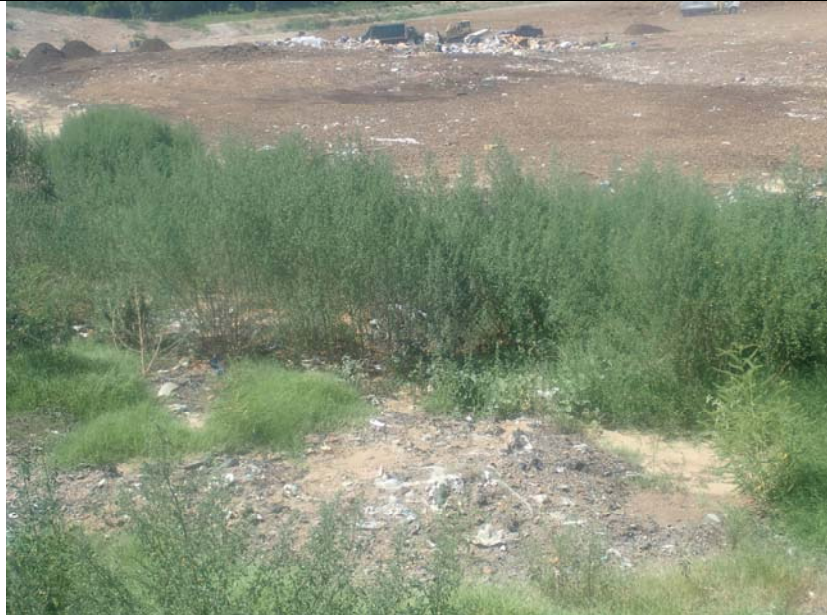
Location	City of Little Rock Class 1			Permit	0266-S1	AFIN	60-01071
Photographer	Kim Davenport		<i>KD</i>	Witness	N/A		
Photo #	5	Of	14	Date	7/31/2023	Time	1118
Description	Erosion with exposed waste was observed on the west slope of Cell 5E.

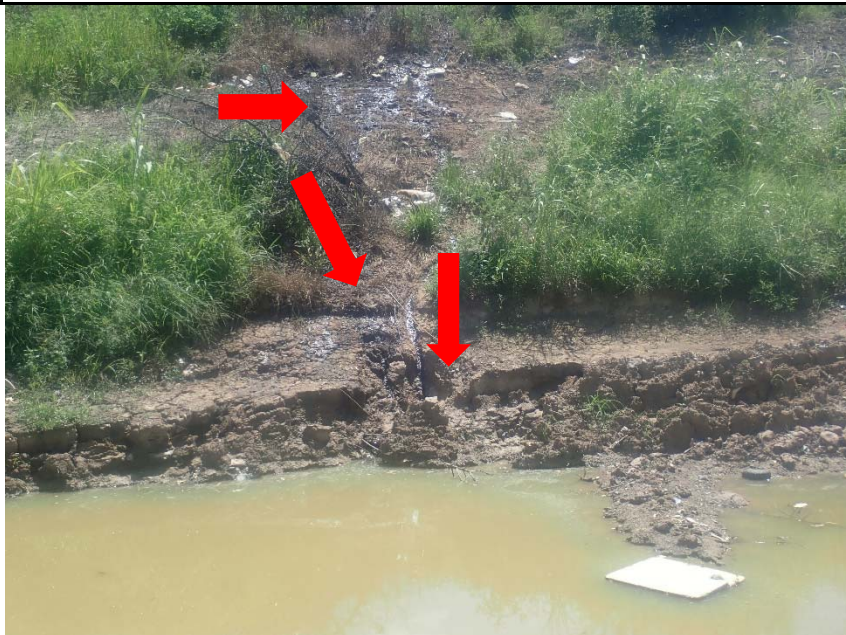
Location	City of Little Rock Class 1			Permit	0266-S1	AFIN	60-01071
Photographer	Kim Davenport		<i>KD</i>	Witness	N/A		
Photo #	6	Of	14	Date	7/31/2023	Time	1148
Description	A closer view of the area shown in Photo #3, to show the leachate flowing into the stormwater pond. The path is shown by red arrows.

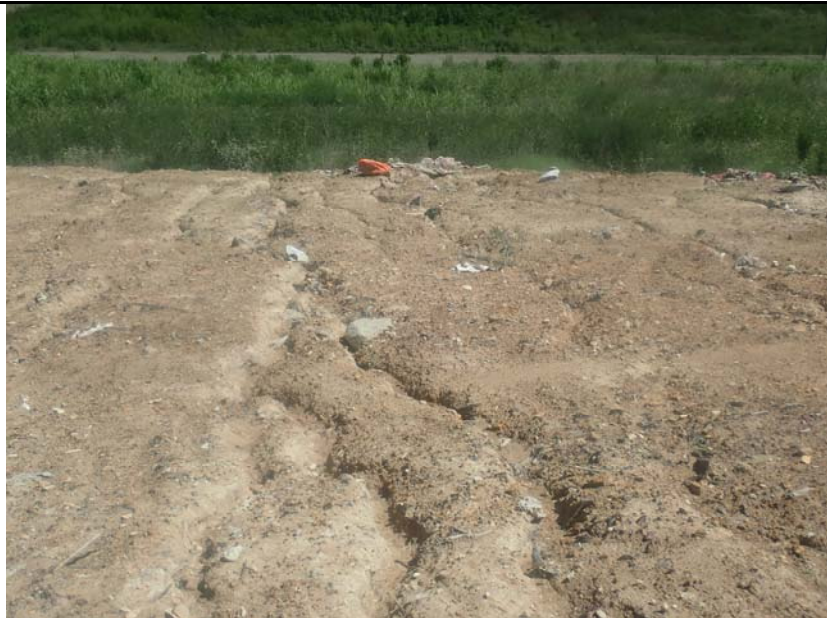
Location	City of Little Rock Class 1			Permit	0266-S1	AFIN	60-01071
Photographer	Kim Davenport		<i>KD</i>	Witness	N/A		
Photo #	7	Of	14	Date	7/31/2023	Time	1118
Description	Erosion with exposed waste was observed on the north slope of Cell 1.

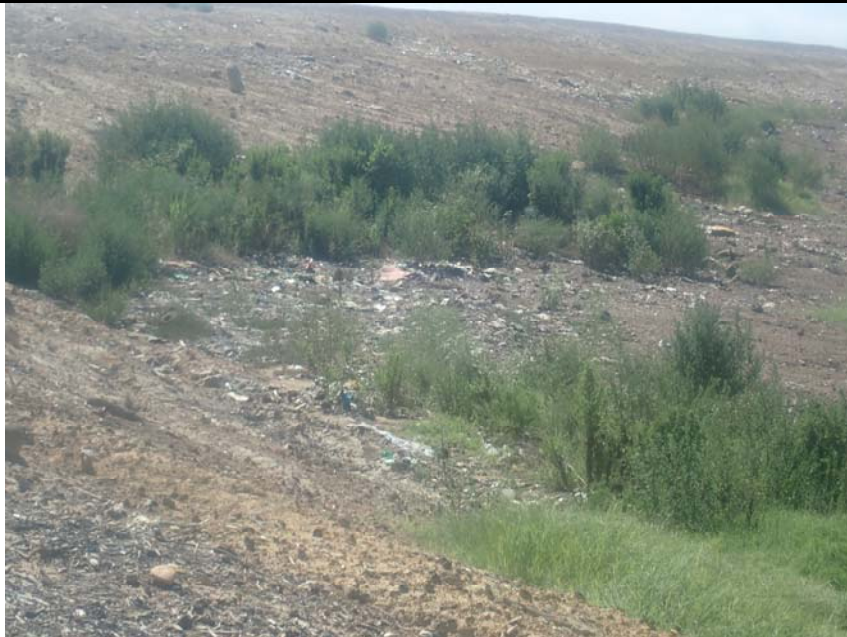
Location	City of Little Rock Class 1			Permit	0266-S1	AFIN	60-01071
Photographer	Kim Davenport		<i>KD</i>	Witness	N/A		
Photo #	8	Of	14	Date	7/31/2023	Time	1118
Description	Exposed waste was observed on the west slope of Cell 5E.

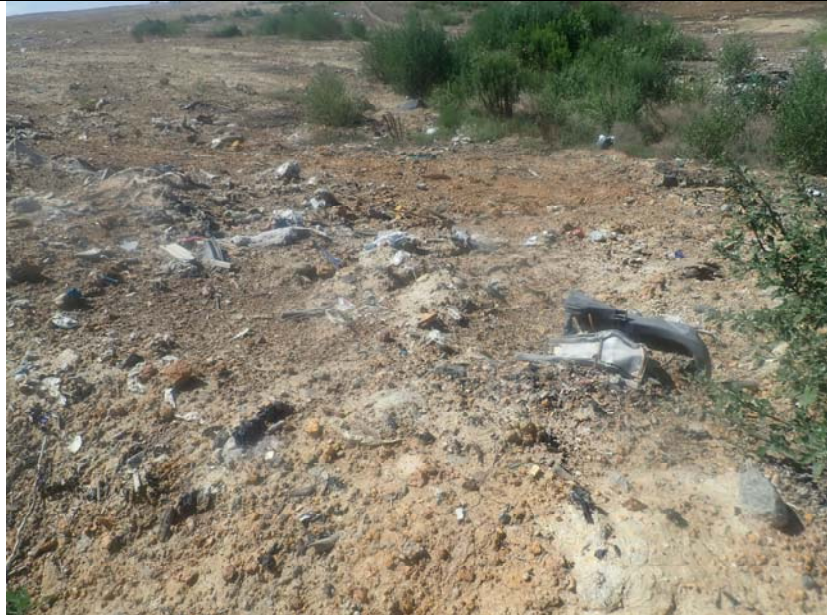
Location	City of Little Rock Class 1			Permit	0266-S1	AFIN	60-01071
Photographer	Kim Davenport	<i>KD</i>		Witness	N/A		
Photo #	9	Of	14	Date	7/31/2023	Time	1125
Description	Exposed waste was observed on the west slope of Cell 5E.

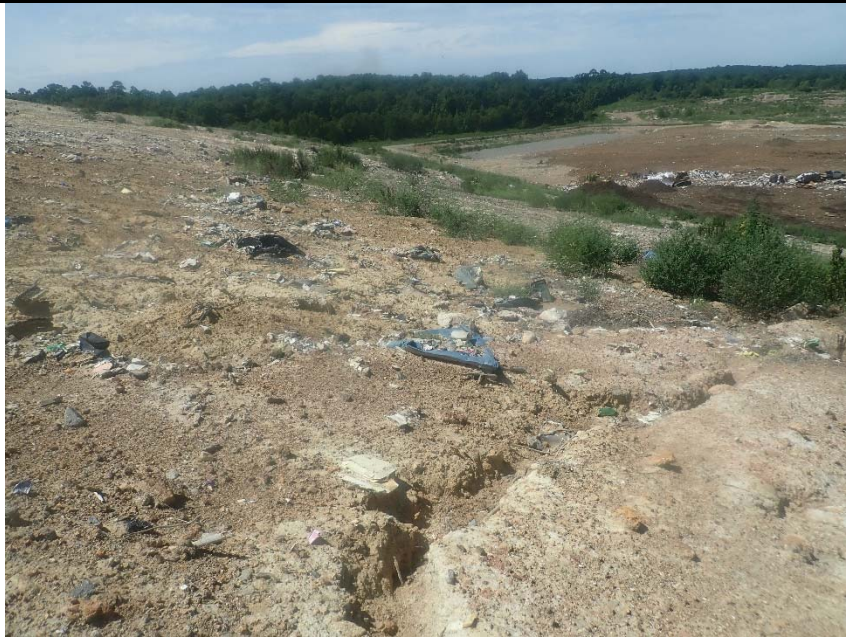
Location	City of Little Rock Class 1			Permit	0266-S1	AFIN	60-01071
Photographer	Kim Davenport	<i>KD</i>		Witness	N/A		
Photo #	10	Of	14	Date	7/31/2023	Time	1127
Description	Exposed waste was observed on the west slope of Cell 5E.

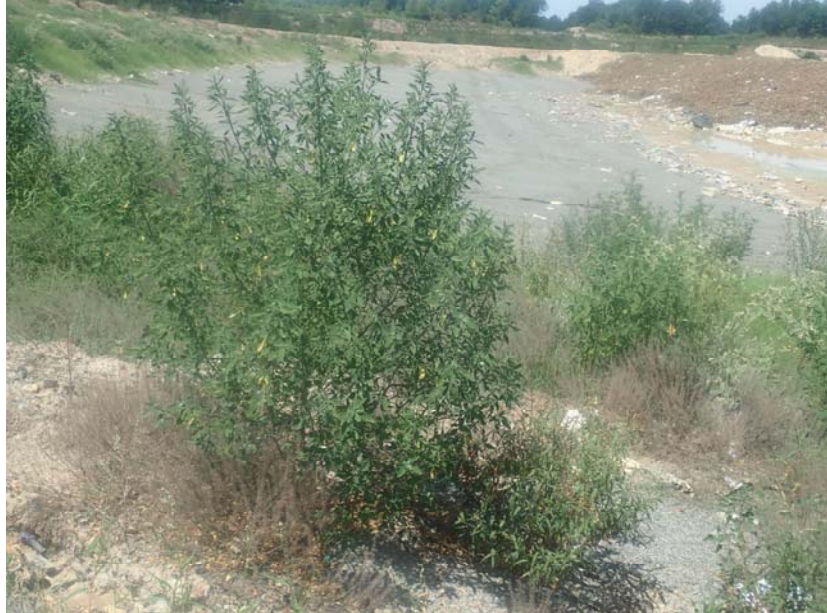
Location	City of Little Rock Class 1			Permit	0266-S1	AFIN	60-01071
Photographer	Kim Davenport		<i>KD</i>	Witness	N/A		
Photo #	13	Of	14	Date	7/31/2023	Time	1203
Description	Vegetation was observed growing through the sand layer of Cell 5W at the unused south end.

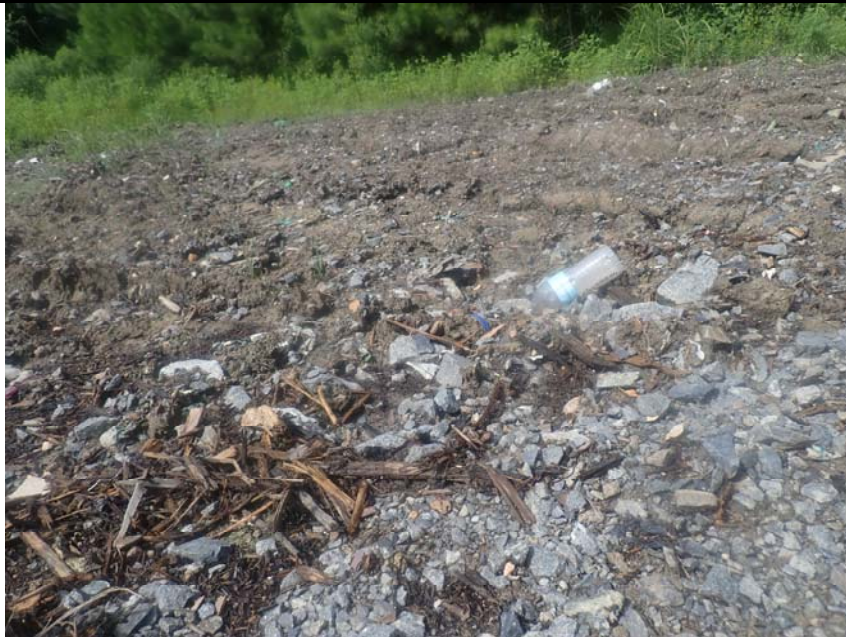
Location	City of Little Rock Class 1			Permit	0266-S1	AFIN	60-01071
Photographer	Kim Davenport		<i>KD</i>	Witness	N/A		
Photo #	14	Of	14	Date	7/31/2023	Time	1037
Description	Partially buried waste was observed in the truck cleanout area, which is off the lined landfill.
