RE: Inspection conducted on September 25, 2023
AFIN 03-00051
Permit Number 0249-S1-R2

**Division of Environmental Quality
Office of Land Resources
Class 1 Landfill Inspection Form**

Site Name	NABORS Class 1 Landfill	County	Baxter	AFIN	03-00051
Facility Address	Hwy 5 N to CR 16 to site entrance- Three Brothers	Phone #	870-688-3822	Permit #	0249-S1-R2
Permittee Address	P.O. Box 1669 Harrison, AR 72602	Email Address	cwsautomotiveandconsulting@gmail.com	PDS #	127666
Date	9/25/2023	Entry Time	1032	Exit Time	1210

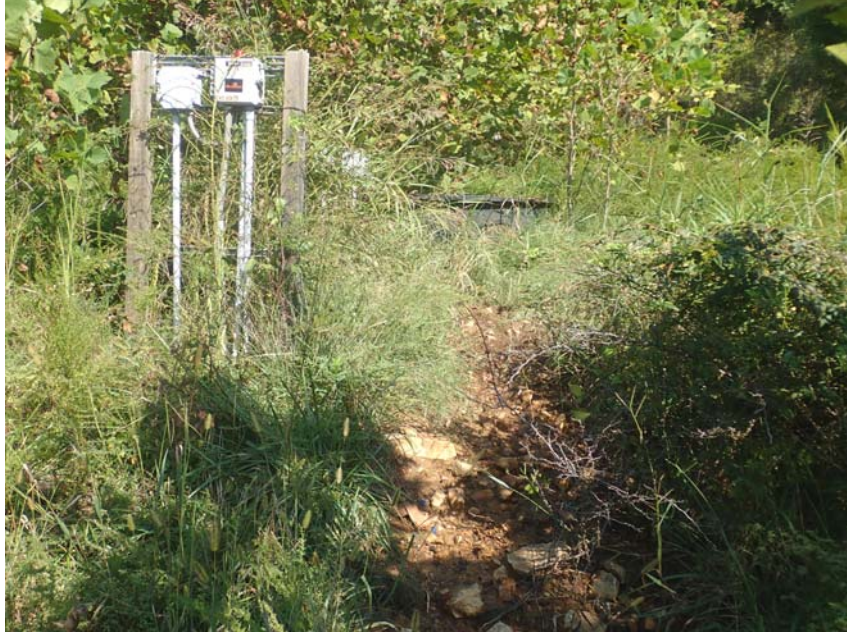
X	417(c) Access and Operational Roads	Road erosion was present between LCS-4 and LCS-5. Vegetative control needed along roads and around the LCS panels. (Refer to Photos #1, #3 and #4.)

Regulation	Item Description	Comments
413(a)(b)(c)	Satisfactory Daily/Alternate/Intermediate Cover	
X	419(a)(5) Cause Discharge/Leachate Leaving Landfill	VLCS-1 sump was observed overflowing. (Refer to Photos #1 and #2.)
	411(f)(3) Depositing Waste in Standing Water Prohibited	
	411(o) Erosion or Other Cover Defects Resulting in Exposed Refuse	
	309(c) Overfill/Off Lined Area

Location	NABORS Class 1			Permit	0249-S1-R2	AFIN	03-00051
Photographer	Darrell Norton, Inspector		<i>DN</i>	Witness	n/a		
Photo #	1	Of	4	Date	9/25/2023	Time	1037
Description	Vegetative growth was observed around VLCS-1. VLCS-1 appears to be failing with leachate overflow visible.

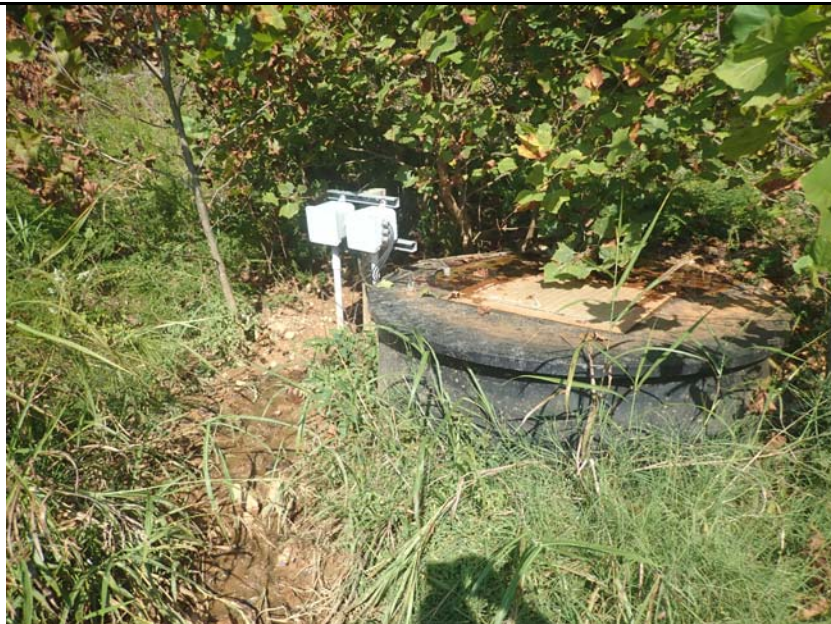
Location	NABORS Class 1			Permit	0249-S1-R2	AFIN	03-00051
Photographer	Darrell Norton, Inspector		<i>DN</i>	Witness	n/a		
Photo #	2	Of	4	Date	9/25/2023	Time	1038
Description	Evidence of leachate overflow from VLCS-1 observed.

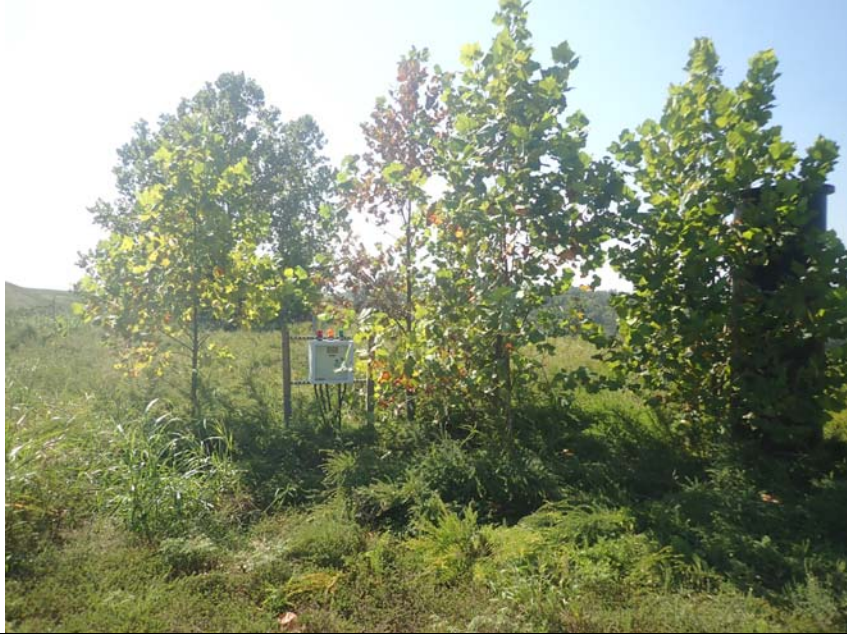
Location	NABORS Class 1			Permit	0249-S1-R2	AFIN	03-00051
Photographer	Darrell Norton, Inspector		<i>DN</i>	Witness	n/a		
Photo #	3	Of	4	Date	9/25/2023	Time	1104
Description	Vegetative growth observed around LCS- 3 panel.

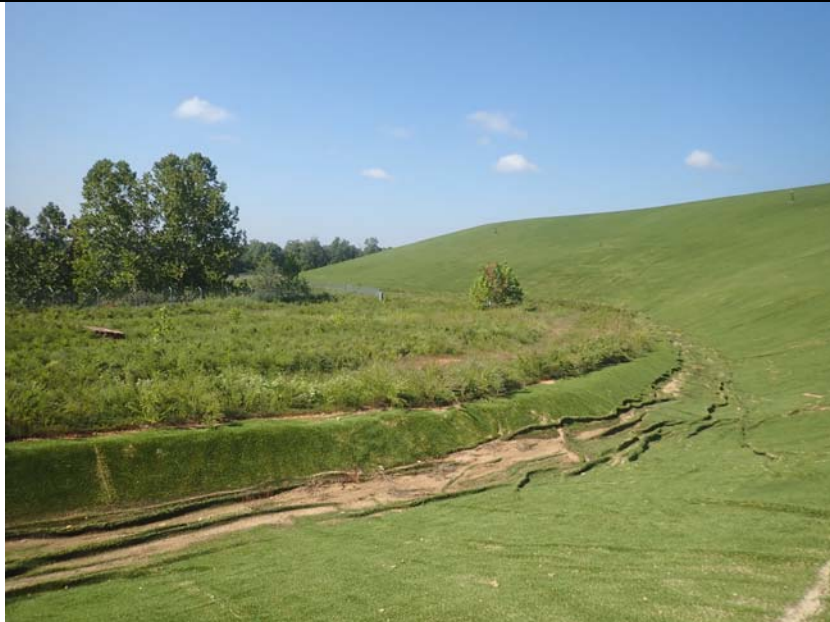
Location	NABORS Class 1			Permit	0249-S1-R2	AFIN	03-00051
Photographer	Darrell Norton, Inspector		<i>DN</i>	Witness	n/a		
Photo #	4	Of	4	Date	9/25/2023	Time	1111
Description	A view of the overgrown access road and turf roll near LCS-4 panel.
