DIVISION OF
ENVIRONMENTAL QUALITY

RE: Inspection conducted on November 13, 2023
AFIN 60-01071
Permit Number 0266-S1

**Division of Environmental Quality
Office of Land Resources
Class 1 Landfill Inspection Form**

Site Name	City of Little Rock	County	Pulaski	AFIN	60-01071
Facility Address	10801 Ironton Cut-Off Rd. Little Rock, AR	Phone #	501-888-4493	Permit #	0266-S1
Permittee Address	10801 Ironton Cut-Off Rd. Little Rock, AR	Email Address	ncharles@littlerock.gov	PDS #	128435
Date	11/13/2023	Entry Time	12:40	Exit Time	13:35

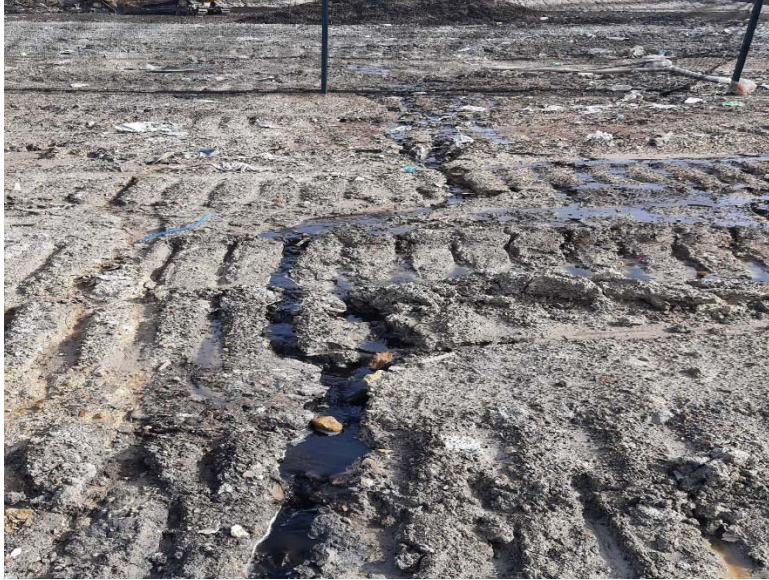
X	427(b)	Surface Water Controls	Run-off (leachate) was observed running from the active portion of the landfill on the west side of Cell 5, across an access road to the storm water ditch, and down to the stormwater pond. (Refer to Photos #1 - #7.)
	411(h)(1)	Contouring Prevents Surface Water Flowing Into or Through Waste	
X	418(b)	Run-off Control System Present and Adequate	Run-off (leachate) from the active portion of the landfill was not being handled in accordance with Reg.22.419 and Reg.22.429. (Refer to Photos #1 - #7.)
	411(h)(2)	Surface Water Control Prevents Off-site Sediment Accumulation	
X	411(i)	Adequate Maintenance of Intermediate/Final Cover Vegetation	Woody vegetation was observed on the west side of Cell 2 in the lined area. (Refer to Photo #8.) No final vegetative cover was observed on Cells 1 and Cell 2. (Refer to Photos #12 and #13.)
	415	Gas Monitoring Program	
	411(o)	Leachate Leaks or Evidence of Leachate Seepage

Location	City of Little Rock Class 1			Permit	0266-S1	AFIN	60-01071
Photographer	Casey Jackson		CJS	Witness	Ryan Hayden		
Photo #	1	Of	13	Date	11/13/2023	Time	12:45
Description	Run-off (leachate) was observed running off of the lined area on the west side of Cell 5.

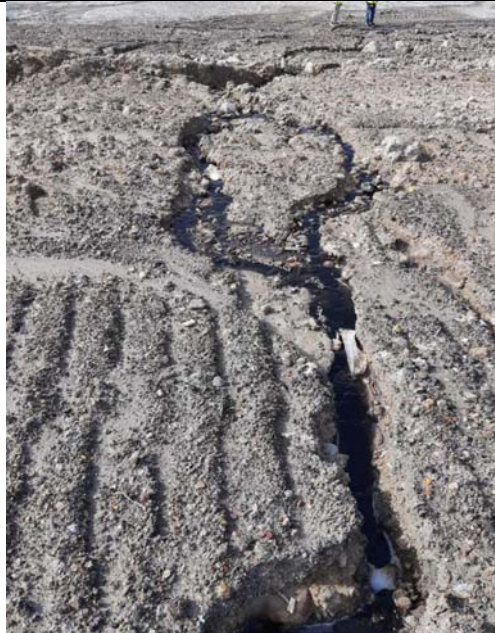
Location	City of Little Rock Class 1			Permit	0266-S1	AFIN	60-01071
Photographer	Casey Jackson		CJS	Witness	Ryan Hayden		
Photo #	2	Of	13	Date	11/13/2023	Time	12:45
Description	Run-off (leachate) was observed running off of the lined area on the west side of Cell 5.

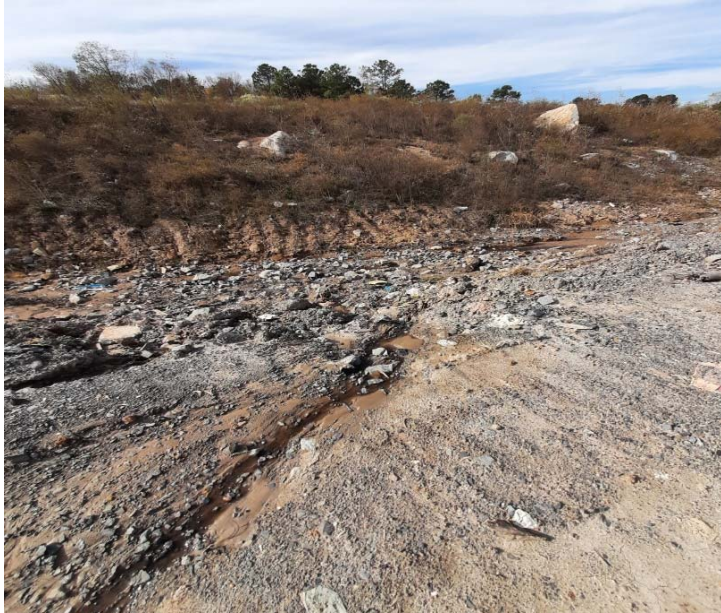
Location	City of Little Rock Class 1			Permit	0266-S1	AFIN	60-01071
Photographer	Casey Jackson		CJJ	Witness	Ryan Hayden		
Photo #	3	Of	13	Date	11/13/2023	Time	12:46
Description	The leachate observed in Photos #1 & #2 flow over the access road and into the stormwater ditch on the opposite side of the road.

Location	City of Little Rock Class 1			Permit	0266-S1	AFIN	60-01071
Photographer	Casey Jackson		CJJ	Witness	Ryan Hayden		
Photo #	4	Of	13	Date	11/13/2023	Time	12:47
Description	Another view of the leachate observed in Photos #1 - #3 flowing over the access road.

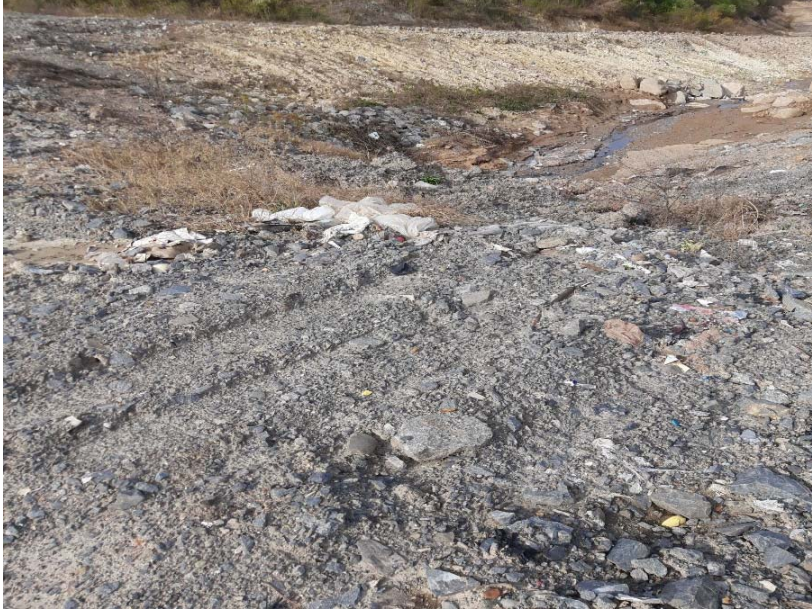
Location	City of Little Rock Class 1			Permit	0266-S1	AFIN	60-01071
Photographer	Casey Jackson		CJJ	Witness	Ryan Hayden		
Photo #	5	Of	13	Date	11/13/2023	Time	12:48
Description	Litter was observed in the storm water drainage ditch, west of Cell 5. This is also the continued path of the leachate flow previously described in Photos #1 - #4.

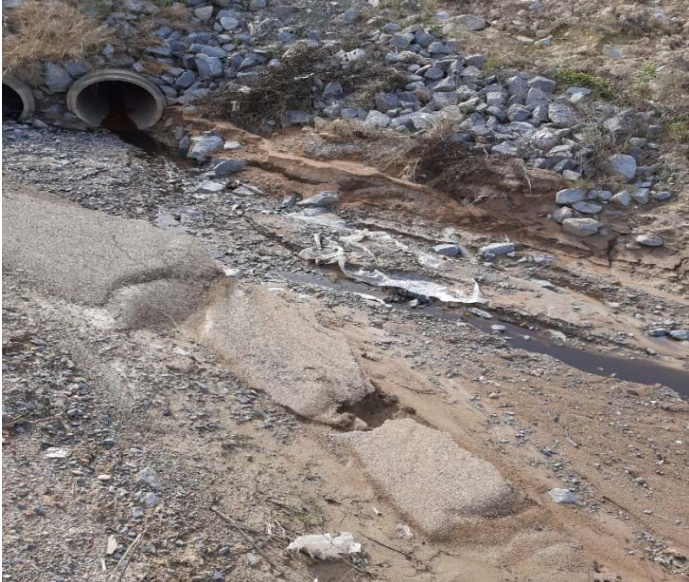
Location	City of Little Rock Class 1			Permit	0266-S1	AFIN	60-01071
Photographer	Casey Jackson		CJJ	Witness	Ryan Hayden		
Photo #	6	Of	13	Date	11/13/2023	Time	12:49
Description	Another view of the litter and leachate flow observed in Photos #1 - #5.

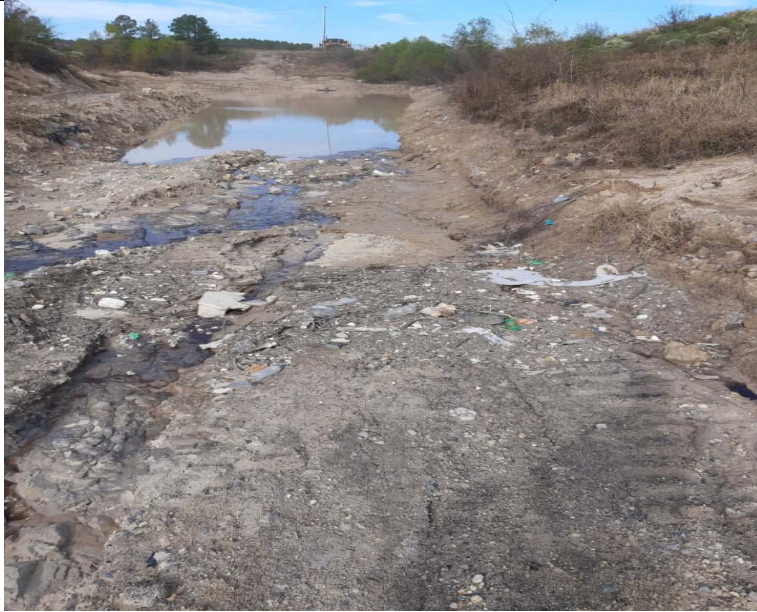
Location	City of Little Rock Class 1	Permit	0266-S1	AFIN	60-01071
Photographer	Casey Jackson	CJJ	Witness Ryan Hayden		
Photo #	7	Of	13	Date	11/13/2023
Description	The stormwater pond is observed in the background. The litter and leachate flow described in Photos #1 - #6 was observed entering the stormwater pond.

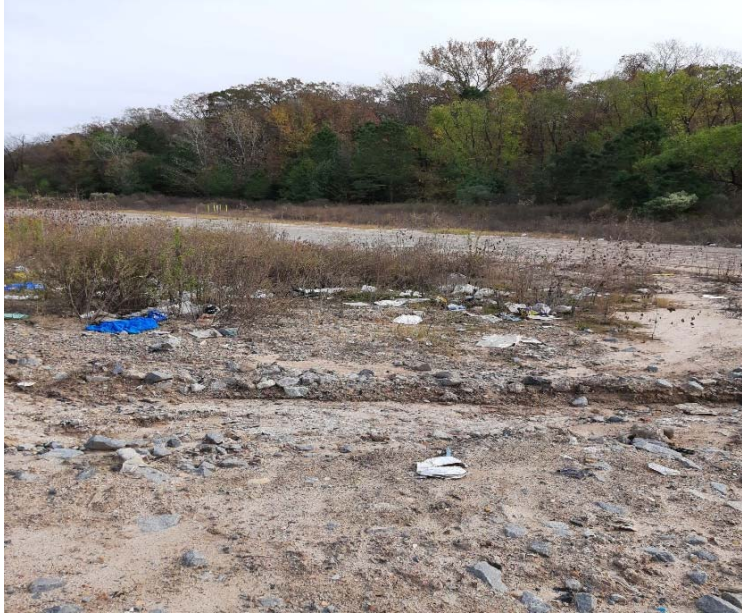
Regulation	Item Description	Comments
X	411(a)	Operations in Accordance with Permit Documents	The last approved Operating Plan (OP) is dated 1996 and requires updating. (Refer to Doc #3716, dated July 26, 1996.) An OP (Doc #60665) was submitted in 2011 but has never been approved and is now also out of date. Alternate daily cover (ADC) was observed on the exterior slope of Cell 9, above Cell 2, email sent on August 14, 2023 to request approval but no letter from DEQ stating that the request was approved. (Refer to Photos #12 and #13.)
	411(c)	Smallest Practical Area, Unloading Supervised, Single Working Face	
	411(b)	Operations by Licensed On-site Personnel at All Times	
X	411(g)	Litter Control Provisions Maintained	Litter was observed entering and surrounding the unlined storm water collection area, located northwest of Cell 5, and in the unused south portion of Cell 5W. (Refer to Photos #5 - #7.) Litter was also observed on the west side of Cell 2 and on the south side of Cell 4. (Refer to Photos #8 and #9.)

Location	City of Little Rock Class 1			Permit	0266-S1	AFIN	60-01071
Photographer	Casey Jackson		CJJ	Witness	Ryan Hayden		
Photo #	9	Of	13	Date	11/13/2023	Time	12:52
Description	Litter was observed on the side of road on the south side of Cell 4.

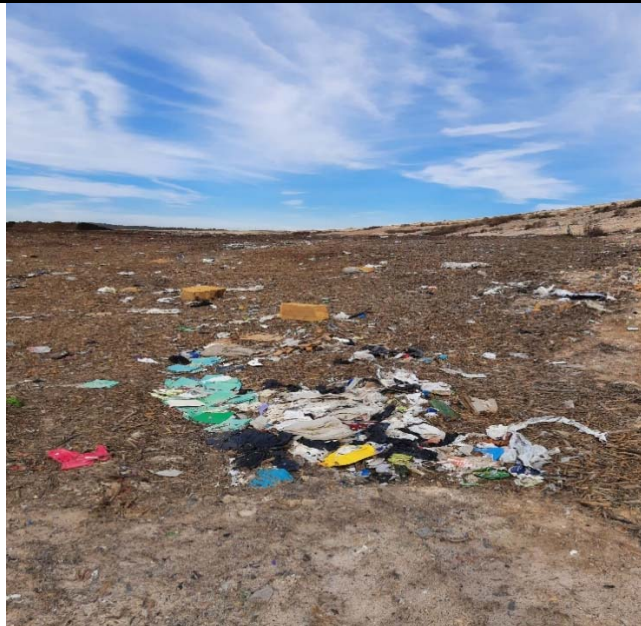
Regulation	Item Description	Comments
X	413(b)	Satisfactory Alternate Cover Materials	Solid waste was observed in the active portion of the landfill without enough alternate daily cover material to sufficiently cover the waste. (Refer to Photos #10 and #11.)

Location	City of Little Rock Class 1			Permit	0266-S1	AFIN	60-01071
Photographer	Casey Jackson		CJJ	Witness	Ryan Hayden		
Photo #	10	Of	13	Date	11/13/2023	Time	12:53
Description	Solid waste was observed in the active portion of the landfill without enough alternate daily cover material to sufficiently cover the waste.

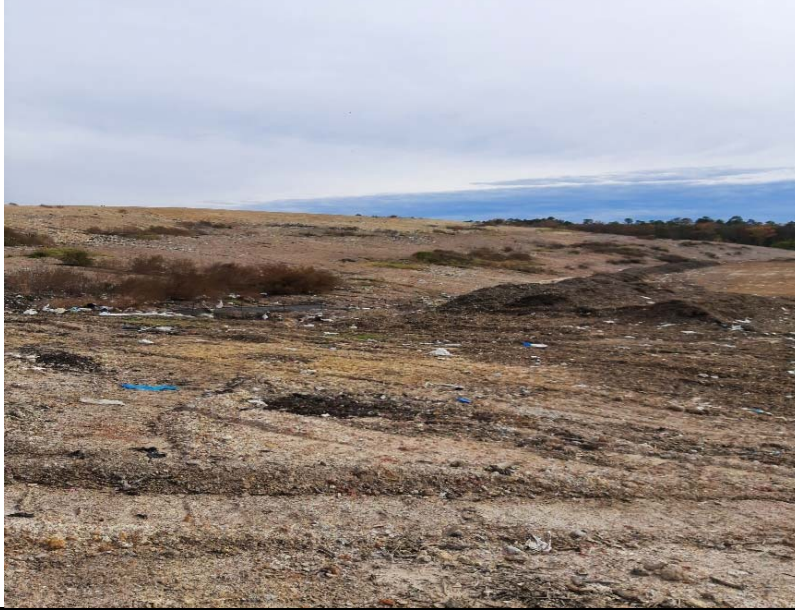
Location	City of Little Rock Class 1			Permit	0266-S1	AFIN	60-01071
Photographer	Casey Jackson		CJJ	Witness	Ryan Hayden		
Photo #	11	Of	13	Date	11/13/2023	Time	12:55
Description	Solid waste was observed in the active portion of the landfill without enough alternate daily cover material to sufficiently cover the waste.

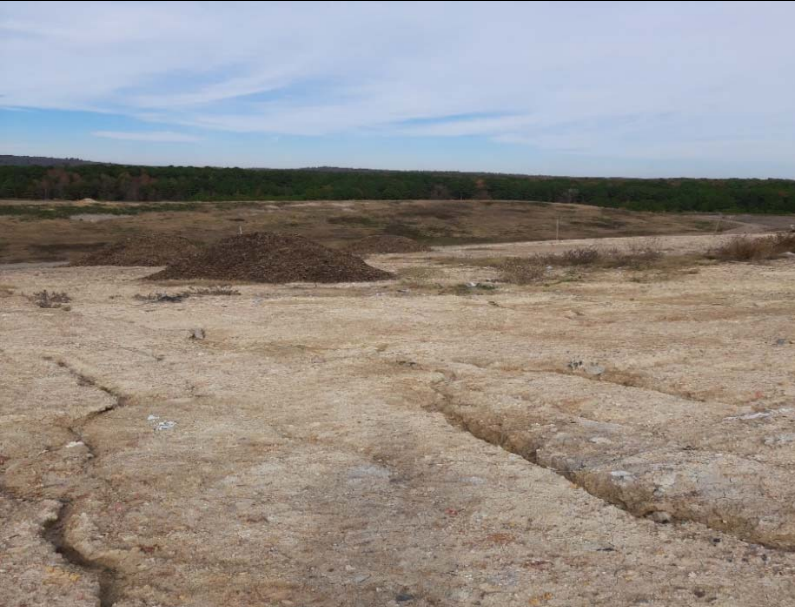
419(a)(5)	Cause Discharge/Leachate Leaving Landfill	
	411(f)(3)	Depositing Waste in Standing Water Prohibited	
X	411(o)	Erosion or Other Cover Defects Resulting in Exposed Refuse	Erosion rills and exposed waste was observed on Cell 1 and Cell 2. (Refer to Photos #12 and #13.)
	309(c)	Overfill/Off Lined Area

Location	City of Little Rock Class 1			Permit	0266-S1	AFIN	60-01071
Photographer	Casey Jackson		CJJ	Witness	Ryan Hayden		
Photo #	12	Of	13	Date	11/13/2023	Time	12:55
Description	Erosion rills and piles of unauthorized alternate cover were observed staged on the north side of Cell 1. No final vegetative cover observed.
