DIVISION OF
ENVIRONMENTAL QUALITY

RE: Inspection conducted on December 13, 2023
AFIN 72-00144
Permit Number 0290-S1-R4

**Division of Environmental Quality
Office of Land Resources
Class 1 Landfill Inspection Form**

Site Name	Eco-Vista Class 1 Landfill	County	Washington	AFIN	72-00144
Facility Address	2210 Waste Management Drive, Springdale, AR 72762	Phone #	870-510-0174	Permit #	0290-S1-R4
Permittee Address	2210 Waste Management Drive, Springdale, AR 72762	Email Address	bsmall@wm.com dtenniso@wm.com	PDS #	128611
Date	12/13/2023	Entry Time	1210	Exit Time	1436

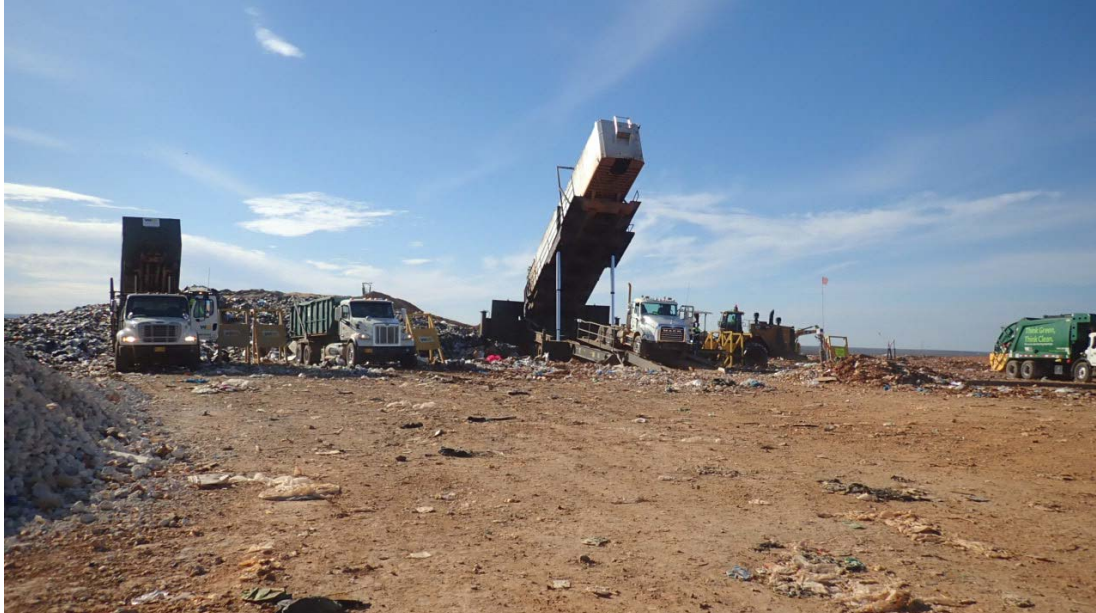
Location	Eco-Vista Class 1 Landfill			Permit	0290-S1-R4	AFIN	72-00144
Photographer	Jason Gilkey - Inspector		JEG	Witness	NA		
Photo #	1	Of	8	Date	12/13/2023	Time	1511
Description	Overall view of the working face unloading lanes, looking to the west.

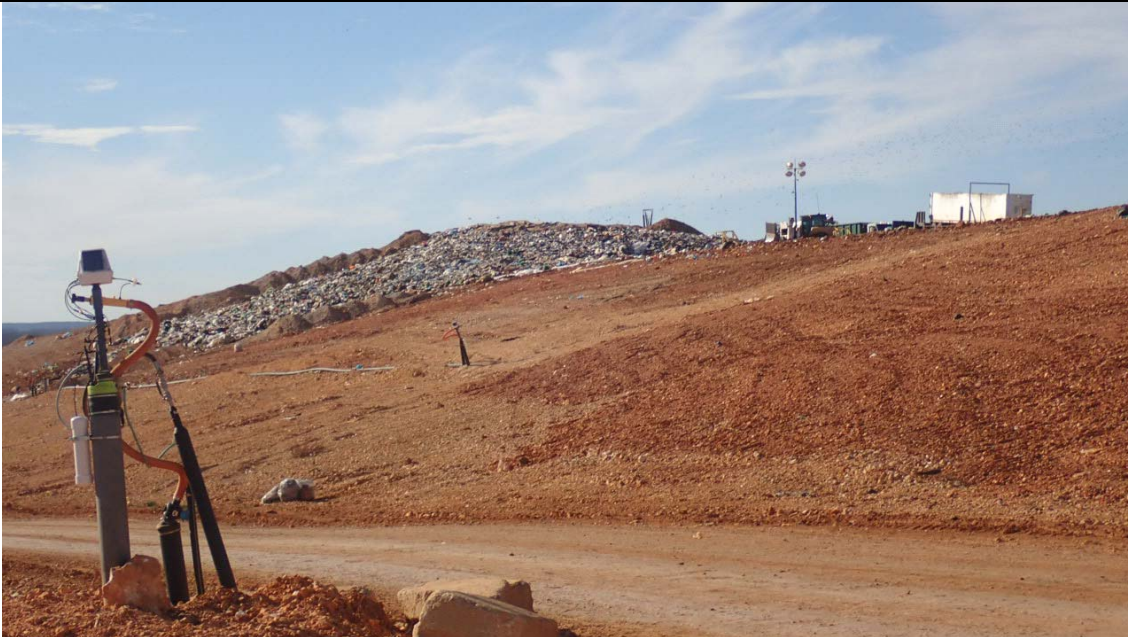
Location	Eco-Vista Class 1 Landfill			Permit	0290-S1-R4	AFIN	72-00144
Photographer	Jason Gilkey - Inspector		JEG	Witness	NA		
Photo #	2	Of	8	Date	12/13/2023	Time	1313
Description	Overall view of the working face from below, looking to the north-northwest.

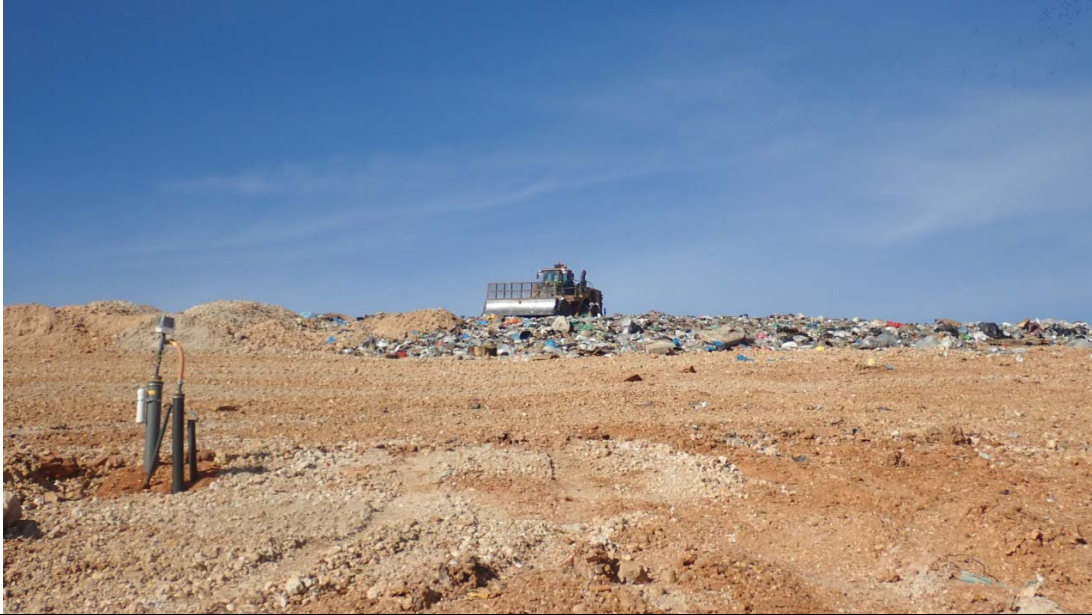
Location	Eco-Vista Class 1 Landfill				Permit	0290-S1-R4	AFIN	72-00144
Photographer	Jason Gilkey - Inspector			JEG	Witness	NA		
Photo #	3	Of	8		Date	12/13/2023	Time	1303
Description	Overall view of the working face from access road, looking north.

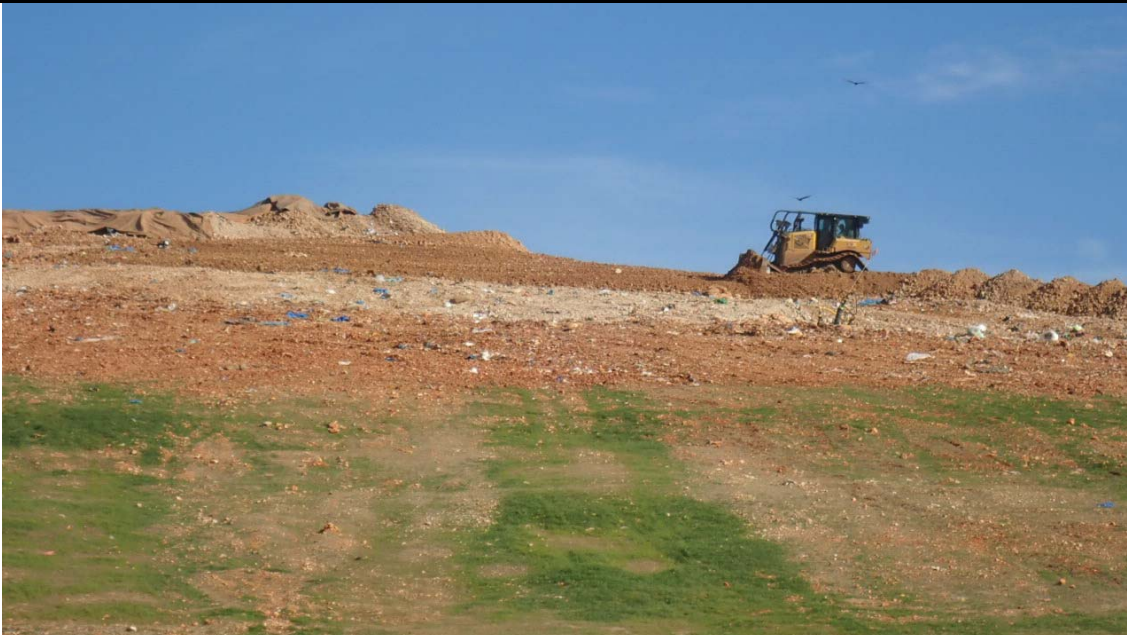
Location	Eco-Vista Class 1 Landfill				Permit	0290-S1-R4	AFIN	72-00144
Photographer	Jason Gilkey - Inspector			JEG	Witness	NA		
Photo #	4	Of	8		Date	12/13/2023	Time	1424
Description	A view of the previous working face from earlier in the day, looking east.

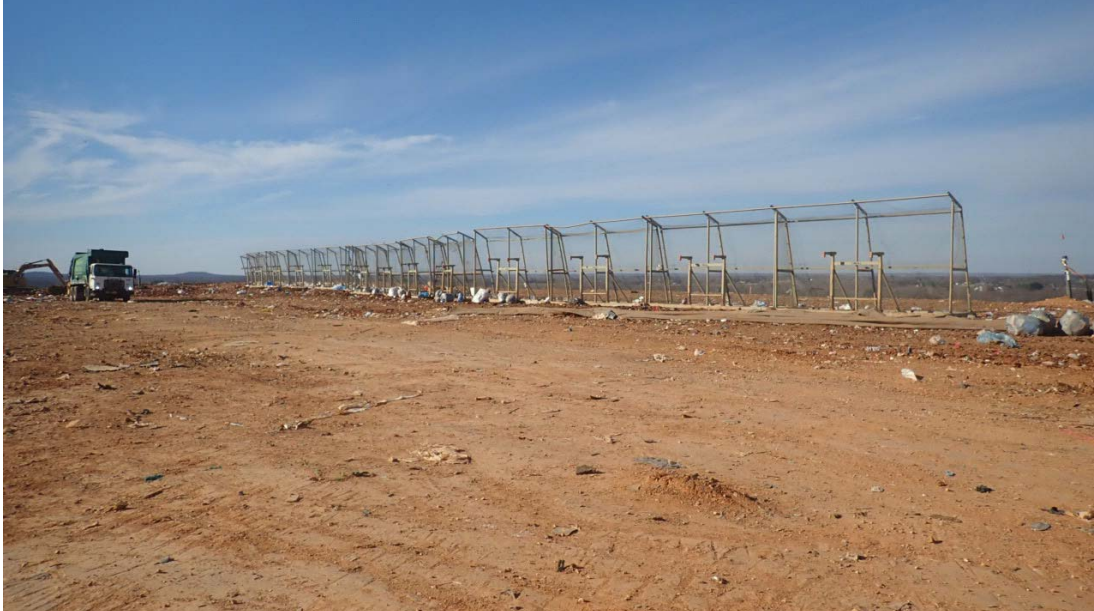
Location	Eco-Vista Class 1 Landfill				Permit	0290-S1-R4	AFIN	72-00144
Photographer	Jason Gilkey - Inspector		JG		Witness	NA		
Photo #	5	Of	8		Date	12/13/2023	Time	1510
Description	A view of the litter control fence on the north edge of the working face, facing northwest.

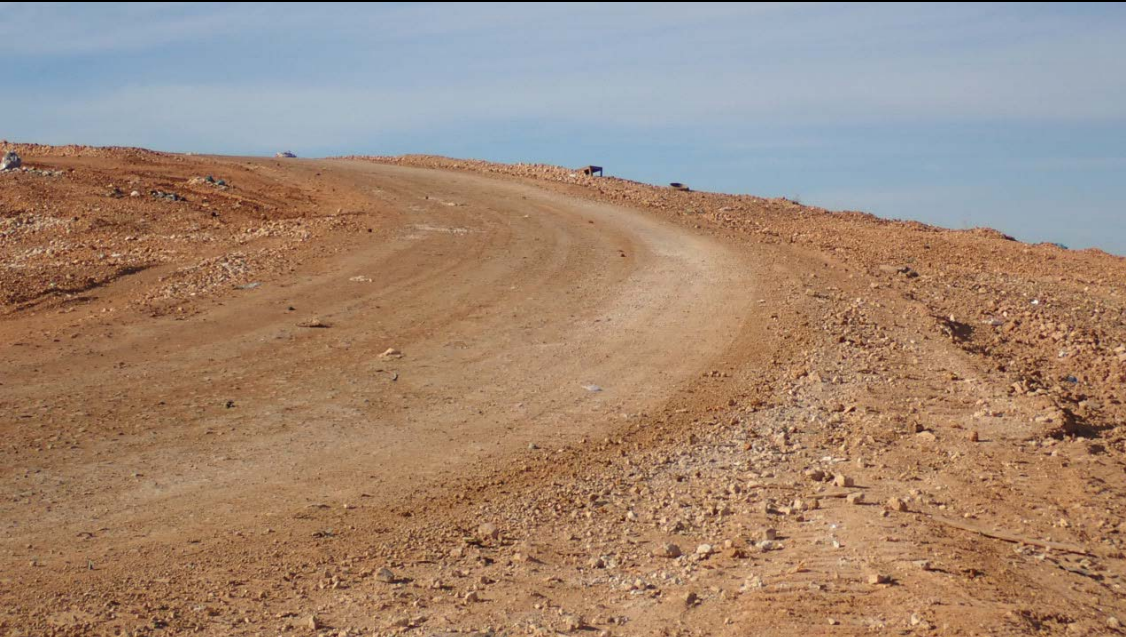
Location	Eco-Vista Class 1 Landfill				Permit	0290-S1-R4	AFIN	72-00144
Photographer	Jason Gilkey - Inspector		JG		Witness	NA		
Photo #	6	Of	8		Date	12/13/2023	Time	1307
Description	A view of the access road up the landfill slope to the working face, looking east.

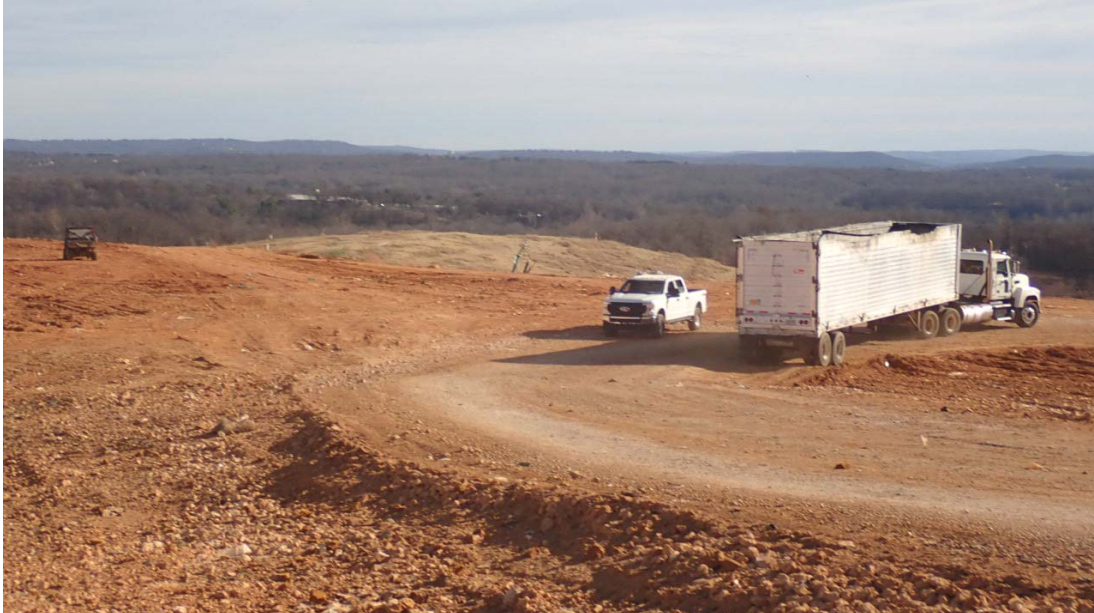
Location	Eco-Vista Class 1 Landfill			Permit	0290-S1-R4	AFIN	72-00144
Photographer	Jason Gilkey - Inspector			Witness	NA		
Photo #	7	Of	8	Date	12/13/2023	Time	1308
Description	Another view of the access road leading to the working face, looking southeast.

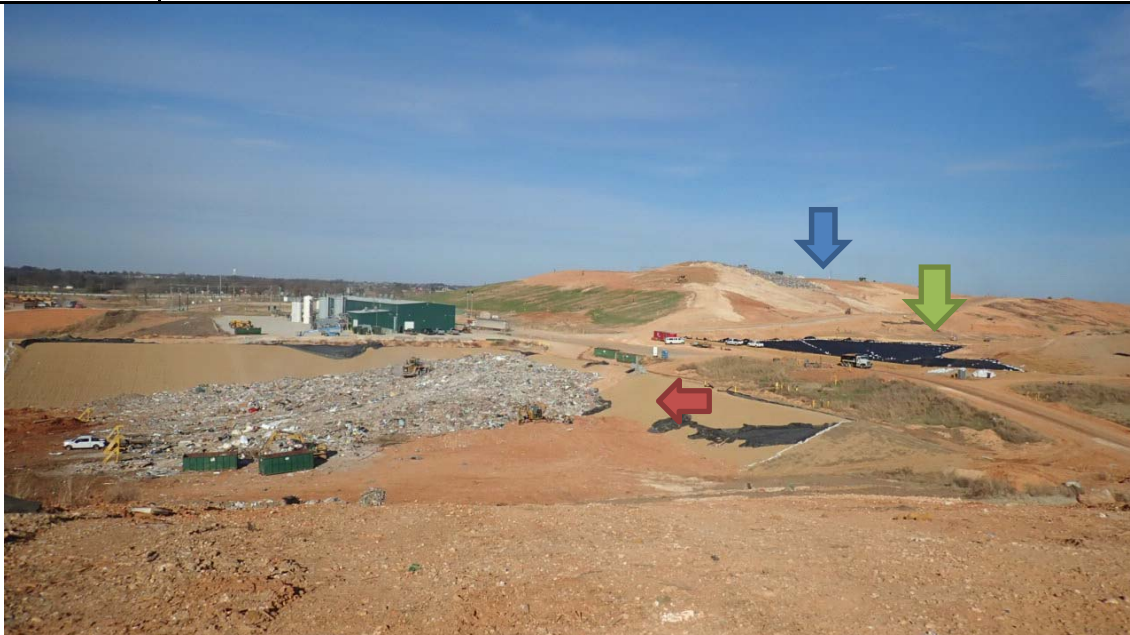
Location	Eco-Vista Class 1 Landfill			Permit	0290-S1-R4	AFIN	72-00144
Photographer	Jason Gilkey - Inspector			Witness	NA		
Photo #	8	Of	8	Date	12/13/2023	Time	1518
Description	An overview of the Landfill showing the location of the Class 1 working face (blue), the new liner construction (green) and the Class 4 working face (red), facing northeast.
