DIVISION OF
ENVIRONMENTAL QUALITY

RE: Inspection conducted on December 20, 2023
AFIN 03-00051
Permit Number 0249-S1-R2

**Division of Environmental Quality
Office of Land Resources
Class 1 Landfill Inspection Form**

Site Name	NABORS Landfill	County	Baxter	AFIN	03-00051
Facility Address	Hwy 5 N to CR 16 to site entrance- Three Brothers	Phone #	870-688-3822	Permit #	0249-S1-R2
Permittee Address	P.O. Box 1669 Harrison, AR 72602	Email Address	chuckwseaton@gmail.com judge@baxtercounty.org	PDS #	128709
Date	12/20/2023	Entry Time	1051	Exit Time	1200

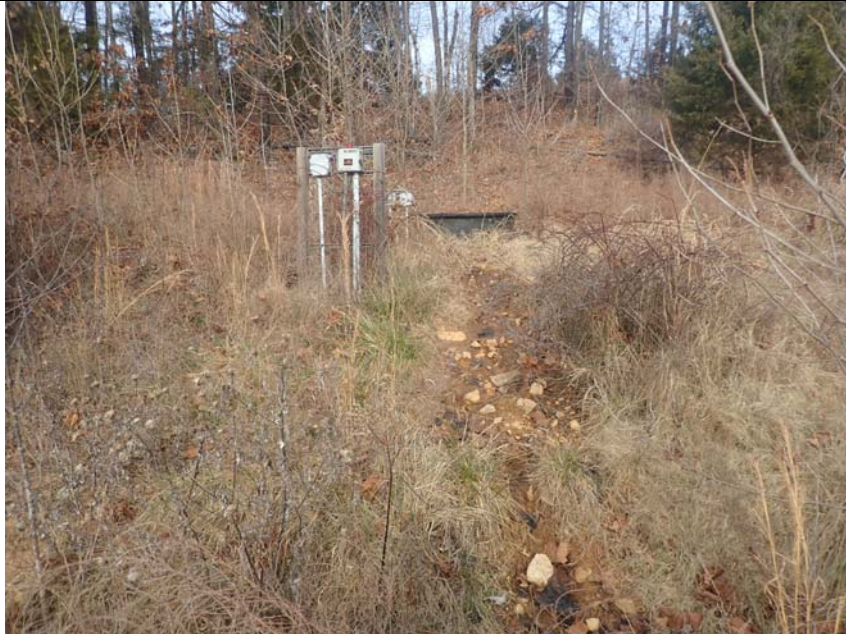
Regulation	Item Description	Comments
	413(a)(b)(c) Satisfactory Daily/Alternate/Intermediate Cover	
X	419(a)(5) Cause Discharge/Leachate Leaving Landfill	VLCS-1 sump observed overflowing. (Refer to Photos #1 and #2.)
	411(f)(3) Depositing Waste in Standing Water Prohibited	
	411(o) Erosion or Other Cover Defects Resulting in Exposed Refuse	
	309(c) Overfill/Off Lined Area

Location	NABORS Class 1			Permit	0249-S1-R2	AFIN	03-00051
Photographer	Darrell Norton, Inspector		<i>DN</i>	Witness	n/a		
Photo #	1	Of	4	Date	12/20/2023	Time	1052
Description	Vegetative growth around VLCS-1. VLCS-1 appears to be failing with leachate overflow visible.

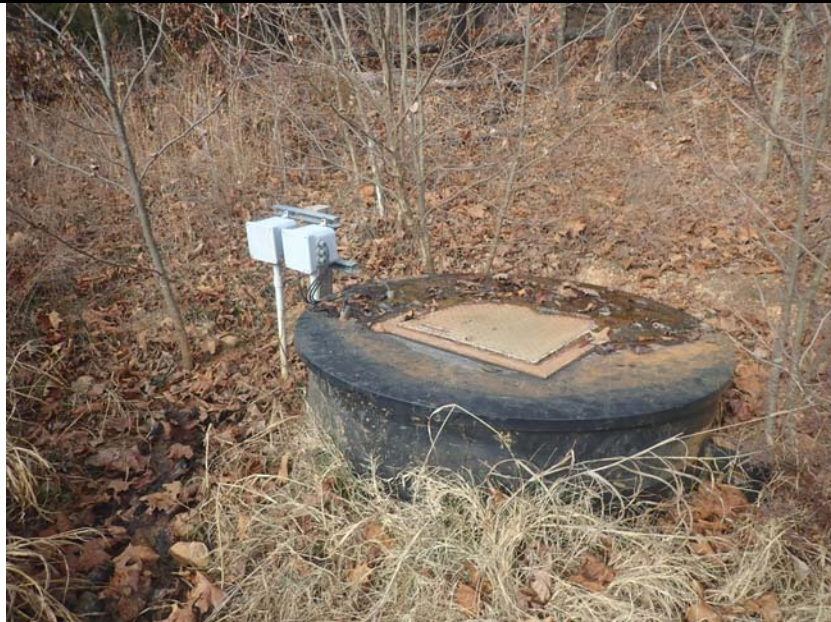
Location	NABORS Class 1			Permit	0249-S1-R2	AFIN	03-00051
Photographer	Darrell Norton, Inspector		<i>DN</i>	Witness	n/a		
Photo #	2	Of	4	Date	12/20/2023	Time	1053
Description	Apparent leachate overflow observed from VLCS-1 basin.

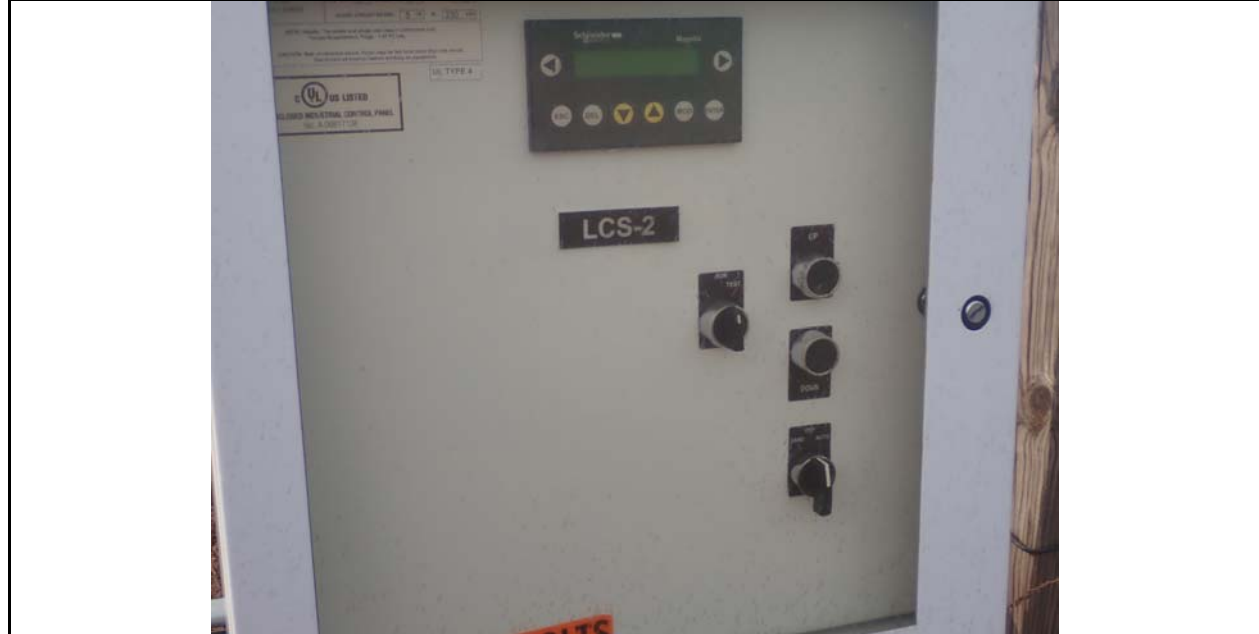
Regulation	Item Description	Comments
411(a)	Operations in Accordance with Permit Documents	
411(c)	Smallest Practical Area, Unloading Supervised, Single Working Face	
411(b)	Operations by Licensed On-site Personnel at All Times	
411(g)	Litter Control Provisions Maintained	
427	Surface Water Controls	
411(h)(1)	Contouring Prevents Surface Water Flowing Into or Through Waste	
418(a)(b)	Run-on/off Control System Present and Adequate	
411(h)(2)	Surface Water Control Prevents Off-site Sediment Accumulation	
X	411(i) Adequate Maintenance of Intermediate/Final Cover Vegetation	Turf roll and damage observed in multiple areas. Woody vegetation observed in the final cover system. (Refer to photo #4.)
	415 Gas Monitoring Program	
	411(o) Leachate Leaks or Evidence of Leachate Seepage	
X	429 Leachate Collection System	Multiple LCS panels observed with the pump control in the off position. Multiple LCS panels observed lacking a head level read-out. The leachate system does not currently provide information as to the head level present on the bottom liner. (Refer to Photo #3.)

Location	NABORS Class 1			Permit	0249-S1-R2	AFIN	03-00051
Photographer	Darrell Norton, Inspector		<i>DN</i>	Witness	n/a		
Photo #	3	Of	4	Date	12/20/2023	Time	1102
Description	LCS 2 observed with the pump in the off position. Multiple LCS panels observed with the pump in the off position.

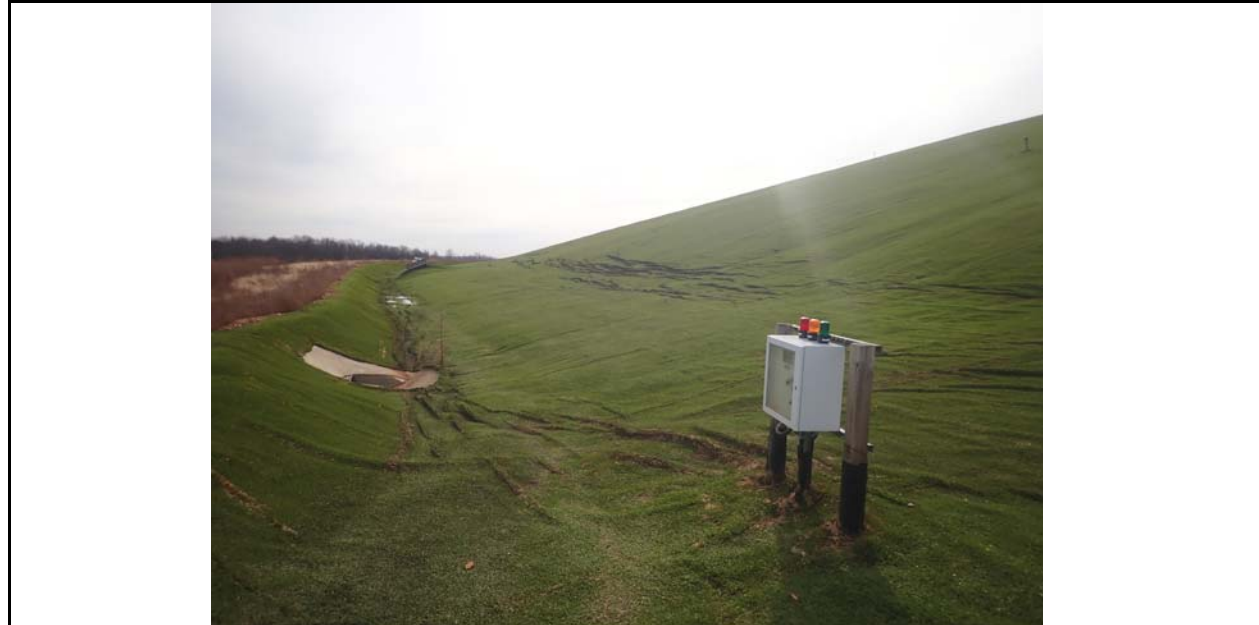
Location	NABORS Class 1			Permit	0249-S1-R2	AFIN	03-00051
Photographer	Darrell Norton, Inspector		<i>DN</i>	Witness	n/a		
Photo #	4	Of	4	Date	12/20/2023	Time	1119
Description	Turf roll and woody vegetation observed near LCS 6.
