DIVISION OF
ENVIRONMENTAL QUALITY

RE: Inspection conducted on December 19, 2023
AFIN 72-00144
Permit Number 0290-S1-R4

**Division of Environmental Quality
Office of Land Resources
Class 1 Landfill Inspection Form**

Site Name	Eco-Vista Class 1 Landfill	County	Washington	AFIN	72-00144
Facility Address	2210 Waste Management Drive, Springdale, AR 72762	Phone #	870-510-0174	Permit #	0290-S1-R4
Permittee Address	2210 Waste Management Drive, Springdale, AR 72762	Email Address	bsmall@wm.com dtenniso@wm.com	PDS #	128753
Date	12/19/2023	Entry Time	1245	Exit Time	1450

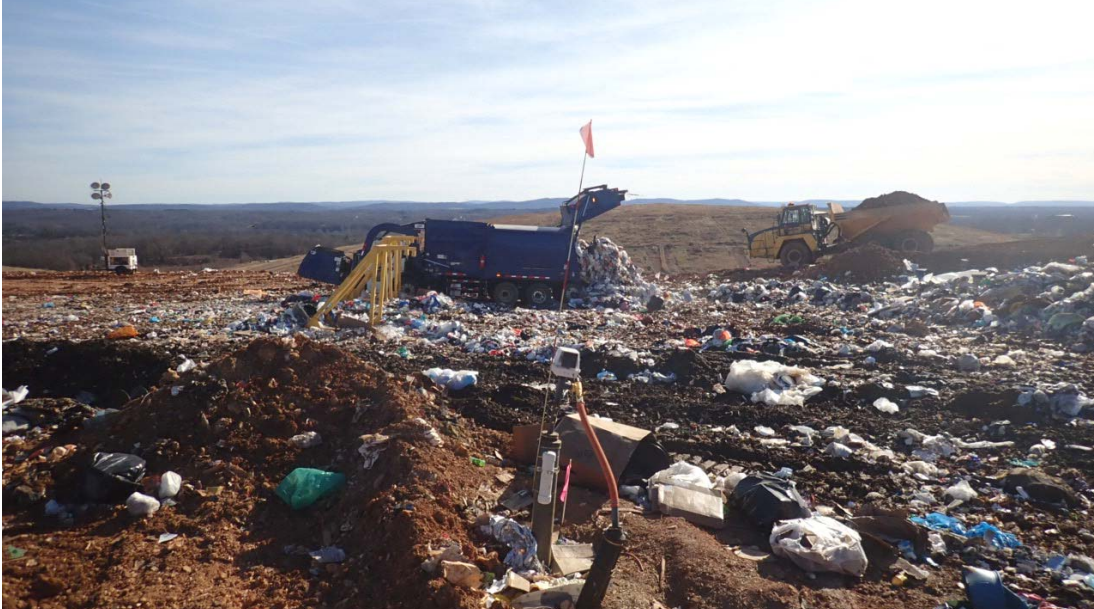
Location	Eco-Vista Class 1 Landfill				Permit	0290-S1-R4	AFIN	72-00144
Photographer	Jason Gilkey - Inspector			JEG	Witness	NA		
Photo #	1	Of	8		Date	12/19/2023	Time	1431
Description	Overall view of the working face unloading lanes, looking to the east.

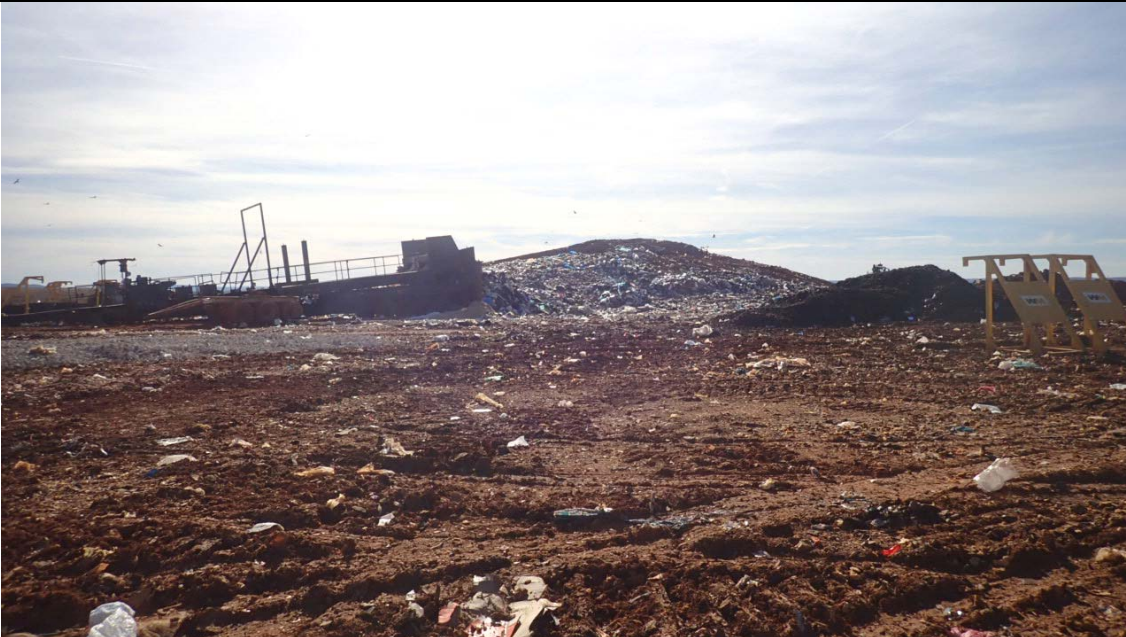
Location	Eco-Vista Class 1 Landfill				Permit	0290-S1-R4	AFIN	72-00144
Photographer	Jason Gilkey - Inspector			JEG	Witness	NA		
Photo #	2	Of	8		Date	12/19/2023	Time	1429
Description	Overall view of the working face, looking to the east.

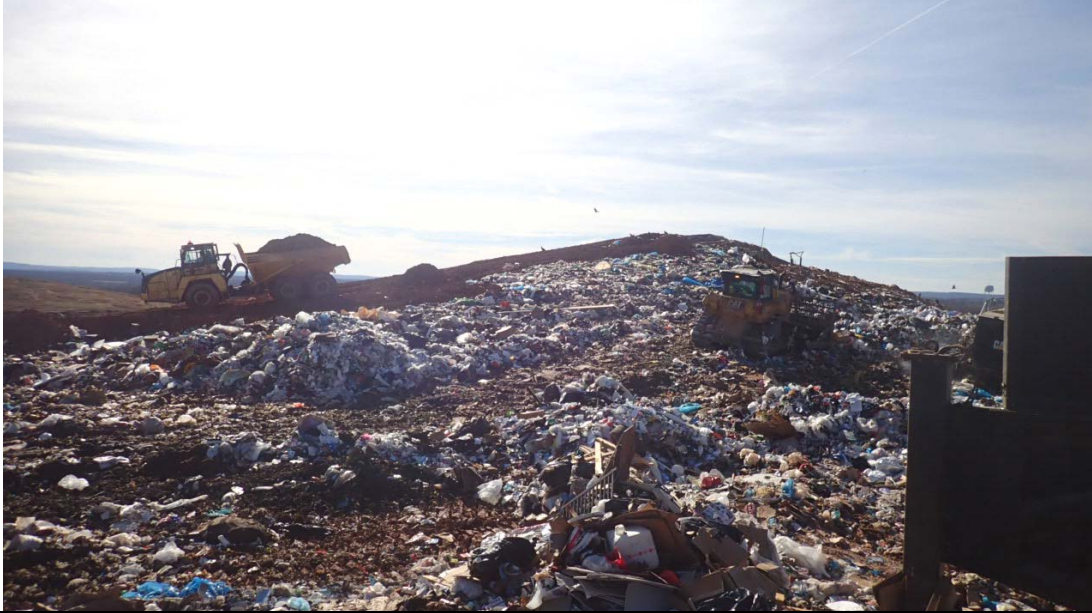
Location	Eco-Vista Class 1 Landfill	Permit	0290-S1-R4	AFIN	72-00144
Photographer	Jason Gilkey - Inspector	SEG	Witness	NA	
Photo #	3	Of	8	Date	12/19/2023
Description	Another view of the working face being spread, compacted, and covered with soil, looking to the east.

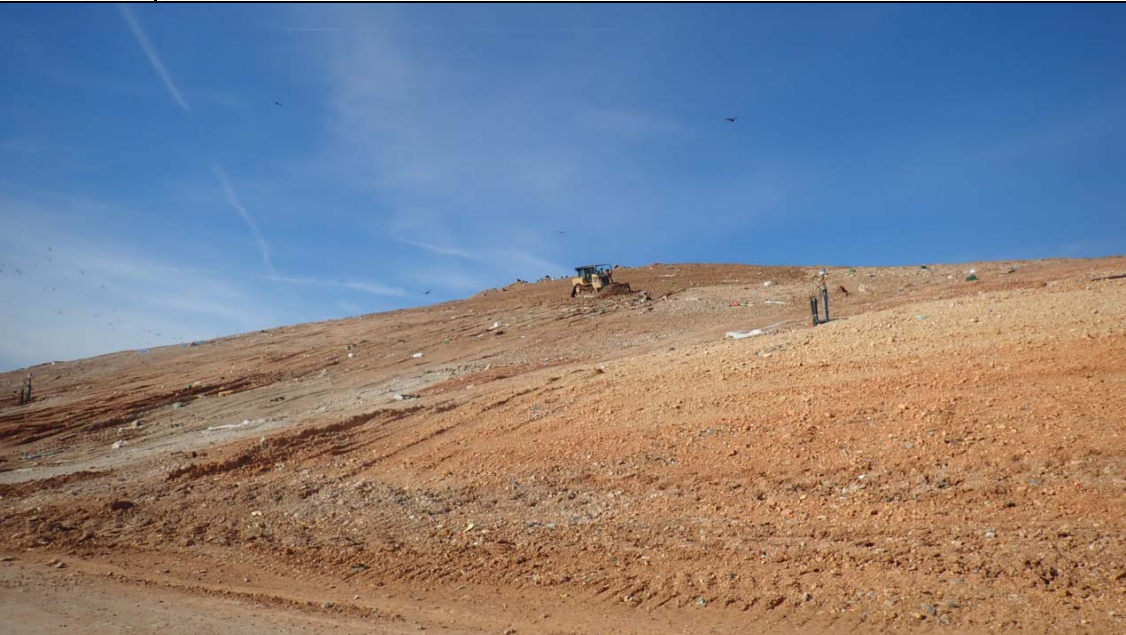
Location	Eco-Vista Class 1 Landfill	Permit	0290-S1-R4	AFIN	72-00144
Photographer	Jason Gilkey - Inspector	SEG	Witness	NA	
Photo #	4	Of	8	Date	12/19/2023
Description	A view of the previous working face from earlier in the day, looking northwest.

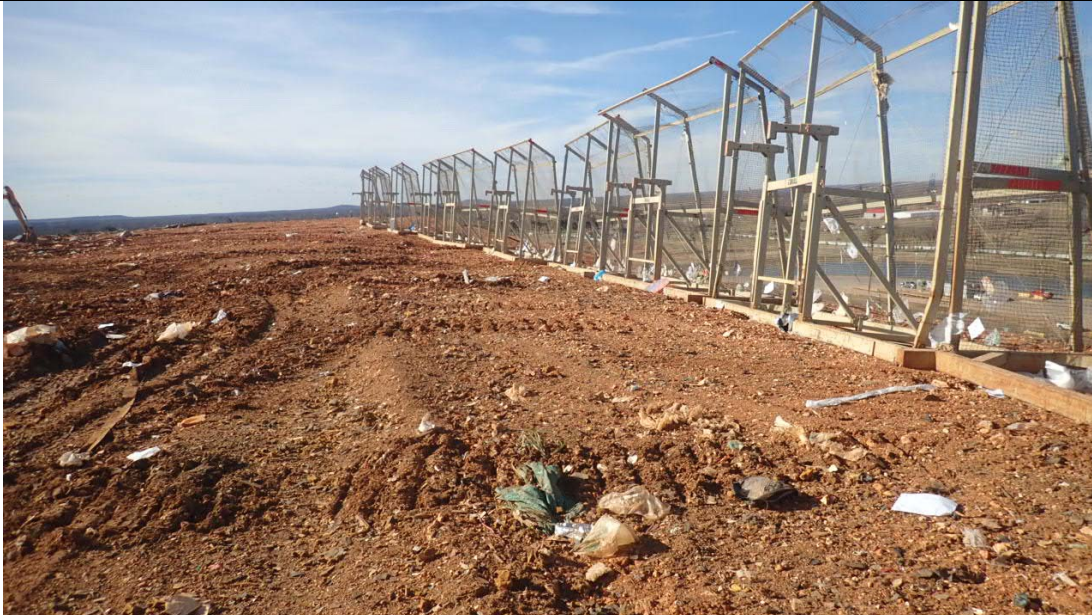
Location	Eco-Vista Class 1 Landfill				Permit	0290-S1-R4	AFIN	72-00144
Photographer	Jason Gilkey - Inspector		JEG		Witness	NA		
Photo #	5	Of	8		Date	12/19/2023	Time	1429
Description	A view of the litter control fence on the north edge of the working face, facing northwest.

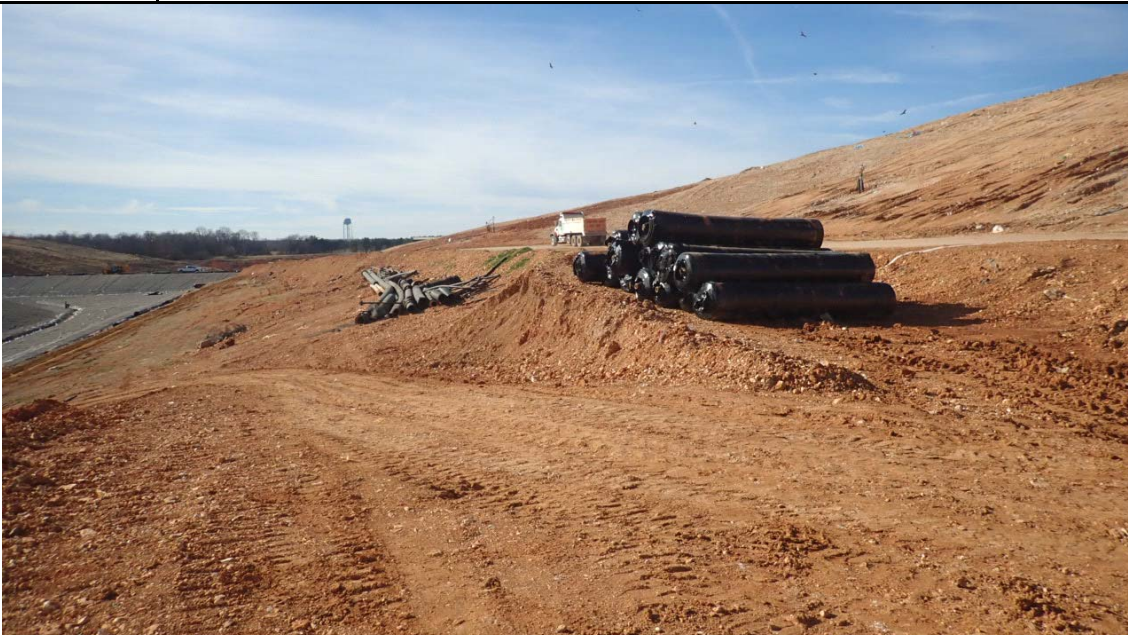
Location	Eco-Vista Class 1 Landfill				Permit	0290-S1-R4	AFIN	72-00144
Photographer	Jason Gilkey - Inspector		JEG		Witness	NA		
Photo #	6	Of	8		Date	12/19/2023	Time	1420
Description	A view of the access road up the landfill slope to the working face, and new liner materials stacked looking west.

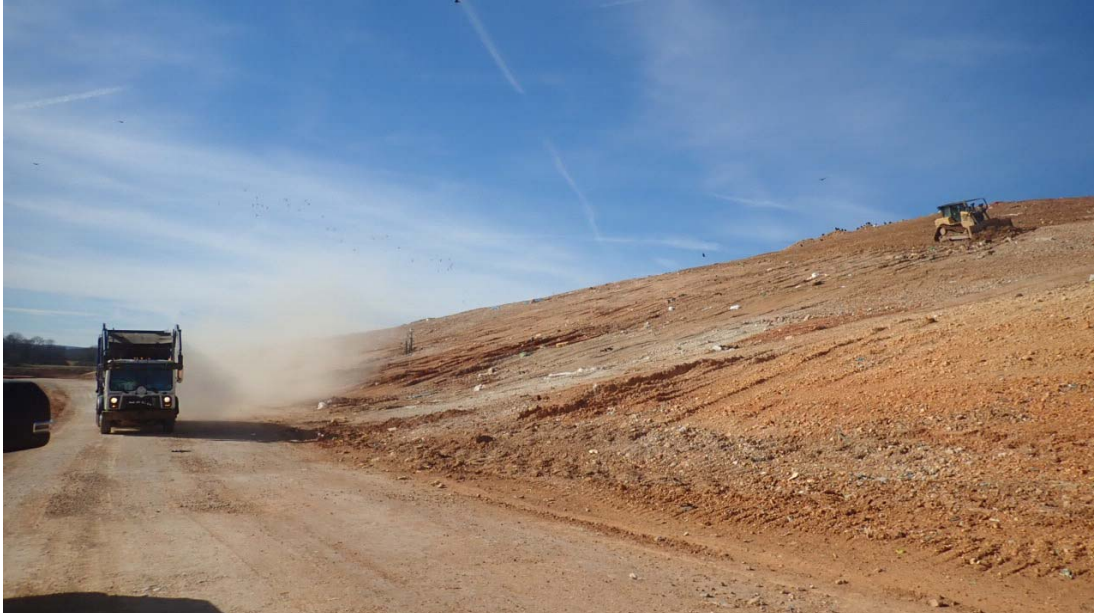
Location	Eco-Vista Class 1 Landfill			Permit	0290-S1-R4	AFIN	72-00144
Photographer	Jason Gilkey - Inspector			<i>JEG</i>	Witness	NA	
Photo #	7	Of	8	Date	12/19/2023	Time	1419
Description	Another view of the access road leading to the working face, looking southeast.

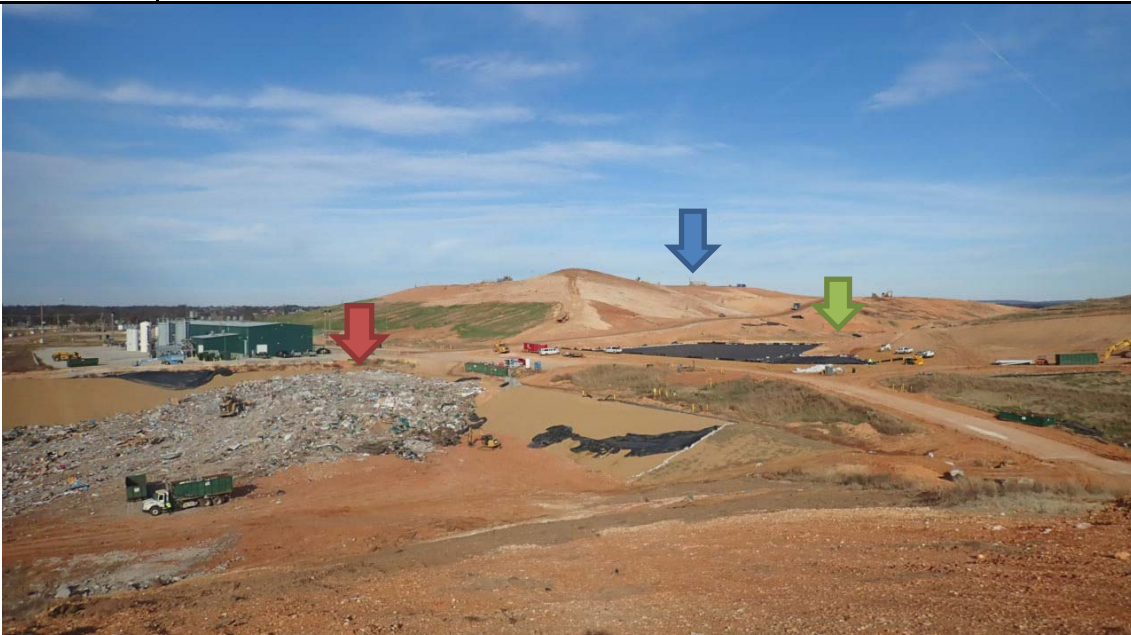
Location	Eco-Vista Class 1 Landfill			Permit	0290-S1-R4	AFIN	72-00144
Photographer	Jason Gilkey - Inspector			<i>JEG</i>	Witness	NA	
Photo #	8	Of	8	Date	12/19/2023	Time	1535
Description	An overview of the Landfill showing the location of the Class 1 working face (blue), the new liner construction (green) and the Class 4 working face (red), facing northeast.
