DIVISION OF
ENVIRONMENTAL QUALITY

RE: Inspection conducted on January 2, 2024
AFIN 60-01071
Permit Number 0266-S1

**Division of Environmental Quality
Office of Land Resources
Class 1 Landfill Inspection Form**

Division of Environmental Quality Official Photograph Sheet

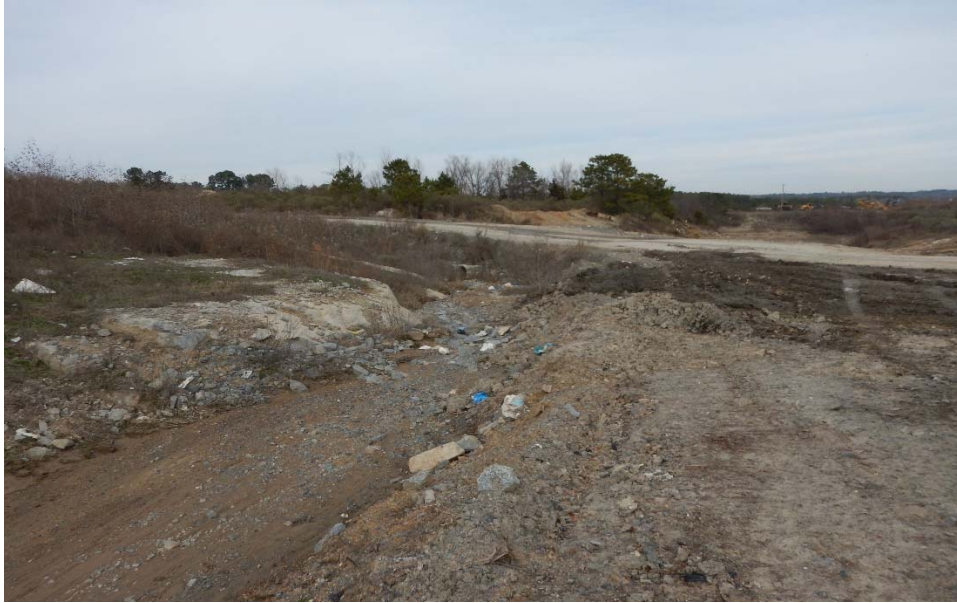
| Photo # | 1 | Of | 8 | Date | 1/2/2024 | Time | 11:11 |

| | Regulation | Item Description | Comments |
|---|---|--|---|
| X | 411(g) | Litter Control Provisions Maintained | Litter was observed entering and surrounding the unlined storm water collection area, located northwest of Cell 5, and in the unused south portion of Cell 5W. (Refer to Photos #1 & #2.) Litter was also observed along the road on the south side of Cell 4 & 5. (Refer to Photo #8.) |

| Description | Litter was observed in the storm water drainage ditch. | | | | | | |

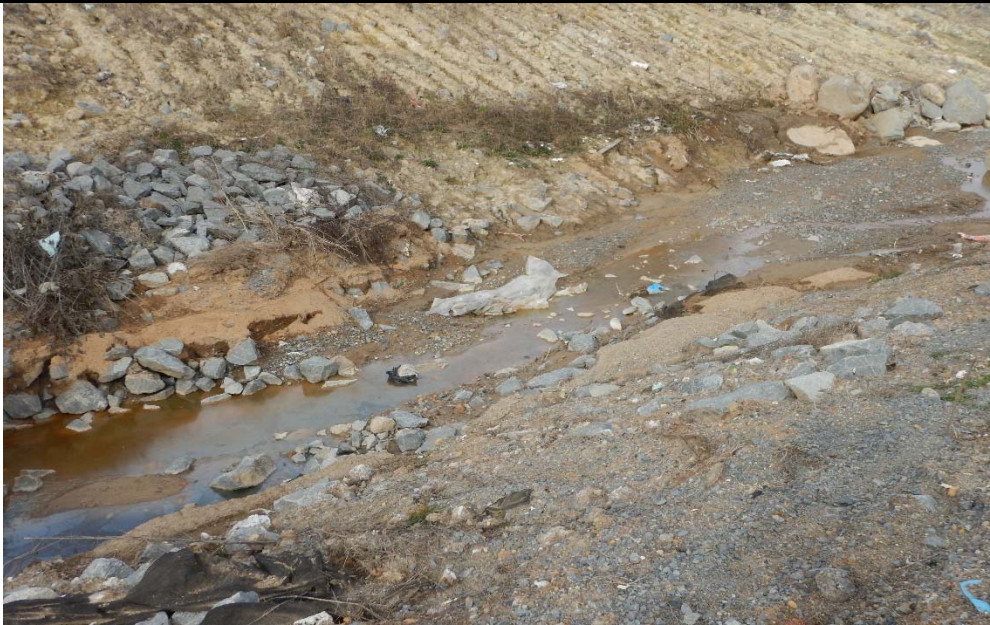
| Photo # | 2 | Of | 8 | Date | 1/2/2024 | Time | 11:13 |

| Description | Another view of litter observed in the stormwater drainage ditch. | | | | | | |

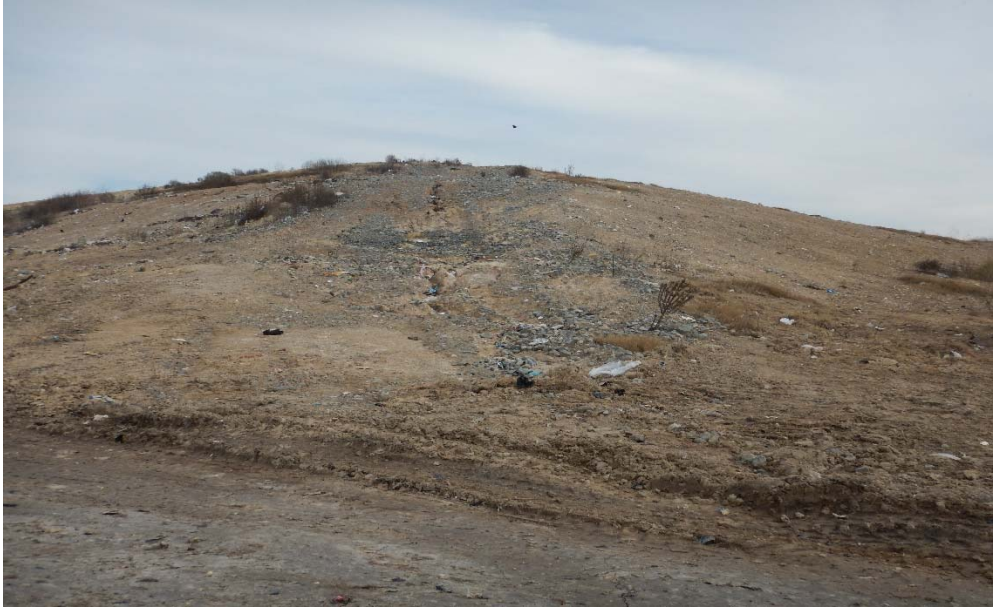
| Photo # | 3 | Of | 8 | Date | 1/2/2024 | Time | 11:19 |

| | Regulation | Item Description | Comments |
|---|---|--|--|
| X | 411(o) | Erosion or Other Cover Defects Resulting in Exposed Refuse | Erosion rills and exposed waste was observed on southwest corner of Cell 4. (Refer to Photos #3 & #4.) |

| Description | Erosion rill and exposed waste on the southwest corner of Cell 4. | | | | | | |

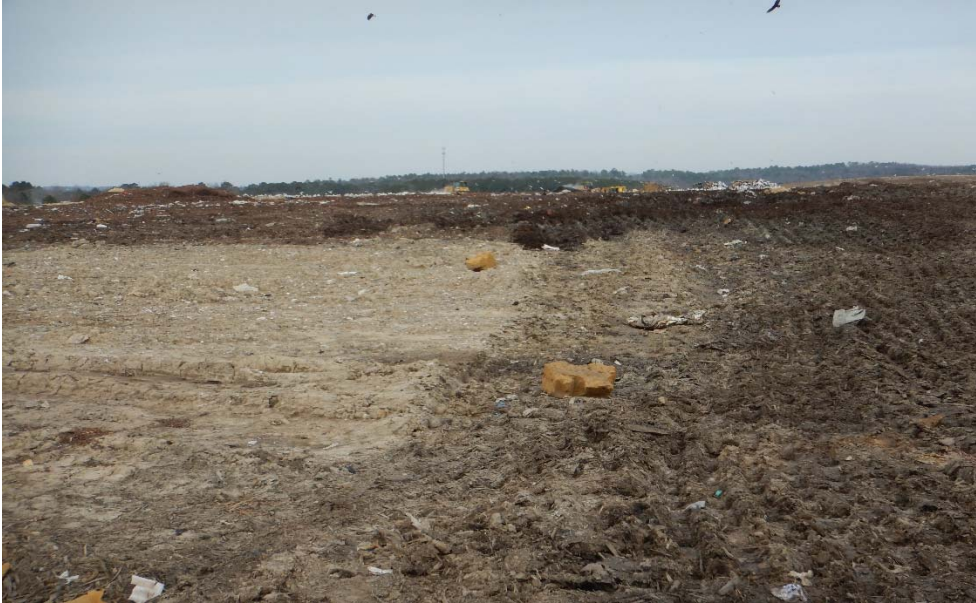
| Photo # | 7 | Of | 8 | Date | 1/2/2024 | Time | 11:19 |

| | Regulation | Item Description | Comments |
|---|---|--|--|
| X | 413(b) | Satisfactory Alternate Cover Materials | Solid waste was observed in the active portion of the landfill without enough alternate daily cover material to sufficiently cover the waste. (Refer to Photos #5 - #7.) |

| Description | Solid waste was observed in the active portion of the landfill without enough alternate daily cover material to sufficiently cover the waste. | | | | | | |

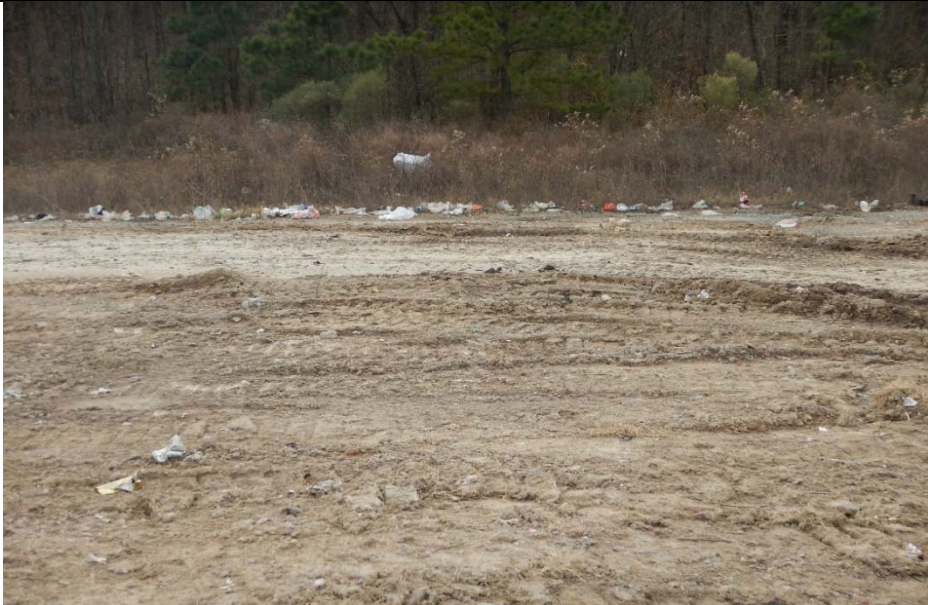
| Photo # | 8 | Of | 8 | Date | 1/2/2024 | Time | 11:24 |

| Description | Solid waste (blown litter) was observed off the lined area along the road way, south of Cell 4 and 5. | | | | | | |
