NOTICE OF NON-COMPLIANCE

RE: Notice of Non-Compliance and Order to Cease Off-Site Tracking of Sediment NPDES Permit No.: ARR000231, AFIN 72-00144

OFFICE OF WATER QUALITY INSPECTION REPORT

AFIN: **72-00144** PERMIT #: **ARR000231** DATE: 2/21/2024

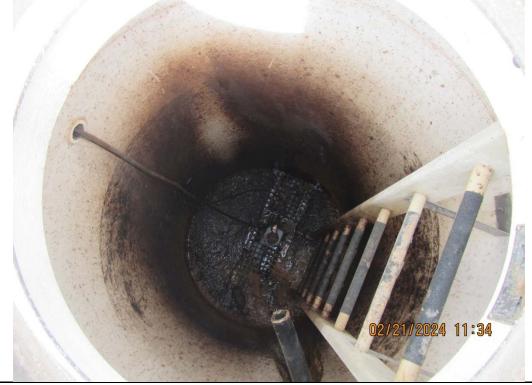
Office of Water Quality Photographic Evidence Sheet Location: Eco-Vista, LLC Photographer: Austin Hawes Date: 2/21/2024 Time: 11:34 Witness: John Roark, Amy Honeycutt, William Cody Photo #: 1 Description: Manhole location with gravity feed from the facility into sewer system. No odors.

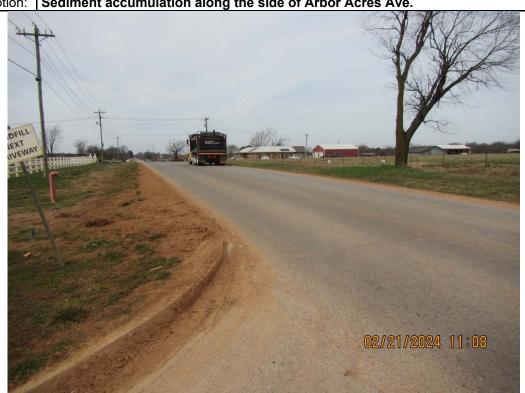
- 1. There is evidence of sediment tracking onto Arbor Acres Avenue as well as sediment accumulation along the side of the road from sweeper activity. This accumulation of loose sediment off-site is in violation of Part 3.1 of the permit and the Arkansas Code Annotated § 8-4-217(a)(2).
- 2. It is required that the facility include all existing measures and controls in the Stormwater Pollution Prevention Plan (SWPPP) during the Industrial Stormwater General Permit renewal process in accordance with Part 4.2.5 of the permit. It was identified that the wheel wash station is not included in the current SWPPP.

Complaint (PDS# 032209) expressed concerns of off-site tracking of sediment onto Arbor Acres Avenue and other nearby roadways. During the inspection, the roads appeared to have been recently swept and in good condition; however, a significant amount of loose sediment could be seen accumulating alongside the roads. It was further explained that the facility's sweeper machine kicks the sediment out to the side of the road rather than capturing the sediment in vacuum-like fashion. Inspector Supervisor Amy Honeycutt reiterated the requirement that this sediment cannot be left along the side of the road, as this still is in violation of allowing sediment to be placed off-site and placing sediment in a location where it has potential to discharge off-site and into a waters of the state. Facility personnel informed us that they are awaiting approval for expansion through a Class I permit, and if granted, the facility will be widening Arbor Acres Avenue and installing curbs and storm drain inlets to help minimize the sediment accumulation off-site. It was mentioned that a sweeper operates daily within the facility, and a sweeper operates on the main road usually around rain events. It was expressed that the heavy traffic during typical operating days makes it unsafe for employees to operate the sweeper on the main road.

Photographer:Austin HawesDate:2/21/2024Time:11:08Witness:Amy Honeycutt, William CodyPhoto #:6Description:Sediment accumulation along the side of Arbor Acres Ave.

1. Immediately cease all off-site tracking from the facility onto Arbor Acres Avenue or other adjacent roadways.

- 2. Immediately remove all accumulated sediment from the sides of Arbor Acres Avenue that has resulted from off-site tracking from the facility.
- 3. Within five (5) calendar days of receipt of this letter, submit documentation, including photographs, detailing the corrective actions implemented to resolve the non-compliance set forth above. All documentation of corrective actions shall be submitted via email to the Office of Water Quality Enforcement Branch at water-enforcement-report@adeq.state.ar.us.

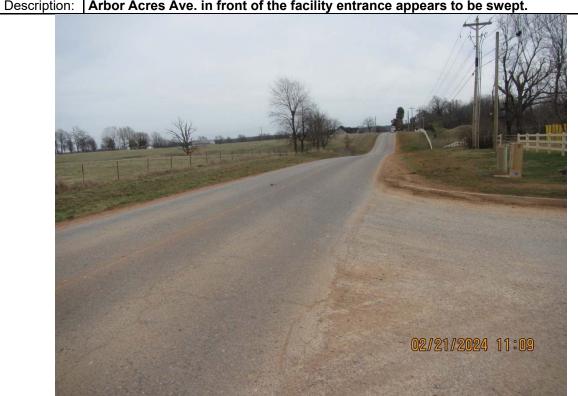
Office of Water Quality Photographic Evidence Sheet							
Location: Eco-Vista, LLC							
Photographer: Austin Hawes Date: 2/21/2024				Time: 1	1:09		
Witness: Amy Honeycutt, William Cody					Photo #:	7	
Description: Arbor Acros Ave. in front of the facility entrance appears to be swent

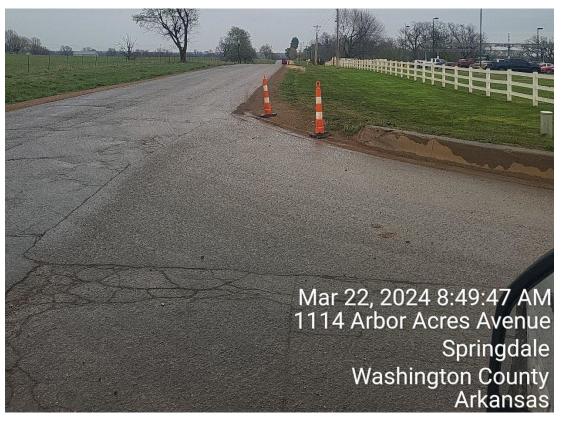
Barriers placed on shoulder at landfill entrance after cleaning

To prevent drivers from leaving the pavement and back dragging sediment onto tires and the road when exiting the facility, Eco-Vista has placed barriers alongside the roadway. The facility has also removed the sediment buildup from Arbor Acres Road and spread straw to stabilize the exposed soil. Eco-Vista personnel is keeping the area maintained weekly or more often as needed. Photographic documentation is provided as an attachment.

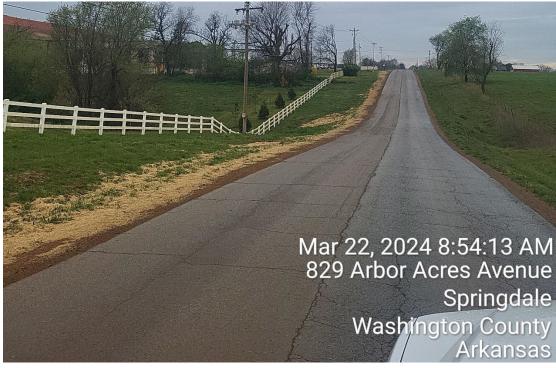
Arbor Acres looking west after sediment cleaning and straw application to cover exposed soils

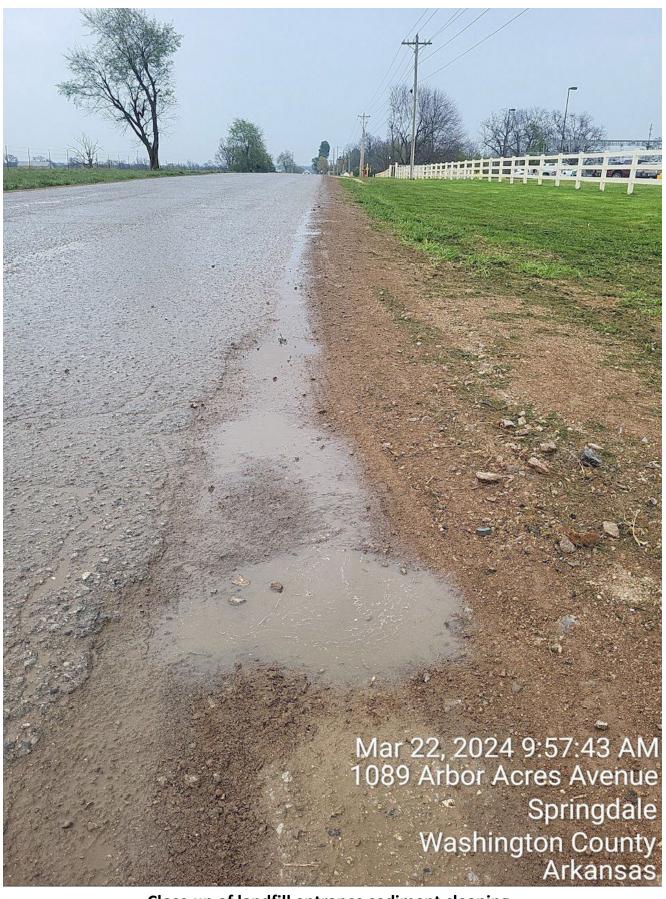
Close up of landfill entrance sediment cleaning

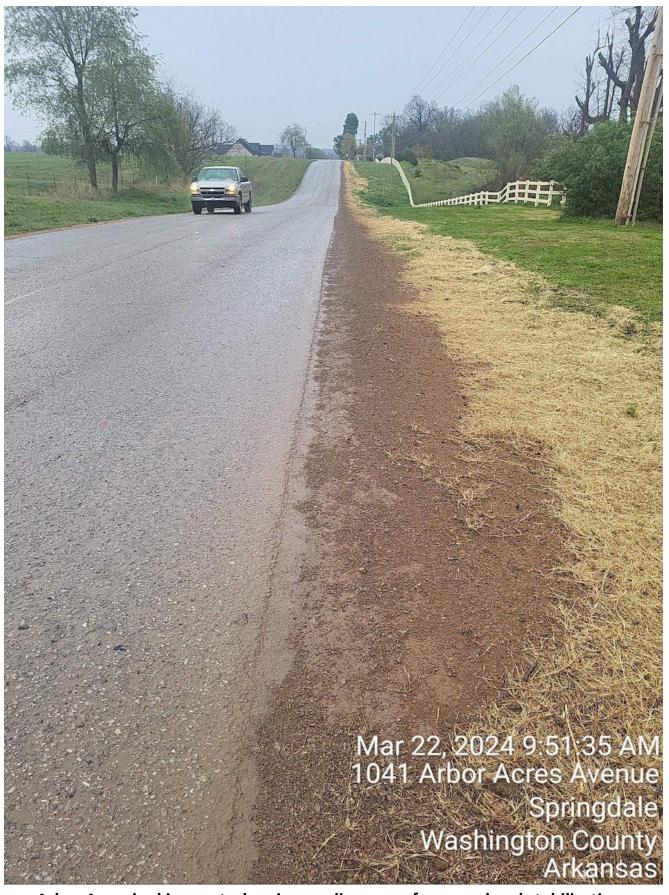
Arbor Acres looking east, showing grading away from road and stabilization

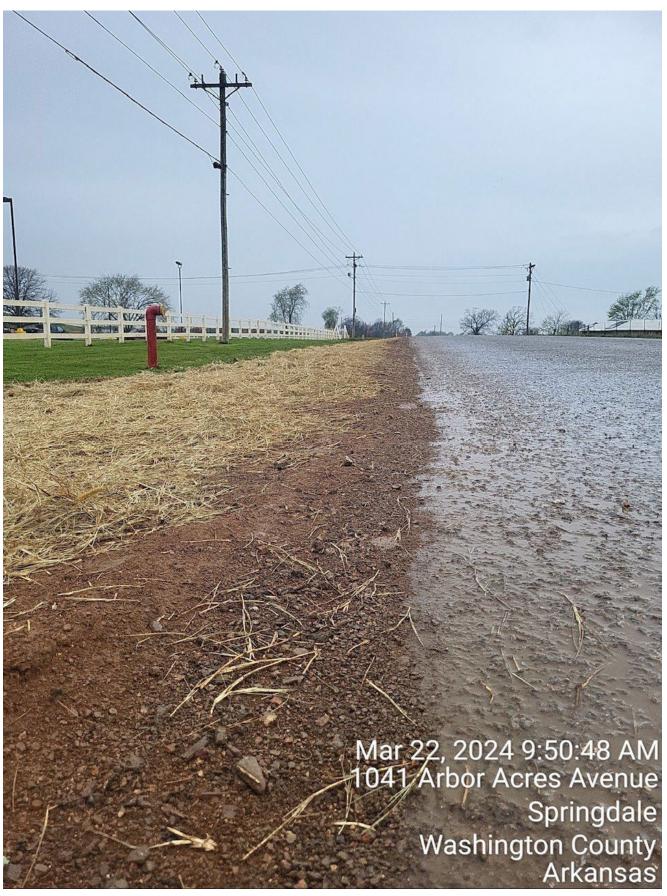
Arbor Acres looking west, showing grading away from road and stabilization
