RE: Inspection conducted on March 19, 2024
AFIN 03-00051
Permit Number 0249-S1-R2

**Division of Environmental Quality
Office of Land Resources
Class 1 Landfill Inspection Form**

Site Name	NABORS Landfill	County	Baxter	AFIN	03-00051
Facility Address	Hwy 5 N to CR 16 to site entrance- Three Brothers	Phone #	870-688-3822	Permit #	0249-S1-R2
Permittee Address	P.O. Box 1669 Harrison, AR 72602	Email Address	chuckwseaton@gmail.com judge@baxtercounty.org	PDS #	129775
Date	3/19/2024	Entry Time	1041	Exit Time	1150

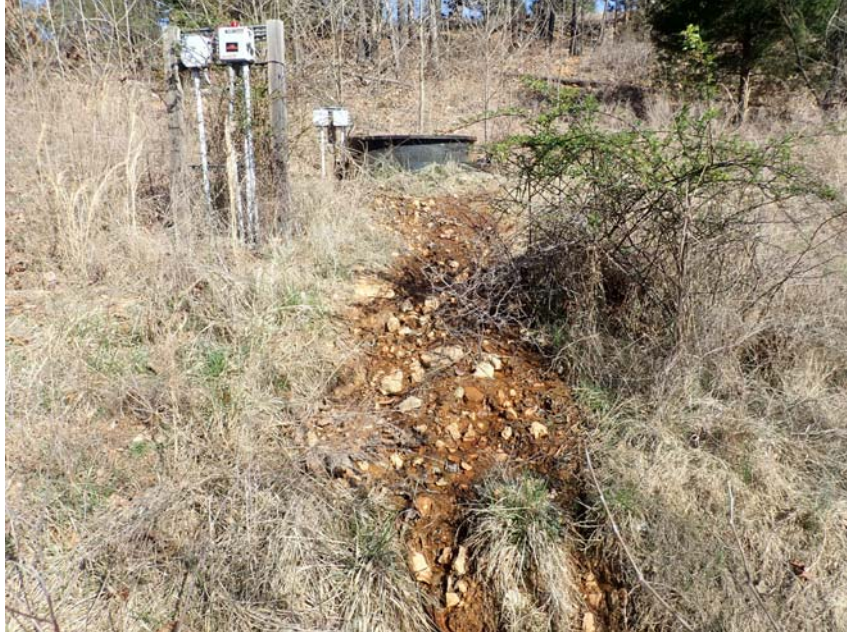
Regulation	Item Description	Comments
	413(a)(b)(c) Satisfactory Daily/Alternate/Intermediate Cover	
X	419(a)(5) Cause Discharge/Leachate Leaving Landfill	VLCS-1 sump observed overflowing. (Refer to photos #1 and #2.)
	411(f)(3) Depositing Waste in Standing Water Prohibited	
	411(o) Erosion or Other Cover Defects Resulting in Exposed Refuse	
	309(c) Overfill/Off Lined Area

Location	NABORS Class 1			Permit	0249-S1-R2	AFIN	03-00051
Photographer	Darrell Norton, Inspector		<i>DN</i>	Witness	n/a		
Photo #	1	Of	4	Date	3/19/2024	Time	1042
Description	Vegetative growth around VLCS-1. VLCS-1 appears to be failing with leachate overflow visible.

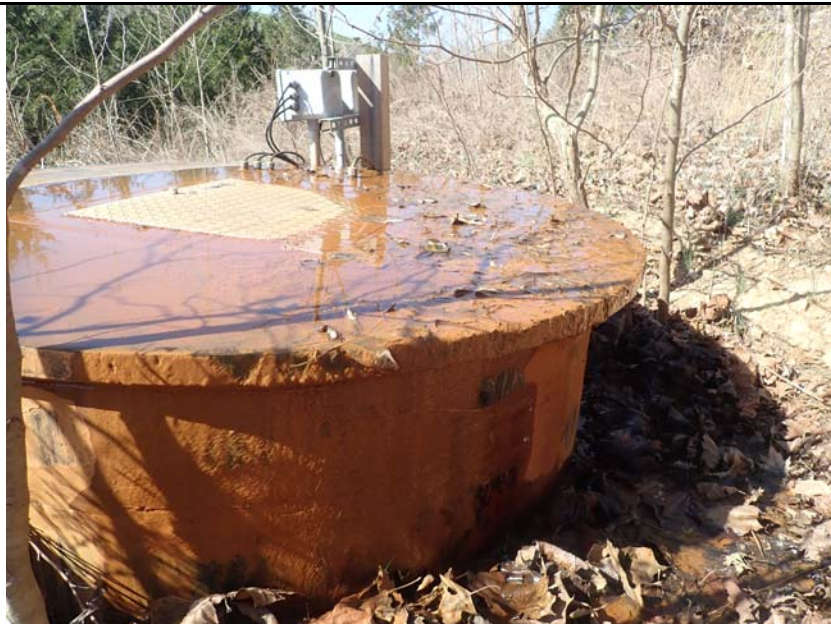
Location	NABORS Class 1			Permit	0249-S1-R2	AFIN	03-00051
Photographer	Darrell Norton, Inspector		<i>DN</i>	Witness	n/a		
Photo #	2	Of	4	Date	3/19/2024	Time	1042
Description	Apparent leachate overflow observed from VLCS-1 basin.

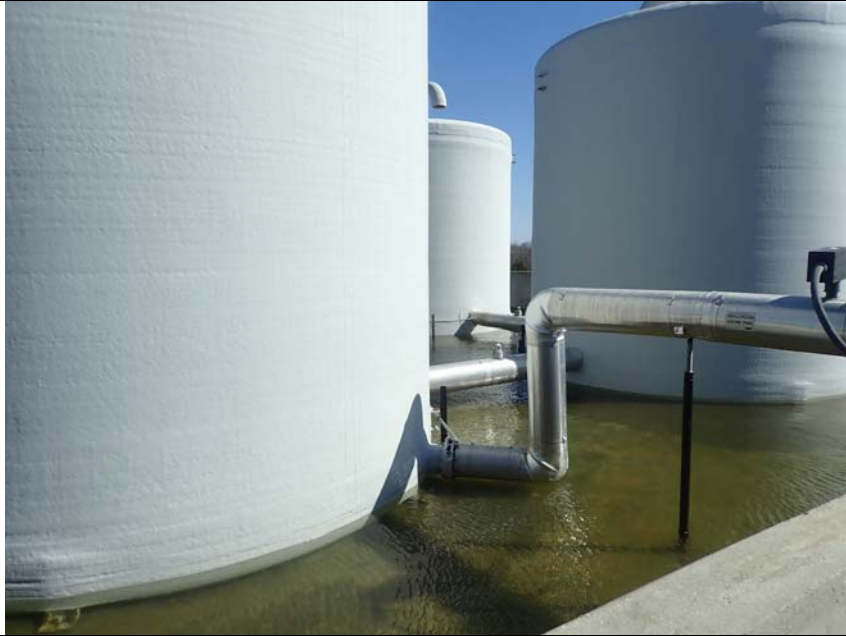
Location	NABORS Class 1			Permit	0249-S1-R2	AFIN	03-00051
Photographer	Darrell Norton, Inspector		<i>DN</i>	Witness	n/a		
Photo #	3	Of	4	Date	3/19/2024	Time	1050
Description	Tank farm and secondary containment.

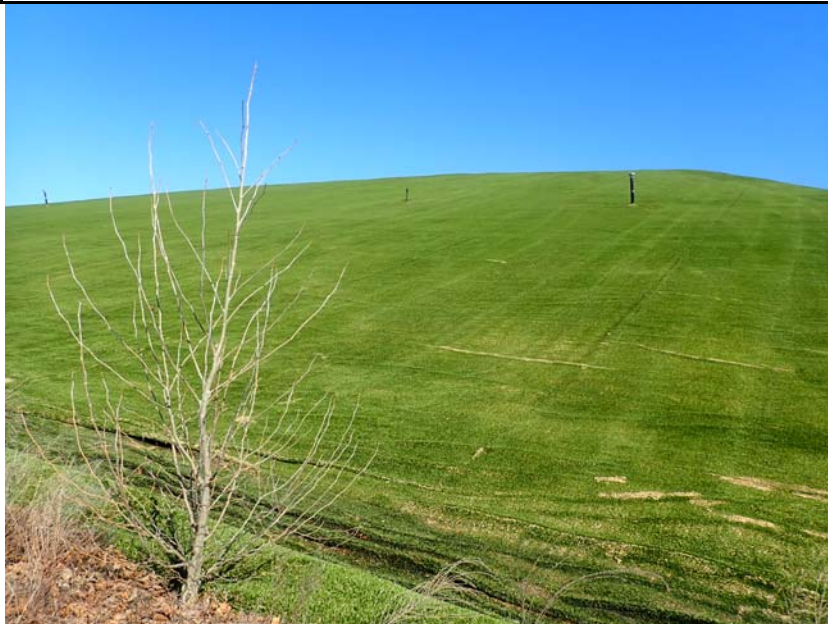
Location	NABORS Class 1			Permit	0249-S1-R2	AFIN	03-00051
Photographer	Darrell Norton, Inspector		<i>DN</i>	Witness	n/a		
Photo #	4	Of	4	Date	3/19/2024	Time	1055
Description	Turf roll and woody vegetation observed south of LCS 2.
