Attached:7/11/2024 - City of Little Rock Class 1 - Q3 Inspection report - with violations

RE: Inspection conducted on July 11, 2024
AFIN 60-01071
Permit Number 0266-S1

**Division of Environmental Quality
Office of Land Resources
Class 1 Landfill Inspection Form**

Site Name	City of Little Rock	County	Pulaski	AFIN	60-01071
Facility Address	10801 Ironton Cut-Off Rd. Little Rock, AR	Phone #	501-888-6751	Permit #	0266-S1
Permittee Address	10801 Ironton Cut-Off Rd. Little Rock, AR	Email Address	sowens@littlerock.gov	PDS #	131316
Date	7/11/2024	Entry Time	0934	Exit Time	1245

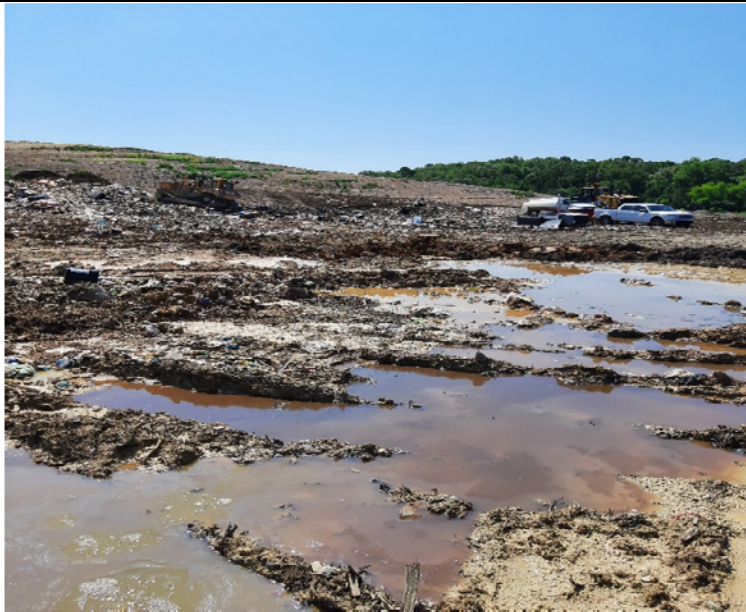
Location	City of Little Rock Class 1			Permit	0266-S1	AFIN	60-01071
Photographer	Casey Jackson		<i>255</i>	Witness	Kim Davenport		
Photo #	1	Of	14	Date	7/11/2024	Time	1051
Description	Exposed waste and ponding water observed in the active portion of cell 5 west.

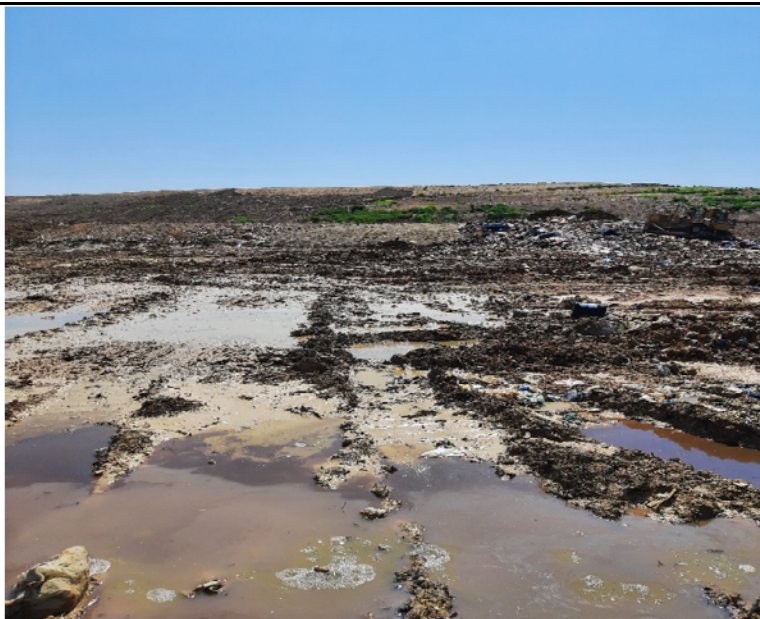
Location	City of Little Rock Class 1			Permit	0266-S1	AFIN	60-01071
Photographer	Casey Jackson		<i>255</i>	Witness	Kim Davenport		
Photo #	2	Of	14	Date	7/11/2024	Time	1051
Description	Exposed waste and ponding water observed in the active portion of cell 5 west.

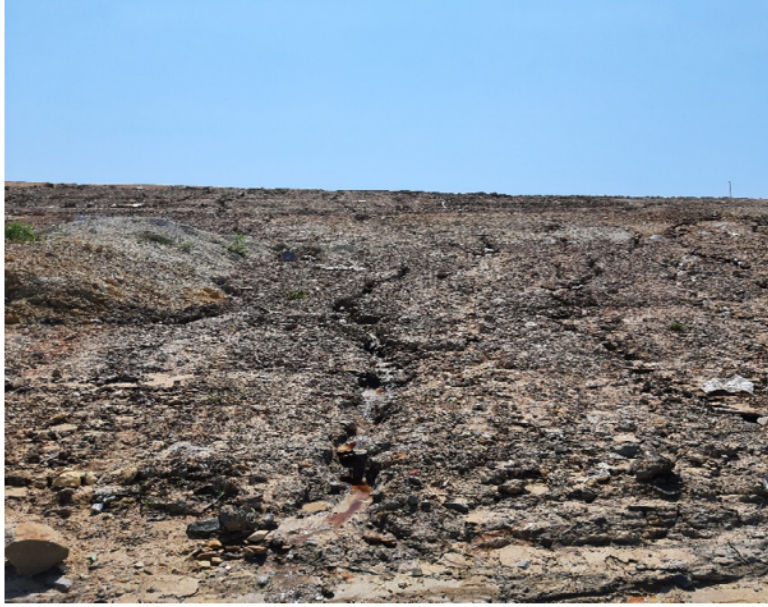
Location	City of Little Rock Class 1			Permit	0266-S1	AFIN	60-01071
Photographer	Casey Jackson	<i>055</i>		Witness	Kim Davenport		
Photo #	3	Of	14	Date	7/11/2024	Time	1037
Description	Run-on/ off controls were not present on the west side of cell 5, with erosion observed. View is east to west.

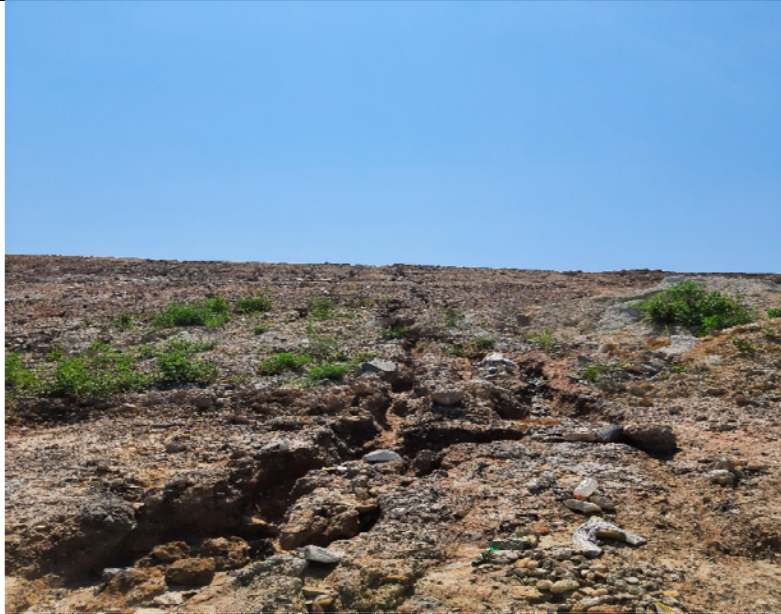
Location	City of Little Rock Class 1			Permit	0266-S1	AFIN	60-01071
Photographer	Casey Jackson	<i>055</i>		Witness	Kim Davenport		
Photo #	4	Of	14	Date	7/11/2024	Time	1037
Description	Erosion observed with no controls in place on the west side of cell 5. View is east to west.

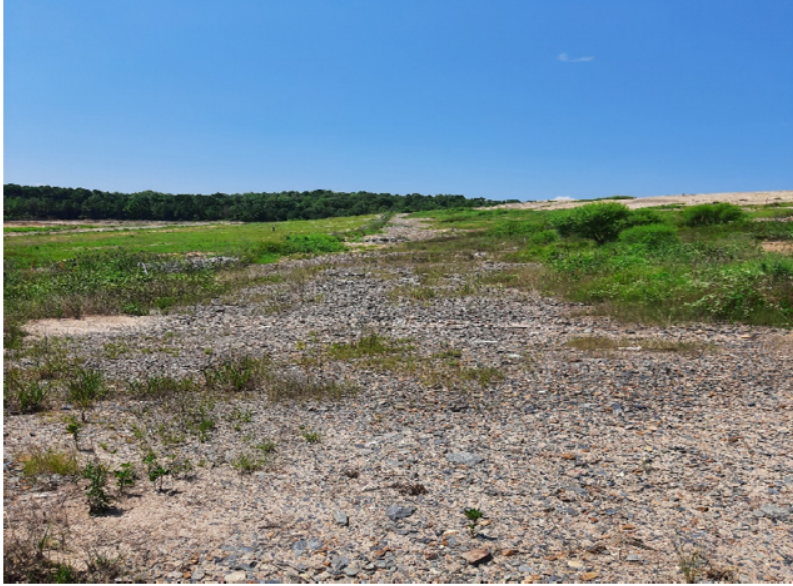
411(h)(2) Surface Water Control Prevents Off-site Sediment Accumulation	
X	411(i) Adequate Maintenance of Intermediate/Final Cover Vegetation	Bare spots observed in the final & intermediate vegetative cover observed on the eastern slope of Cell 4. (Refer to Photos #5, #6 and #7.)
X	415(d)(3) Gas Monitoring Program	A gas remediation plan has not been submitted for Q3 (Doc#84912) & Q4 (Doc#85611) of 2023. The current facility EGM report (Second Quarter 2024 Explosive Gas Monitoring Report) indicates the issue is ongoing.
X	411(o) Leachate Leaks or Evidence of Leachate Seepage	Leachate observed emerging from the west side of cell 5 into the storm water ditch and storm water pond located west of the active area. (Refer to Photos #8, #9, #10, #11, and #12.)
	429 Leachate Collection System

Location	City of Little Rock Class 1			Permit	0266-S1	AFIN	60-01071
Photographer	Casey Jackson		<i>css</i>	Witness	Kim Davenport		
Photo #	5	Of	14	Date	7/11/2024	Time	1135
Description	Bare spots observed in the final & intermediate vegetative cover on the eastern slope of Cell 4.

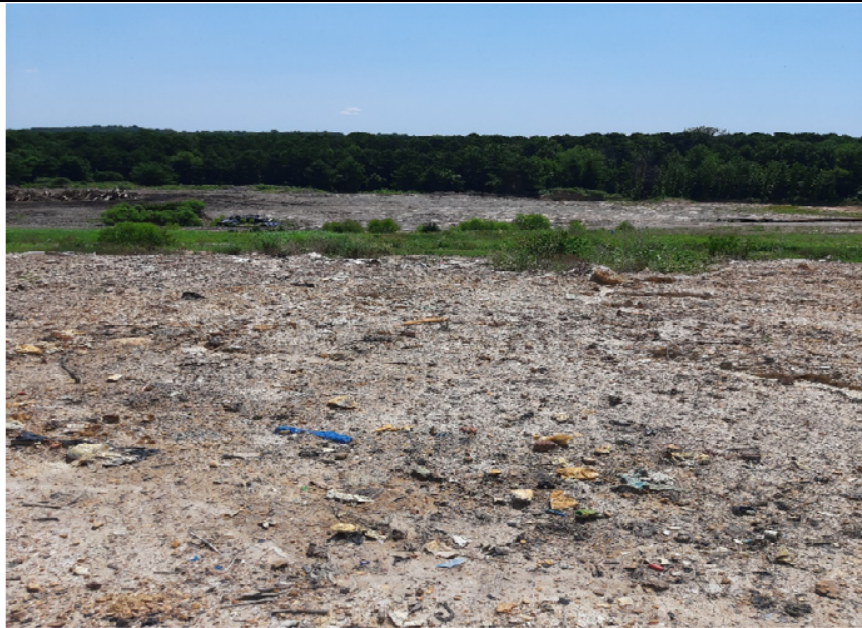
Location	City of Little Rock Class 1			Permit	0266-S1	AFIN	60-01071
Photographer	Casey Jackson		<i>css</i>	Witness	Kim Davenport		
Photo #	6	Of	14	Date	7/11/2024	Time	1137
Description	Bare spots observed in the final & intermediate vegetative cover on the eastern slope of Cell 4 with exposed waste.

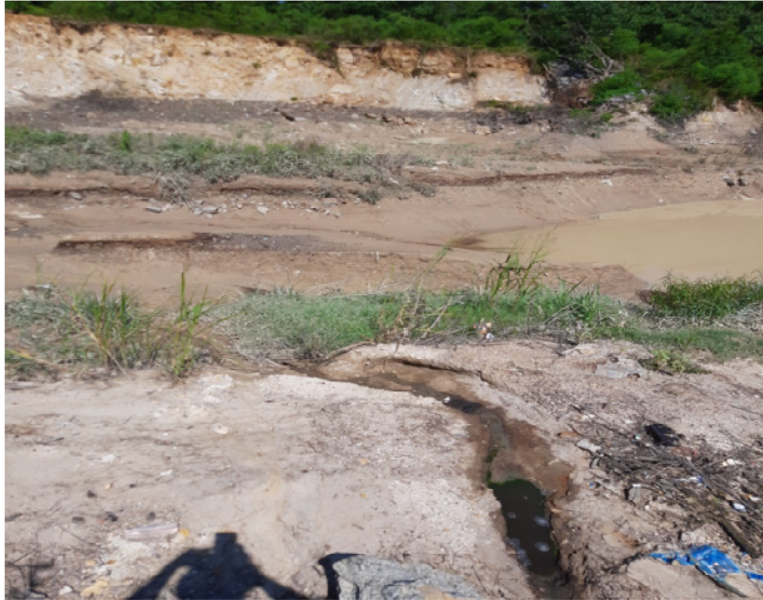
Location	City of Little Rock Class 1	Permit	0266-S1	AFIN	60-01071
Photographer	Casey Jackson	<i>ESS</i>	Witness	Kim Davenport	
Photo #	11	Of	14	Date	7/11/2024
Description	Leachate observed flowing into an unlined stormwater collection area.

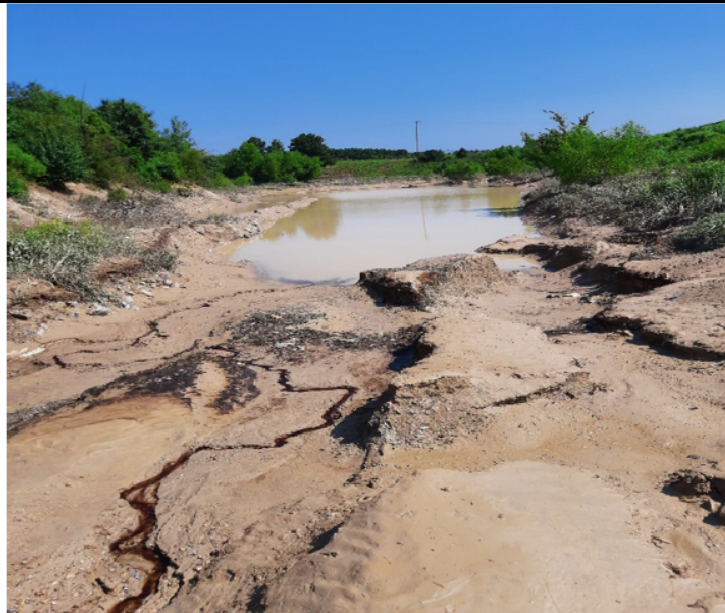
Location	City of Little Rock Class 1	Permit	0266-S1	AFIN	60-01071
Photographer	Casey Jackson	<i>ESS</i>	Witness	Kim Davenport	
Photo #	12	Of	14	Date	7/11/2024
Description	Leachate observed flowing into an unlined stormwater collection area.

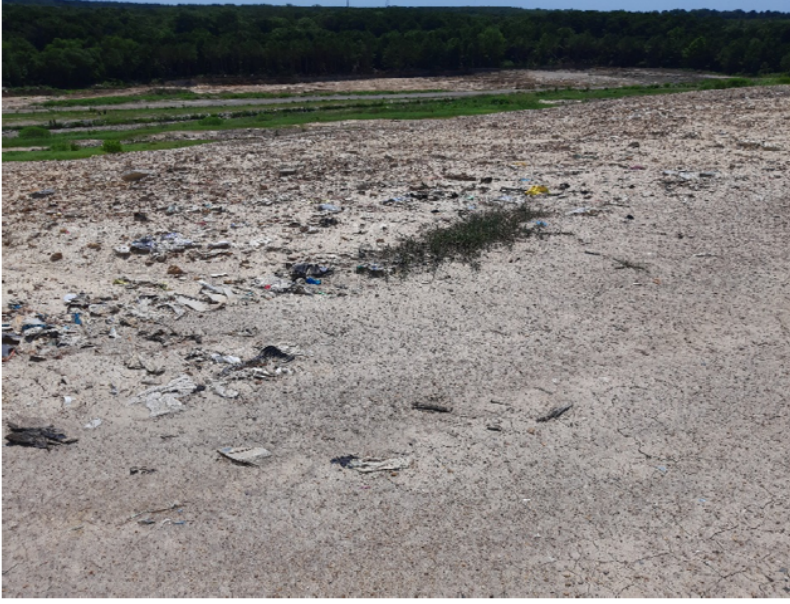
Regulation	Item Description	Comments
X	413(a)(b) Satisfactory Daily/Alternate/Intermediate Cover	Daily/Alternate daily cover observed in the active portion of Cell 5W does not prevent exposed waste, blowing litter, or leachate. (Refer to Photos #1 & #2).
	419(a)(5) Cause Discharge/Leachate Leaving Landfill	
	411(f)(3) Depositing Waste in Standing Water Prohibited	
X	411(o) Erosion or Other Cover Defects Resulting in Exposed Refuse	Erosion on the east side slopes on cells 1 and 4. (Refer to Photos #13 and #14.)

Location	City of Little Rock Class 1			Permit	0266-S1	AFIN	60-01071
Photographer	Casey Jackson	<i>055</i>		Witness	Kim Davenport		
Photo #	13	Of	14	Date	7/11/2024	Time	1141
Description	Erosion observed on the eastern slopes of cells 1 and cell 4.
