DIVISION OF
ENVIRONMENTAL QUALITY

RE: Inspection conducted on July 11, 2024
AFIN 60-01071
Permit Number 0266-S1

**Division of Environmental Quality
Office of Land Resources
Class 1 Landfill Inspection Form**

Site Name	City of Little Rock	County	Pulaski	AFIN	60-01071
Facility Address	10801 Ironton Cut-Off Rd. Little Rock, AR	Phone #	501-888-6751	Permit #	0266-S1
Permittee Address	10801 Ironton Cut-Off Rd. Little Rock, AR	Email Address	sowens@littlerock.gov	PDS #	131316
Date	7/11/2024	Entry Time	0934	Exit Time	1245

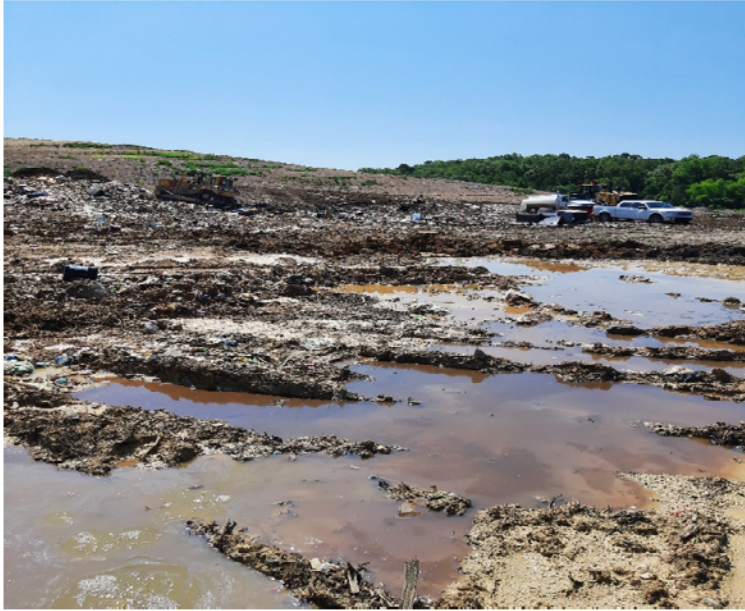
Regulation	Item Description	Comments
X	413(a)(b) Satisfactory Daily/Alternate/Intermediate Cover	Daily/Alternate daily cover observed in the active portion of Cell 5W does not prevent exposed waste, blowing litter, or leachate. (Refer to Photos #1 & #2).
	419(a)(5) Cause Discharge/Leachate Leaving Landfill	
	411(f)(3) Depositing Waste in Standing Water Prohibited	
X	411(o) Erosion or Other Cover Defects Resulting in Exposed Refuse	Erosion on the east side slopes on cells 1 and 4. (Refer to Photos #13 and #14.)

Location	City of Little Rock Class 1			Permit	0266-S1	AFIN	60-01071
Photographer	Casey Jackson		<i>255</i>	Witness	Kim Davenport		
Photo #	1	Of	14	Date	7/11/2024	Time	1051
Description	Exposed waste and ponding water observed in the active portion of cell 5 west.

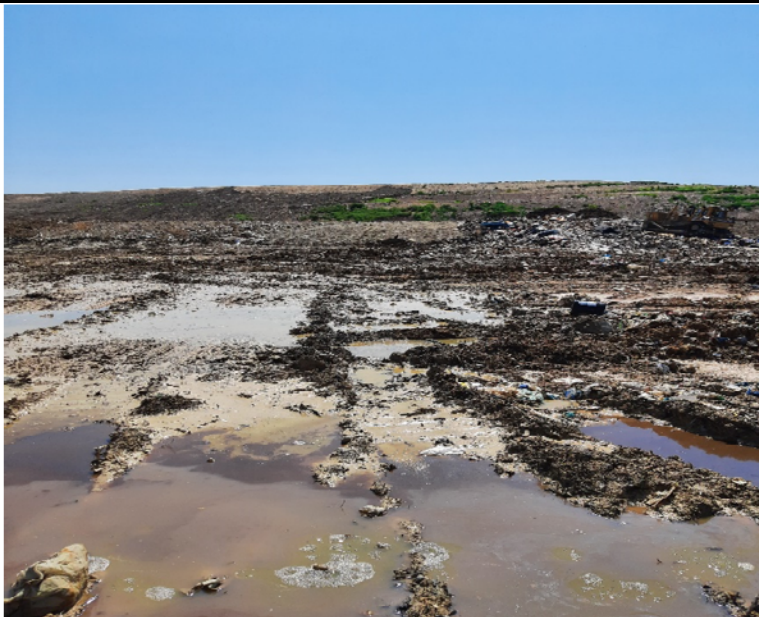
Location	City of Little Rock Class 1			Permit	0266-S1	AFIN	60-01071
Photographer	Casey Jackson		<i>255</i>	Witness	Kim Davenport		
Photo #	2	Of	14	Date	7/11/2024	Time	1051
Description	Exposed waste and ponding water observed in the active portion of cell 5 west.

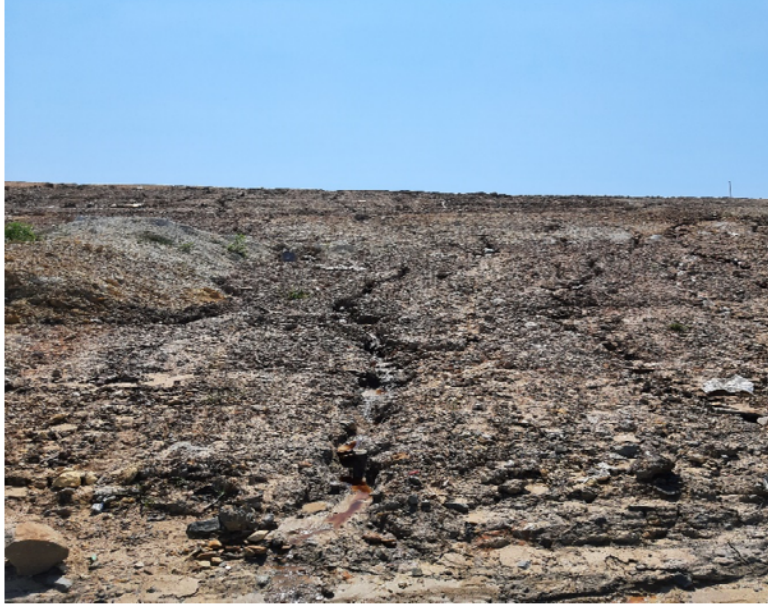
Regulation	Item Description	Comments
422(c)	Operations in Accordance with Permit Documents	The last approved Operating Plan (OP) is dated 1996 and requires updating. (Refer to Doc #3716, dated 7/26/1996). A New draft OP was submitted 2/1/2024 (Doc #85107).
411(c)	Smallest Practical Area, Unloading Supervised, Single Working Face	
411(b)	Operations by Licensed On-site Personnel at All Times	
411(g)	Litter Control Provisions Maintained	
427	Surface Water Controls	
X	411(h)(1) Contouring Prevents Surface Water Flowing Into or Through Waste	The surface of the active area is not contoured to minimize surface water run-on or flow through the working face as evidenced by ponding observed in the active area. (Refer to Photos #1 and #2.)
X	418(a)(b) Run-on/off Control System Present and Adequate	A run-on/off control system is not in place to prevent washout of solid waste from the active portion of the landfill. (Refer to Photos #3 and #4.)

Location	City of Little Rock Class 1			Permit	0266-S1	AFIN	60-01071
Photographer	Casey Jackson	<i>055</i>		Witness	Kim Davenport		
Photo #	3	Of	14	Date	7/11/2024	Time	1037
Description	Run-on/ off controls were not present on the west side of cell 5, with erosion observed. View is east to west.

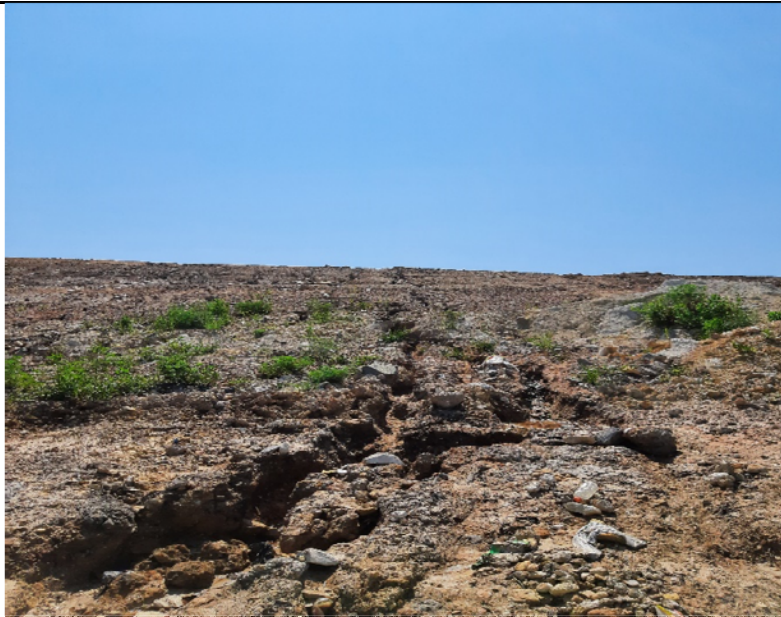
Location	City of Little Rock Class 1			Permit	0266-S1	AFIN	60-01071
Photographer	Casey Jackson	<i>055</i>		Witness	Kim Davenport		
Photo #	4	Of	14	Date	7/11/2024	Time	1037
Description	Erosion observed with no controls in place on the west side of cell 5. View is east to west.

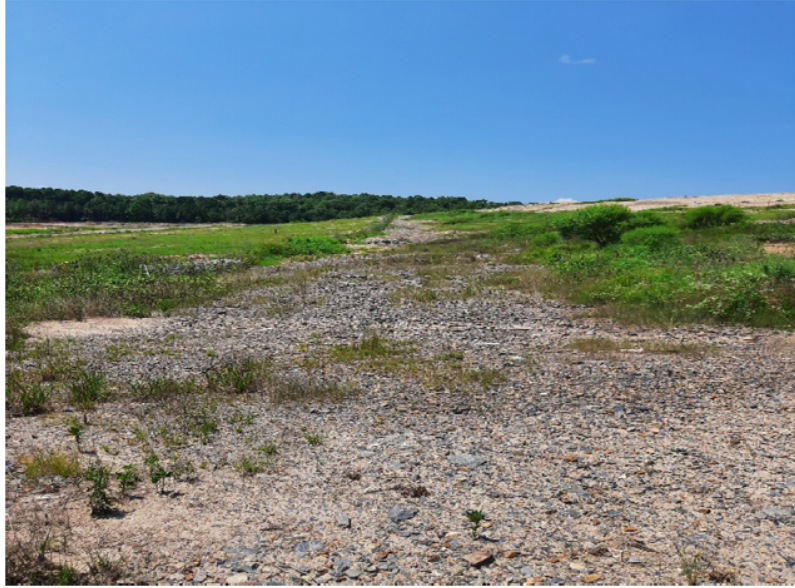
411(h)(2) Surface Water Control Prevents Off-site Sediment Accumulation	
X	411(i) Adequate Maintenance of Intermediate/Final Cover Vegetation	Bare spots observed in the final & intermediate vegetative cover observed on the eastern slope of Cell 4. (Refer to Photos #5, #6 and #7.)
X	415(d)(3) Gas Monitoring Program	A gas remediation plan has not been submitted for Q3 (Doc#84912) & Q4 (Doc#85611) of 2023. The current facility EGM report (Second Quarter 2024 Explosive Gas Monitoring Report) indicates the issue is ongoing.
X	411(o) Leachate Leaks or Evidence of Leachate Seepage	Leachate observed emerging from the west side of cell 5 into the storm water ditch and storm water pond located west of the active area. (Refer to Photos #8, #9, #10, #11, and #12.)
	429 Leachate Collection System

Location	City of Little Rock Class 1			Permit	0266-S1	AFIN	60-01071
Photographer	Casey Jackson		<i>css</i>	Witness	Kim Davenport		
Photo #	5	Of	14	Date	7/11/2024	Time	1135
Description	Bare spots observed in the final & intermediate vegetative cover on the eastern slope of Cell 4.

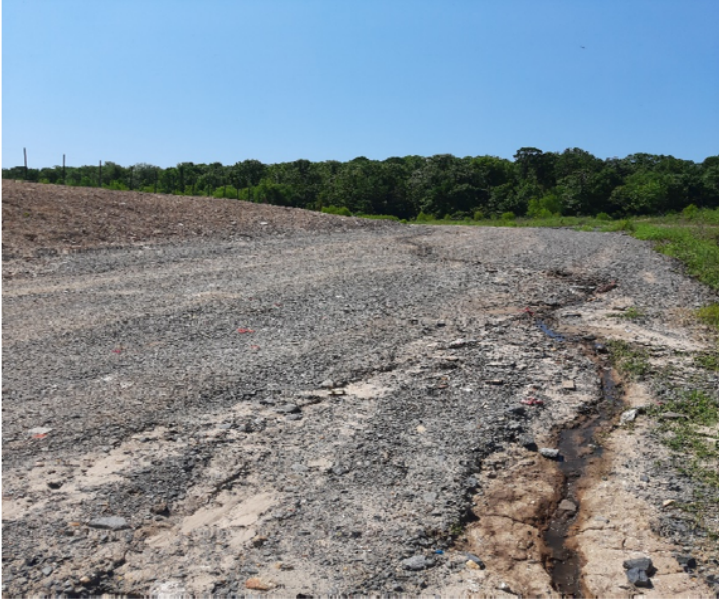
Location	City of Little Rock Class 1			Permit	0266-S1	AFIN	60-01071
Photographer	Casey Jackson		<i>css</i>	Witness	Kim Davenport		
Photo #	9	Of	14	Date	7/11/2024	Time	1105
Description	Leachate flowing from the southwest corner of cell 5 west into the stormwater ditch.

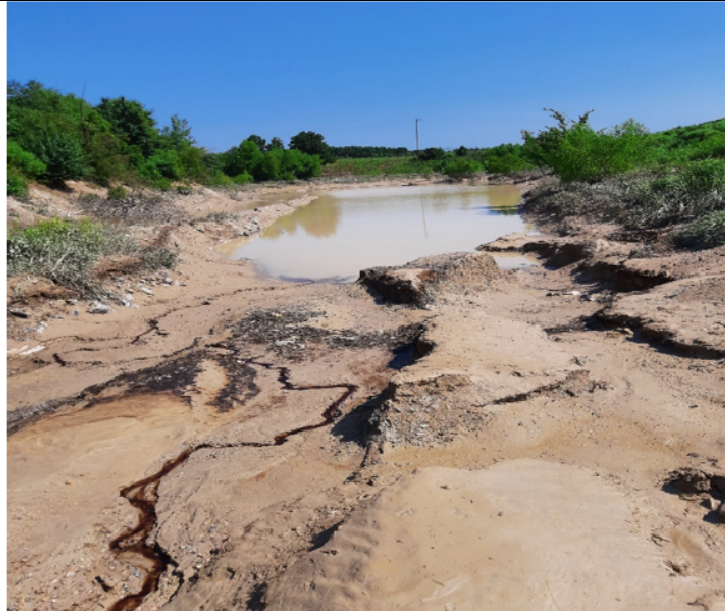
Location	City of Little Rock Class 1	Permit	0266-S1	AFIN	60-01071
Photographer	Casey Jackson	<i>ESS</i>	Witness	Kim Davenport	
Photo #	12	Of	14	Date	7/11/2024
Description	Leachate observed flowing into an unlined stormwater collection area.

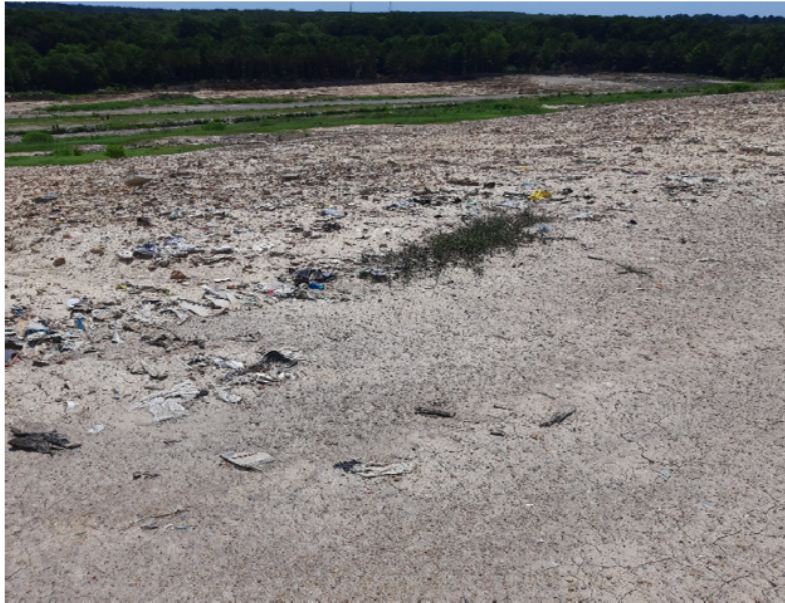
Location	City of Little Rock Class 1			Permit	0266-S1	AFIN	60-01071
Photographer	Casey Jackson	<i>055</i>		Witness	Kim Davenport		
Photo #	13	Of	14	Date	7/11/2024	Time	1141
Description	Erosion observed on the eastern slopes of cells 1 and cell 4.

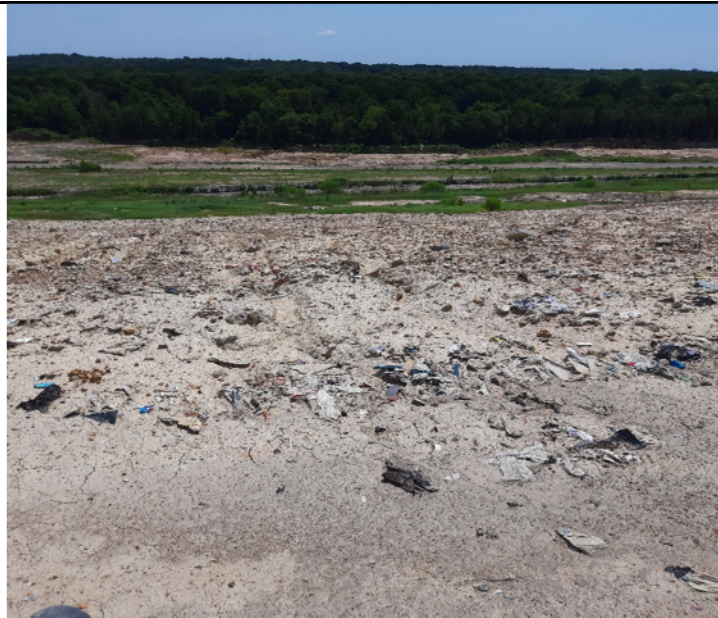
Location	City of Little Rock Class 1			Permit	0266-S1	AFIN	60-01071
Photographer	Casey Jackson	<i>055</i>		Witness	Kim Davenport		
Photo #	14	Of	14	Date	7/11/2024	Time	1141
Description	Erosion observed on the eastern slopes of cells 1 and cell 4.
