**DIVISION OF  
ENVIRONMENTAL QUALITY**

**RE: Inspection conducted on November 26, 2024**  
**AFIN 60-01071**  
**Permit Number 0266-S1**

**Division of Environmental Quality  
Office of Land Resources  
Class 1 Landfill Inspection Form**

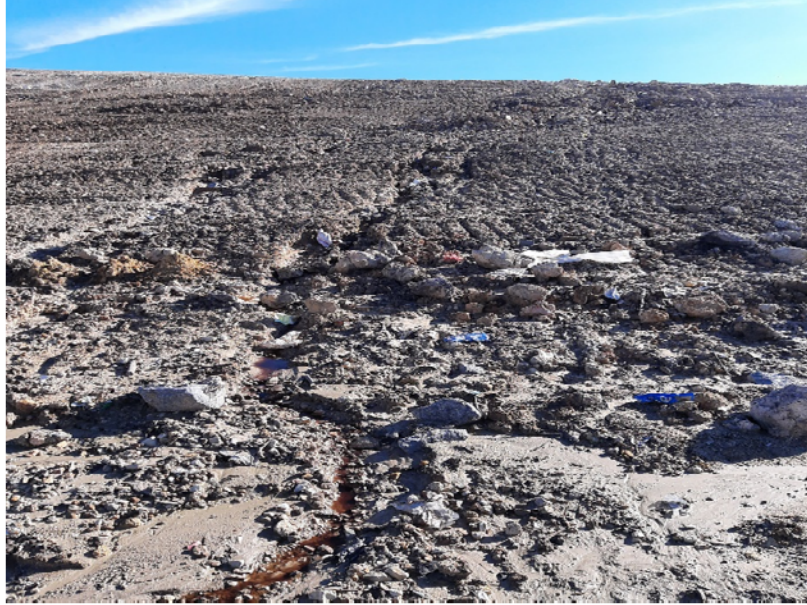
| <b>Photo #</b> | 1 | of | 7 | <b>Date</b> | 11/26/2024 | <b>Time</b> | 1005 |

| | Regulation | Item Description | Comments |
|---|---|---|---|
| X | 418(a)(b) | Run-on/off Control System Present and Adequate | A run-on/off control system is not in place to prevent washout of solid waste from the active portion of the landfill. (Refer to Photo #1.) |

| <b>Description</b> | Run-on/ off controls were not present on the west side of cell 5, with erosion and leachate observed flowing into an unlined stormwater collection area. View is east to west. | | | | | | |

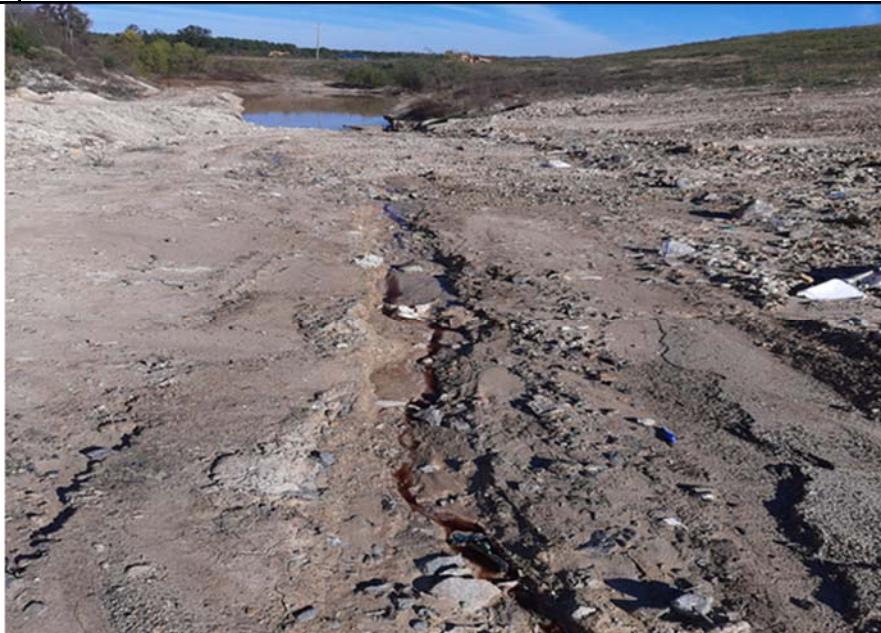
| <b>Photo #</b> | 2 | of | 7 | <b>Date</b> | 11/26/2024 | <b>Time</b> | 1004 |

| | Regulation | Item Description | Comments |
|---|---|---|---|
| X | 411(o) | Leachate Leaks or Evidence of Leachate Seepage | Leachate observed emerging from the west side of cell 5 into the storm water ditch and storm water pond located west of the active area. (Refer to Photos #2-#7.) |

| <b>Description</b> | Leachate observed flowing into an unlined stormwater collection area. | | | | | | |

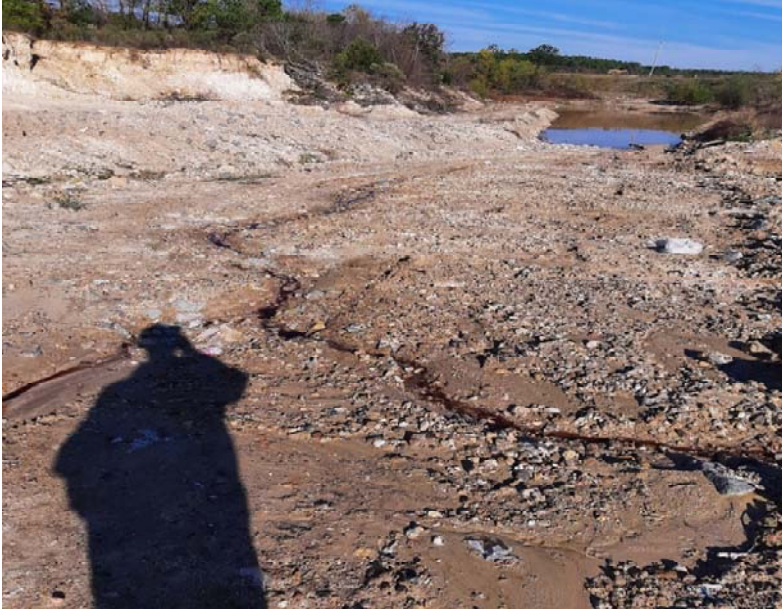
| <b>Photo #</b> | 3 | <b>of</b> | 7 | <b>Date</b> | 11/26/2024 | <b>Time</b> | 1004 |

| <b>Description</b> | Leachate observed flowing into an unlined stormwater collection area, continuation of photo #2. | | | | | | |

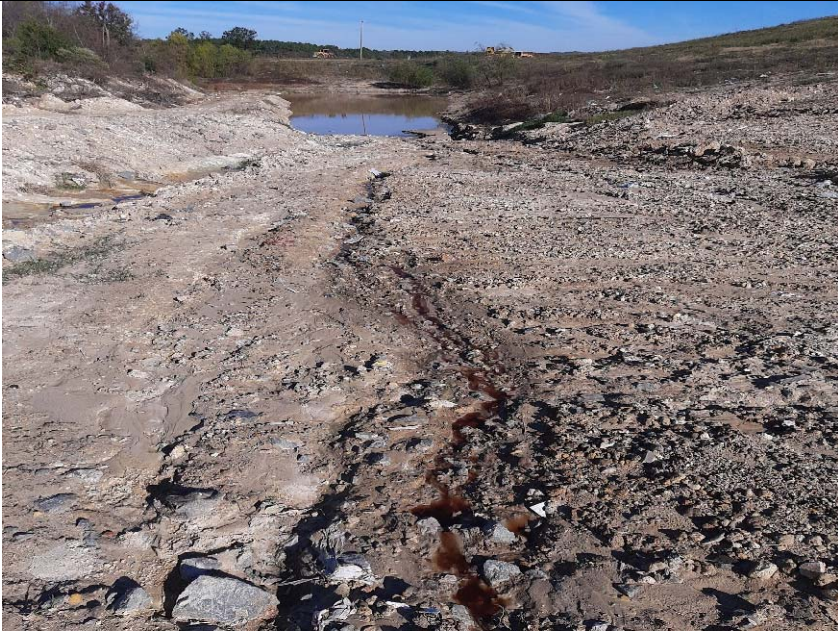
| <b>Photo #</b> | 4 | <b>of</b> | 7 | <b>Date</b> | 11/26/2024 | <b>Time</b> | 1005 |

| <b>Description</b> | Leachate observed flowing into an unlined stormwater collection area, continuation of photo #3. | | | | | | |

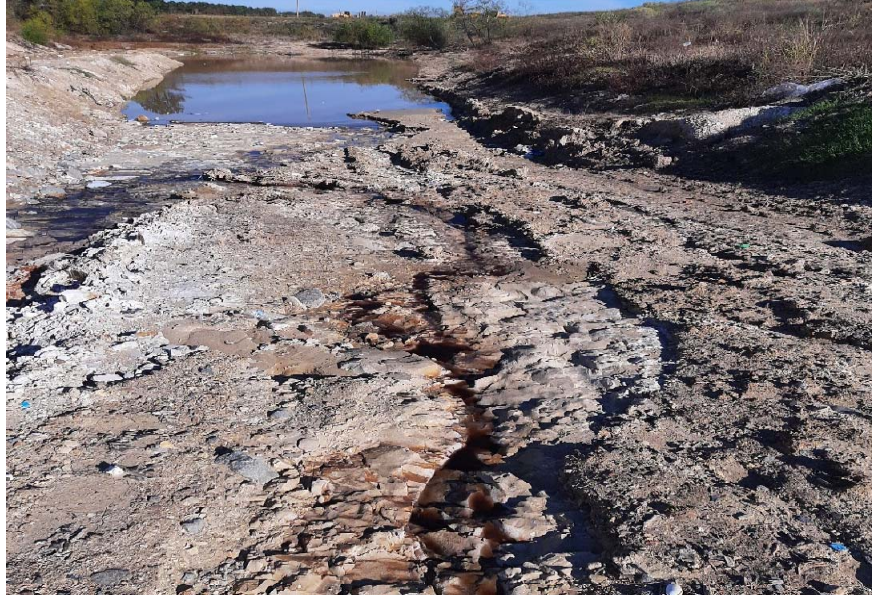
| <b>Photo #</b> | 5 | <b>of</b> | 7 | <b>Date</b> | 11/26/2024 | <b>Time</b> | 1005 |

| <b>Description</b> | Leachate observed flowing into an unlined stormwater collection area, continuation of photo #4. | | | | | | |

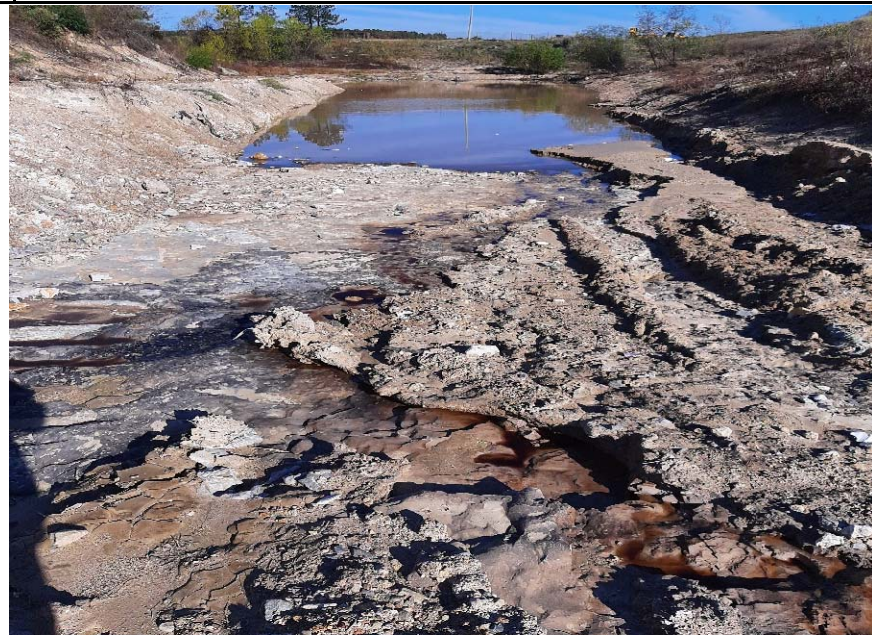
| <b>Photo #</b> | 6 | <b>of</b> | 7 | <b>Date</b> | 11/26/2024 | <b>Time</b> | 1005 |

| <b>Description</b> | Leachate observed flowing into an unlined stormwater collection area, continuation of photo #5. | | | | | | |

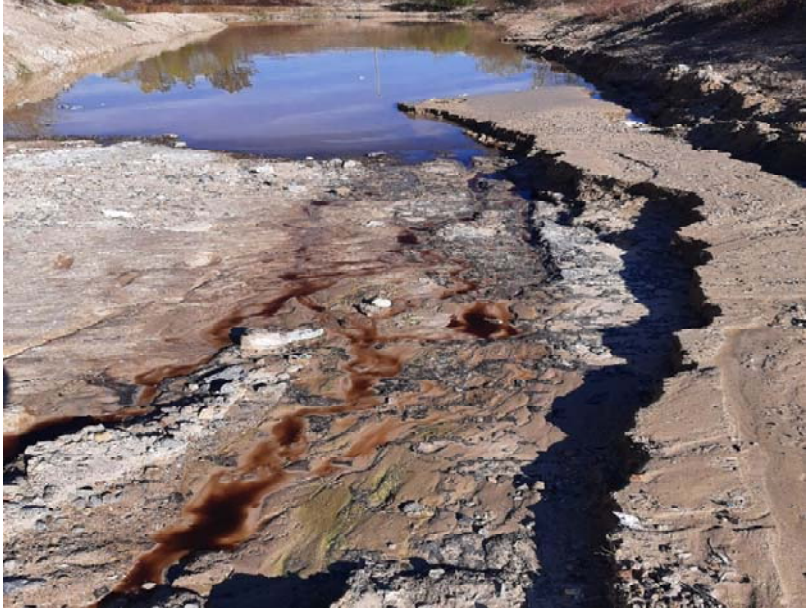
| <b>Photo #</b> | 7 | <b>Of</b> | 7 | <b>Date</b> | 11/26/2024 | <b>Time</b> | 1005 |

| <b>Description</b> | Leachate observed flowing into an unlined stormwater collection area, continuation of photo #6. | | | | | | |
