DIVISION OF
ENVIRONMENTAL QUALITY

RE: Inspection conducted on August 8, 2025
AFIN 72-00144
Permit Number 0290-S4-R2

Division of Environmental Quality - Office of Land Resources
Class 4 Landfill Inspection Form

Site Name	Eco-Vista Class 4 Landfill	County	Washington	AFIN	72-00144
Facility Address	2210 Waste Management Drive, Springdale, AR 72762	Phone #	870-510-0174	Permit #	0290-S4-R2
Permittee Address	2210 Waste Management Drive, Springdale, AR 72762	Email Address	bsmall@wm.com dtenniso@wm.com	PDS #	133948
Date	8/8/2025	Entry Time	1115	Exit Time	1340

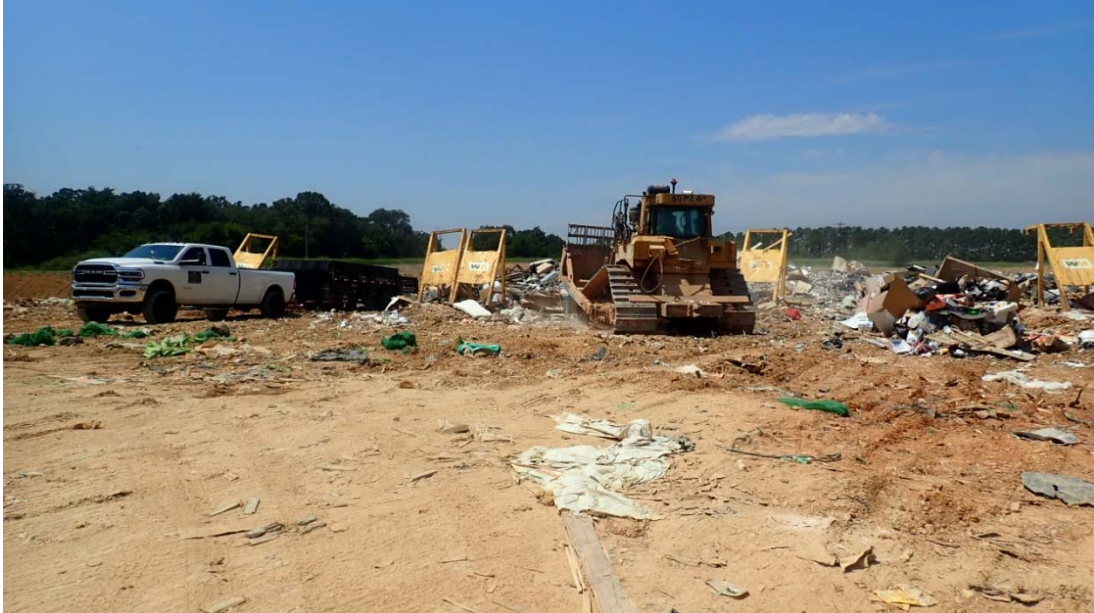
Location	Eco-Vista Class 4 Landfill				Permit	0290-S4-R2	AFIN	72-00144
Photographer	Jason Gilkey - Inspector			JLG	Witness	NA		
Photo #	1	of	2		Date	8/8/2025	Time	1233
Description	The Class 4 working face was observed in operation, facing north.

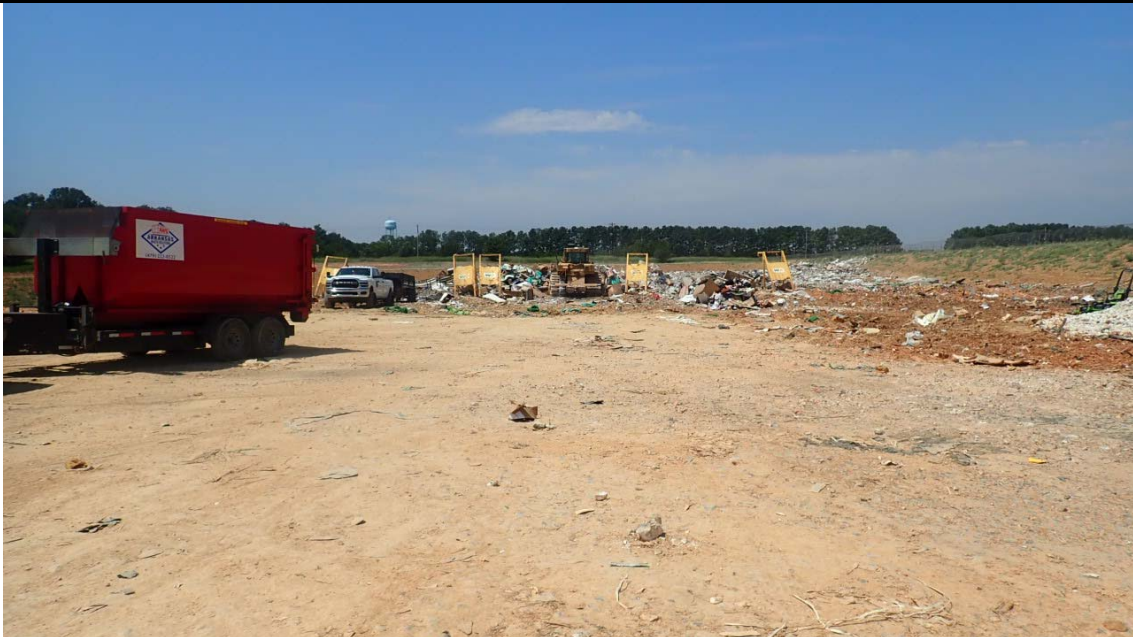
Location	Eco-Vista Class 4 Landfill				Permit	0290-S4-R2	AFIN	72-00144
Photographer	Jason Gilkey - Inspector			JLG	Witness	NA		
Photo #	2	of	2		Date	8/8/2025	Time	1233
Description	The working face was observed in operation, facing west.
