DIVISION OF ENVIRONMENTAL QUALITY

RE: Inspection conducted on August 21, 2025
AFIN 02-00013
Permit Number 0292-S3N

Class 3 Landfill Inspection Form

Site Name	Georgia Pacific Crossett LLC	County	Ashley	AFIN	02-00013
Facility Address	100 Mill Supply Road , Crossett, AR	Phone #	870-415-6363	Permit #	0292-S3N
Permittee Address	P.O. Box 3333 Crossett, AR 71635	Email Address	sarah.ross@gapac.com	PDS #	133989
Date	8/21/2025	Entry Time	1121	Exit Time	1325

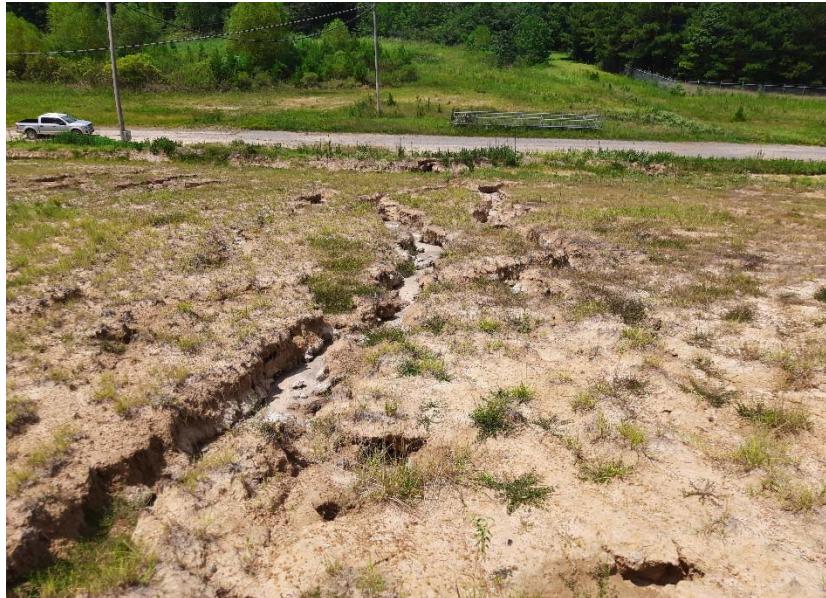
Citation	Description	Comments
	8 CAR § 60-512	Satisfactory Daily/Intermediate/Alternative Cover	
	8 CAR § 60-518(a)(5)	Allow Leachate unpermitted by NPDES to Leave Landfill	
X	8 CAR § 60-510(n)(1)	Erosion Resulting in Exposure of the Infiltration Barrier of the Final Cover System	Erosion exposing the barrier was observed in final cover on the southwest and northwest corners of the landfill. (Refer to Photos #1 - #2.)
	8 CAR § 60-309(c)	Overfill / Off Lined Area

Location	Georgia Pacific Crossett LLC			Permit	0292-S3N	AFIN	02-00013
Photographer	Casey Jackson			<i>CJS</i>	Witness	N/A	
Photo #	1	of	2		Date	8/21/2025	Time 1233
Description	Erosion was observed on the southwest corner of the landfill. The view is northeast to southwest.

You should immediately initiate actions to correct the alleged violations cited. A written response of the corrective actions taken, or to be taken, must be submitted within thirty (30) calendar days from the date on this letter to the attention of Casey Jackson. The response may include, but is not limited to, photographs, copies of disposal receipts, records, or analytical results, as applicable. If you have any questions regarding the alleged violations, please do not hesitate to contact me at (501) 682-0832 or casey.jackson@arkansas.gov.

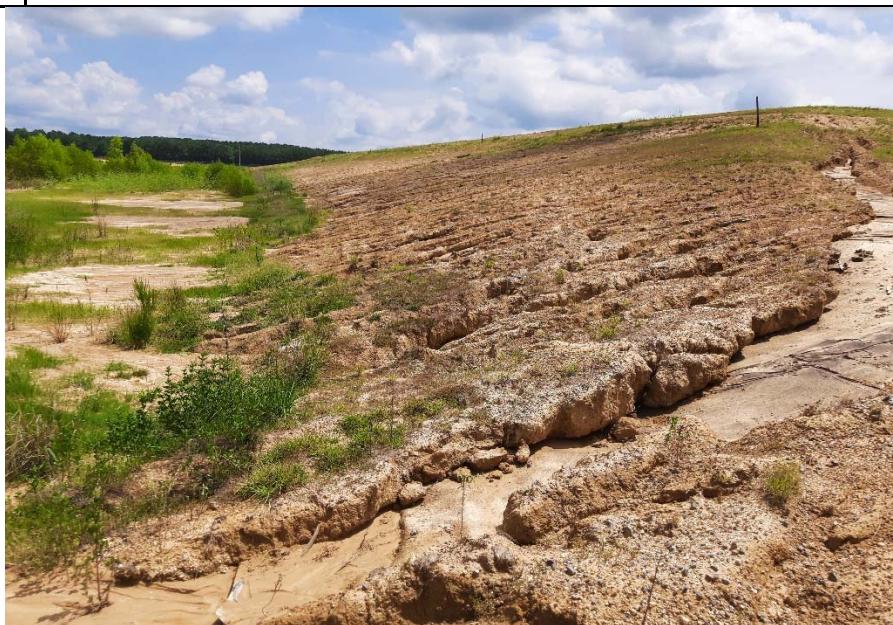
Location	Georgia Pacific Crossett LLC			Permit	0292-S3N	AFIN	02-00013
Photographer	Casey Jackson			<i>CJS</i>	Witness	N/A	
Photo #	2	of	2		Date	8/21/2025	Time 1242
Description	Erosion with exposed barrier observed on the northwest corner of the landfill. The view is from west to east.
