DIVISION OF
ENVIRONMENTAL QUALITY

RE: Inspection conducted on September 23, 2025
AFIN 60-01071
Permit Number 0266-S1

Class 1 Landfill Inspection Form

Site Name	City of Little Rock	County	Pulaski	AFIN	60-01071
Facility Address	10801 Ironton Cut-Off Rd Little Rock, AR	Phone #	501-888-6751	Permit #	0266-S1
Permittee Address	10801 Ironton Cut-Off Rd Little Rock, AR	Email Address	sowens@littlerock.gov	PDS #	134157
Date	09/23/2025	Entry Time	0926	Exit Time	1205

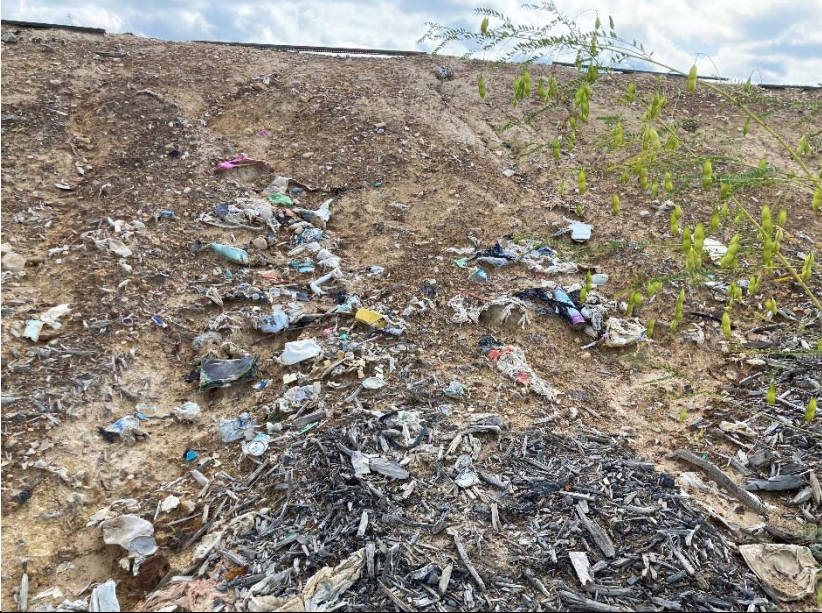
Location	Little Rock Class 1 Landfill			Permit	0266-S1	AFIN	60-01071
Photographer	Daniel Cullum		<i>DC</i>	Witness	Kim Davenport		
Photo #	3	of	12	Date	09/23/2025	Time	1050
Description	Lack of vegetation and exposed waste observed in the final cover of the east slope.

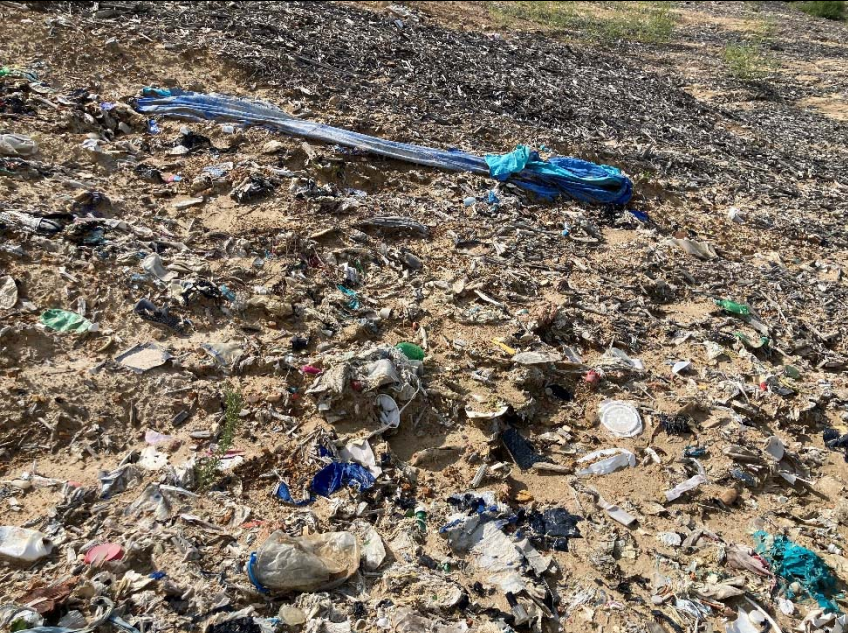
Location	Little Rock Class 1 Landfill			Permit	0266-S1	AFIN	60-01071
Photographer	Daniel Cullum		<i>DC</i>	Witness	Kim Davenport		
Photo #	4	of	12	Date	09/23/2025	Time	1050
Description	Lack of vegetation and exposed waste observed in the final cover of the east slope.

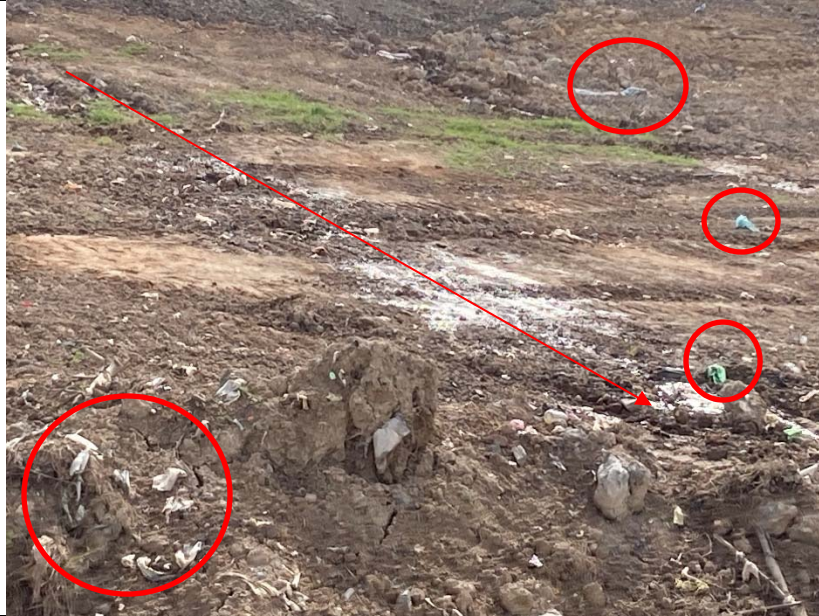
Citation	Description	Comments
X	8 CAR § 60-413(c)	Satisfactory Intermediate Cover	Exposed waste was observed in multiple areas across Cell 5. (Refer to Photos #1, #2, & #5.)
X	8 CAR § 60-419(a)(5)	Allow Leachate not permitted under NPDES to Leave Landfill	Leachate from the west slope was observed entering an unlined storm water collection area. (Refer to photos #5 - #10.)
	8 CAR § 60-413(f)(3)	Depositing Waste in Standing Water is Prohibited	
X	8 CAR § 60-411(o)(1)	Erosion or Other Cover Defects Resulting in Exposed Refuse	Erosion and exposed waste observed on top of the landfill, Cell 9. (Refer to Photos #11 & #12.)
	8 CAR § 60-309(c)	Overfill/Off Lined Area

Location	Little Rock Class 1 Landfill			Permit	0266-S1	AFIN	60-01071
Photographer	Daniel Cullum		<i>DC</i>	Witness	Kim Davenport		
Photo #	5	of	12	Date	09/23/2025	Time	1106
Description	Leachate was observed flowing down the west slope of Cell 5 (red arrow). It was observed flowing into a stormwater collection ditch at the base of the slope and then flows towards and enters an unlined stormwater collection area (Refer to Photos #6 - #10). In addition to the leachate seepage, exposed waste was observed on the slope (red circles).

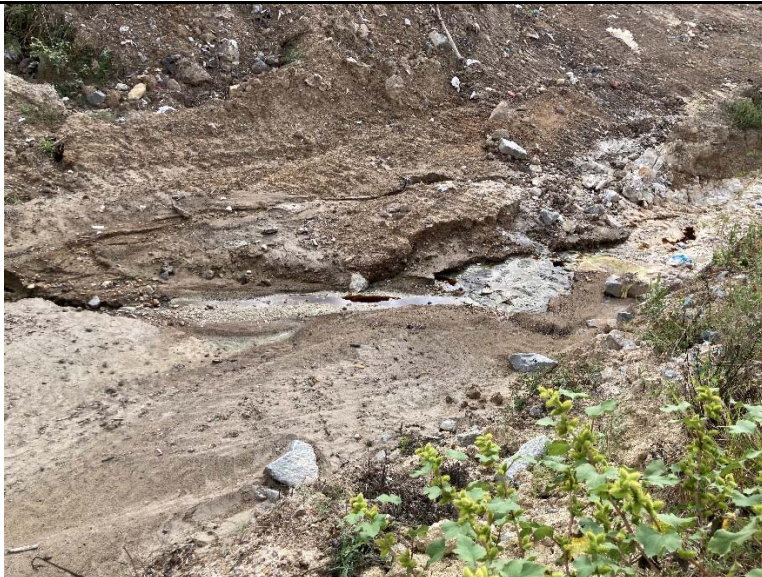
Location	Little Rock Class 1 Landfill			Permit	0266-S1	AFIN	60-01071
Photographer	Daniel Cullum		<i>DC</i>	Witness	Kim Davenport		
Photo #	6	of	12	Date	09/23/2025	Time	1106
Description	View of the stormwater ditch below the area shown in Photo #5, where leachate was observed as it continues to flow towards the unlined storm water collection area, observed in Photo #10.

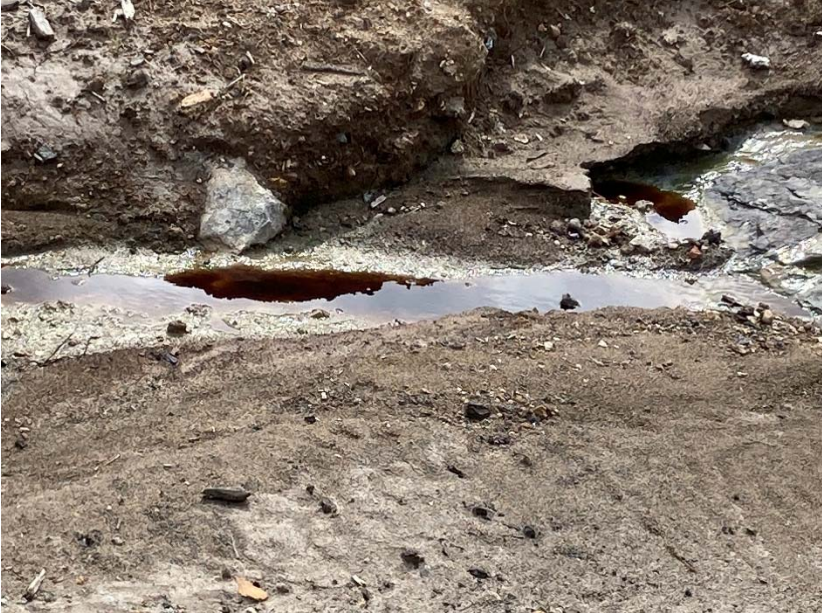
Location	Little Rock Class 1 Landfill				Permit	0266-S1	AFIN	60-01071
Photographer	Daniel Cullum		<i>DC</i>	Witness	Kim Davenport			
Photo #	7	of	12	Date	09/23/2025	Time	1106	
Description	A close-up view of the leachate flow observed in Photos #5 & #6.

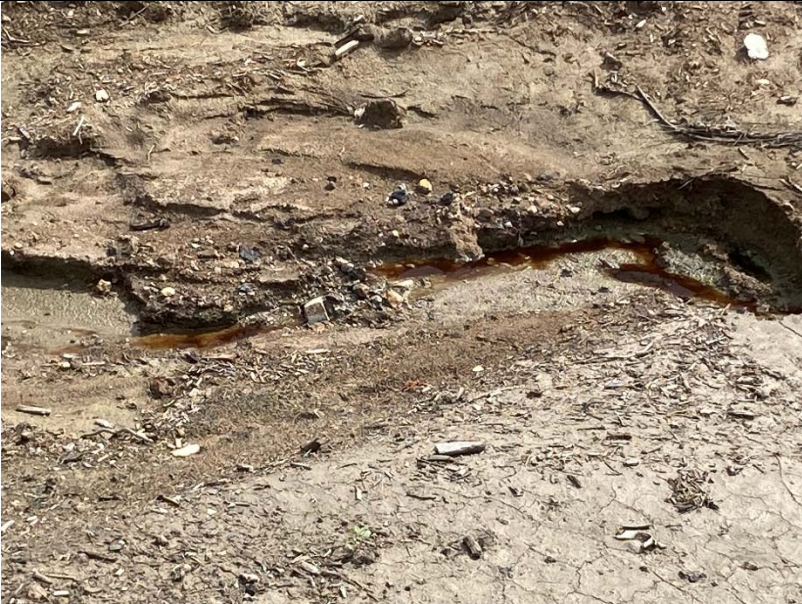
Location	Little Rock Class 1 Landfill				Permit	0266-S1	AFIN	60-01071
Photographer	Daniel Cullum		<i>DC</i>	Witness	Kim Davenport			
Photo #	8	of	12	Date	09/23/2025	Time	1106	
Description	Another close-up view of the leachate flow observed in Photos #5 - #7.

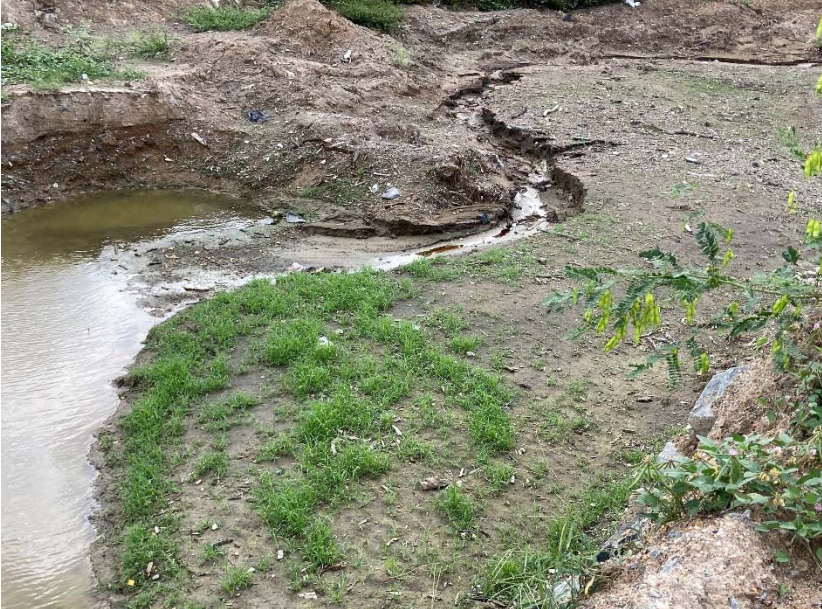
Location	Little Rock Class 1 Landfill			Permit	0266-S1	AFIN	60-01071
Photographer	Daniel Cullum		<i>DC</i>	Witness	Kim Davenport		
Photo #	9	of	12	Date	09/23/2025	Time	1104
Description	Continued view of the leachate from the west slope as it enters an unlined stormwater collection area.

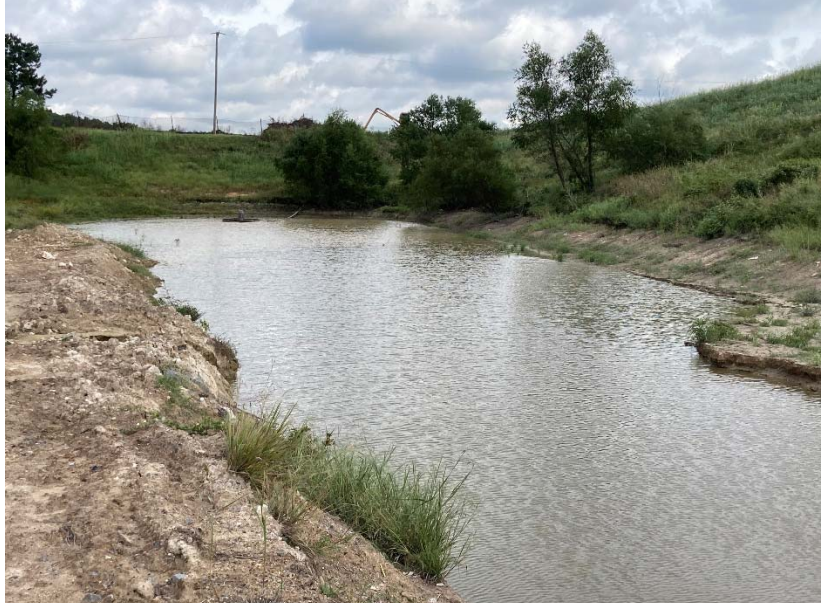
Location	Little Rock Class 1 Landfill			Permit	0266-S1	AFIN	60-01071
Photographer	Daniel Cullum		<i>DC</i>	Witness	Kim Davenport		
Photo #	10	of	12	Date	09/23/2025	Time	1104
Description	A view of the unlined stormwater collection area, where the leachate observed in Photos #5 - #9, from the west slope of Cell 5, has entered.

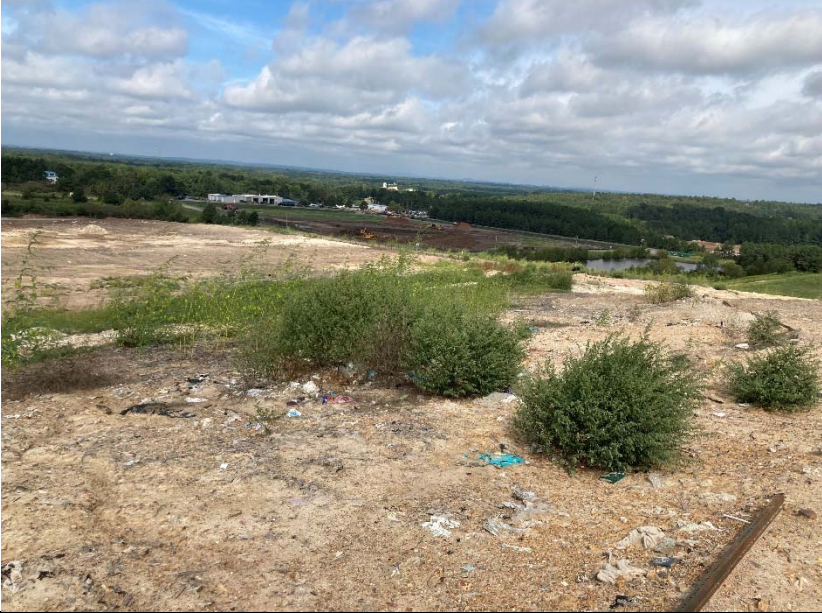
Location	Little Rock Class 1 Landfill			Permit	0266-S1	AFIN	60-01071
Photographer	Daniel Cullum		<i>DC</i>	Witness	Kim Davenport		
Photo #	11	of	12	Date	09/23/2025	Time	1049
Description	Erosion and exposed waste observed on top of the landfill, Cell 9.
