Re: Inspection Response, Dated February 2, 2021
City of Melbourne (Izard County)
NPDES Permit: AR 0020036, AFIN: 33-00026

Following are responses to findings listed in the inspection report referenced above for the City of Melbourne Wastewater Facility. As you mentioned in the report, the facility is in a rehabilitation project that will bring the facility back into compliance. A site visit of these items was conducted on Tuesday, September 28, 2021, to confirm the status of the items listed in the inspection.

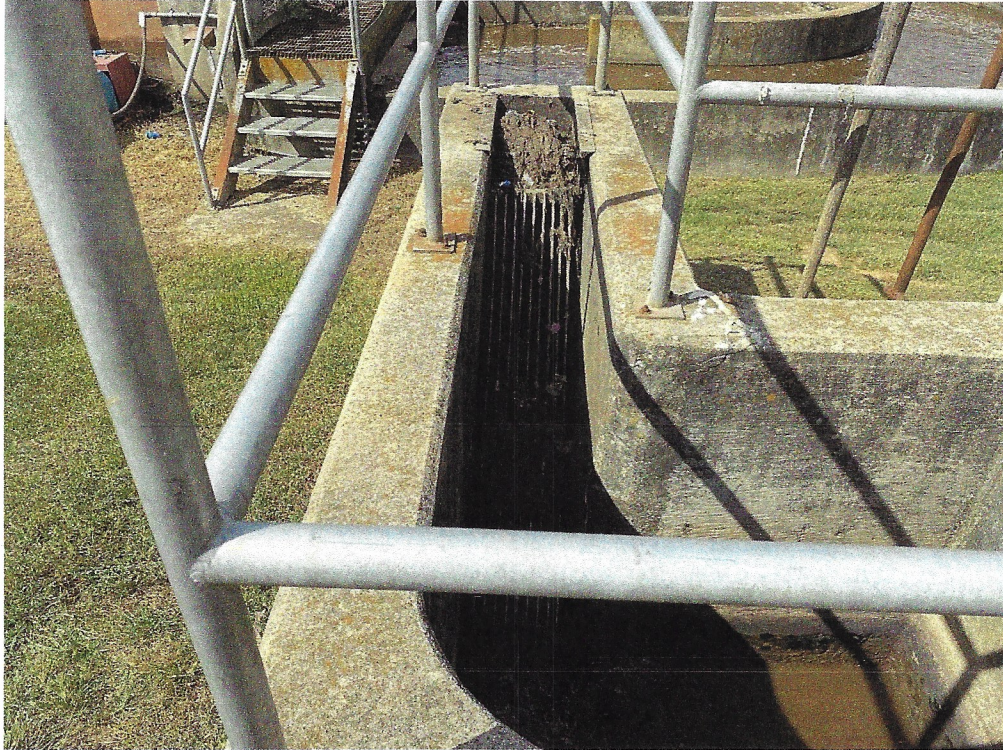
The headworks is all manual at this point. Cleaning of the bar screen is a manual process and during a high flow event, can be subject to overflow. The headworks will be replaced with an automated bar screen that will be self-cleaning as part of the rehab project. City staff had been advised to increase the interval of cleaning or the screen and to add a container in which to deposit the materials removed. At the time of the site visit, the container was not present, but as mentioned above, the area has recently been mowed and it was likely that the container was moved to mow next to the structure. There was a small amount of material at the top of the bar screen that was being allowed to dry, but no excess material was observed around the structure or on the ground.

Figure 1- Head works bar screen

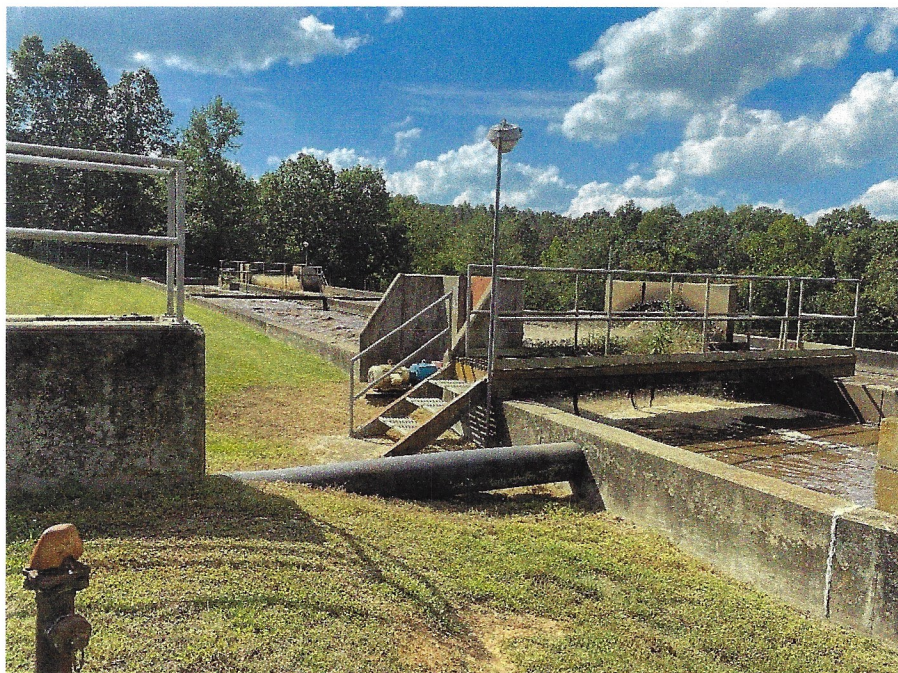
Figure 2- Racetrack Aeration

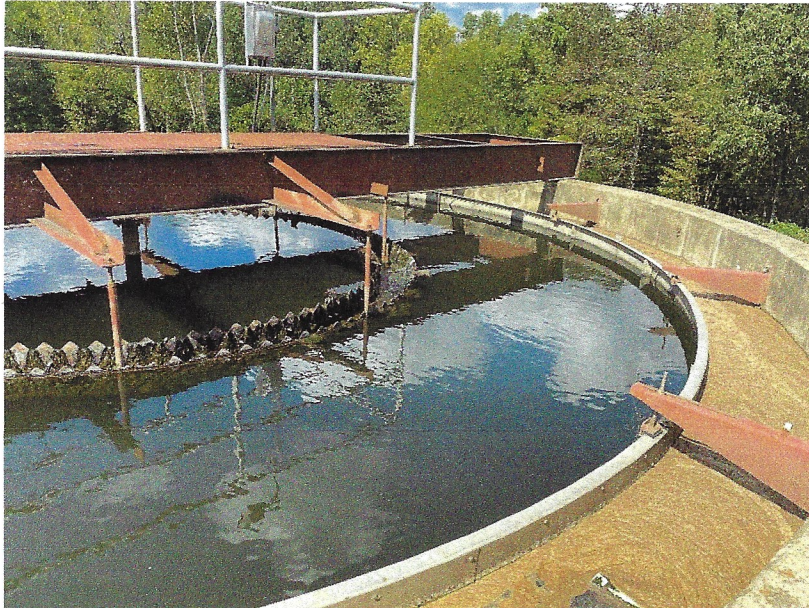
- a. Floatables in the clarifier – As mentioned above, the facility is currently in the process of completing design of a major rehabilitation project for the facility. This issue is related to that project. The existing clarifiers are in desperate need of rehab. The automatic skimmer for the basin that was in operation the day of this follow-up inspection, the northern of the two clarifiers, is not currently operational. The removal process is being done manually by the plant staff. At the time of the visit the was only foam visible in the trough. City staff was scheduled to do a skimming of the foam later in the day.

Figure 3- Clarifier in use at site visit

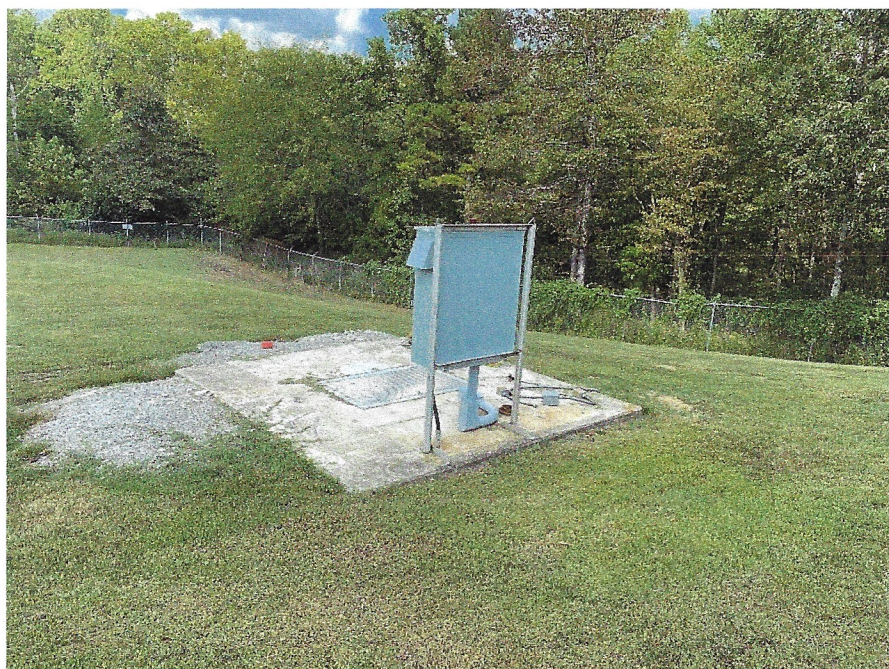
Figure 4 - New RAS Station

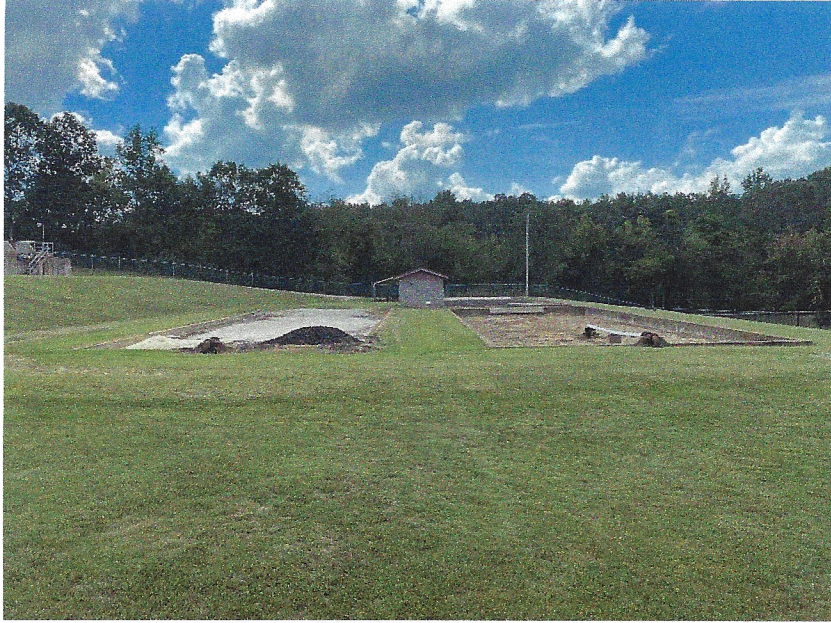
Since the October inspection, the staff had been able to remove some of the accumulated sludge that was in the drying beds at the site. They had recently performed a sludge wasting as sludge was observed in the drying bed. Also, the Return Activated Sludge pump station had failed and has been replaced with a new system.

Figure 5 - Sludge Drying beds
