RE: Evaluation Report
UV Disinfection System
City of Berryville
Carroll County, Arkansas

EVALUATION REPORT

UV DISINFECTION FACILITIES

***CITY OF BERRYVILLE WWTP
CARROLL COUNTY, ARKANSAS***

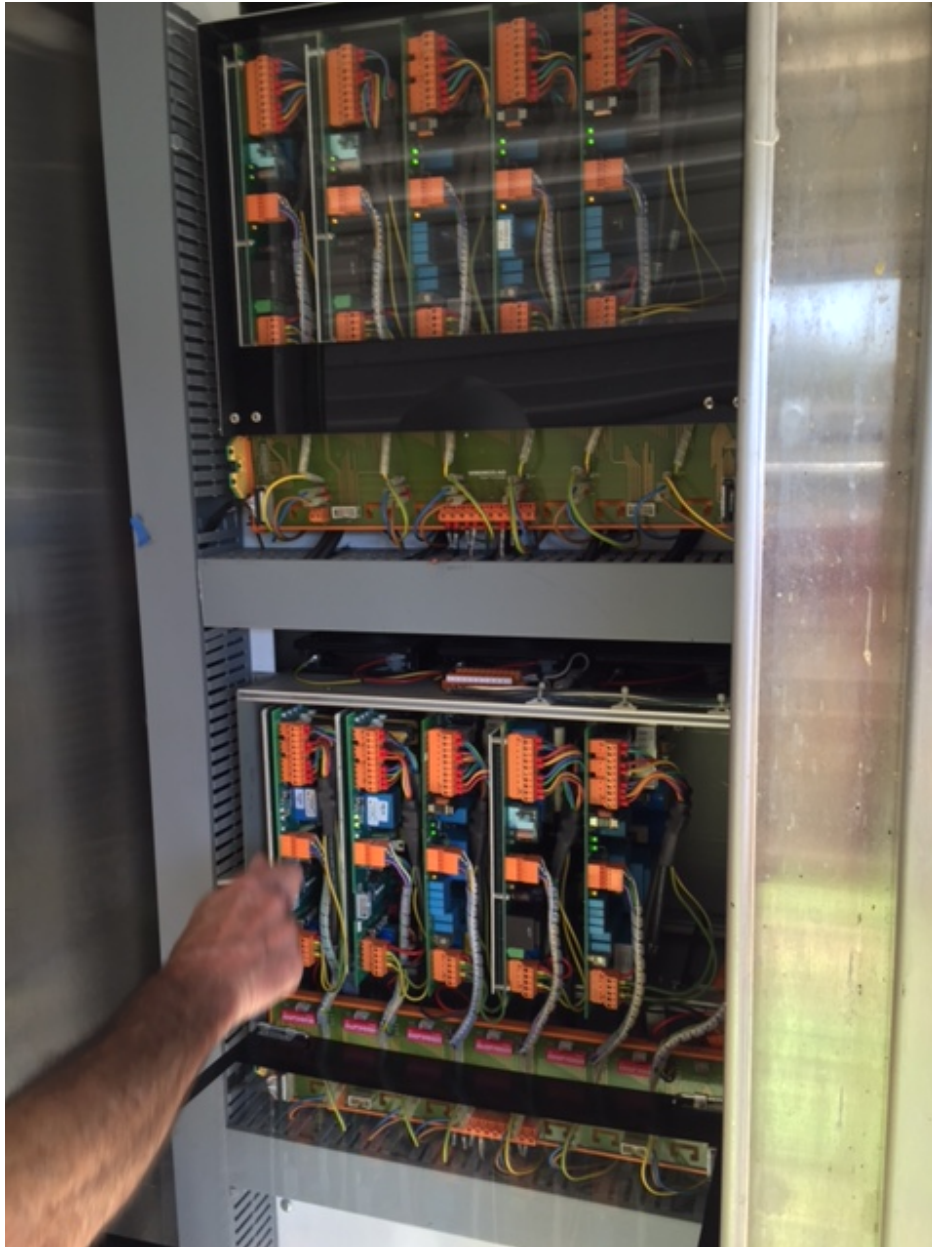
FIGURE 2.4 CONTROL CENTER – BALLAST CABINET

Overall, the electrical and controls equipment installed in the Control Center appeared to be in good condition. During the field evaluation, the controls appeared to be working satisfactorily. Again, much like the Disinfection Basin equipment, the Control Center is somewhat outdated with more modern control capabilities available in newer installations. One of the primary issues is the lack of flexibility in the PLC. The CH2M staff is unable to make any modifications to the underlying software. The manufacturer's representative must come out whenever there are changes that need to be made. Furthermore, while the air conditioning units appeared to have been functioning well during the field evaluation, it is apparent that modifications could be made

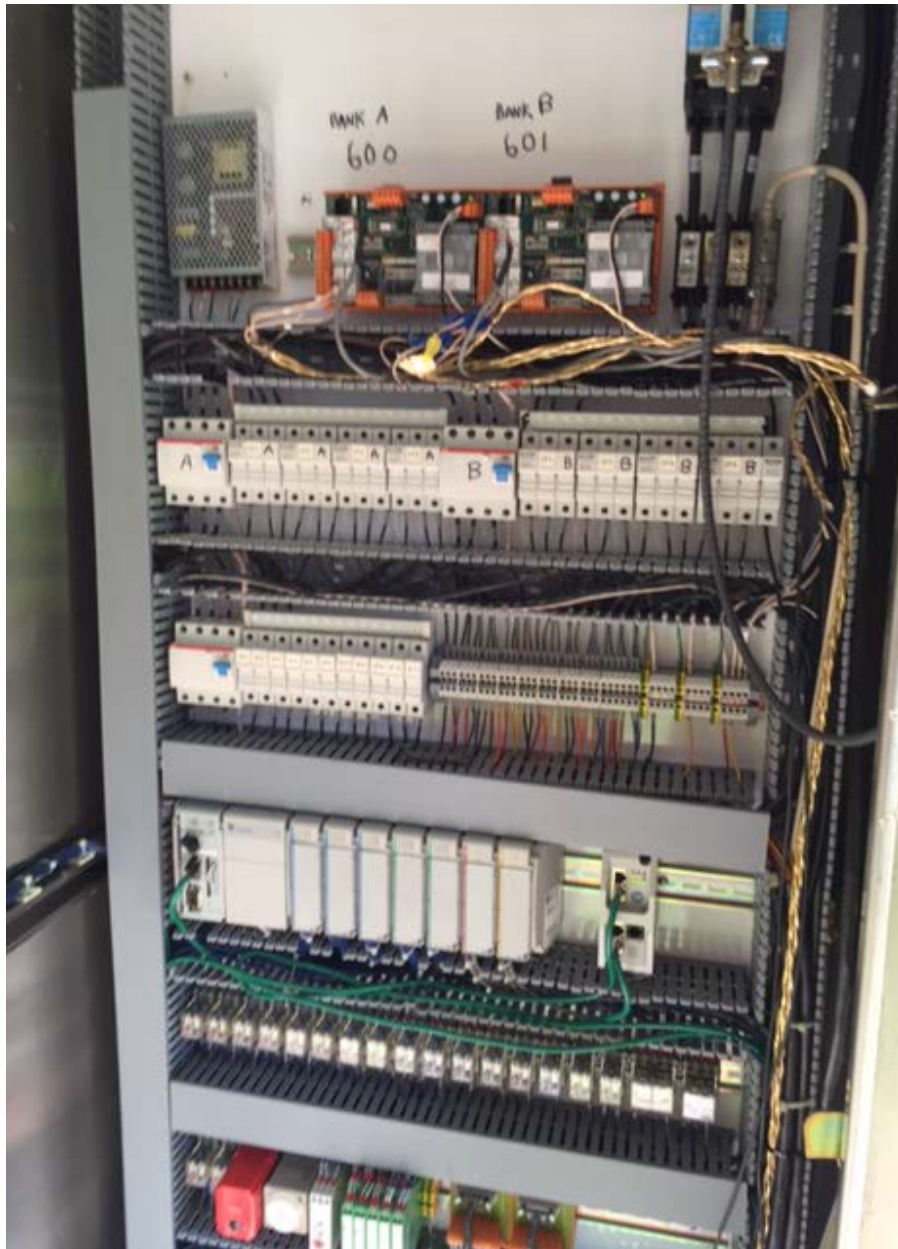
FIGURE 2.5 CONTROL CENTER – PLC CABINET

to improve the panel cooling system. The central panel that houses the PLC is not directly cooled. Instead, small openings in the bottom of the interior side walls of the central cabinet allow the cooled air from either side to circulate through. This could be modified to allow for an increased amount of cool air to be directly furnished to the PLC cabinet.

The cooling system for the cabinets, while completely functional as is, could be bolstered to provide increased performance / redundancy. As previously discussed, the central cabinet which houses the PLC is not directly cooled. Instead, openings in the bottom of the side walls in the cabinet allow cooled air from either side cabinet to circulate through and cool the components located in the central cabinet. Improvements to this scheme could be made by installation of an additional air conditioning unit, some associated ductwork, and directly cool the central cabinet, or to install circulation fans inside the cabinets to improve air circulation.

Another alternative to consider which could improve performance would be to install a temperature probe in the central cabinet and provide a high temperature alarm. The recent issues associated with the air conditioning units lead to the panels overheating, which in turn causes the entire system to shut down as a preventative measure. A temperature probe with an alarm setting at a temperature that was warmer than normal operation, but cooler than shut down temperature could give the operational staff some advanced warning that a temperature-dependent shut down was imminent. The advanced warning could provide the operators the time necessary to correct the issue prior to a hard shut down, thus eliminating discharge of untreated effluent.
