RE: Evaluation Report  
UV Disinfection System  
City of Berryville  
Carroll County, Arkansas

# *EVALUATION REPORT*

*UV DISINFECTION FACILITIES*

*CITY OF BERRYVILLE WWTP  
CARROLL COUNTY, ARKANSAS*

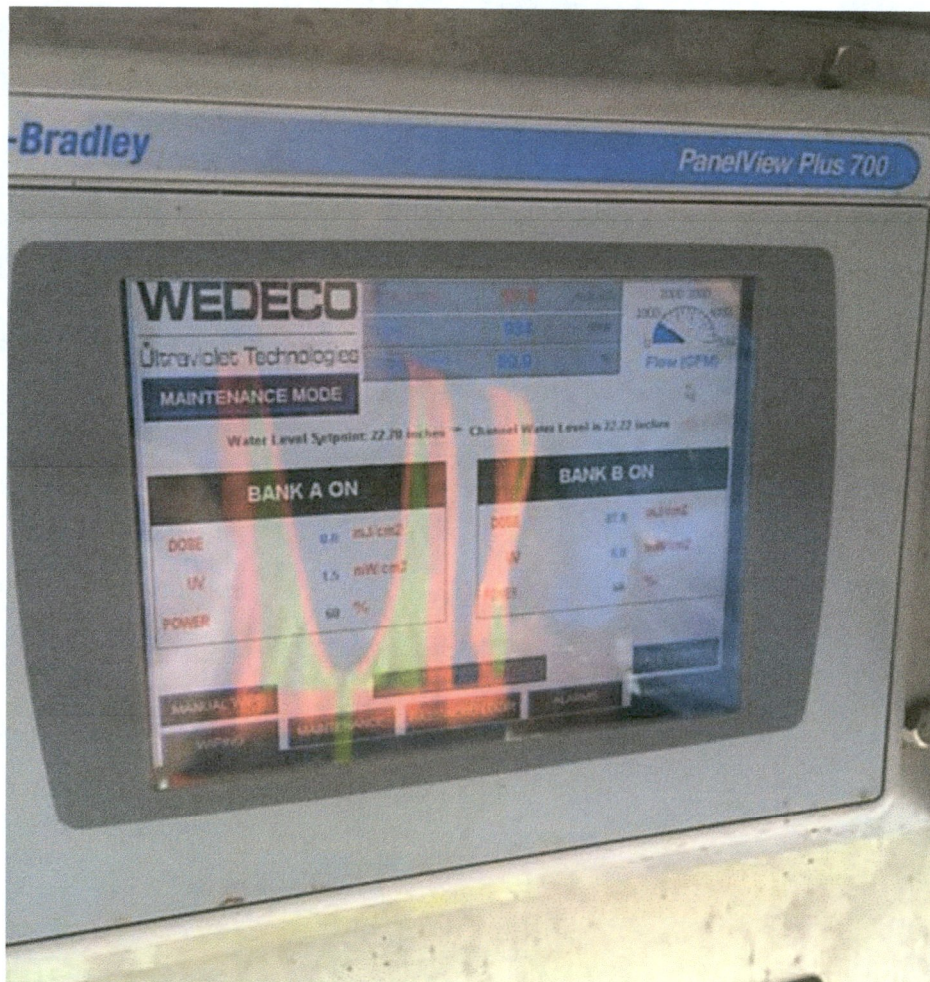
**FIGURE 2.2 PLC USER INTERFACE**

Overall, the electrical and controls equipment installed in the Control Center appeared to be in good condition. During the field evaluation, the controls appeared to be working satisfactorily. Again, much like the Disinfection Basin equipment, the Control Center is somewhat outdated with more modern control capabilities available in newer installations. One of the primary issues is the lack of flexibility in the PLC. The CH2M staff is unable to make any modifications to the underlying software. The manufacturer's representative must come out whenever there are changes that need to be made. Furthermore, while the air conditioning units appeared to have been functioning well during the field evaluation, it is apparent that modifications could be made

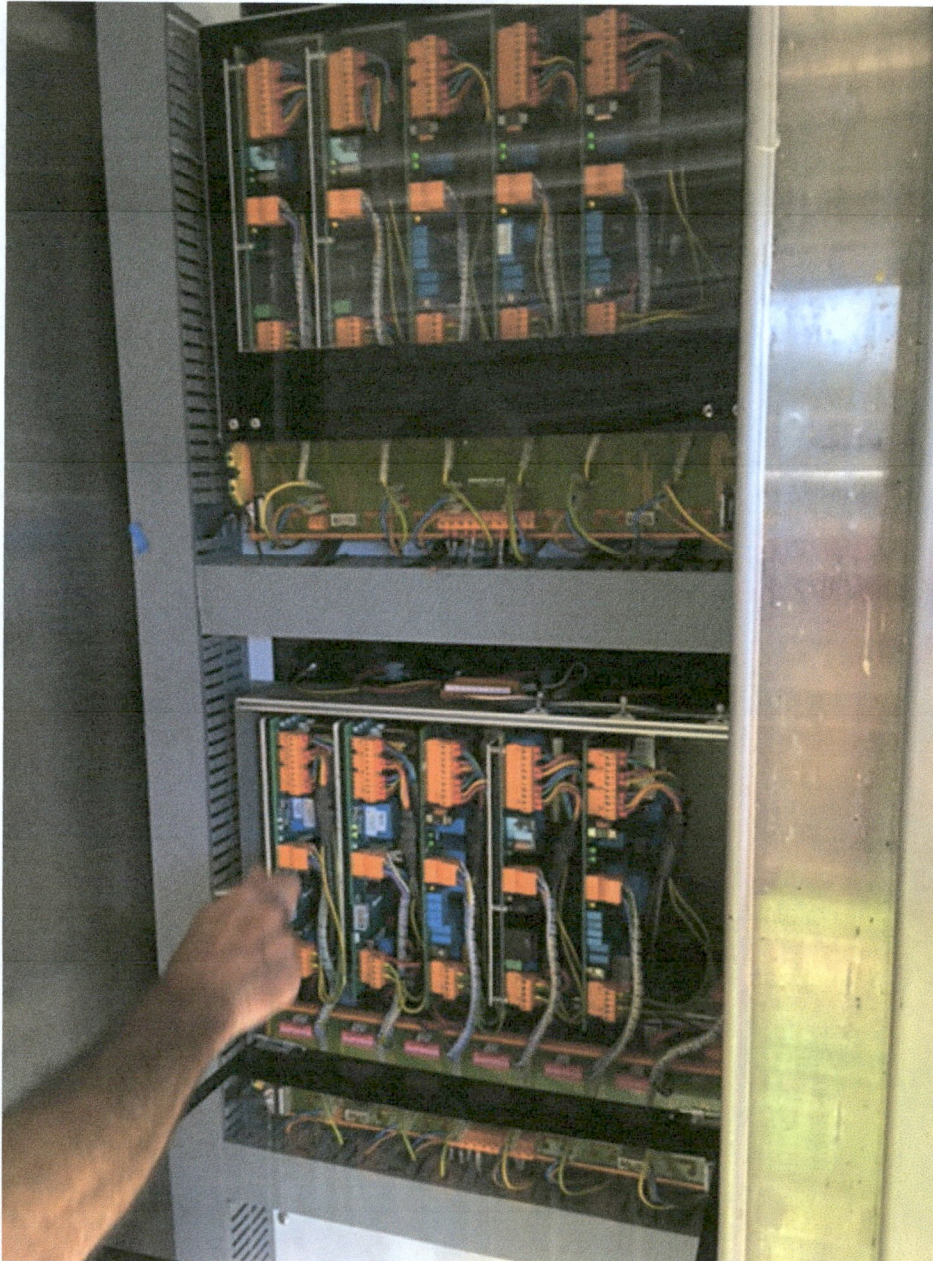
**FIGURE 2.4 CONTROL CENTER – BALLAST CABINET**

to improve the panel cooling system. The central panel that houses the PLC is not directly cooled. Instead, small openings in the bottom of the interior side walls of the central cabinet allow the cooled air from either side to circulate through. This could be modified to allow for an increased amount of cool air to be directly furnished to the PLC cabinet.

Additionally, it is unusual for a Control Center of this nature to be installed in an exterior situation. Ideally, these panels would be located inside a climate controlled building. This would mitigate some of the panel overheating issues as the ambient temperature inside a climate controlled building would be much more ideal for operations. Furthermore, a controls building would help protect the equipment as well as the workers from the elements, especially while they maintenance on the equipment is being performed. Eliminating the possibility of CH2M staff working on electrical components while exposed to rain would certainly be a safety improvement. Finally, a controls building would help to protect the panels from flooding during heavy rainfall events. Major damage to the controls components could occur if the cabinets were to flood.

The cooling system for the cabinets, while completely functional as is, could be bolstered to provide increased performance / redundancy. As previously discussed, the central cabinet which houses the PLC is not directly cooled. Instead, openings in the bottom of the side walls in the cabinet allow cooled air from either side cabinet to circulate through and cool the components located in the central cabinet. Improvements to this scheme could be made by installation of an additional air conditioning unit, some associated ductwork, and directly cool the central cabinet, or to install circulation fans inside the cabinets to improve air circulation.

Another alternative to consider which could improve performance would be to install a temperature probe in the central cabinet and provide a high temperature alarm. The recent issues associated with the air conditioning units lead to the panels overheating, which in turn causes the entire system to shut down as a preventative measure. A temperature probe with an alarm setting at a temperature that was warmer than normal operation, but cooler than shut down temperature could give the operational staff some advanced warning that a temperature-dependent shut down was imminent. The advanced warning could provide the operators the time necessary to correct the issue prior to a hard shut down, thus eliminating discharge of untreated effluent.
