From:	Zane Lewis <zlewis@mce.us.com></zlewis@mce.us.com>
Sent:	Friday, December 22, 2023 1:02 PM
То:	Water-Inspection-Report
Cc:	Richard Healey (adpce.ad); William Cody (adpce.ad); Simon Wiley
	(swiley@eurekaspringsar.gov); Terry Long (eswwtp@yahoo.com); Spencer Briggs; Nick
	Batker; Butch Berry
Subject:	23-2159 Eureka Springs WWTP - Response to DEQ Inspection Report - PDS#
	128366(Carroll Co.), AFIN:08-0036, Permit#AR0021865
Attachments:	Attachments A B C.pdf; 23-2159 Eureka Springs WWTF Response Letter to DEQ
	Comments 12 22 2023_reduced size.pdf

December 22, 2023

RE: NPDES Permit AR0021865; AFIN 08-00036

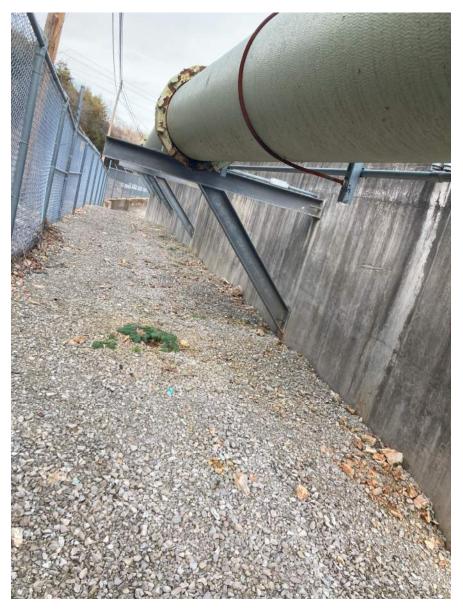
Firstly, it has been reiterated multiple times by plant staff that preventing discharge of sludge into the adjacent Leatherwood Creek is their number one concern along with maintaining full compliance with all permit requirements. See Figure 1 for a picture of the area of unintentional discharge on November 9, 2023. This area has been cleaned and no further discharges have occurred.

Figure 1: West side of SBR system where initial overflow occurred indicating there have been no recent overflows

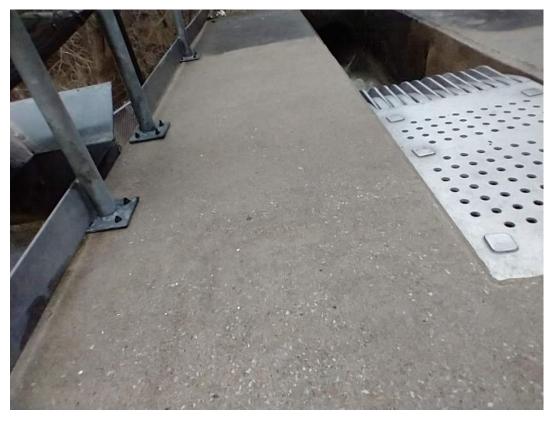
2. There is evidence of exposed solids on the concrete slab adjacent to the influent bar screen. Furthermore, the collection container (55-gallon barrel) does not have additional measures to prevent a discharge in the event of a spill. The solids accumulation next to the bar screen is in violation of Part III, B.6.A of the permit.

Figure 2: Concrete slab adjacent to slab after cleaning

At the influent manual bar screen the spilled waste solids referenced above have been removed from the concrete slab, see Figure 2. Following the solids removal, the area has been washed down with a garden hose and bleach. The disinfectant was allowed to sit for approximately five (5) minutes and then washed into the influent flow channel with site NPW.

New standard operating procedure moving forward shall be that the operators will not ever leave any solids on the concrete during, or after, cleaning the manual influent bar screen. If solids do fall off the shovel during cleaning they will be immediately picked up and placed in the waste barrel for disposal and the concrete area flushed with water directed back to the influent channel and the entire area cleaned with bleach as need.

The area adjacent to the manual bar screenings collection 55-gallon barrel drum will be paved with a concrete pad with a perimeter containment curb/lip like the new slab adjacent to the mechanical screen and grit removal unit. The existing 55-gallon barrel with drain to this secondary containment area in case of a spill, see Figure 3 and Figure 4 for pictures of the new containment slab at the mechanical equipment area.

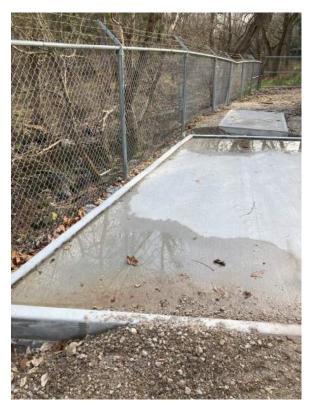
Figure 3: East side of newly constructed concrete slab adjacent to screening and grit removal equipment.

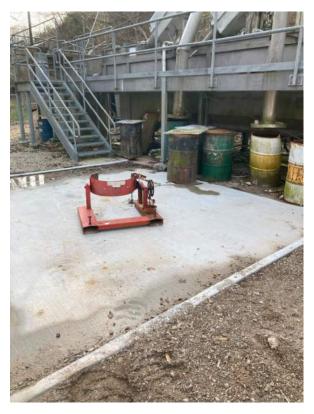
Figure 4: West side of newly constructed concrete slab adjacent to screening and grit removal equipment.

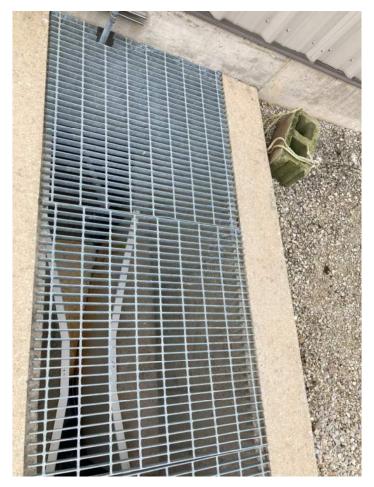
3. A cinder block is currently used for manual flow measurements, which is not consistent with accepted scientific practices and does not ensure reliable data. It is required that a staff gauge and/or ruler of adequate length be implemented for manual flow measurements at the Parshall flume before Outfall 001. This is in violation of Part III, C.2 of the permit.

Figure 5: Photo indicating that the cinder block and attached rope have been removed from the Parshall flume

Effluent flow measurement from the wastewater treatment system is performed at the existing Parshall flume. A concrete cinder block has been used as a temporary offset for manual flow depth measurements. This temporary item has been removed from the area of the Parshall flume. A stainless-steel measurement ruler has been ordered to be used for the periodic verification of effluent flow measurement for calibration/verification of the automatic flow meter.

The existing Parshall flume measurement gauge affixed to the wall of the flume is also used for flow measurement/verification. The existing automatic effluent flow meter is calibrated annually, as required by the permit, by a third party. See Figure 5 for a view of the top of the Parshall flume box, covered in protective grating.

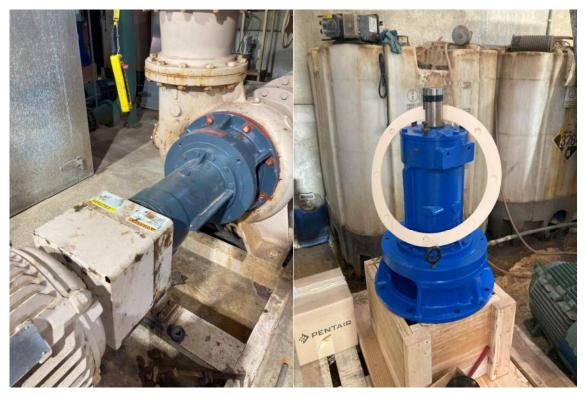
Motive pump for SBR#1 failed due to a bent drive shaft. The enclosed drive shaft coupling/bearing housing has been replaced and the pump has been rebuilt and placed back into service.

Figure 6: Rebuilt motive pump for SBR#1 in service (left); new backup pump (right)

Additionally, a spare enclosed drive shaft coupling/bearing assembly has been purchased to have on hand as an immediate repair if this issue occurs again. See Figure 6 for photos of the repaired pump system and spare parts.

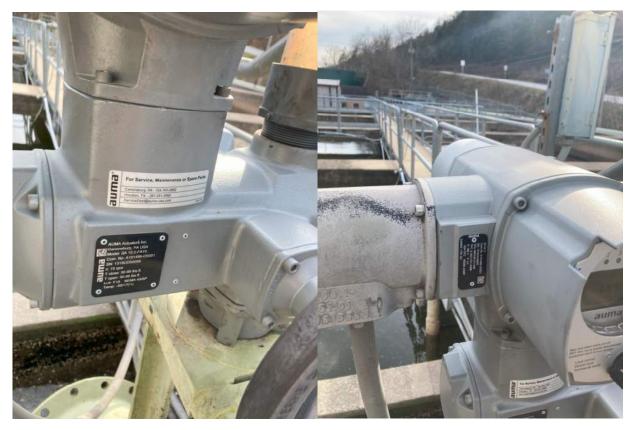
Influent valve for SBR#1 failed due to a broken actuator. The broken actuator was replaced, and reverse internal acme threads were added to the brass drive nut to provide more reliable service. See Figure 7 for pictures of the replaced valve actuator.

Figure 7: Influent valve for SBR#1 in operation

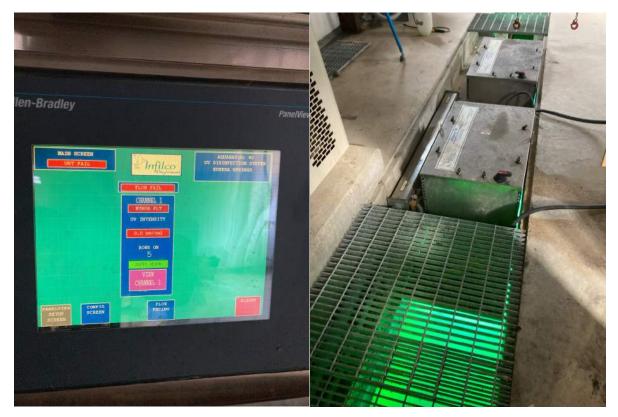
The exiting UV Disinfection unit failed due to multiple components reaching the end of their useful life. The system has been repaired with new quartz sleeves, new UV bulbs, a new DCA assembly, and new liquid tight strain relief fittings.

Currently both UV treatment modules are operational. However, the system is still experiencing communications/controls issues between the UV system control panel and UV modules.

Figure 8: Ongoing issue with communication (left); both UV modules in operation (right)

Plant staff continues to coordinate with a manufacturer's field service technician to resolve these issues. See Figure 8 for pictures of the rebuilt UV system.

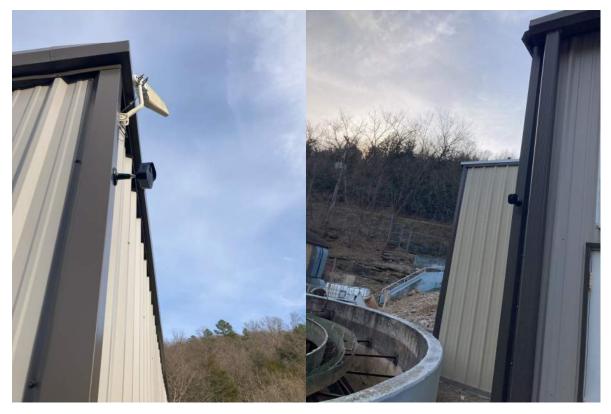
Plant site security has been an ongoing issue. The plant has experienced multiple occurances of members of the public entering the plant while staff is away. Previously no remote monitoring was possible at the plant. Recently, new wireless security cameras have been installed and are operational. To fully active this new security/monitoring system a new wifi signal booster will be installed at the plant to provide the required service at remote corners. See Figure 9 for pictures of the new security cameras.

Figure 9: Camera used to monitor SBR basins (left); camera to monitor fence gap and sludge storage (right)

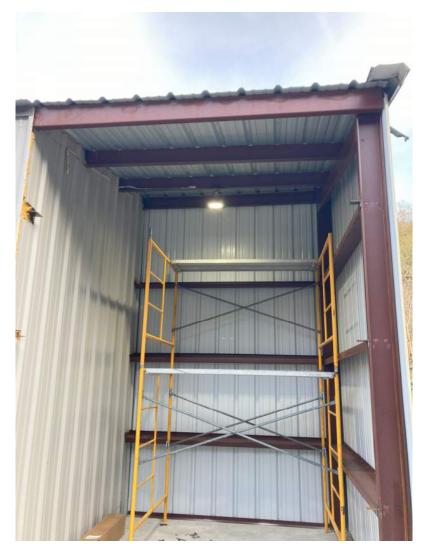
Onsite bulk chemical storage has been expanded with new construction at the existing belt filter press building. A new chemical storage bay has been added to the south side of the existing building. See Figure 10 for pictures of the new storage area. The new storage areas will provide a temperature-controlled environment for the chemicals.

Figure 10: Building add on for temperature controlled chemical storage
