CITY OF BLYTHEVILLE

SANITARY SEWER COLLECTION SYSTEM REPORT

February 2012

CCTV and Smoke Test Results

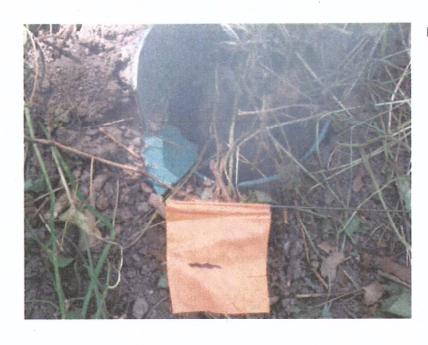
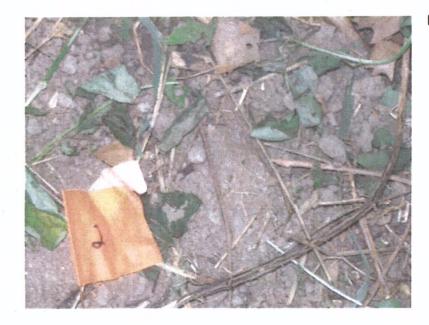
PICTURE #1

Log #: 3		Location: 72	
Manhole#	Length	Leak Y/N	Description/Comments	
NC4	373.6	N		
NC4	404.7	Υ		
NC4	420	Υ	PIC. 3	
NC41	449.1	N		
NC3	320.9	N		
NC3	437.2	Υ	PIC. 4, 5, 6	
NC38	453.5	N		
NC3	405	N		
NC25	344	N		
NC24	193.9	N		
NC24	148.3	N		
	3950.2			
	Manhole# NC4 NC4 NC4 NC41 NC3 NC3 NC3 NC3 NC38 NC38 NC3 NC25 NC24	Manhole# Length NC4 373.6 NC4 404.7 NC4 420 NC41 449.1 NC3 320.9 NC3 437.2 NC38 453.5 NC3 405 NC25 344 NC24 193.9	Manhole# Length Leak Y/N NC4 373.6 N NC4 404.7 Y NC4 420 Y NC41 449.1 N NC3 320.9 N NC3 437.2 Y NC38 453.5 N NC3 405 N NC25 344 N NC24 193.9 N NC24 148.3 N	Manhole# Length Leak Y/N Description/Comments NC4 373.6 N NC4 404.7 Y PIC. 1, 2 NC4 420 Y PIC. 3 NC41 449.1 N NC3 320.9 N NC3 437.2 Y PIC. 4, 5, 6 NC38 453.5 N NC3 405 N NC25 344 N NC24 193.9 N NC24 148.3 N
