CORRECTIVE ACTION ORDER UPDATE

BLYTHEVILLE WEST WASTEWATER TREATMENT FACILITY
ASSESSMENT AND RECOMMENDED PLAN FOR CORRECTIVE MEASURES

Prepared for:
City of Blytheville

Date:
April 27, 2015

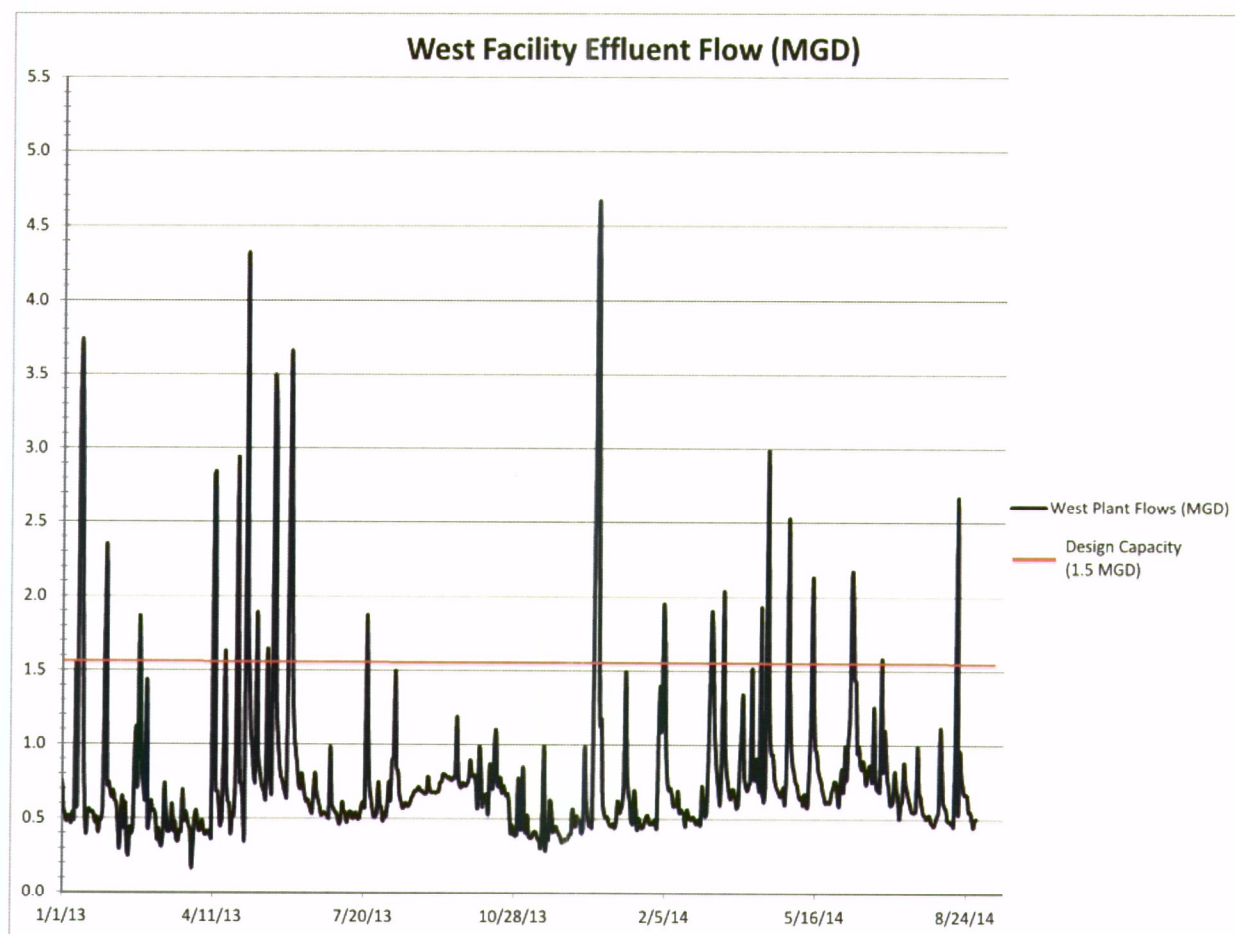
Figure 2.1 – Daily Effluent Flows

The daily effluent flows for the facility are summarized in Table 2.2. During a heavy rain event, the facility can go multiple days where the influent flows exceed the facility's design capacity, as evidenced by Figure 2.1 below. Over the last two years, influent flows have exceeded the design flow by as much as 350 percent.

These flow excursions are directly related to rainfall events as identified in the Daily Operation Reports (DOR's) provided by the City. During these spikes, the plant loses a majority of its microbial treatment ability due to the washout of the nitrifying organisms from the treatment basins. This is confirmed by the Daily Monitoring Reports (DMRs) that show lower-than-normal mixed liquor suspended solids (MLSS) concentrations in the primary mixing basin (as compared to pre-rainfall concentrations) and high total suspended solids (TSS) concentrations in the effluent after every rain event that increased plant flow. The carbonaceous biochemical oxygen demand (CBOD) loading in the influent flow also drops significantly during and immediately after every rainfall event that affects flow. This is due to dilution by inflow and infiltration. This diluted CBOD loading further promotes degradation of the biomass used to treat the wastewater.

The facility was originally designed to have a hydraulic residence time of between 24 and 48 hours to allow for adequate treatment. When the facility receives flows in excess of the design maximum flow, three conditions occur that affect the treatment capabilities of the facility: (1) the hydraulic residence time is reduced such that there is not adequate time for treatment to occur; (2) the additional flow has a very low concentration of CBOD, sharply decreasing the strength of the waste stream, and depriving the biomass of needed nutrients for growth and treatment abilities; and (3) the MLSS concentration in the treatment basin is significantly reduced due to washout of the biomass from the basins, thereby preventing adequate treatment of subsequent incoming flows. As a result of these conditions, the facility could possibly be out of compliance for multiple permit limits for several days while the biomass attempts to reestablish itself.
