# Memo

Re: Sewer line rupture at 2816 Albert Pike, Hot Springs (occurred August 20, 2015); PDS# 086146

## Water Division Photographic Evidence Sheet

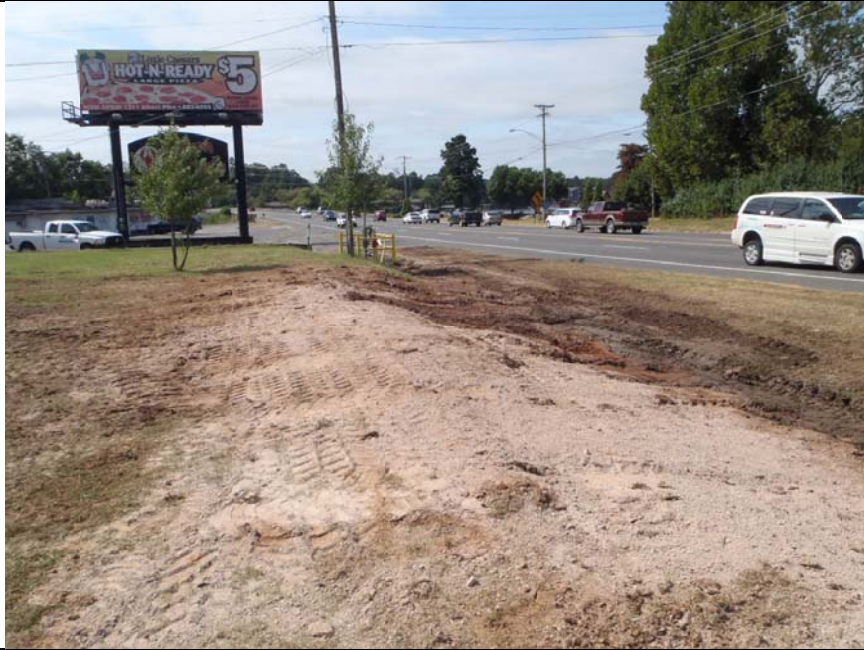
Location:	Hot Springs sewer rupture 2816 Albert Pike.				
Photographer:	Travis Harmon	Date:	8/21/15	Time:	1054
Witness:	Bobby Harris			Photo #:	1
Description:	Area where line rupture occurred along Albert Pike; looking south.

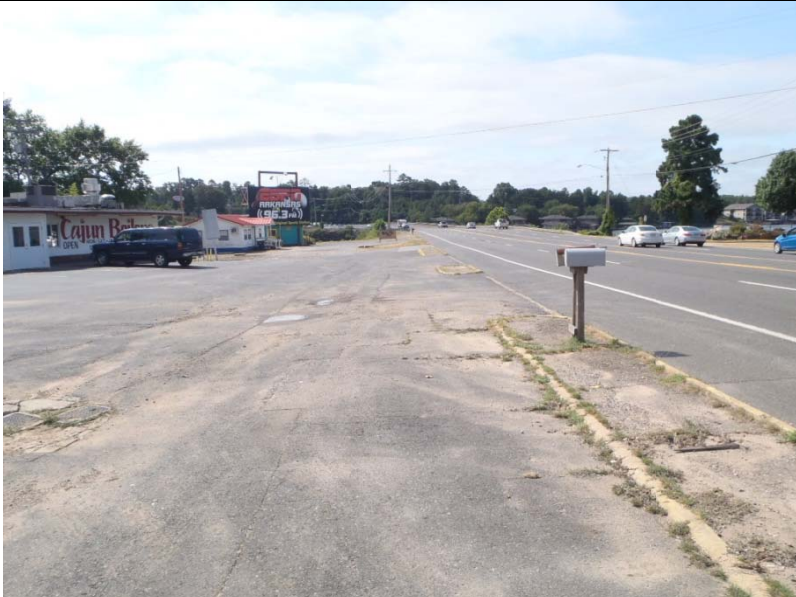
Photographer:	Travis Harmon	Date:	8/21/15	Time:	1055
Witness:	Bobby Harris			Photo #:	2
Description:	The discharge flowed across the Cajun Boilers parking lot and then left between the two buildings. The City washed this area of the parking lot clean prior to my arrival.

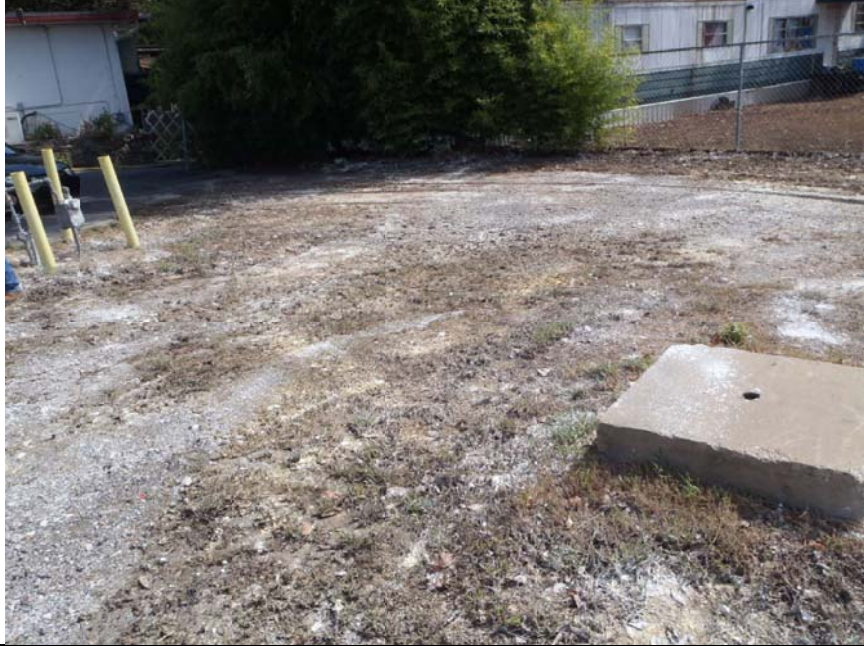
Location:	Hot Springs sewer rupture 2816 Albert Pike.				
Photographer:	Travis Harmon	Date:	8/21/15	Time:	1056
Witness:	Bobby Harris			Photo #:	3
Description:	Solids (dissolved tissue) and lime on property south of Cajun Boilers.

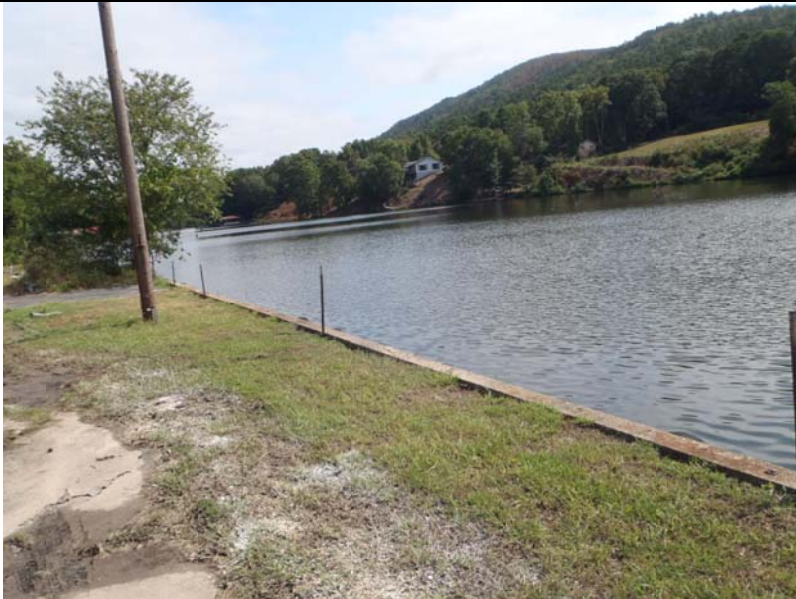
Photographer:	Travis Harmon	Date:	8/21/15	Time:	1058
Witness:	Bobby Harris			Photo #:	24
Description:	Location where the wastewater entered lake Hamilton. Some solids (dissolved tissue) visible in grass.

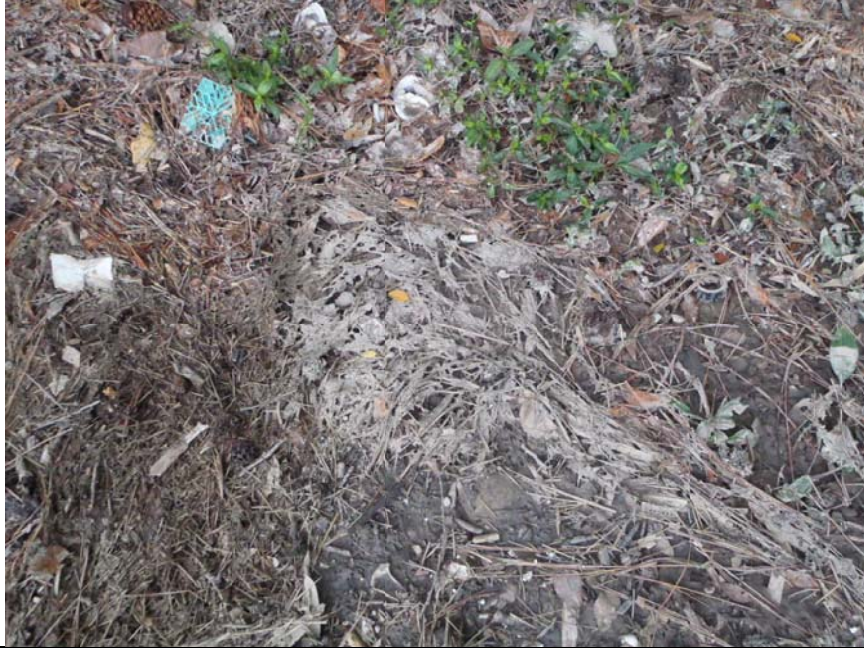
Location:	Hot Springs sewer rupture 2816 Albert Pike.				
Photographer:	Travis Harmon	Date:	8/21/15	Time:	1111
Witness:	Bobby Harris	Photo #:	5		
Description:	Closer view of dissolved tissue (solids) indicative of a wastewater discharge.

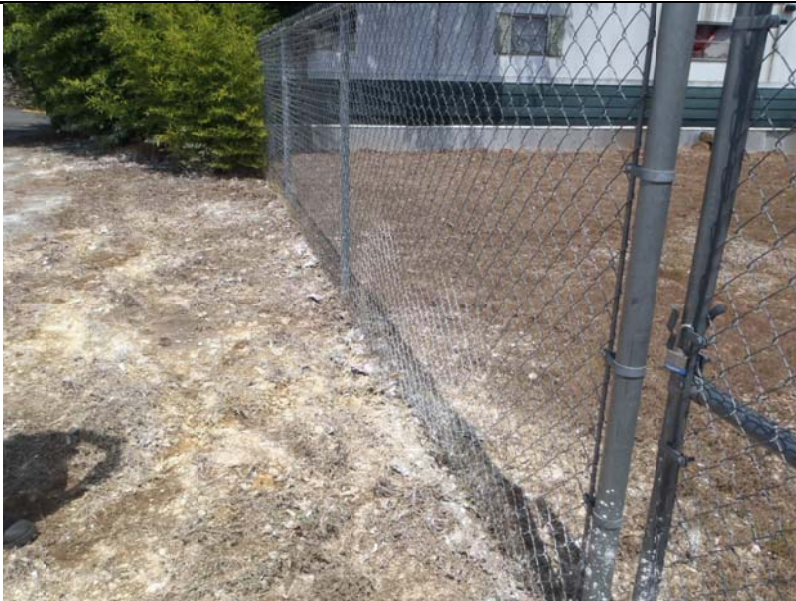
Photographer:	Travis Harmon	Date:	8/21/15	Time:	1351
Witness:	Dean VanDerhoff	Photo #:	6		
Description:	Solids and lime along fence at property south of Cajun Boilers.

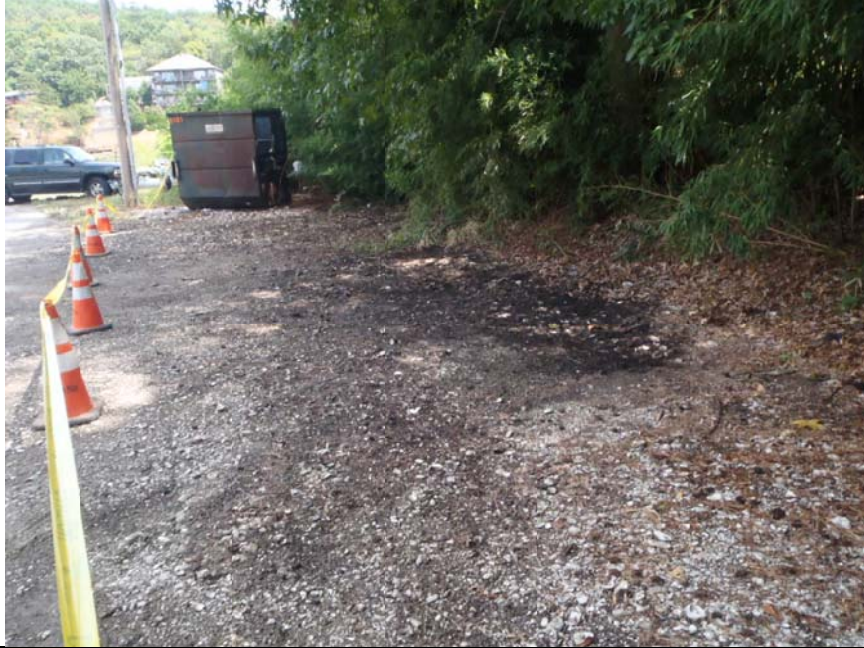
Location:	Hot Springs sewer rupture 2816 Albert Pike.				
Photographer:	Travis Harmon	Date:	8/21/15	Time:	1357
Witness:	Dean VanDerhoff			Photo #:	7
Description:	Employee parking after raking.

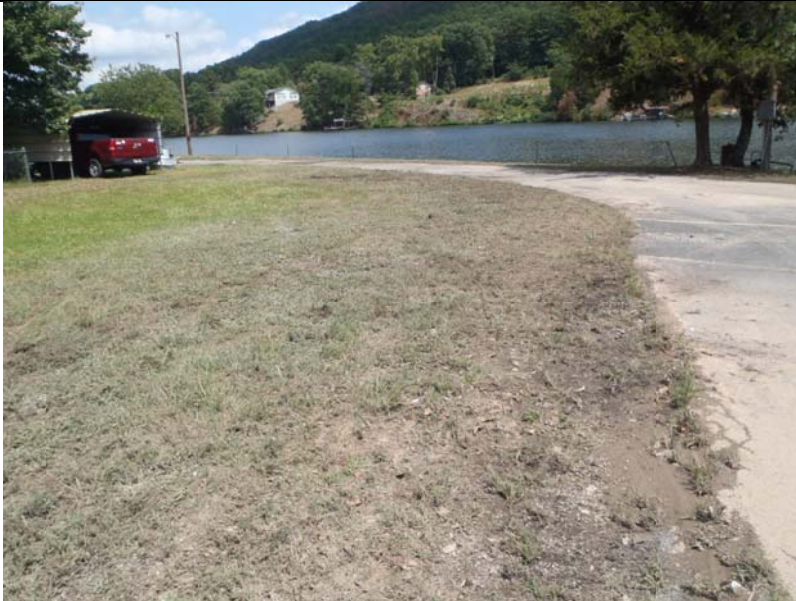
Photographer:	Travis Harmon	Date:	8/21/15	Time:	1358
Witness:	Dean VanDerhoff			Photo #:	8
Description:	Lakeside parking and docking area after raking.

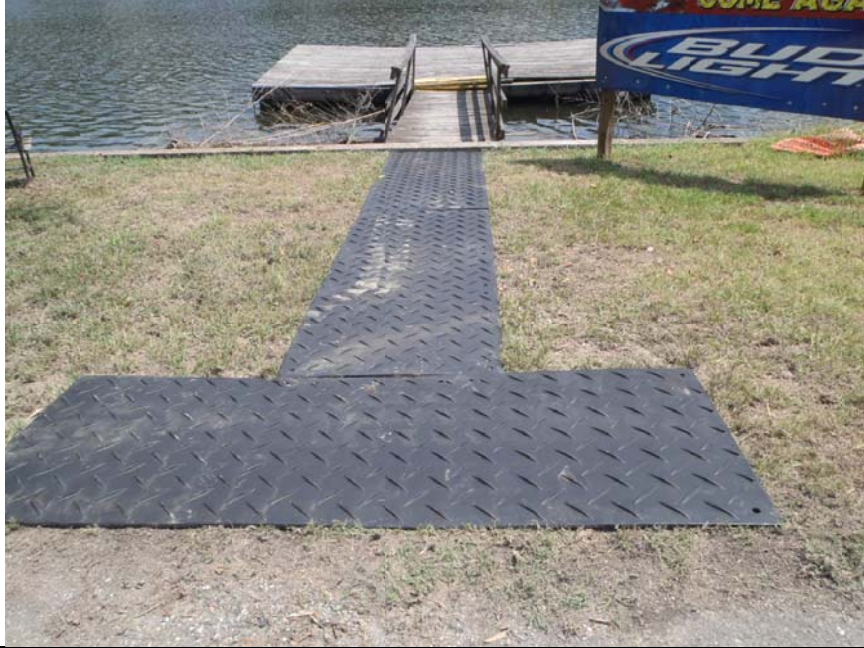
Location:	Hot Springs sewer rupture 2816 Albert Pike.				
Photographer:	Travis Harmon	Date:	8/21/15	Time:	1358
Witness:	Dean VanDerhoff	Photo #:	9		
Description:	The City installed a walkway at the dock to reduce contact with affected soils/grass.

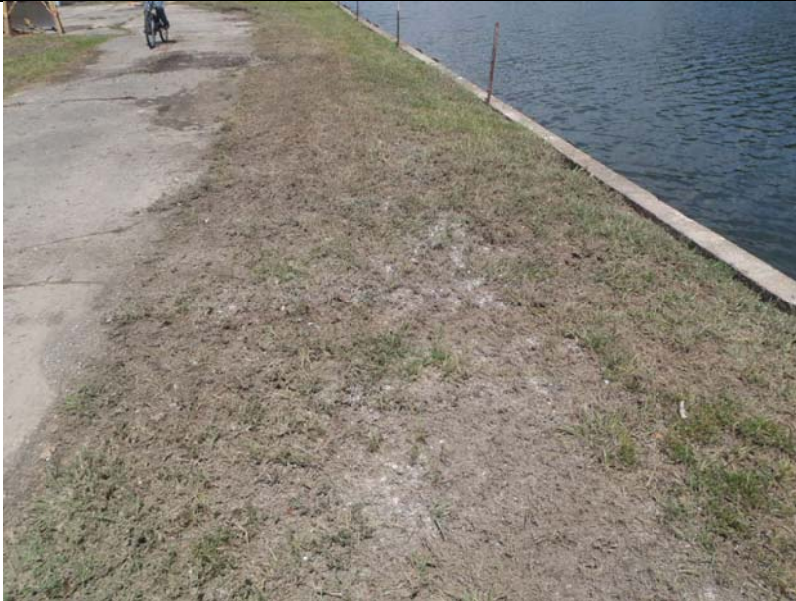
Photographer:	Travis Harmon	Date:	8/21/15	Time:	1358
Witness:	Dean VanDerhoff	Photo #:	10		
Description:	Docking area and lake discharge point after raking.

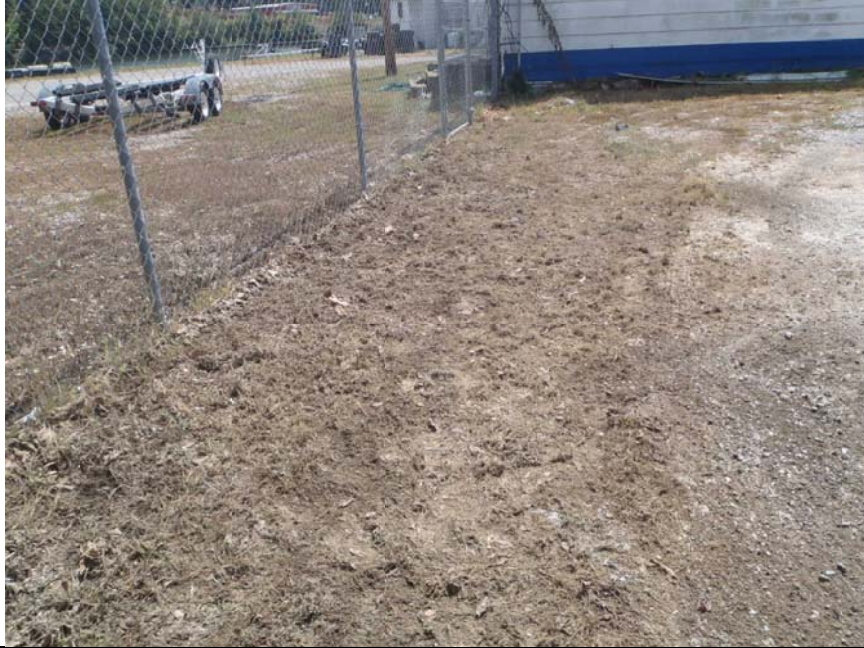
Location:	Hot Springs sewer rupture 2816 Albert Pike.				
Photographer:	Travis Harmon	Date:	8/21/15	Time:	1405
Witness:	Dean VanDerhoff	Photo #:	11		
Description:	Property south of Cajun Boilers after raking.

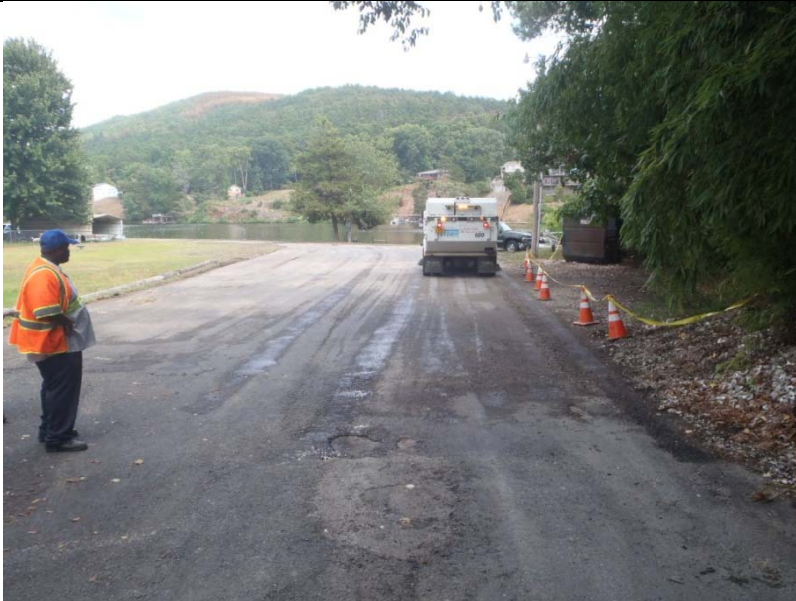
Photographer:	Travis Harmon	Date:	8/21/15	Time:	1441
Witness:	Dean VanDerhoff	Photo #:	12		
Description:	Street sweeper cleaning back (lakeside) parking area at Cajun Boilers.
