RE: City of Bryant  
LIS 16-057, AFIN 63-0005, Permit No. AR0034002  
CIP Update

Subject: City of Bryant – SECAP update with Future Development Capacity Analysis & Improvement Tech Memo

## Draft Report

City of Bryant, AR

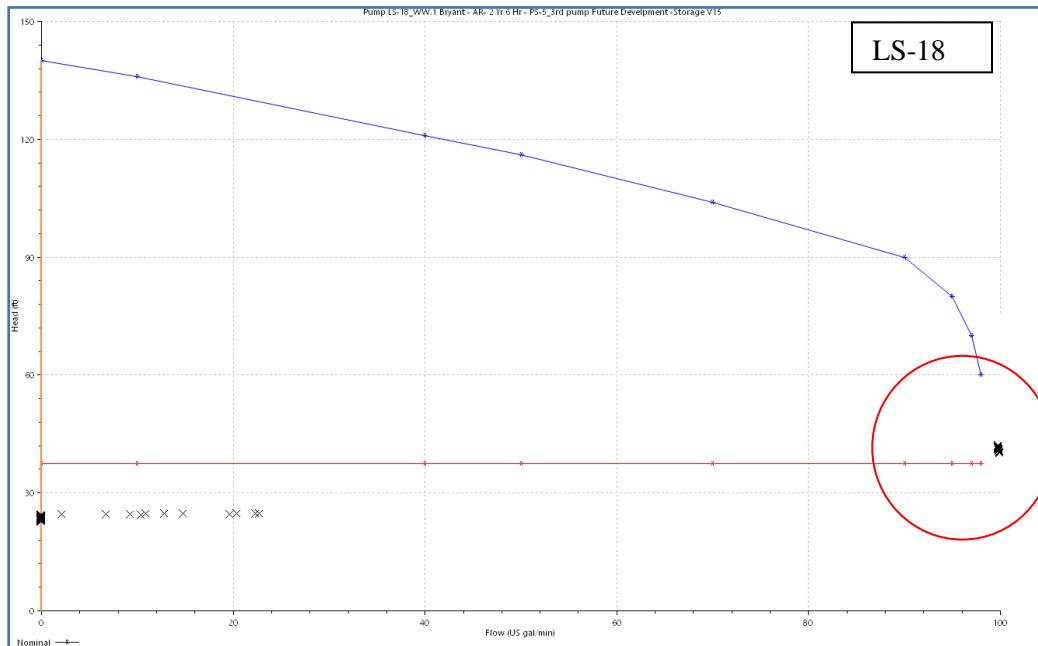
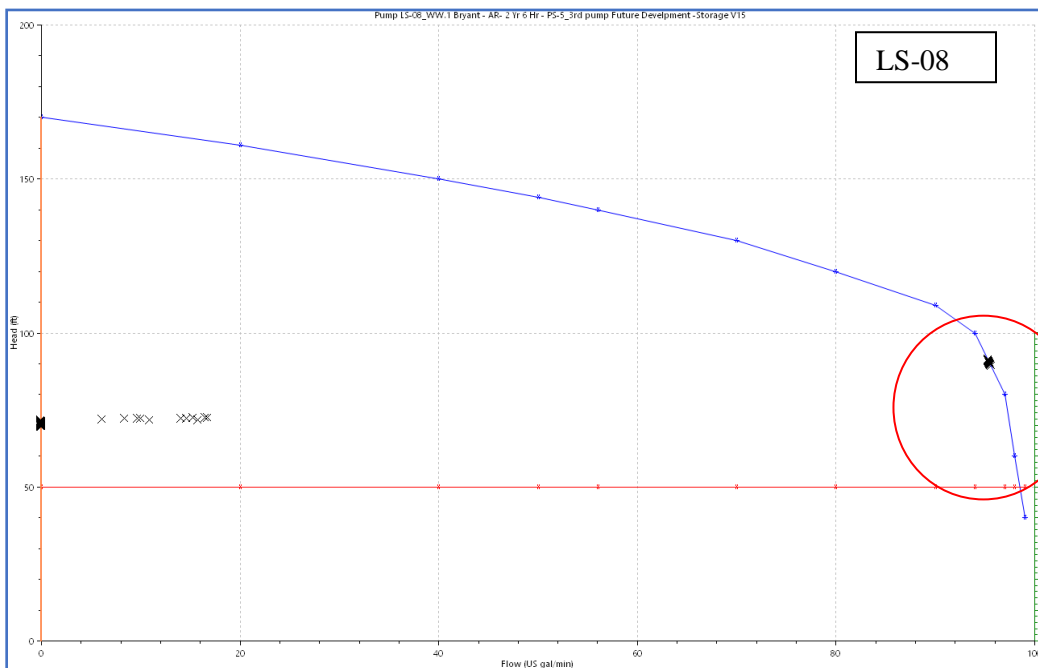
Figure 1. Examples of Pumps Operating at the Right-Hand End of Their Curve

Figure 1 illustrates several pumps that are operating either “off their curve” or at the lower end of their curve. If during normal DWF conditions the pumps are operating at the right-hand end of their pump curve the likelihood of cavitation and wear greatly increases.

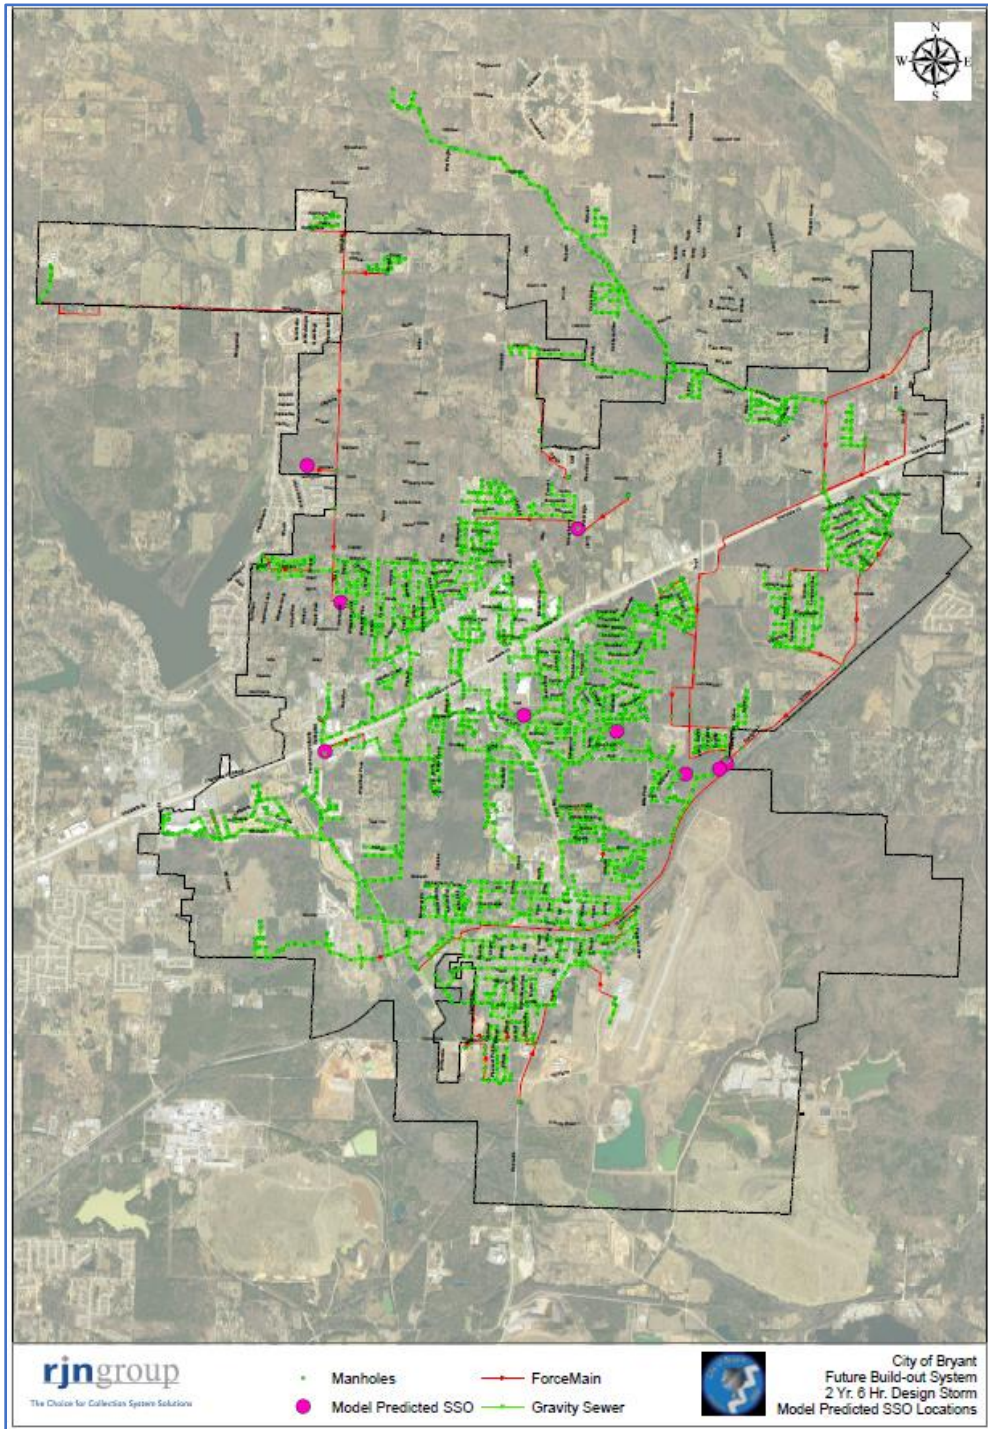
Figure 4. SSO Locations

The capacity analysis highlighted that by including the additional flows from future growth/development, the previous SECAP upgrades were not sufficient to transport all wet weather flow associated with the 2-year/6-hour design storm. The model results showed a total of nine (9) predicted SSOs locations with a total overflow volume of 0.18 MG. A further thirty-six (36) locations experience peak surcharge levels within 3 ft of MH rim. The SSO locations are presented in Table 4 and shown in Figure 4.

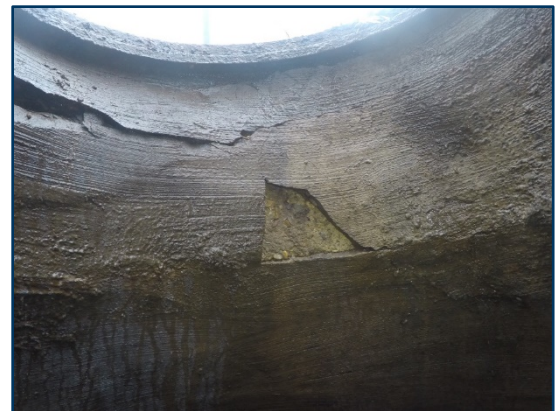
*Defective Chimney  
(BR-03) 50110*

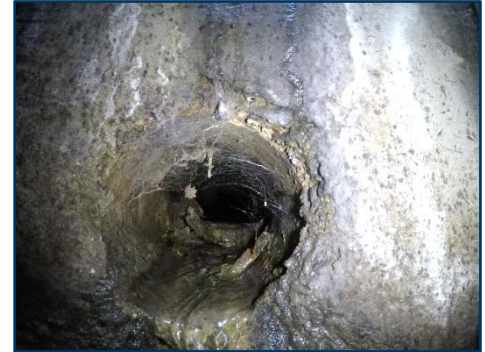
*(BR-03) 50405 N-In*

*Collapsed Pipe*

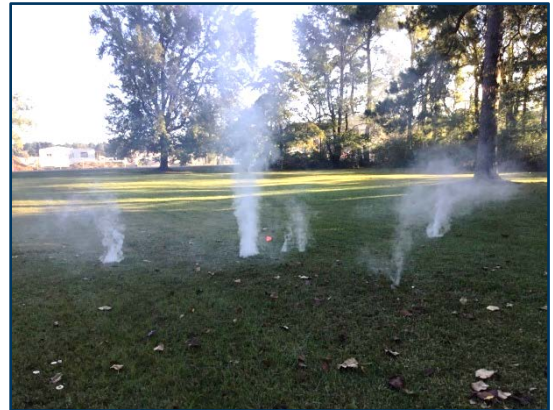
*(BR-03) 50535:50555*

*Lateral Defect*

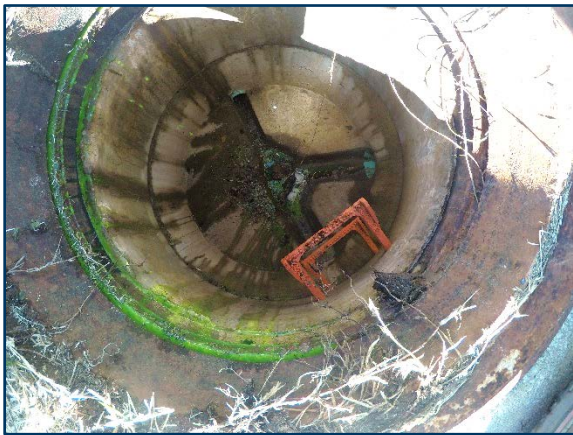
*Dye – Positive*  
*(BR-06) 61125:61115*

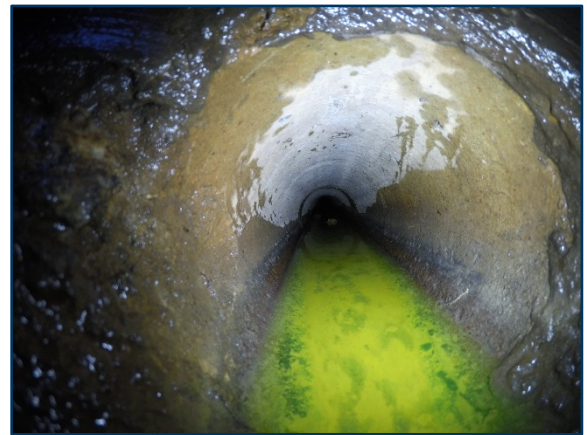
During smoke testing a main line defect was identified on segment (BR-03) 50450:50445. This defect resulted in 0.002 mgd which was the largest contributor of inflow identified during dye testing. Other positive dye tests include a cross connection on segment (BR-03) 50555:50540 and a frame seal on segment (BR-06) 61125:61115, both allowing a significant amount of inflow. These defects are shown in Figure 2.2. Dye testing identified a total of 0.004 mgd of inflow; addressing these defects should make an immediate impact to the system.

*Dye – Positive*  
*(BR-03) 50450:50445*

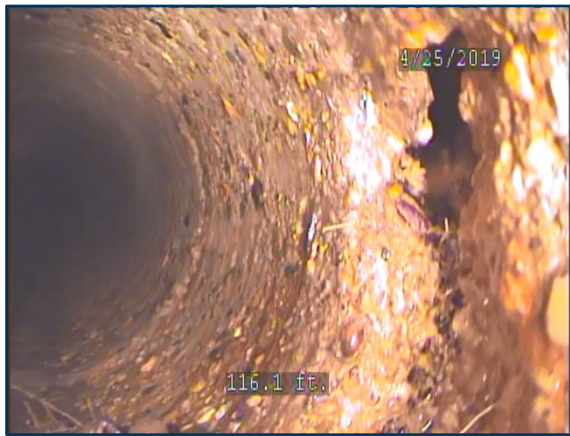
A total of 13,903 was attempted with 13,166 successfully televised and submitted to RJN for review. Due to defects or obstacles such as heavy roots, grease, broken or collapsed pipe not all segments were completely surveyed, many segments were inspected enough to make a recommendation. A summary of the line segments reviewed is provided in Appendix E. A total of three segments have voids visible; making the pipe susceptible to collapse and high I/I. A summary of these segments are given in Table 2.5 and shown in Figure 2.3. Two of the segments, 50445:50430 and 50530:50535, are shown in the photos below, and are recommended for immediate repair.

Pipe with hole  
(BR-03) 50445:50430

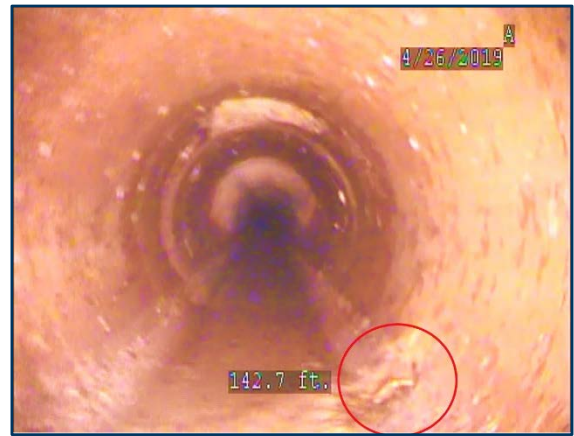
Pipe with hole  
(BR-03) 50530:50535
