2019 Sanitary Sewer Evaluation Study

Final Report

Malvern Water Works

RJN Project No. 18-3337-00

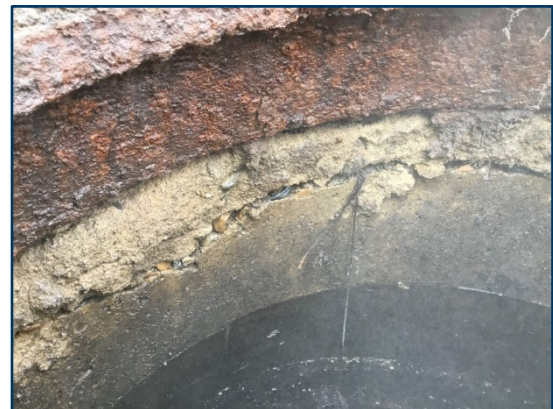
*Defective Chimney
(Basin 3) MH0336*

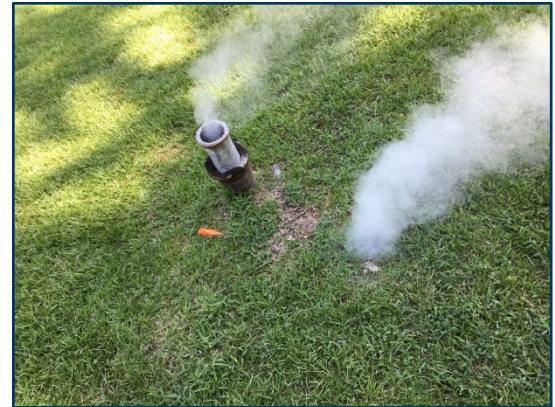
*Lateral Defect
(Basin 5A) MH0199:MH0197*

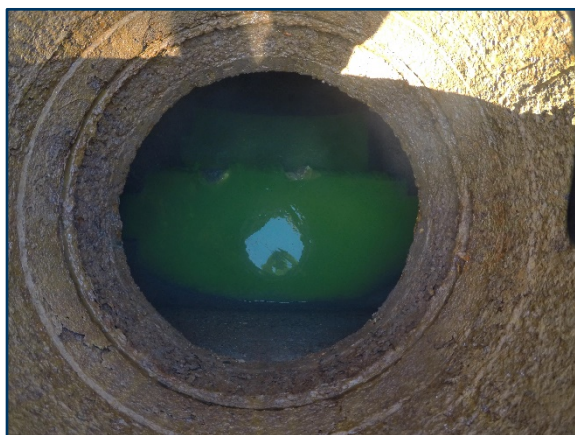
During smoke testing, a storm ditch defect was identified on segment (Basin 5) MH0100:MH0094. This defect resulted in 0.181 mgd which was the largest contributor of inflow identified during dye testing. Other positive dye tests include a catch basin on segment (Basin 5A) MH0729:MH0727 and a potential mainline on segment (Basin 5A) MH0204:MH0194, both allowing a significant amount of inflow. The locations of the 16 dye tests are

Dye – Positive
(Basin 5) MH0100:MH0094

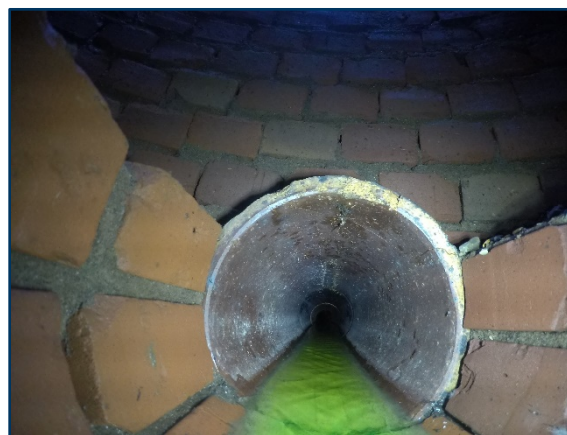
Dye – Positive
(Basin 5A) MH0729:MH0727

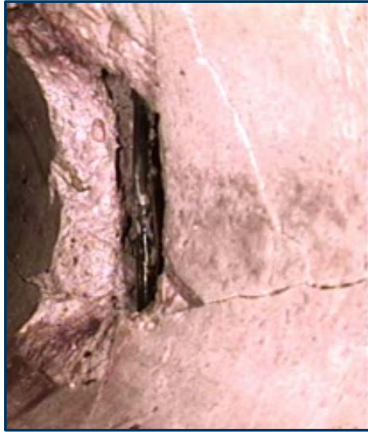
(Basin 2) MH0034:MH0033

Pipe with hole

A total of 21,942 was successfully televised and coded in PACP by AIMS, then submitted to RJN for review. Due to defects or obstacles such as heavy roots, grease, broken, or collapsed pipe not all segments were completely surveyed; however, most segments were inspected enough to make a recommendation. All information regarding televised line segments are in the PACP database attached with this report. A total of 13 segments have voids visible; making the pipe susceptible to collapse and high I/I. A summary of these segments is given in Table 2.5 and shown in Figure 2.3. Two of the segments, MH0034:MH0033 and MH0173:MH2159, are shown in the photos below, and are recommended for immediate repair.
