2023 City of Malvern Sanitary Sewer Evaluation Study

FINAL REPORT

Subject: City of Malvern – 2023 Sanitary Sewer Evaluation Study (SSES)

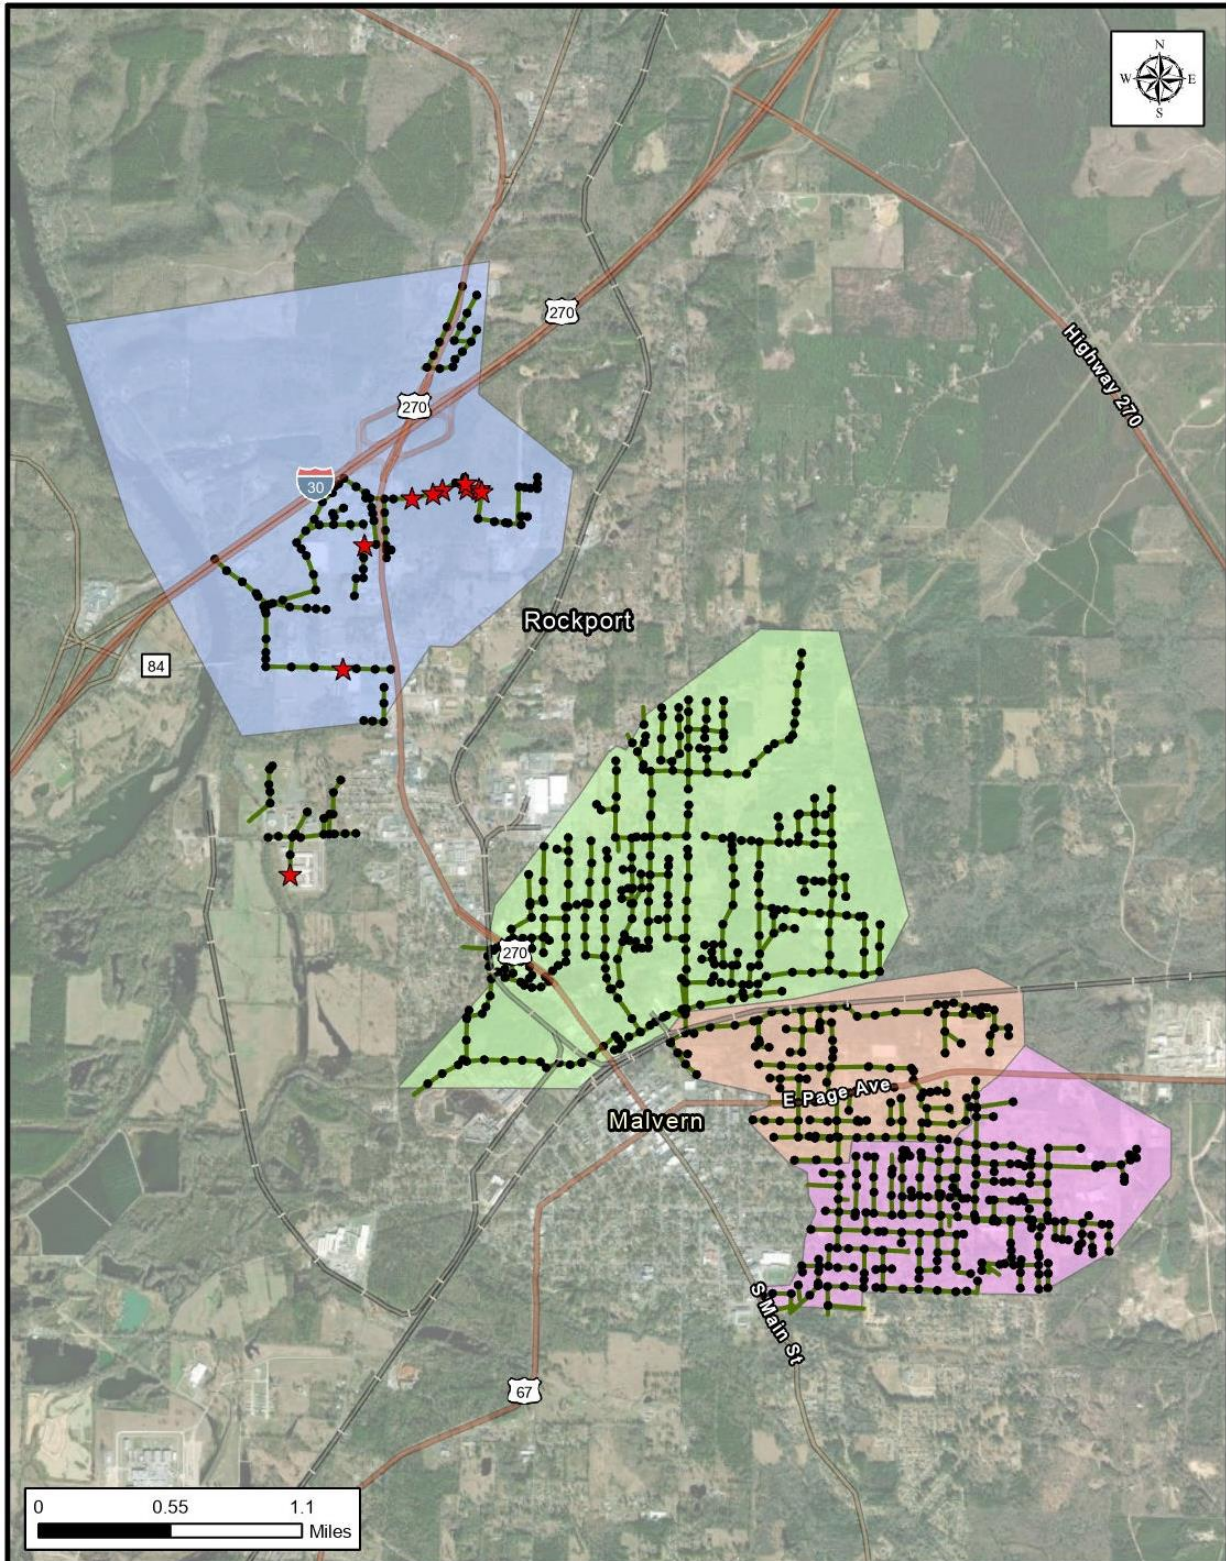
Figure 2.1
Manholes With
Evidence of
Surcharging

Additionally, a total of ten manholes located throughout the study area indicated evidence of surcharging. These manholes are shown on Figure 2.1.

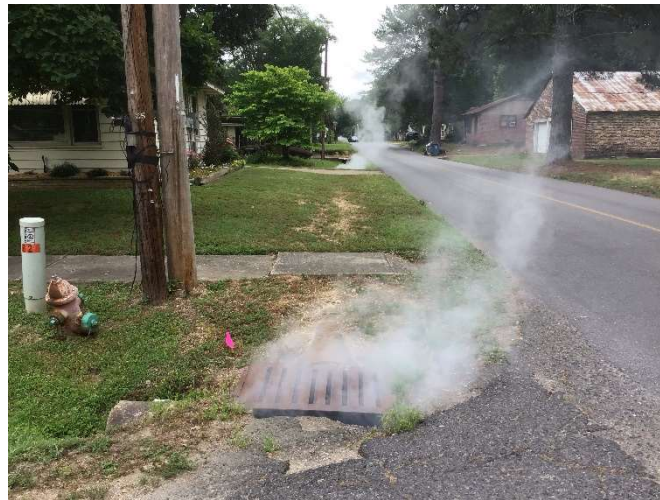
MH0118:MH0119

Catch Basin
