2023 City of Malvern Sanitary Sewer Evaluation Study

FINAL REPORT

Subject: City of Malvern – 2023 Sanitary Sewer Evaluation Study (SSES)

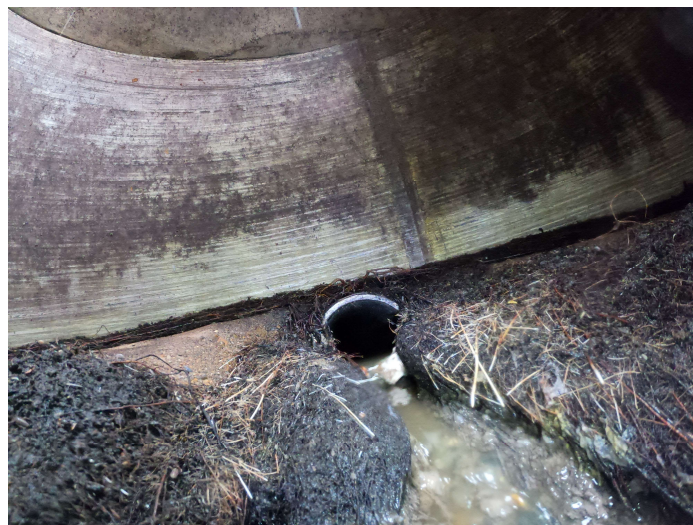
Pipe Seal

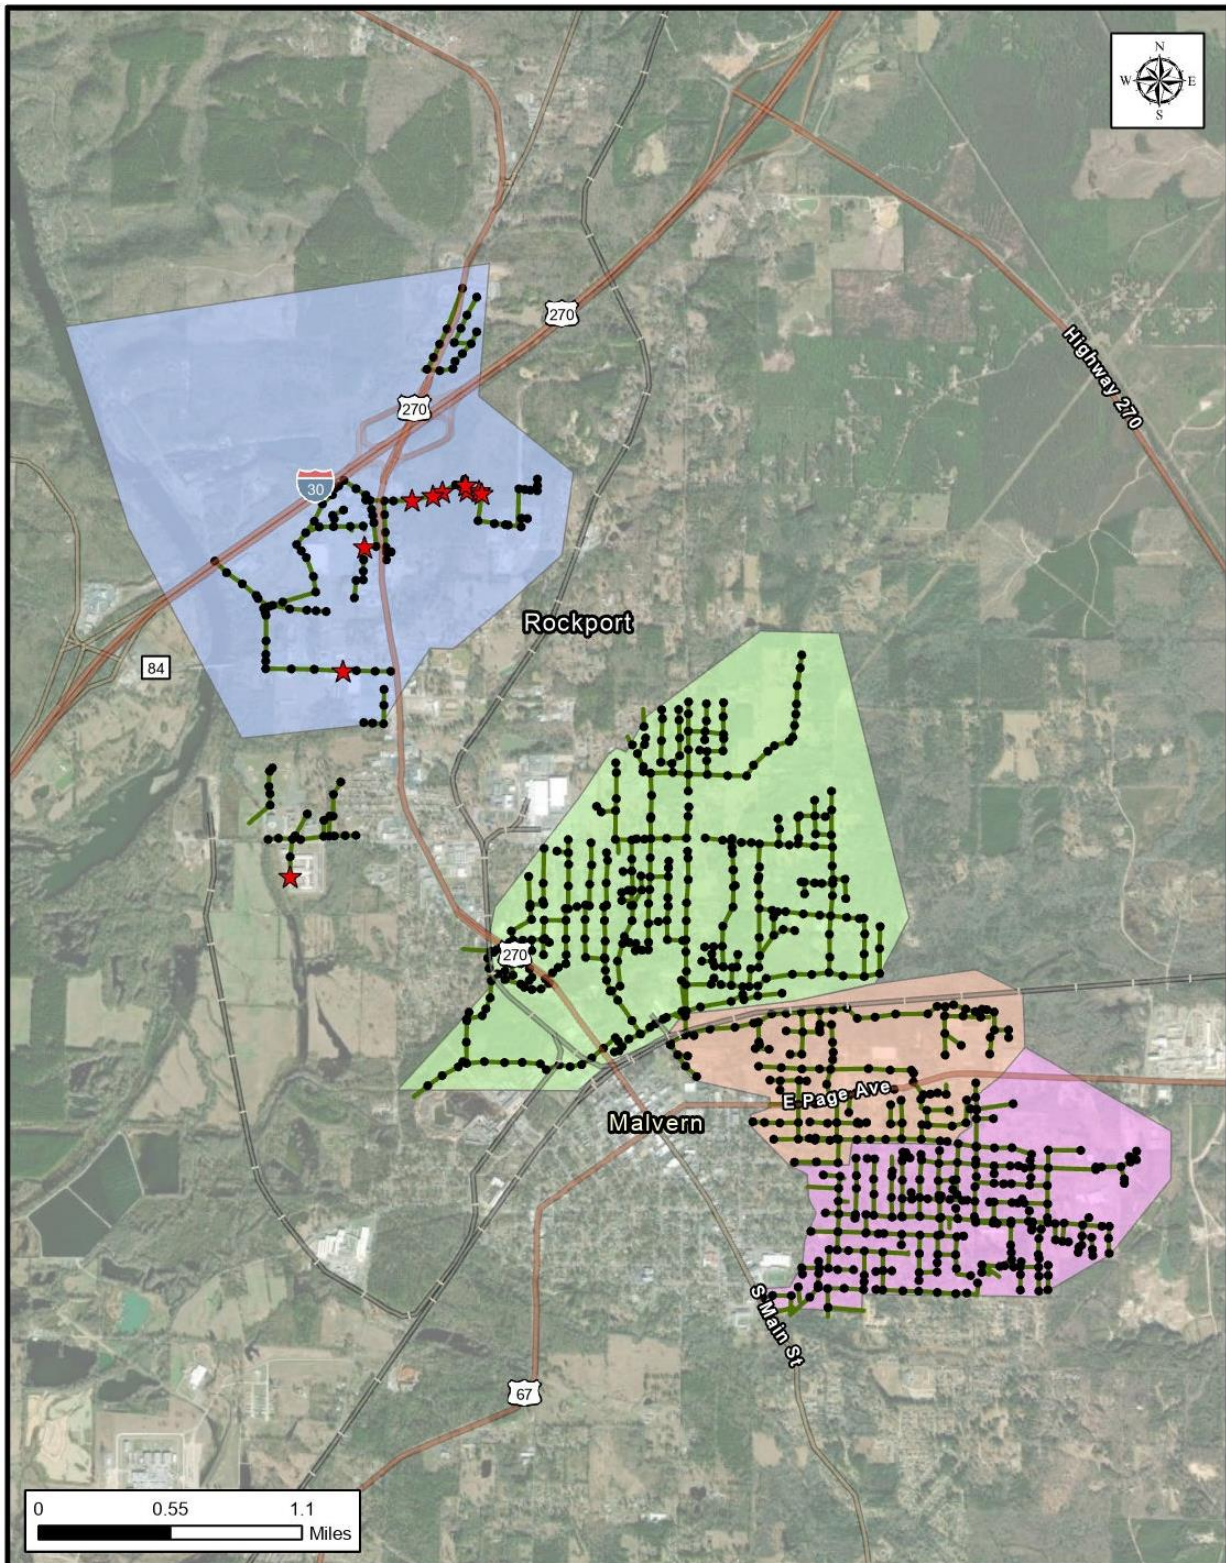
Figure 2.1
Manholes With
Evidence of
Surcharging

Additionally, a total of ten manholes located throughout the study area indicated evidence of surcharging. These manholes are shown on Figure 2.1.

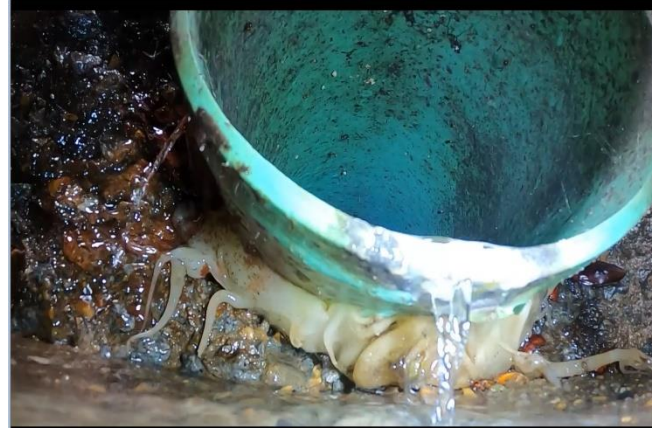
MH1541 – (2) N-In

Defective Pipe Seal

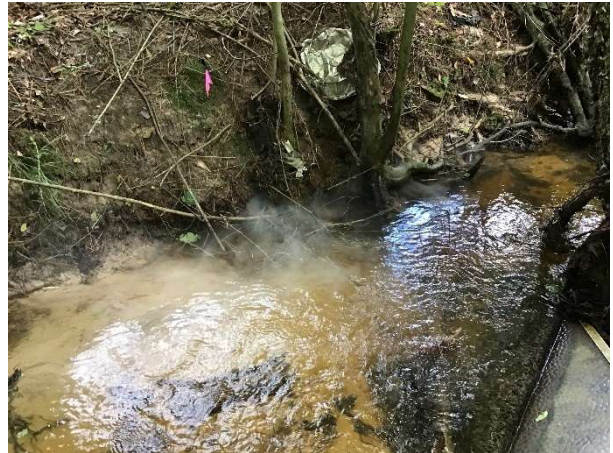
MH1087:MH1086

Other

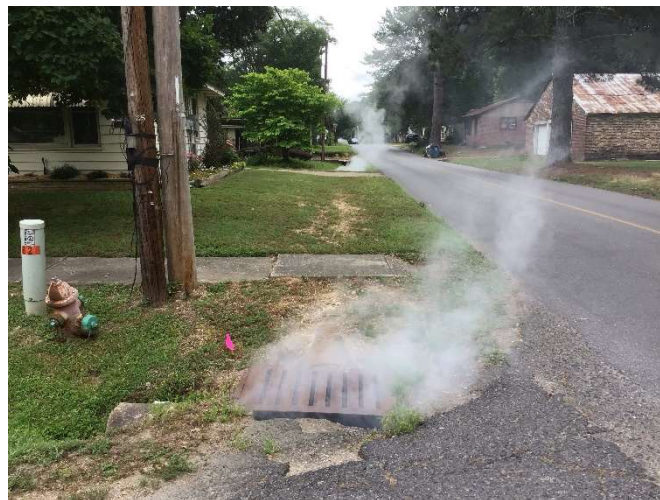
MH0118:MH0119

Catch Basin

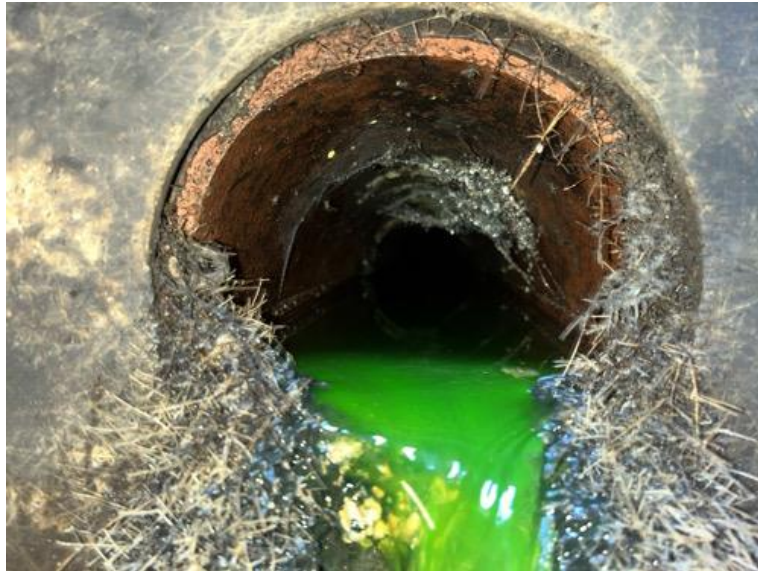
Dye – Positive
MH1132_MH1160

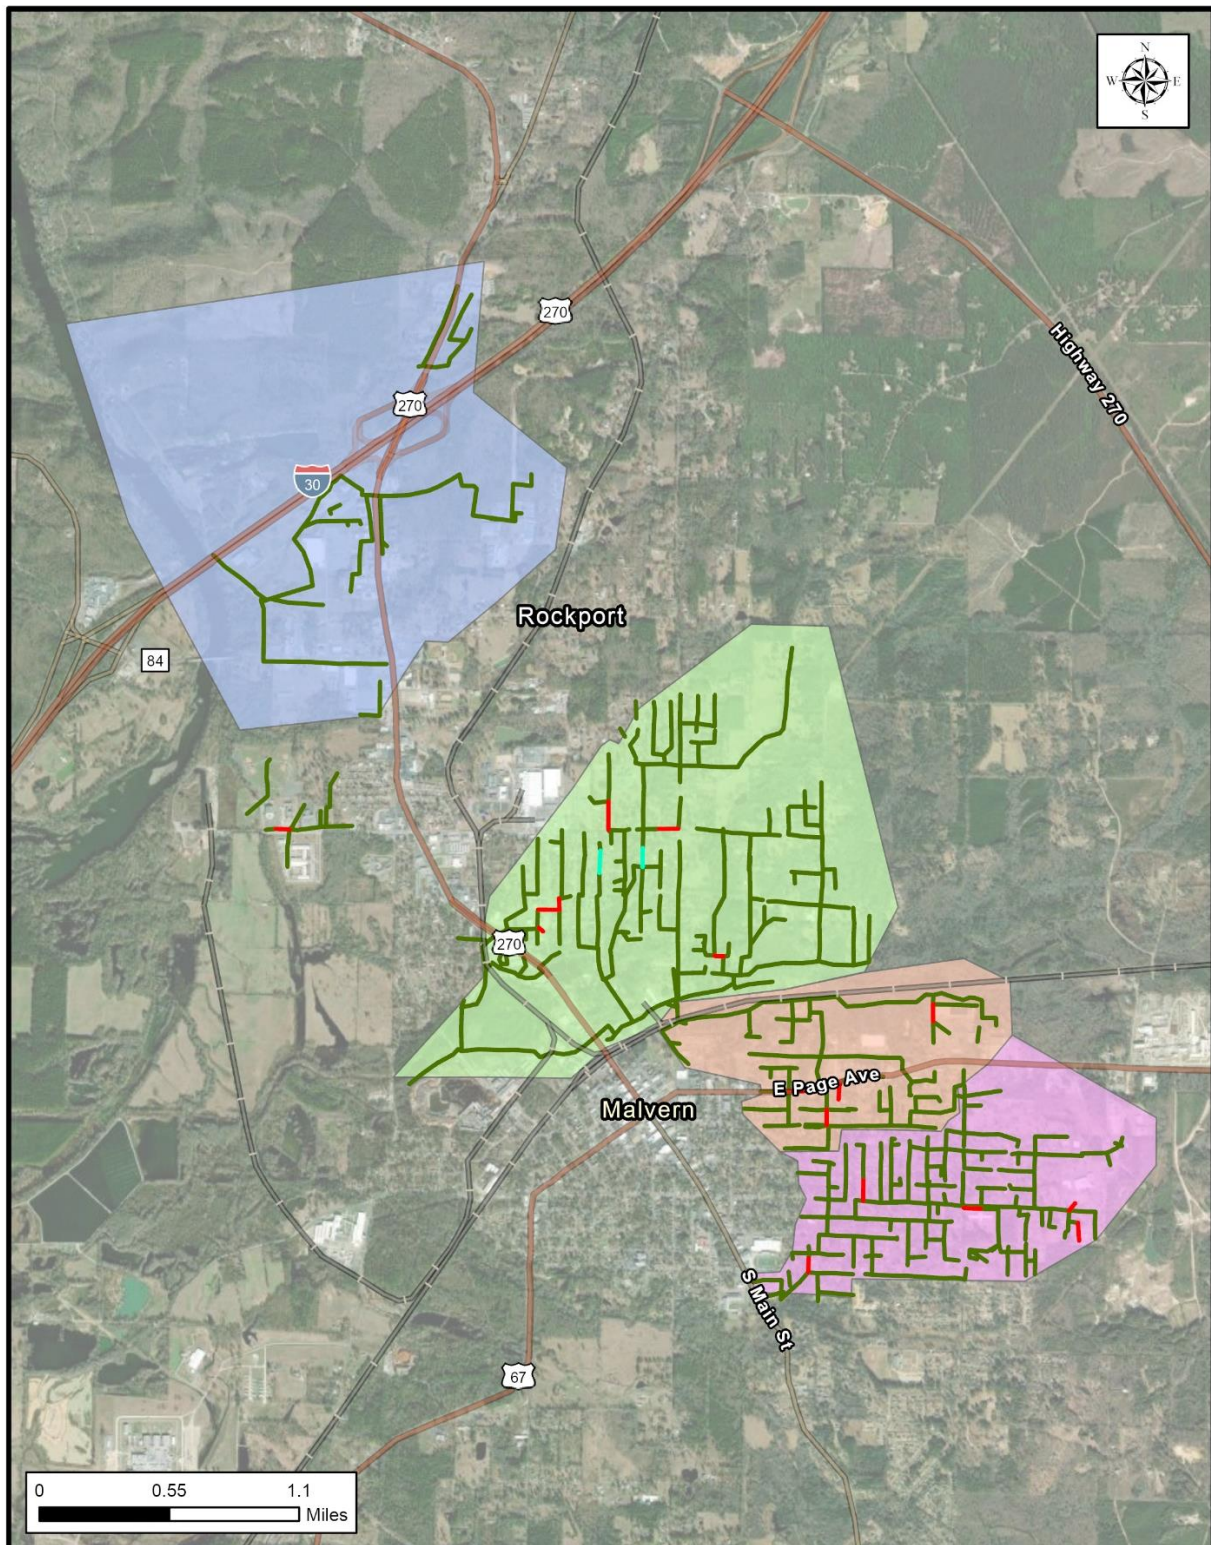
Figure 2.2
Dye Testing

The locations of the 21 dye tests are shown in Figure 2.2 on page 2-17 and dye test data can be found in Appendix D. Dye testing identified a total of 137,952 gpd of inflow; addressing these defects should make an immediate impact to the system. Table 2.4 summarizes the dye testing efforts.

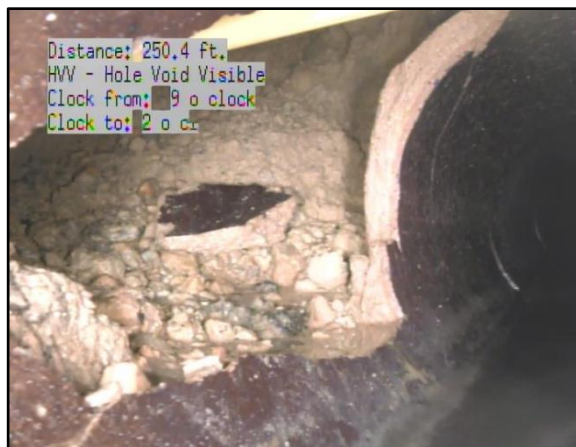
Hole Void Visible
MH0101:MH0092

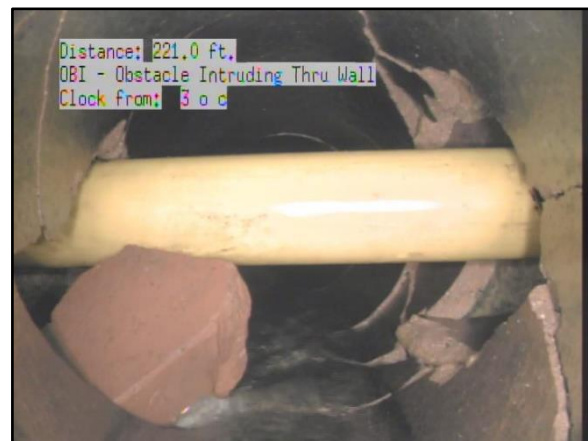
Pipe Intruding Through Wall
MH0093:MH0080
