From: Scotty Jones <scottytpw@gmail.com>
Sent: Friday, October 13, 2017 11:23 AM
To: Anderson, Alan
Subject: Re: Complaint
Attachments: Birch Sewer repair.jpg

Point Repair Sewer Main Birch and East Speedway

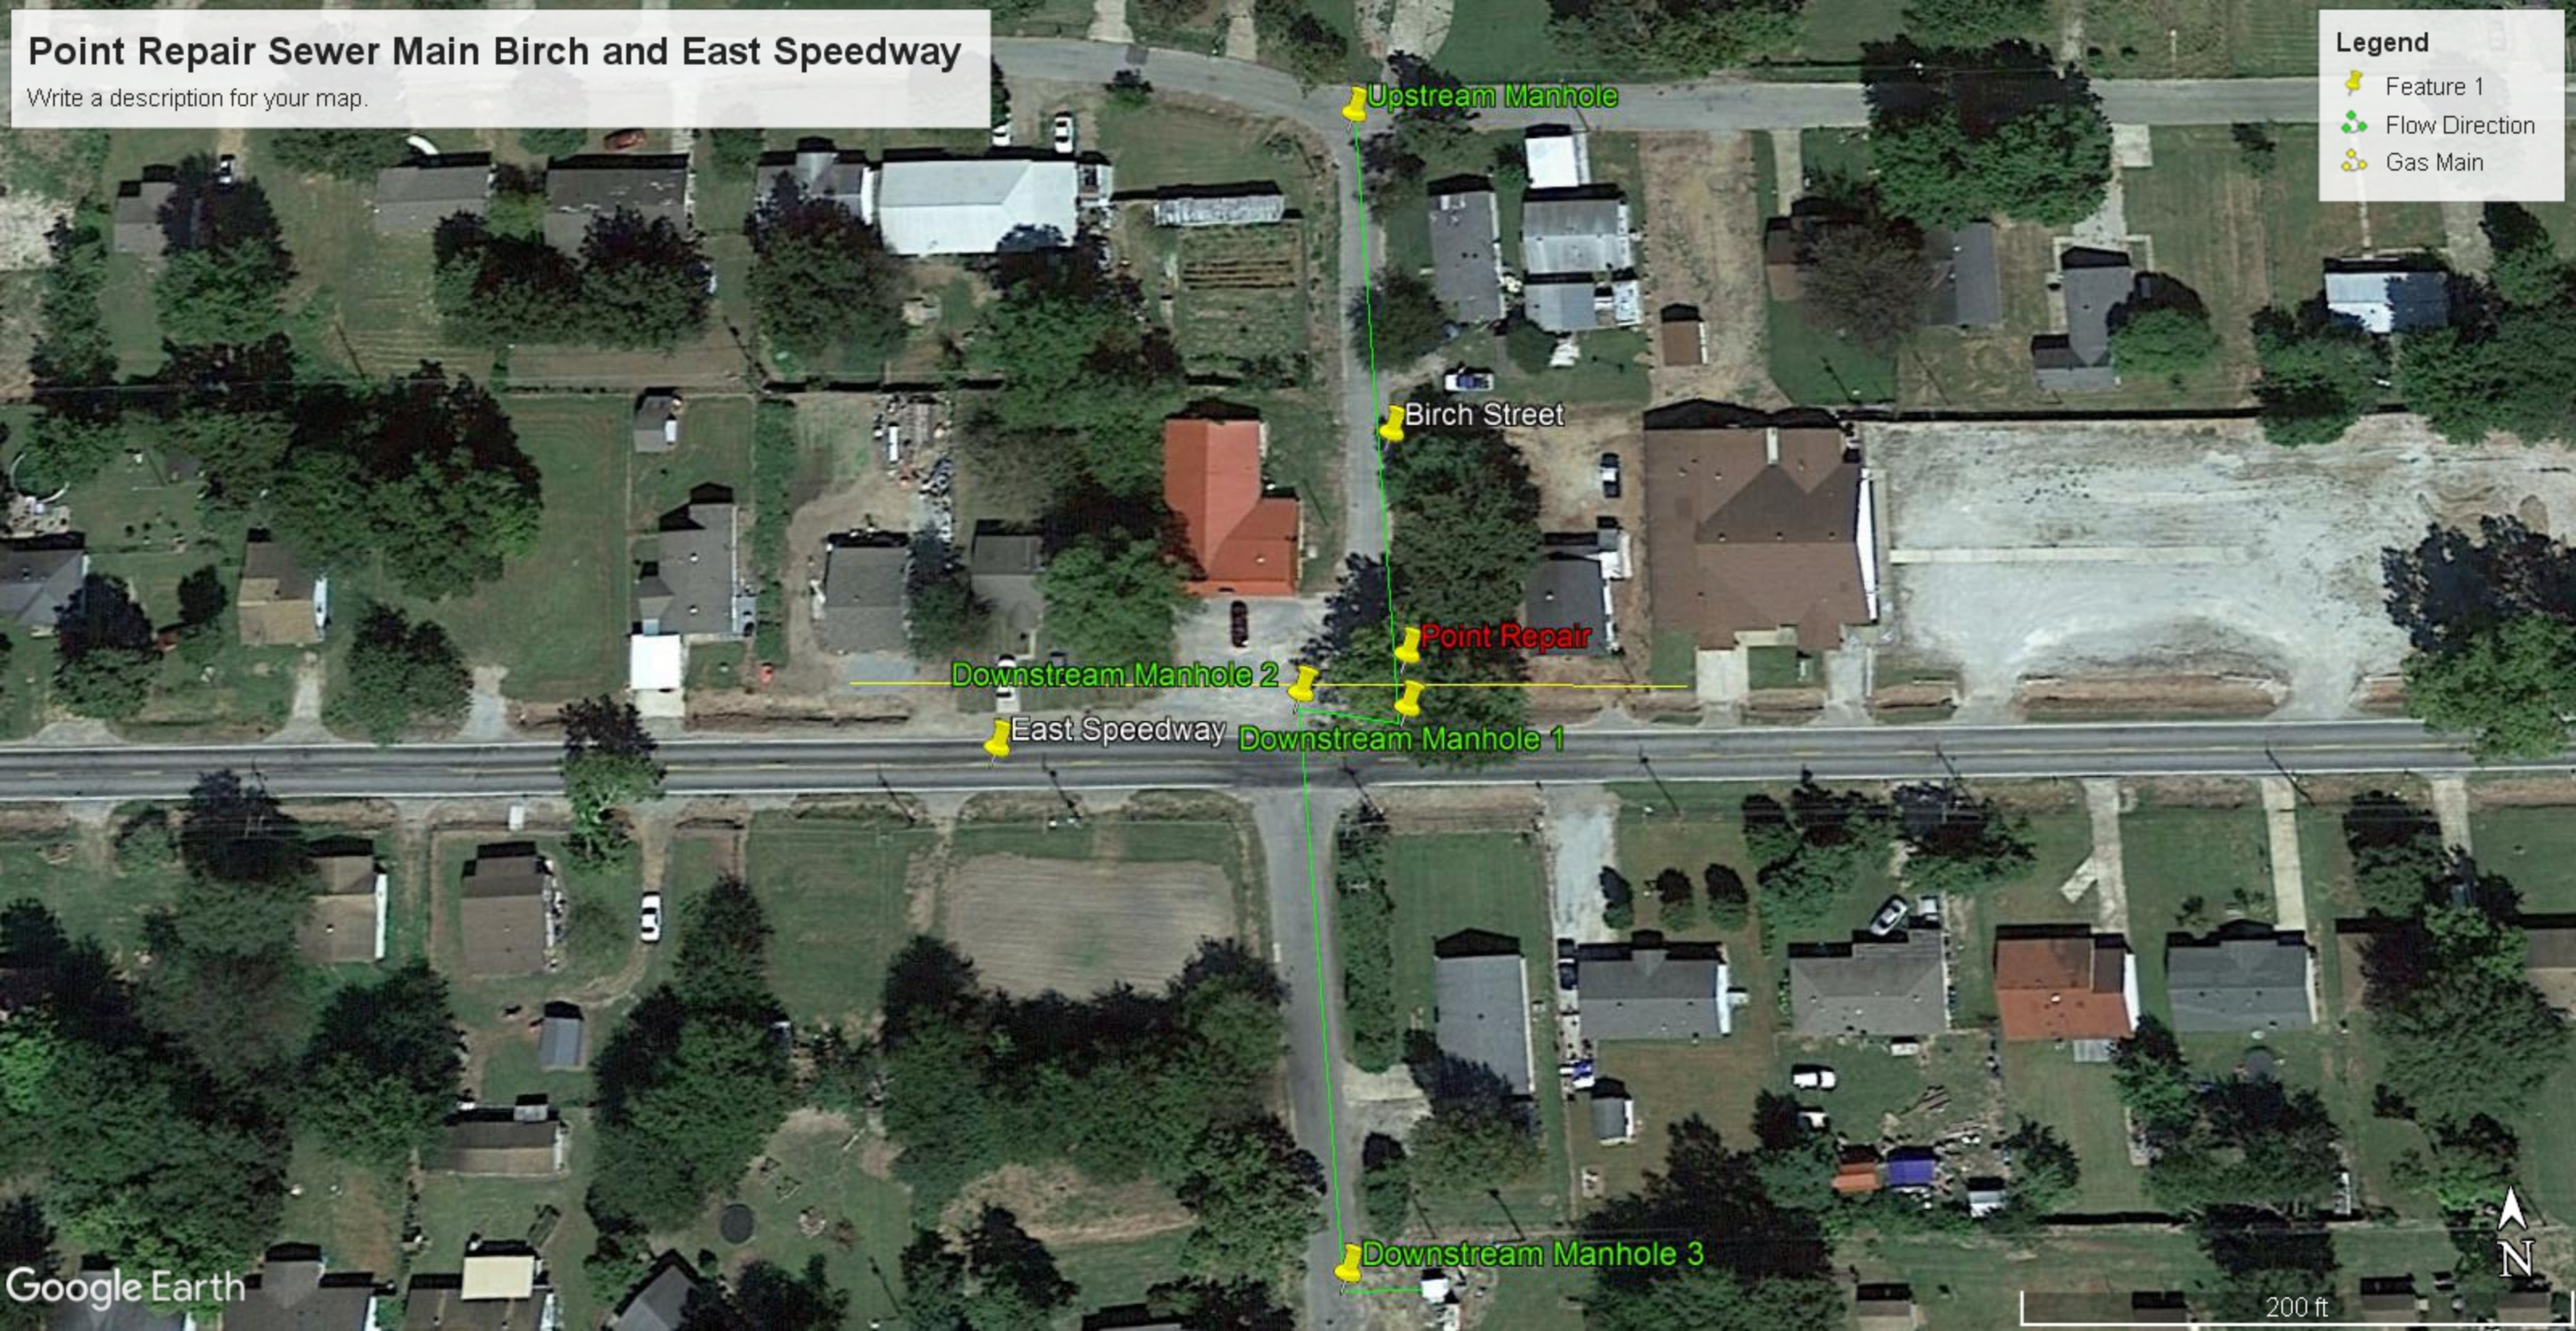
A customer report was made to Trumann Waterworks on October 3rd that their toilet was slow to flush and asked us to check the sewer main in that area. Field employees discovered that the sewer main was clogged with no signs of any overflow. They attempted to water jet the line downstream of the clog and could not get the nozzle to pass through the line. After a locate was completed it was identified the very same spot where the jet nozzle would not pass there was recently a directional bored gas main installed. To keep from working all night in the dark, with safety of the employees a big concern, we temporarily placed a 3" pump in the upstream manhole and pumped the sewer to downstream manhole #2. No leakage from the pump, hoses, or any fittings was allowed. On October 4th air plugs were installed upstream and downstream of the area designated for point repair. The 3' pump was ran periodically throughout the day to maintain the flow of the sewer main. AHTD was notified that excavation was being performed inside their right of way. Upon exposing the sewer main it was confirmed the gas main had penetrated the sewer line and dirt infiltration had caused the clog. Approximately a 10' section of concrete sewer line was removed and replaced with SDR 26 pvc. The gas main was elevated to clear the sewer main. Spoil material was placed in a container and hauled to our permitted landfill. New sand bedding material and 3/4 minus limestone was used as fill for the excavation area. At no time was any sewer allowed to escape upon any surface surrounding the point repair or adjacent neighborhood area. Work and cleanup was completed late that evening on October 4th. Air plugs were removed and normal gravity sewer flow resumed.

Point Repair
