MEMORANDUM

To: Mr. Charles Pittman
From: Adrian J. Kaufman, P.E.
Re: Mena Water Utilities
Wastewater Treatment Plant
Lagoon Levee Analysis
HWEI Project No: 2018149
Date: August 29, 2019

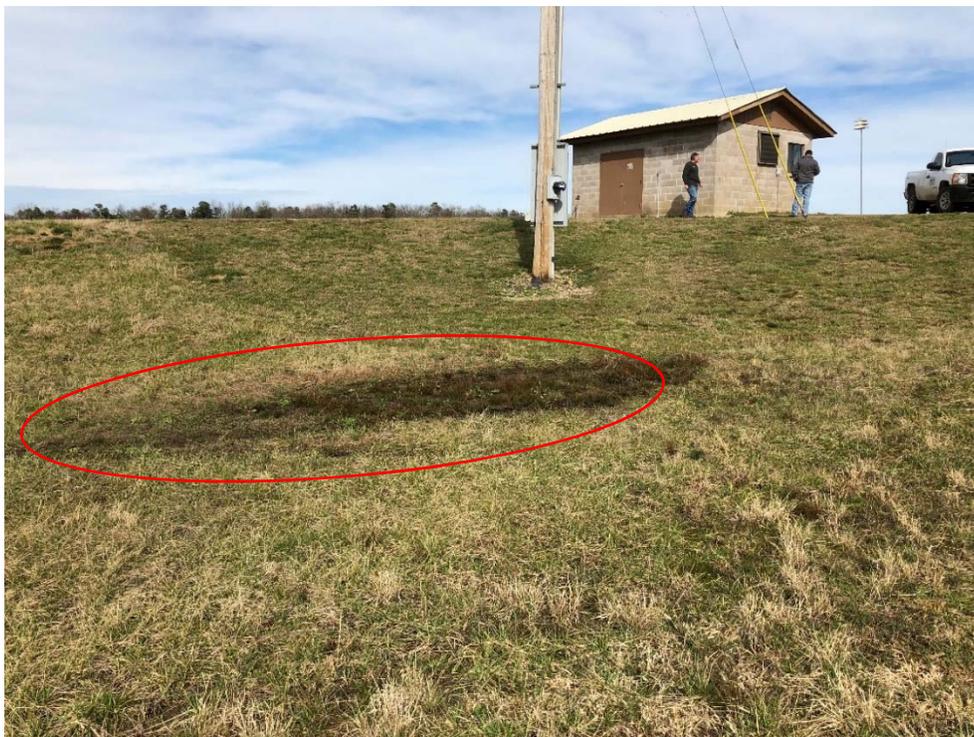
Figure 1: Excess moisture between Lagoon No. 1 and No. 2

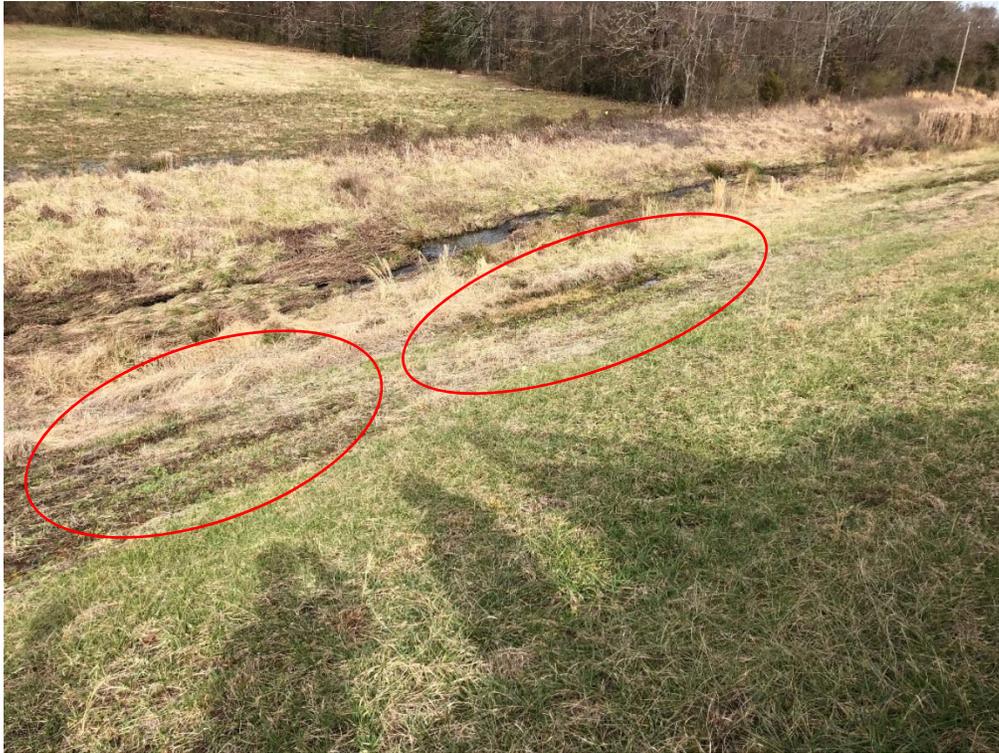
Figure 2: Excessive moisture on north slope of Lagoon No. 2

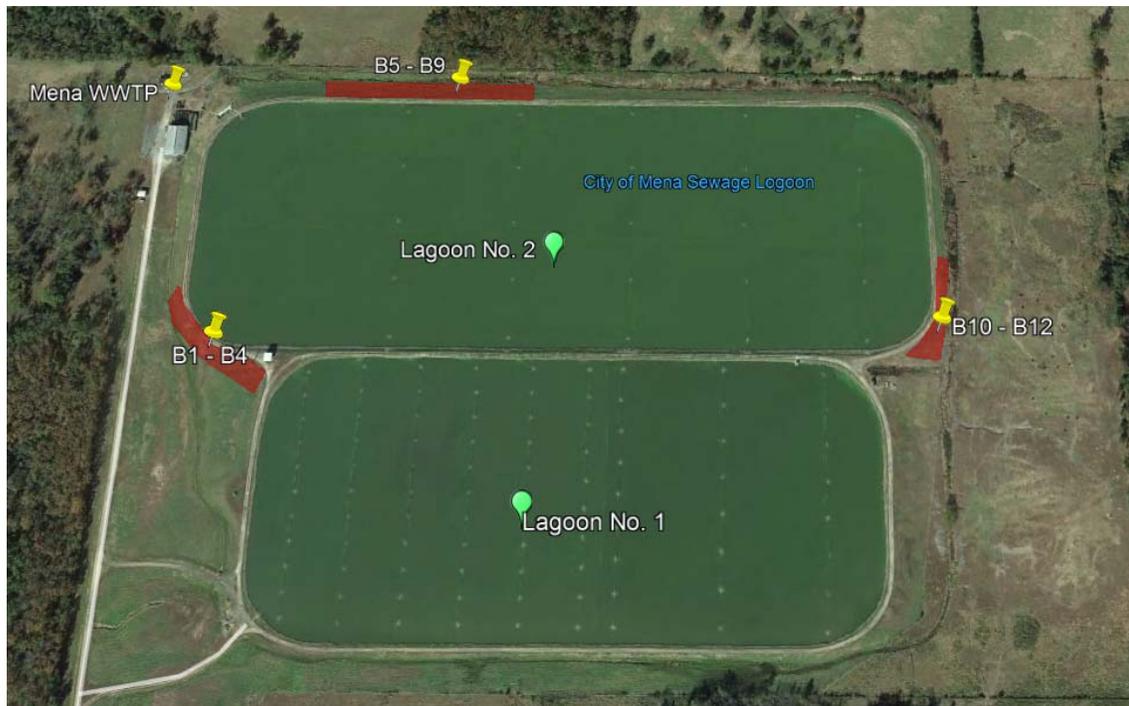
Figure 3: Approximate Boring Locations

Note : Areas identified with excess moisture are highlighted in red.
