SANITARY SEWER EVALUATION & SURVEY

***MENA WATER UTILITIES
MENA, ARKANSAS***

MAY 2012

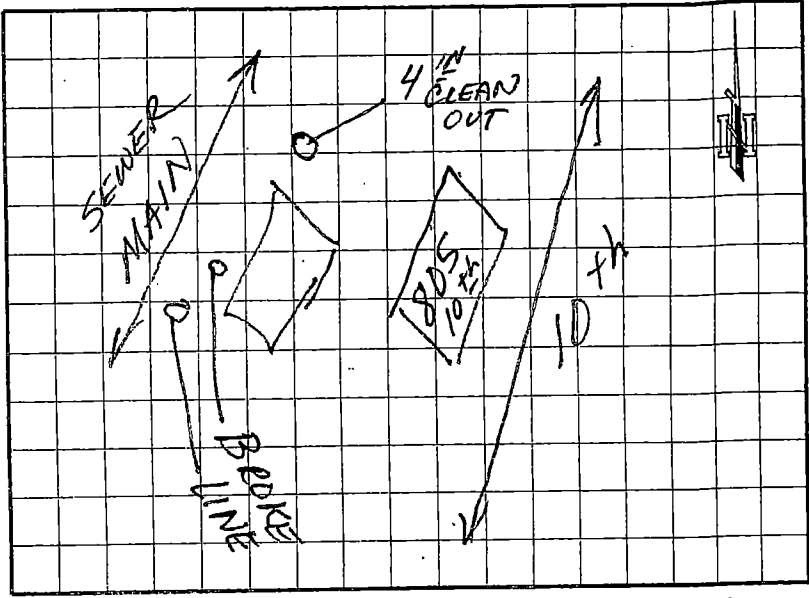
DESCRIPTION OF LEAK: CLEAN OUT NO TOP & VERY LARGE PONDING AREA WITH TRENCH DUG TO PONDING AREA.

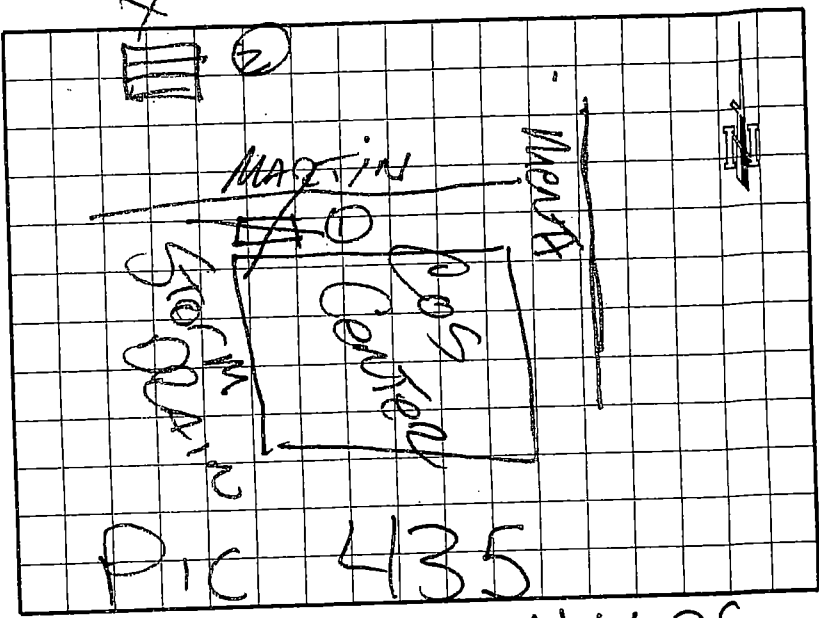
DESCRIPTION OF LEAK: SORM DRAINS @ MARTIN NW of
Cos Center and @ SW Corner of Herods

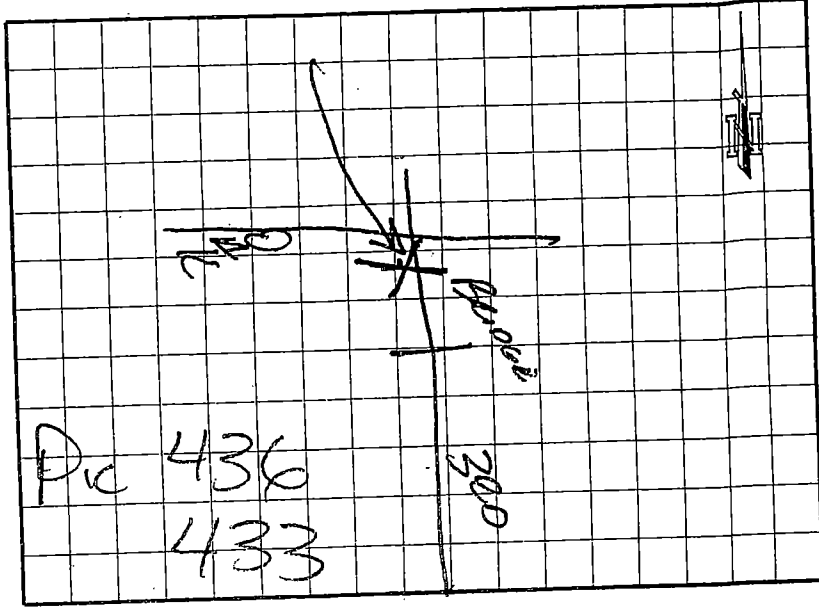
Project: Mena Utilities SSES
 Location: 3rd Oak
 Area: SECTION 12
 Line No. _____
 Leak No. _____
 Date: July 10 Time: _____
 Inspector: Mike

DESCRIPTION OF LEAK: Major
in Creek NEAR MH 353

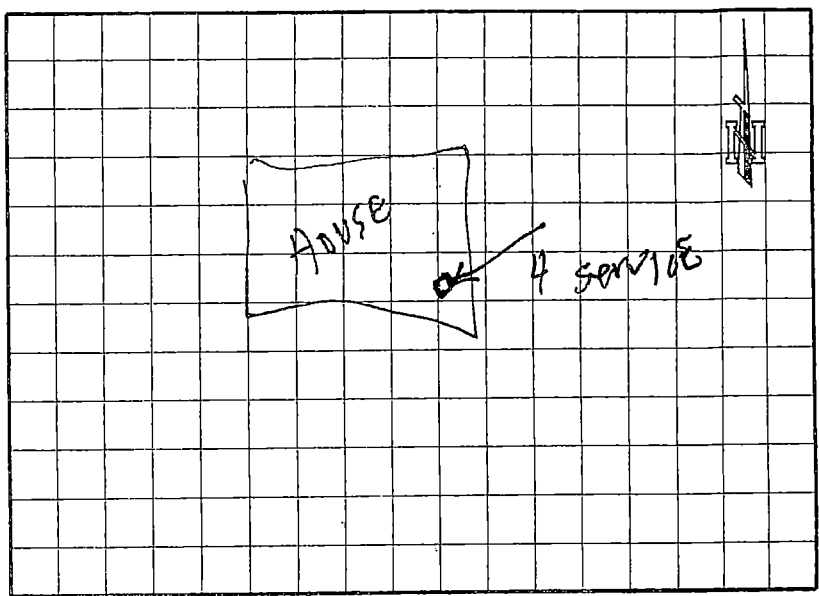
Subject: Mena Utilities SSES
 Location: 2201 MISSOURI
 Area: FRONT RIGHT OF PROP.
 Line No. _____
 Leak No. 1
 Date: 6.22.10 Time: _____
 Inspector: (BB)

DESCRIPTION OF LEAK: NO CAP PRESENT ON CLEAN OUT FOR RES.

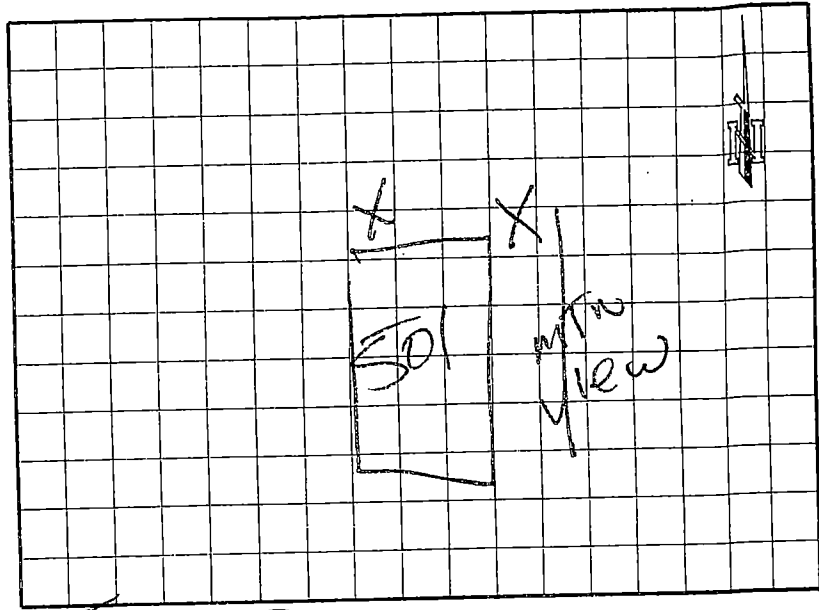
Subject: Mend Utilities SSES
 Location: 501 N Gary
 Area: SECTION 2
 Line No. _____
 Leak No. _____
 Date: _____ Time: _____
 Inspector: _____

DESCRIPTION OF LEAK: Clean out X 2

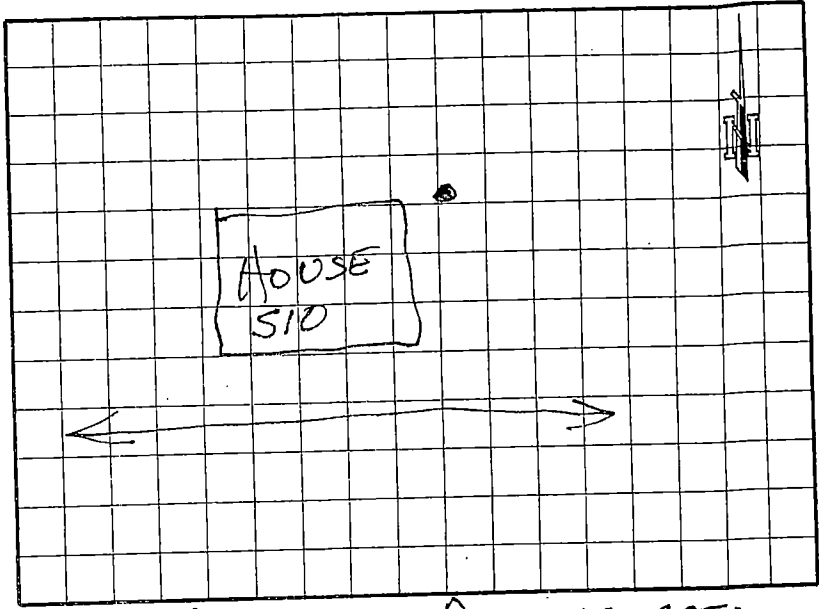
Subject: Mend Utilities SSES
 Location: 510 WARNER
 Area: 2
 Line No.: _____
 Leak No.: _____
 Date: 6-30-10 Time: _____
 Inspector: BR

DESCRIPTION OF LEAK: NO CLEAN OUT PRESENT PONDING AREA
FARLY LARGE

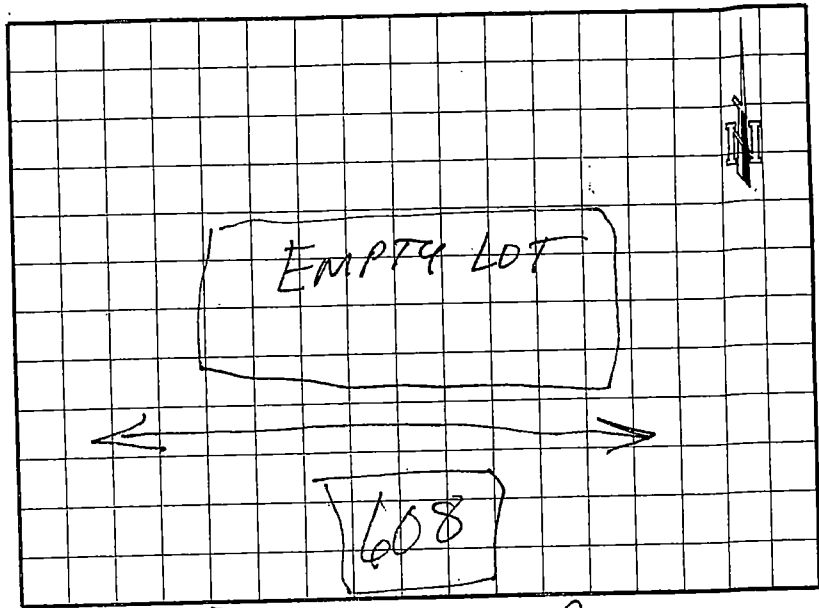
Project: Mend Utilities SSES
 Location: ACROSS FROM 608 WARNER / VACINT LOT
 Area: 2
 Line No.: _____
 Leak No.: _____
 Date: _____ Time: _____
 Inspector: _____

DESCRIPTION OF LEAK: 3 to 4 HOLES IN PIPE SMOKE PRES.

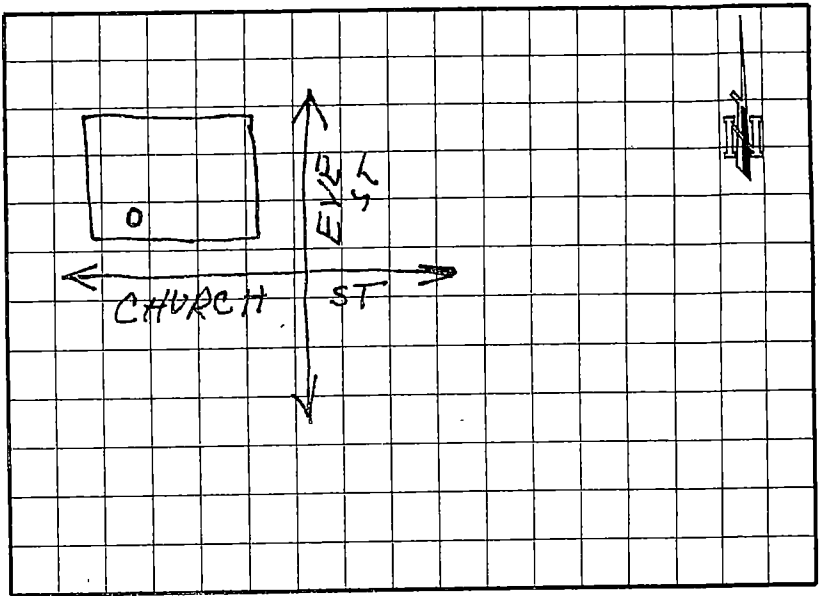
Subject: Mend Utilities SSES
 Location: EVE & CHURCH
 (EMPTY LOT)
 Area: LF. SIDE OF PROP.
 Line No.: _____
 Leak No. 5
 Date: 10-22-10 Time: _____
 Inspector: BB

DESCRIPTION OF LEAK: BROKE OFF CLEAN OUT CAP. ON EMPTY LOT.

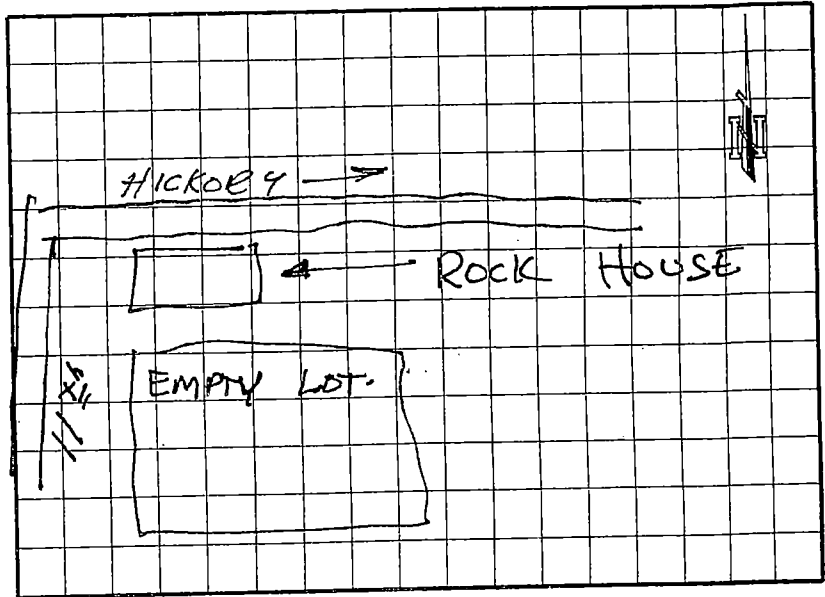
Subject: Mena Utilities SSES
 Location: EMPTY LOT BEHIND ROCK HOUSE
ON ~~11th~~ 11th & Hickory / 11th St.
 Area: EMPTY LOT.
 Line No.: _____
 Leak No.: 2
 Date: 6-22-10 Time: _____
 Inspector: (Signature)

DESCRIPTION OF LEAK: COMING FROM CLEAN OUTS.

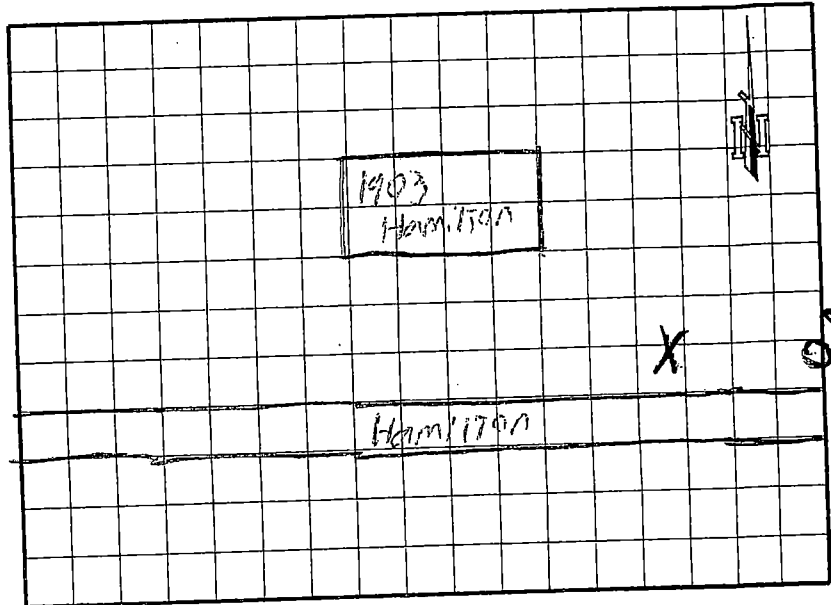
Subject: Mena Utilities SSES
 Location: 1903 Hamilton
Right Front corner of property
 Area:
 Line No.:
 Leak No.: 9
 Date: 6/23/10 Time:
 Inspector: Bodley

DESCRIPTION OF LEAK: Service line broke?

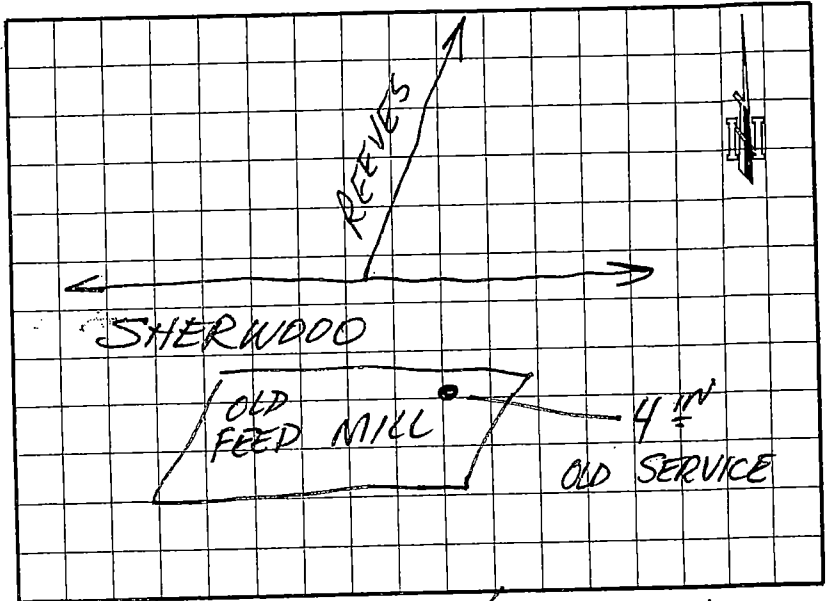
Subject: Memor Utilities SSES
 Location: SHERWOOD & REEVES
 Area: _____
 Line No.: _____
 Leak No.: _____
 Date: 6-26-10 Time: _____
 Inspector: GA

DESCRIPTION OF LEAK: OLD CLEAN OUT FOR FEED MILL / CASTIRON.

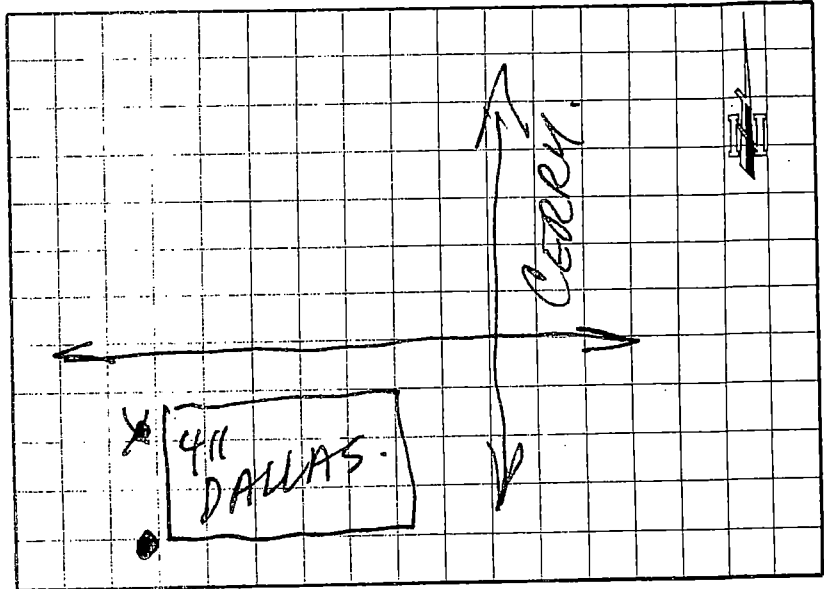
DESCRIPTION OF LEAK: 4" SERVICE NO CLEAN OUT CAP.

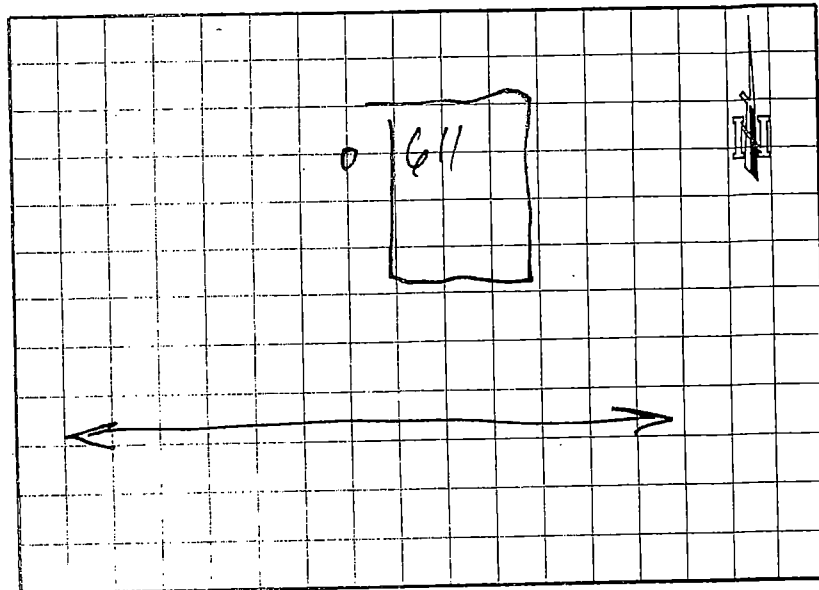
DESCRIPTION OF LEAK: CLEAN OUT NISS. CAP.

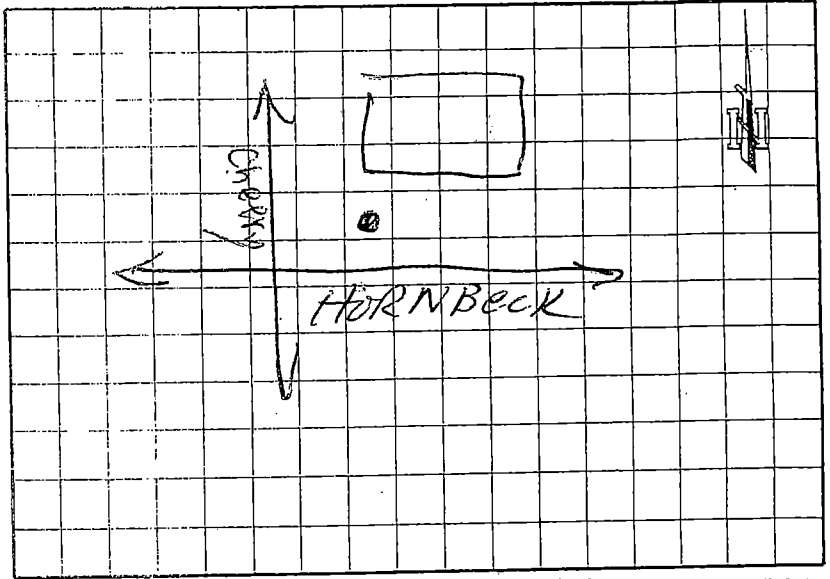
Subject: Mena Utilities SSES
 Location: Cheery & Hornbeck
 Area: 7
 Line No. _____
 Leak No. _____
 Date: 1/8/10 Time: _____
 Inspector: [Signature]

DESCRIPTION OF LEAK: SMOKE COMING FROM WEST. ARK. COUNSELING

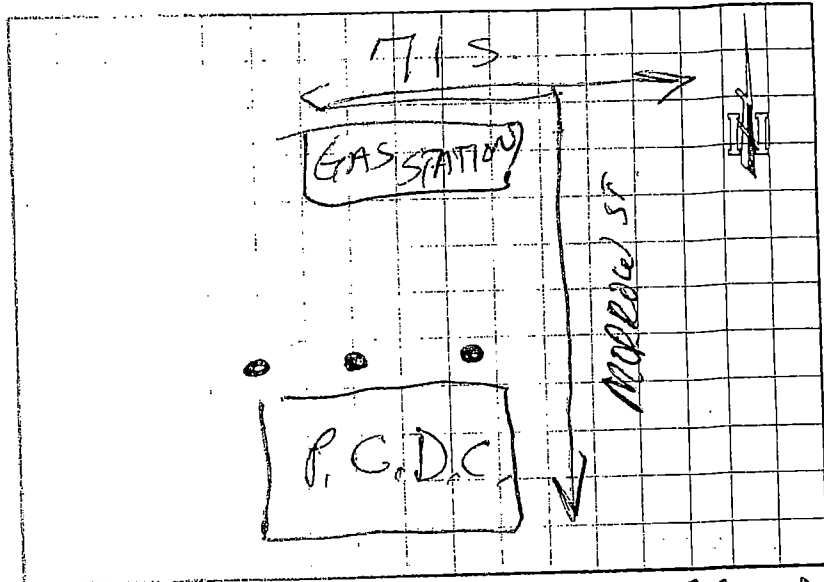
Subject: Mena Utilities SSES
 Location: MORROW ST.
@ P.C.D.C.
 Area: 7
 Line No. _____
 Leak No. _____
 Date: 8/10 Time: _____
 Inspector: BK

DESCRIPTION OF LEAK: 3 4" SERVICE LINE STUBB OUTS UNDER GROUND
Level NO CAP/CATCHING DITCH H₂O & RUN OFF FROM ROOF OF
Building
 MEASURED INFLOW (GPD) _____

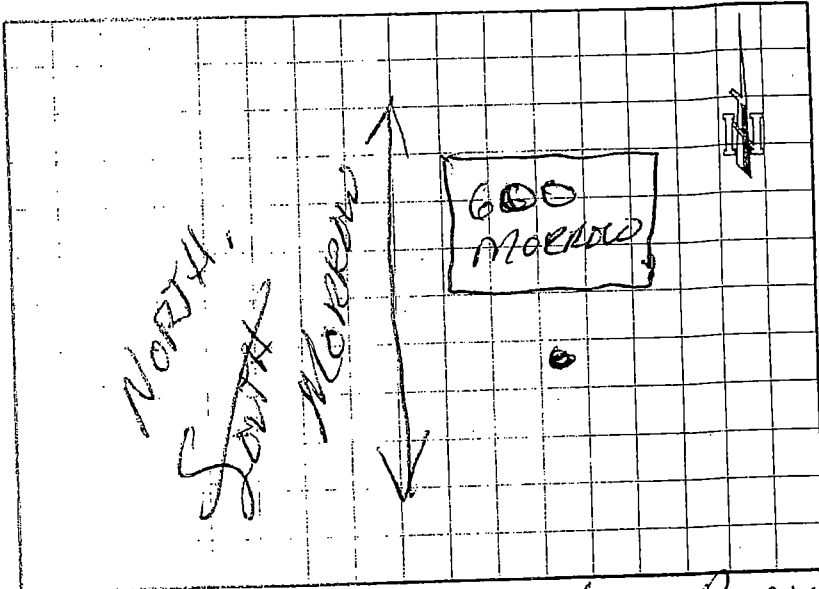
Area: 7
Line No. _____
Leak No. _____
Date: 8/10 Time: _____
Inspector: (BA)

DESCRIPTION OF LEAK: 4" CAP MISS. DRAINAGE IS HOLE PARKING LOT.

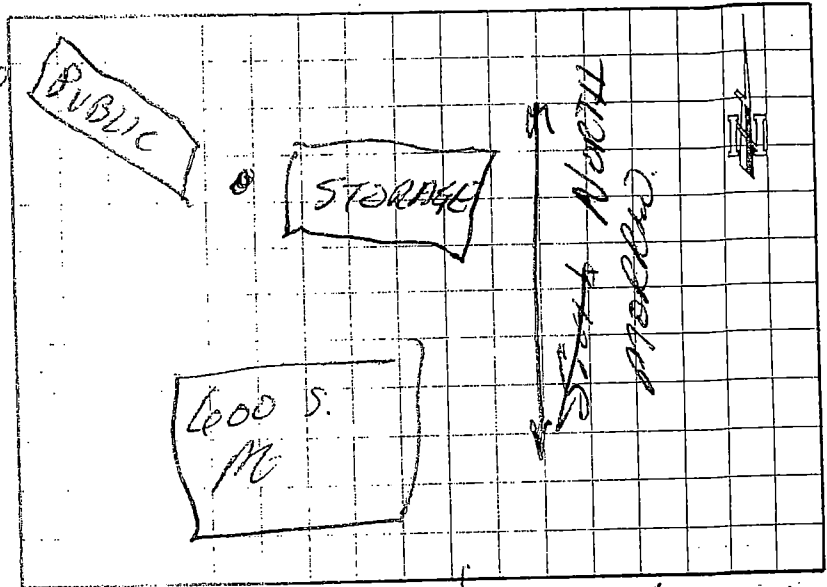
Subject: Mena Utilities SSES
 Location: IN FRONT OF 600 MADRWA
@ PUBLIC STORAGE
 Area: 7
 Line No. _____
 Leak No. _____
 Date: 8/10 Time: _____
 Inspector: BR

DESCRIPTION OF LEAK: 4" SERVICE WITH BROKE 4" & MISSING CLEAN
OUT CAP. DRAINAGE AREA IS A PARKING
LOT.

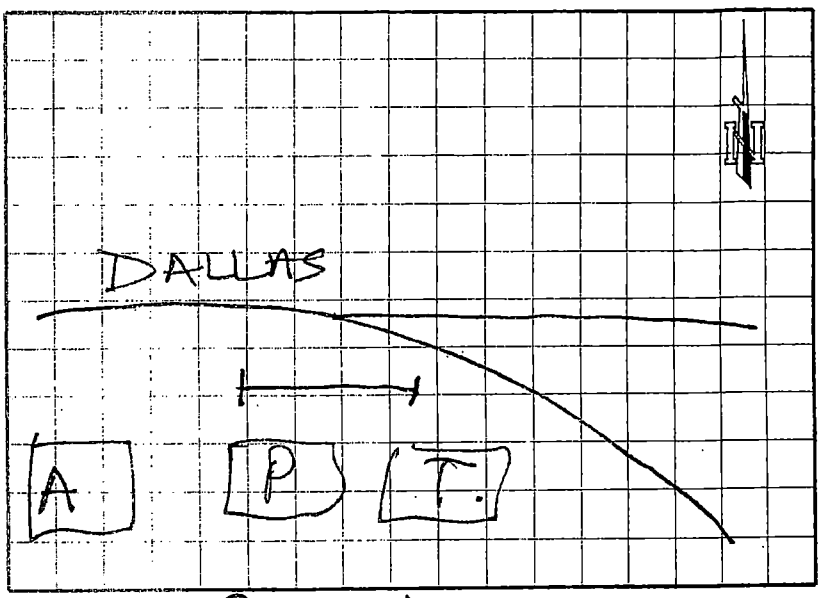
Subject: Mena Utilities SSES
 Location: REBECCAS'S APT.
ACROSS FROM 709 DALLAS
 Area: _____
 Line No.: _____
 Leak No. 2
 Date: _____ Time: _____
 Inspector: _____

DESCRIPTION OF LEAK: SMOILE COMING FROM DITCH.
