Re: Progress Report for Sanitary Sewer Collection System Evaluation
Mena Water Utilities – NPDES No. AR0036692
ADEQ Consent Order LIS 18-046

MENA SSES PROGRESS REPORT

MENA SANTIARY SEWER STUDY PROGRESS REPORT

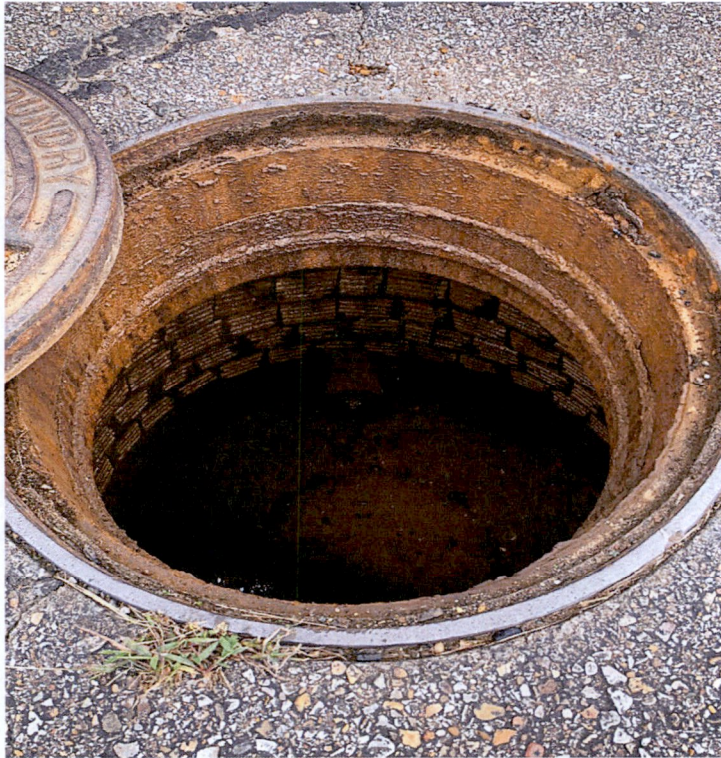
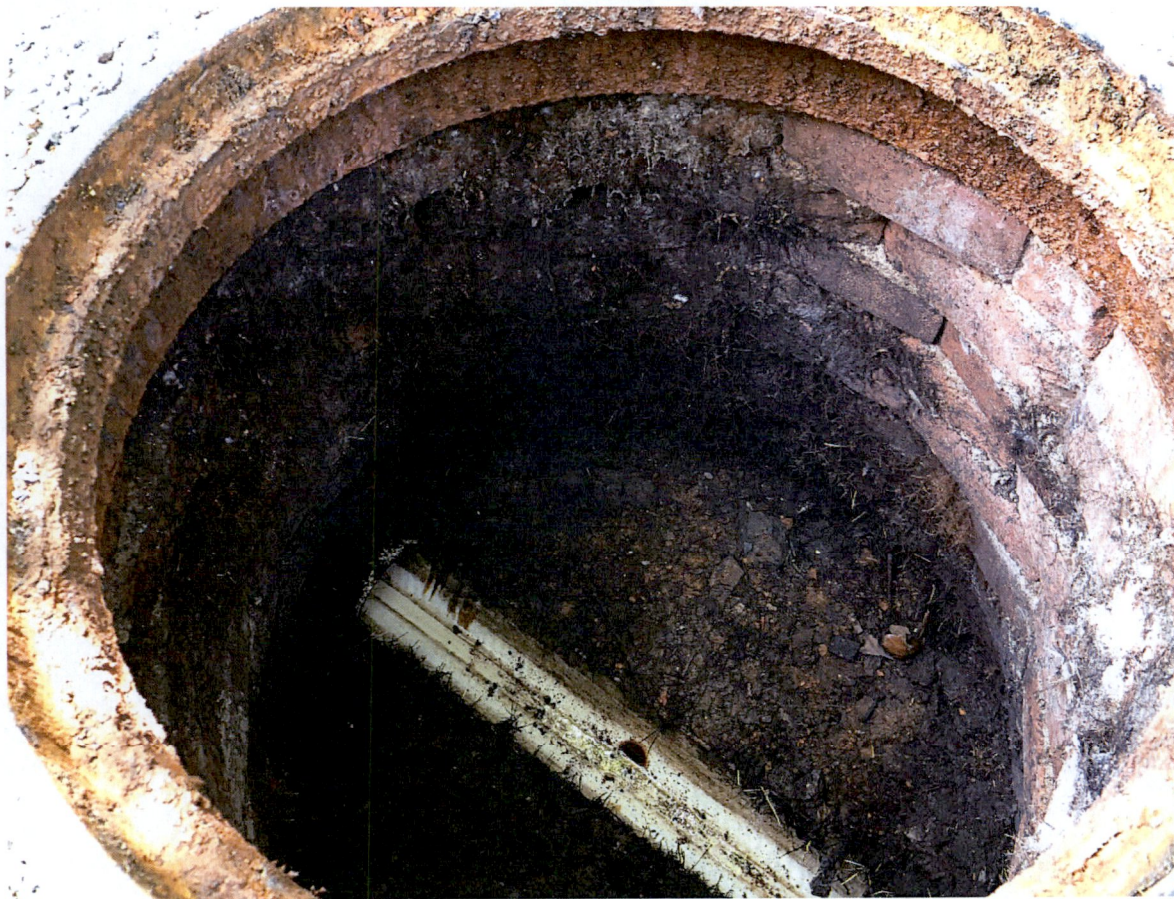
Brick Manhole Types in the Collection System (age and condition varies).

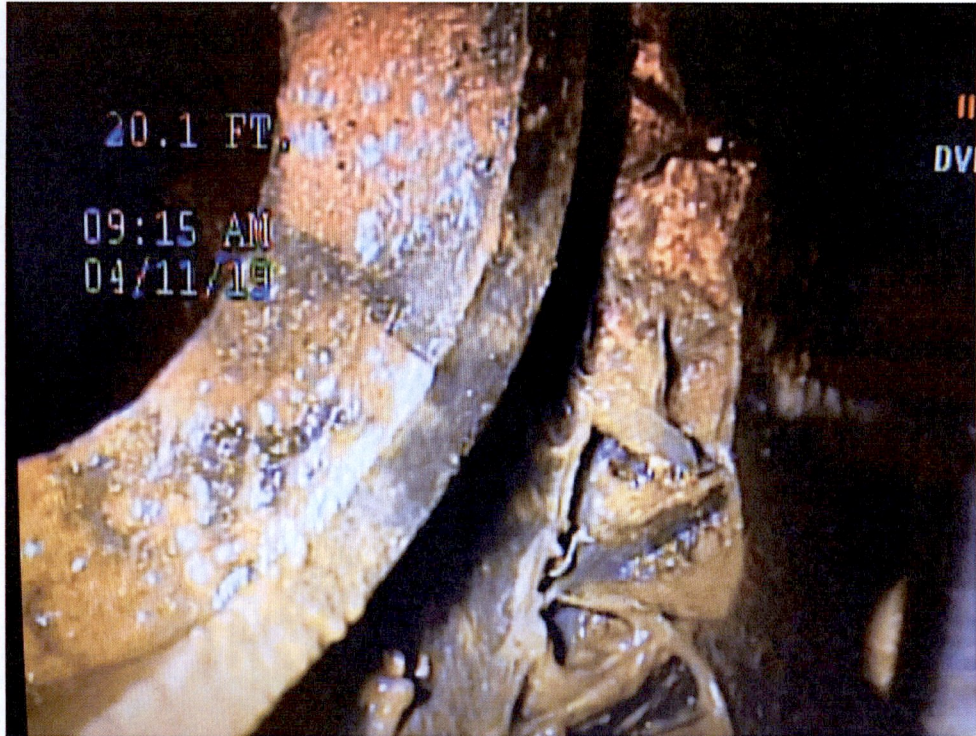
Service Line Tap into Truss pipe sewer Main, note the gap and failure to seal the joint

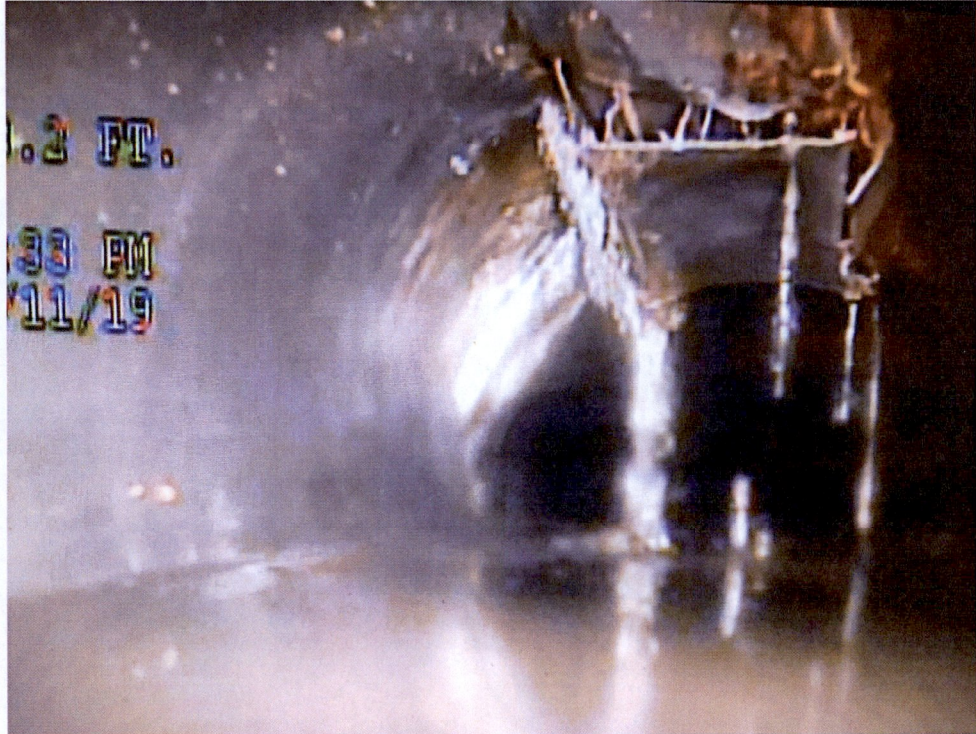
Several lines in the Mid South Lift Station Basin have been reviewed first and are generally located along W Boundary Rd, Locust St, and Wertz St among others. Collection mains in this basin include a large amount of 'Truss Pipe' that dates to the late 70s and early 80s. This pipe is a unique material that features a cement lining within a dual wall pvc pipe with a truss wall pattern. In general this pipe material appears to be in decent condition and has maintained its shape and good flow properties. However, a common occurrence has been infiltration into the main at service line connections. This appears to be from poorly performed connections without the use of gasketed joints (refer to pictures). In several instances the pipe was cracked and I/I was observed, as well. The Utility has begun repairing leaks observed found in this area.

A break in the top of a Truss pipe sewer main, groundwater infiltration is occurring.

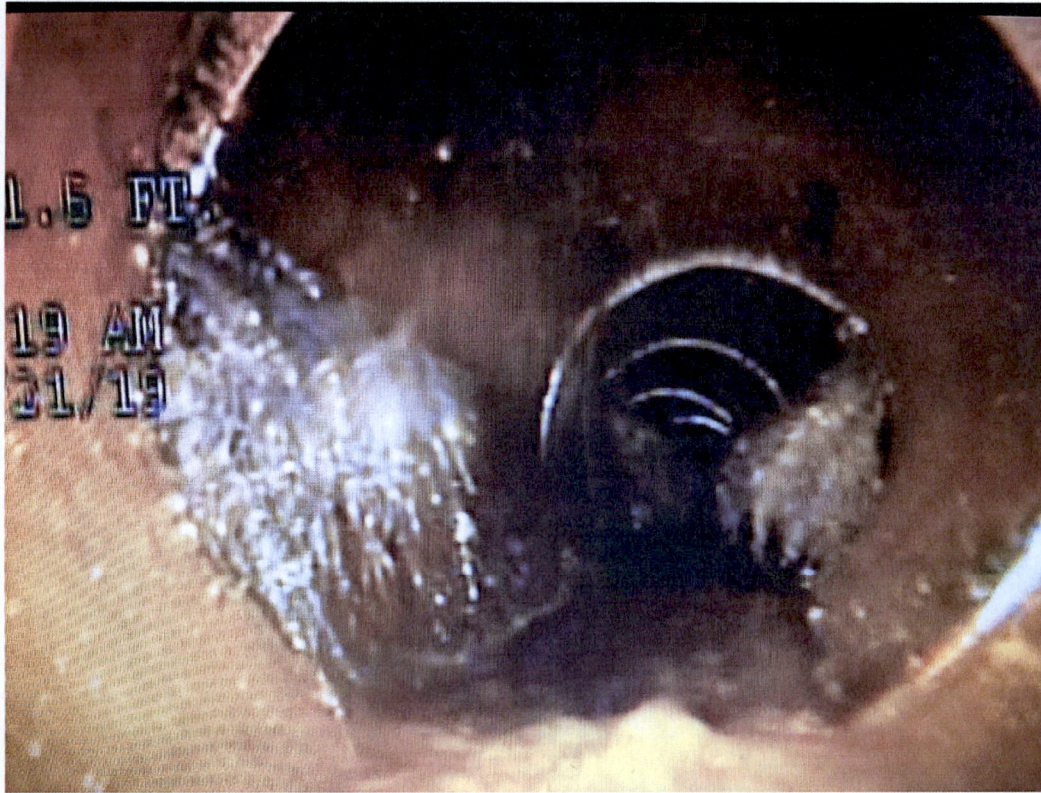
Clay Sewer Main with root intrusion at each joint

- **Maintain Sewer Right-of-Ways** – As observed in recent study results, excessive vegetation along sewer mains can result in severe root intrusions. Clay and Concrete sewer mains are more likely to deteriorate at joints over time which can be caused by root intrusion. This task is best performed during summer months.

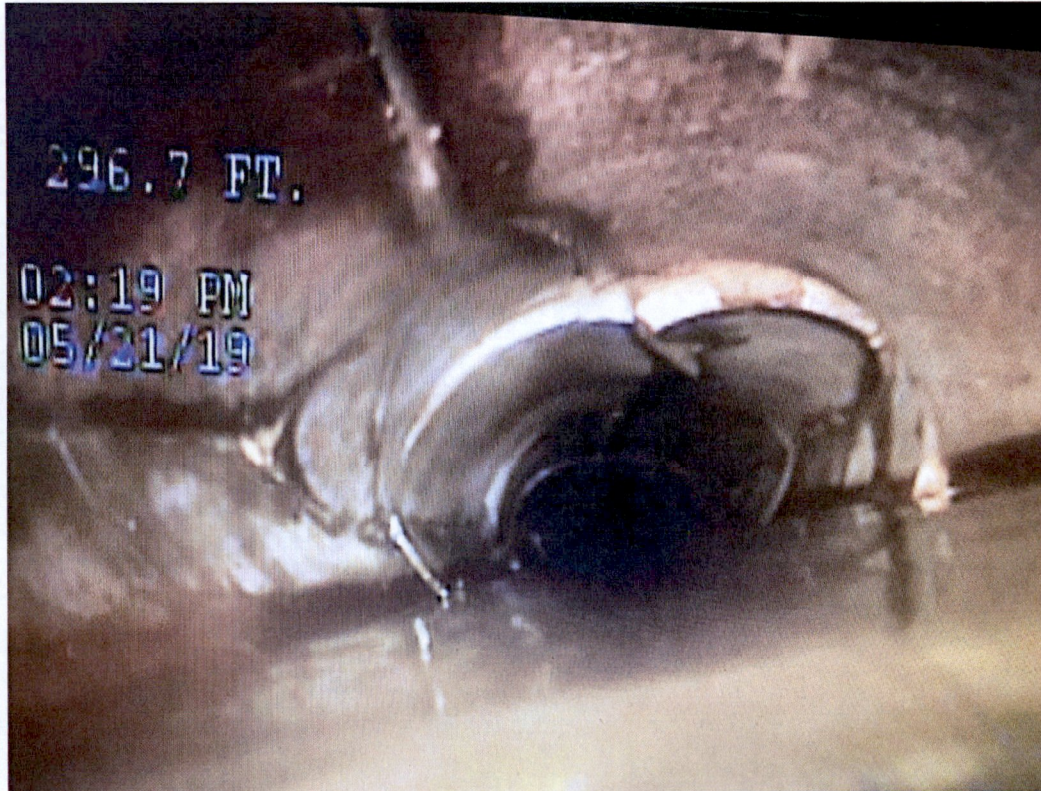
Recent sewer televising efforts have also been performed along an alleyway being south of Jansen Park and between 7th and 9th Streets. This sewer main was clay pipe construction and likely some of the original sewer main installed in the system. Upon televising the main severe leaking was observed at joints, cracks in the pipe, and severe root intrusion into the main. The Utility is currently working to replace this section of pipe as noted.

Clay Sewer Main with broken pipe, severely deformed, likely to collapse.

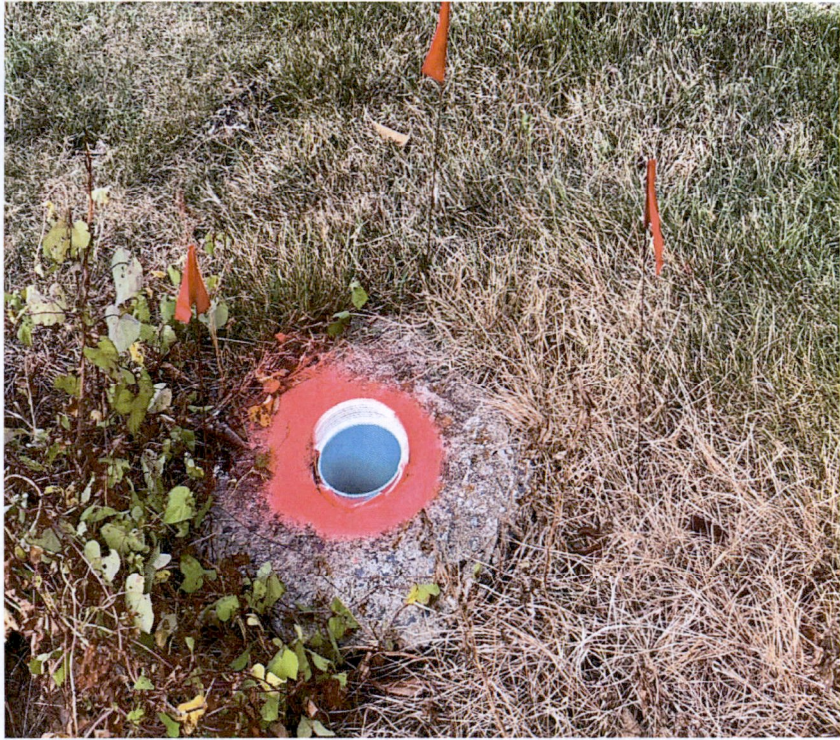
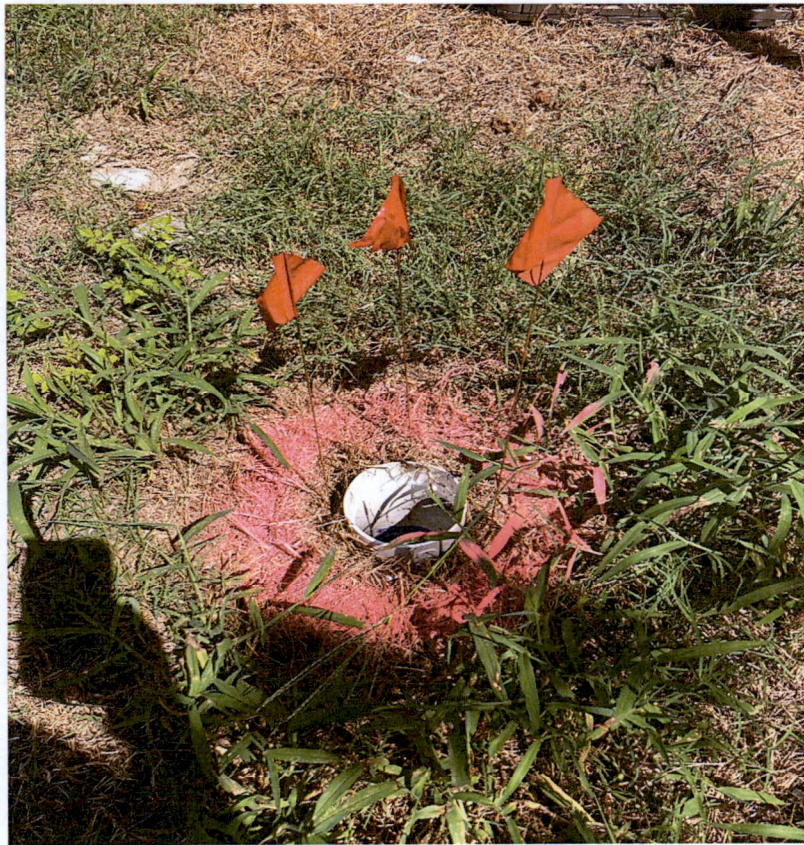
Typical Private Service Line Leaks that are easily corrected.

Consideration by the City regarding a new ordinance is recommended that may include financial assistance to residents that qualify as low income. Business owners and home owners should receive notification from the City that a problem has been observed to the service line and repairs are necessary.

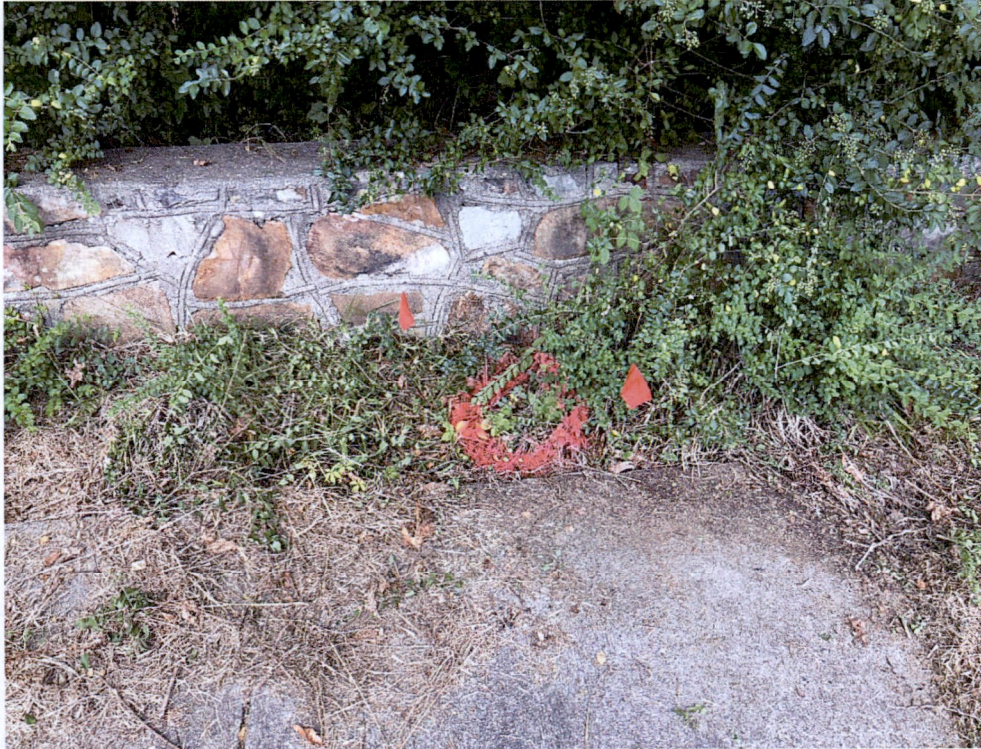
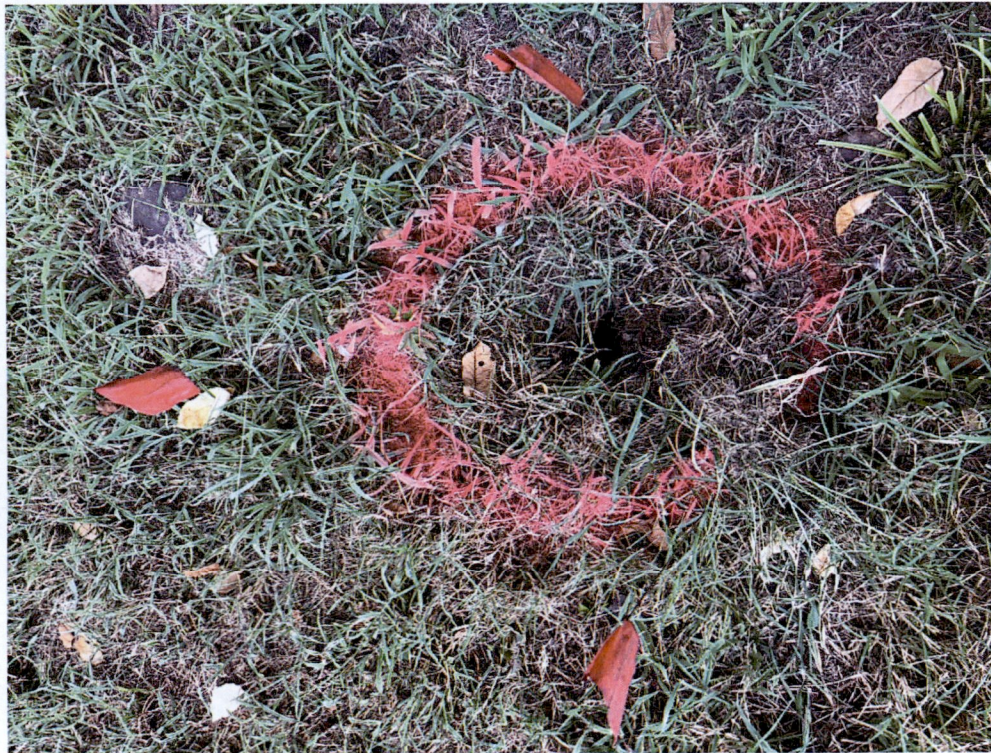
Private Service Line leaks that will require additional effort for repair.
