**SANITARY SEWER
EVALUATION & SURVEY**

MENA WATER UTILITIES

MENA, ARKANSAS

January 2020

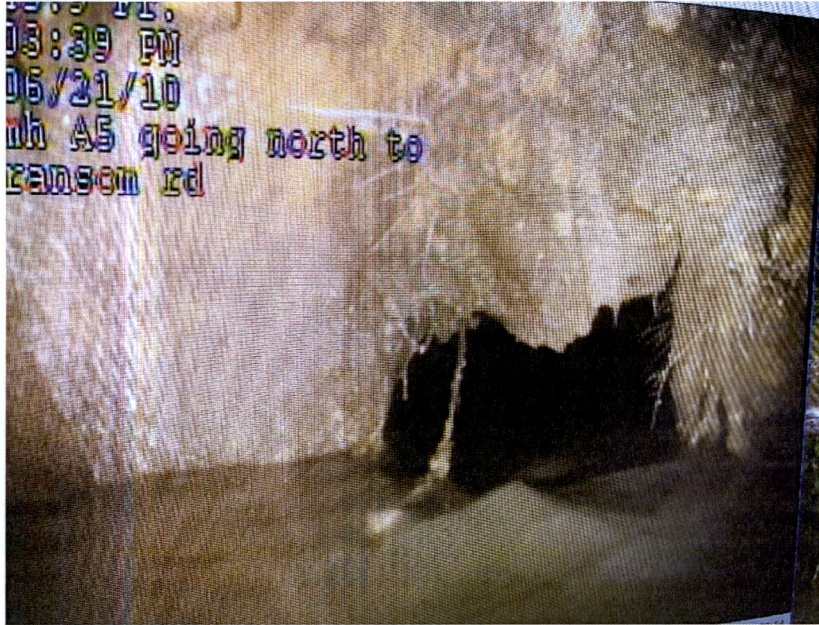
1) Ranson Rd Line going north from manhole A5 (115?) toward Ransom Rd

18" concrete main, 45-ft north of manhole line has severe root intrusion at joint, urgent leak to be repaired.

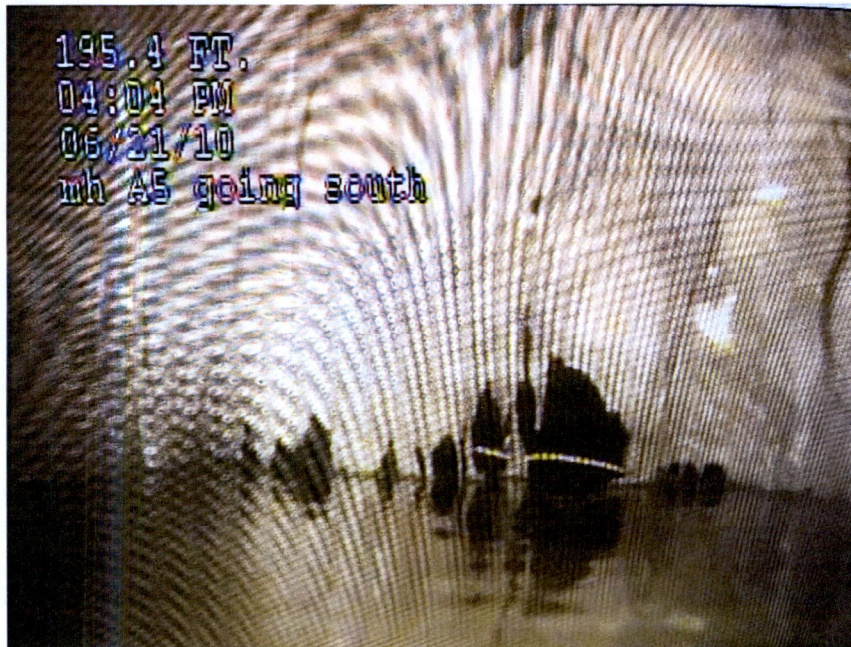
2) Manhole A5 going south (perhaps mh 115)

18" concrete main, 196-ft south of manhole, severe root intrusion at joint, urgent leak to be repaired

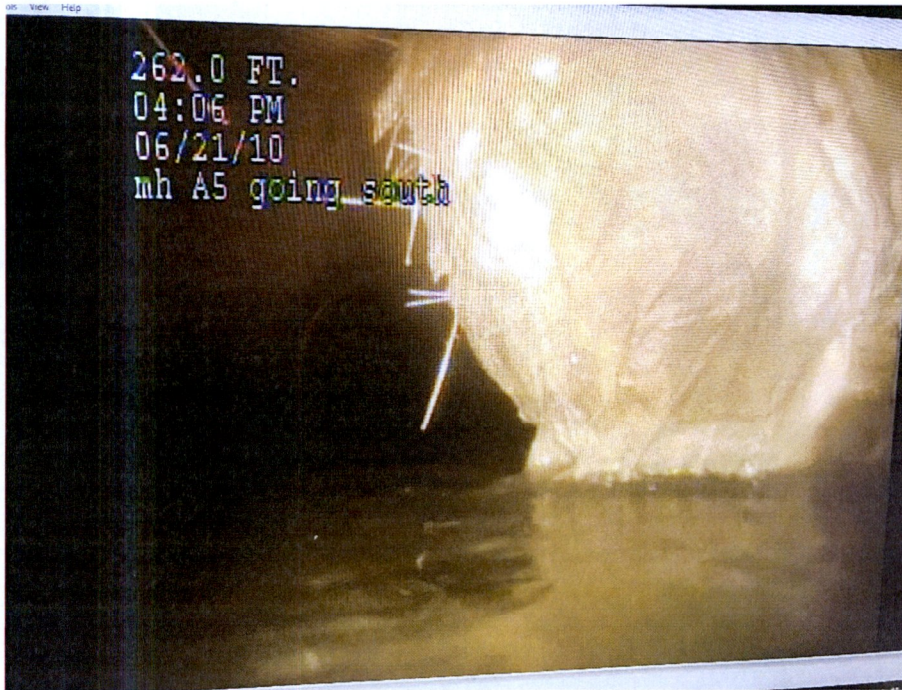
18" concrete main, 262-ft south of manhole A5, severe root intrusion at joint, urgent leak to be repaired

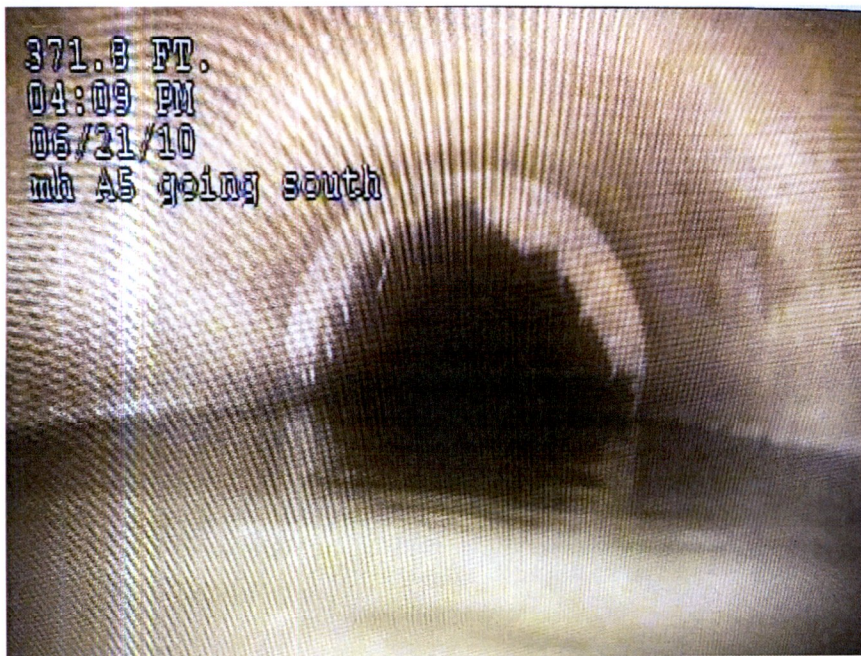
18" concrete main, 375-ft south of manhole A5, moderate root intrusion at joint

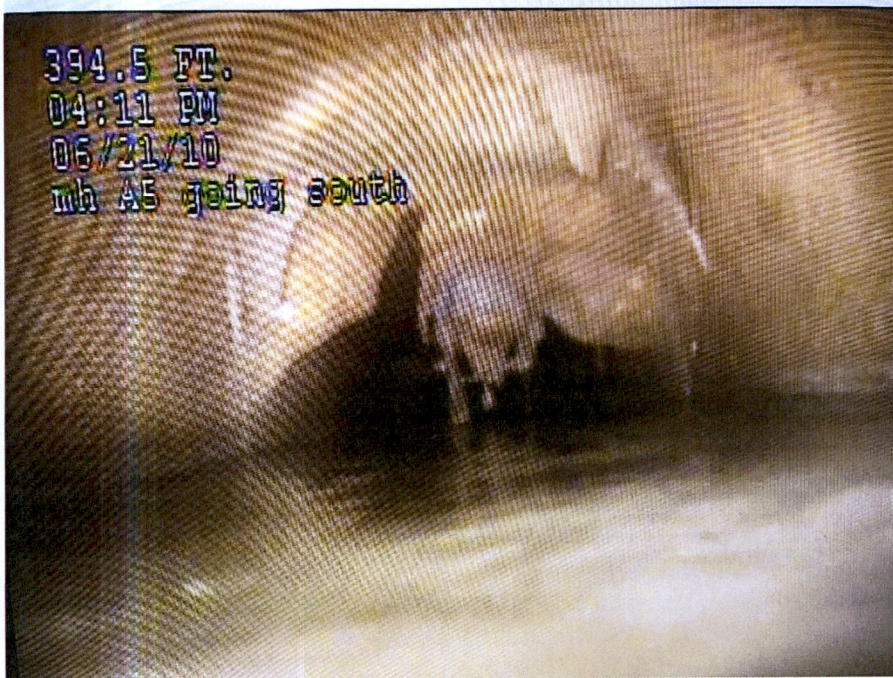
18" concrete main, 397-ft south of manhole A5, roughly 13-ft south of manhole 114, severe root intrusion at joint, urgent repair

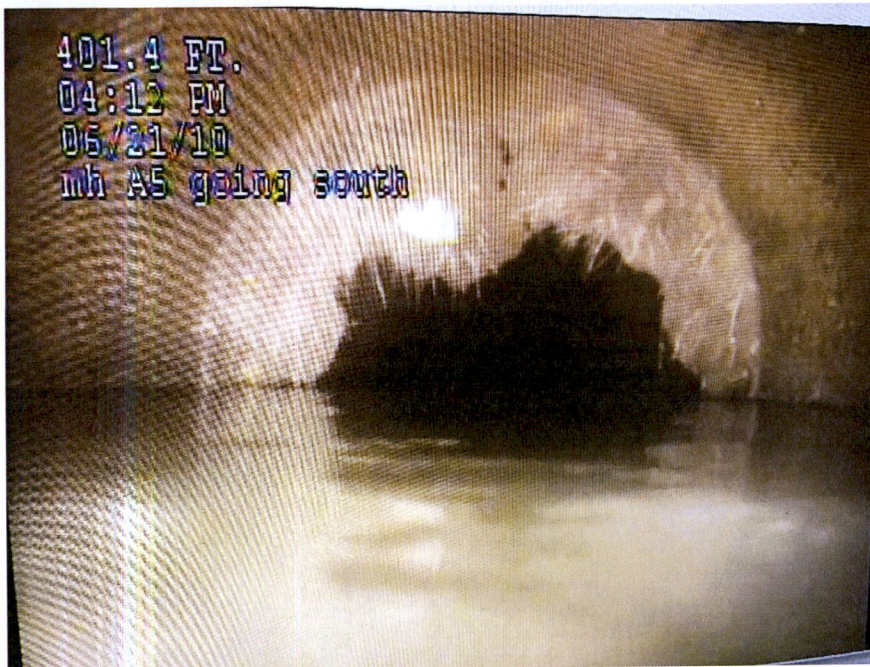
18" concrete main, 403-ft south of manhole A5, roughly 19-ft south of manhole 114, severe root intrusion at joint, urgent repair

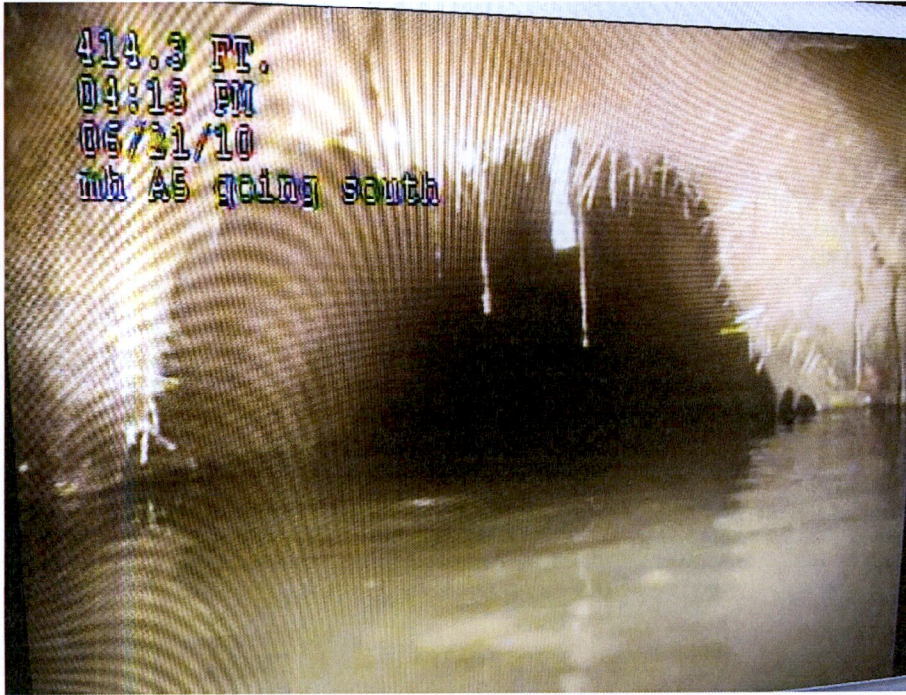
18" concrete main, 414-ft south of manhole A5, roughly 30-ft south of manhole 114, severe root intrusion at joint

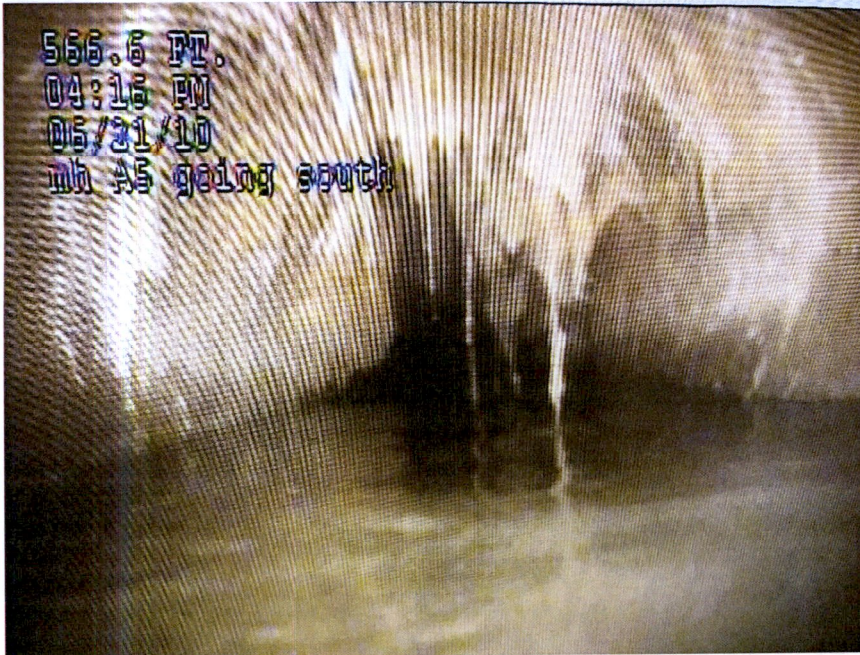
18" concrete main, 567-ft south of manhole A5, roughly 183-ft south of manhole 114, severe root intrusion at joint

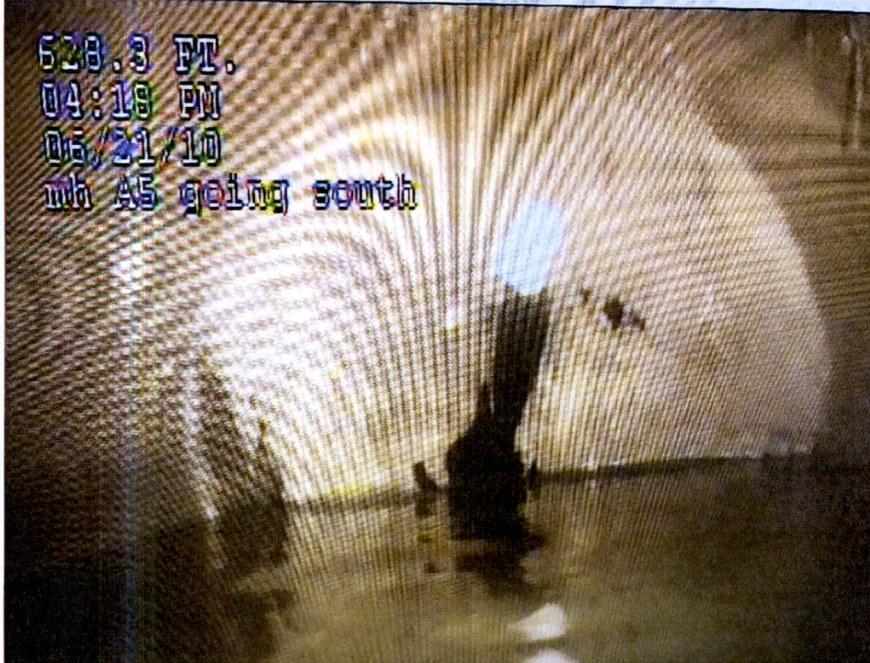
18" concrete main, 630-ft south of manhole A5, roughly 246-ft south of manhole 114, severe root intrusion at joint (150-ft north of manhole 113)

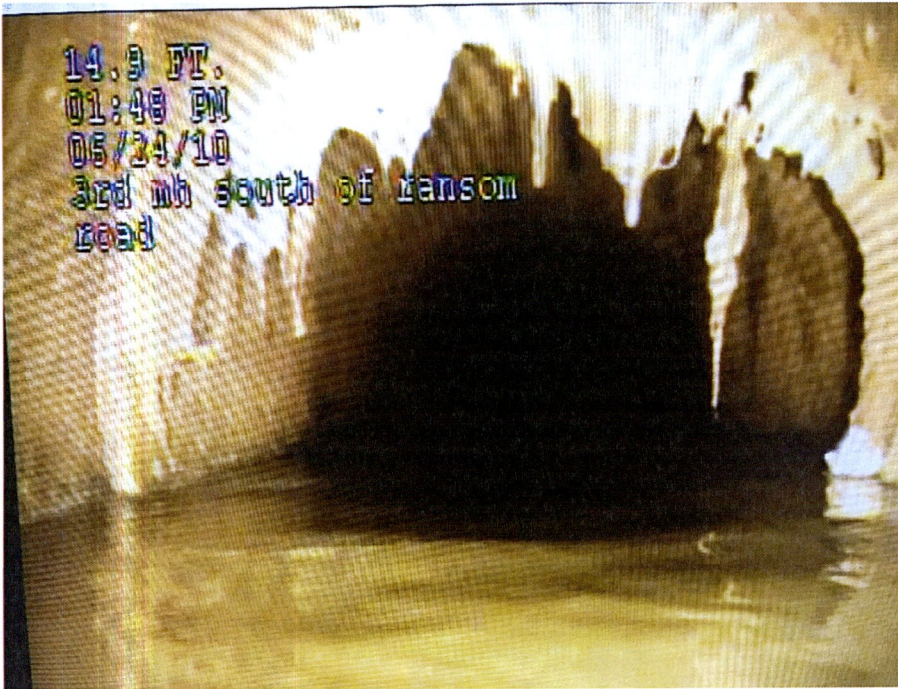
3) Ransom Rd 18" concrete sewer main heading south from manhole 113

15-ft from manhole, root intrusion at joint

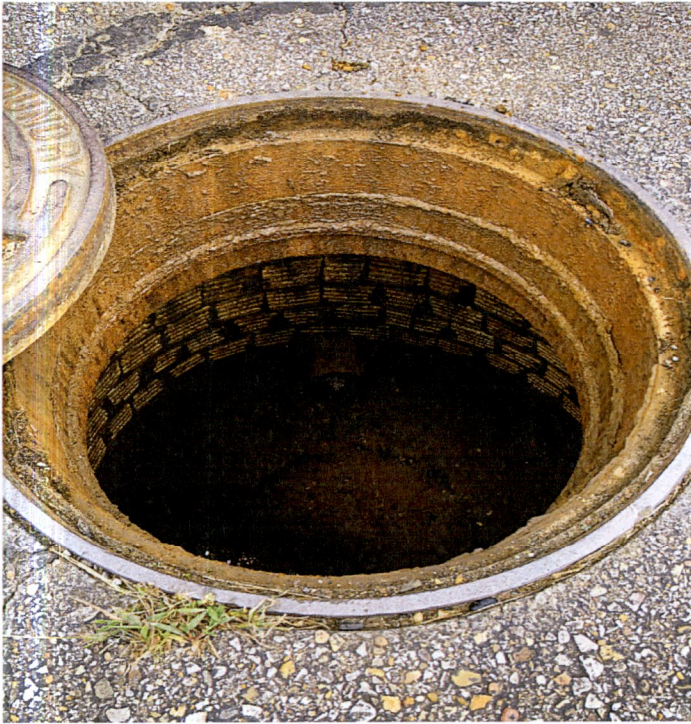
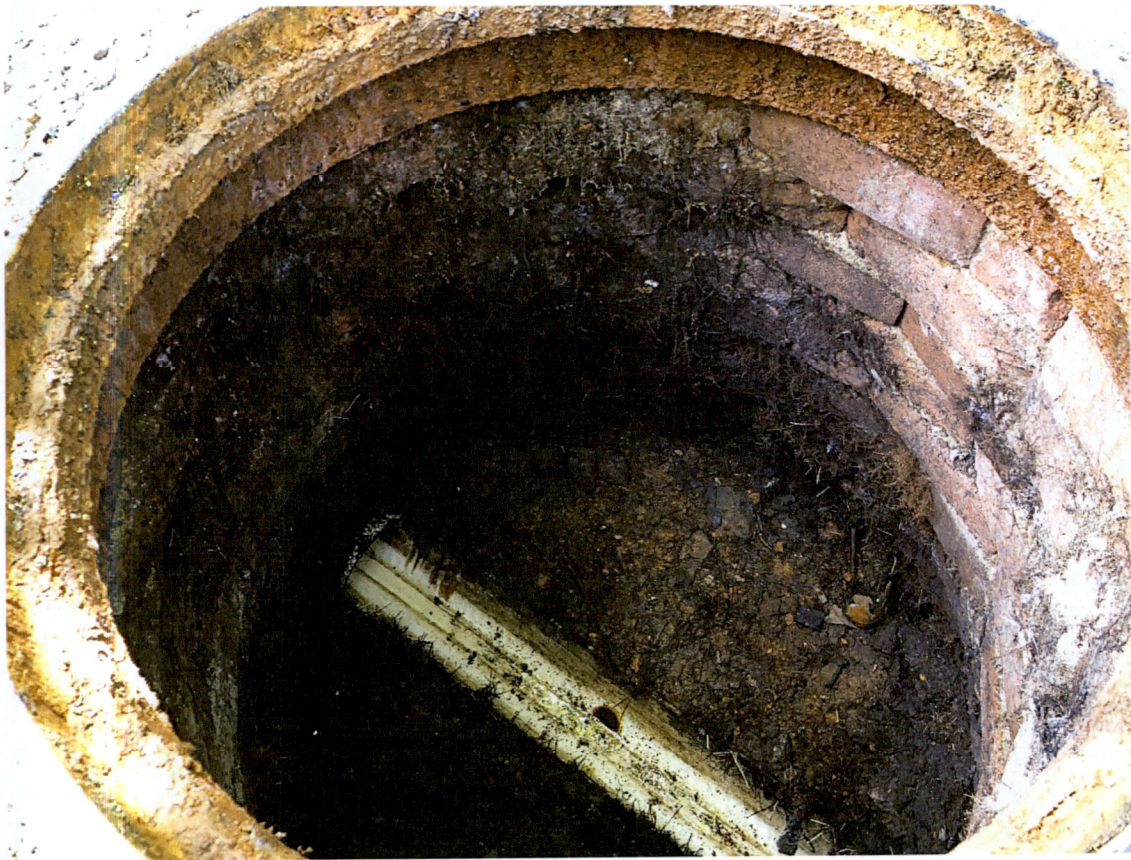
Brick Manhole Types in the Collection System (age and condition varies).

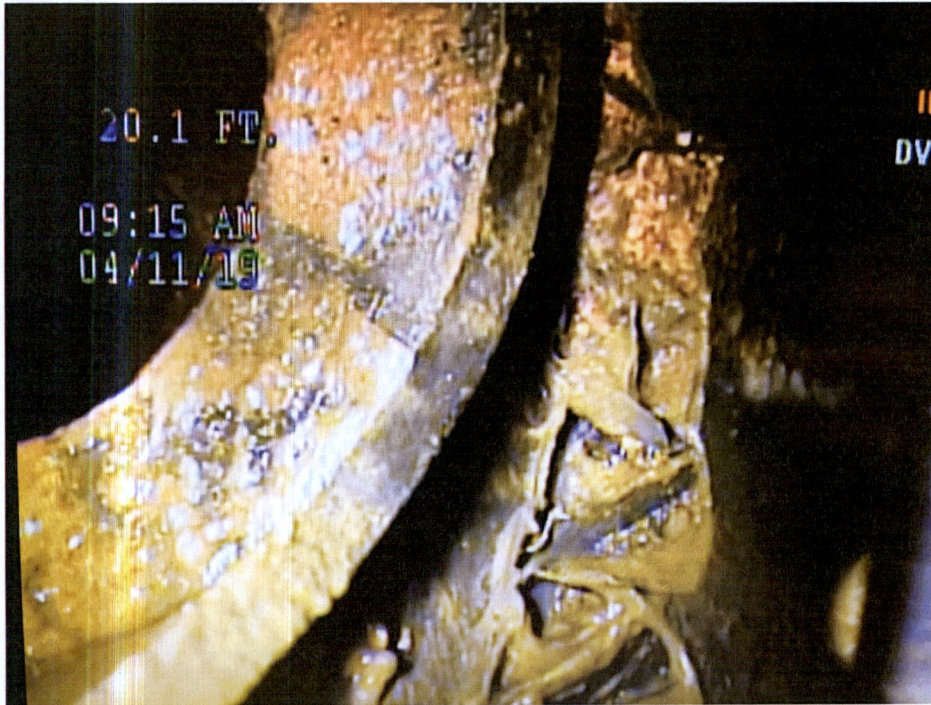
Service Line Tap into Truss pipe sewer Main, note the gap and failure to seal the joint

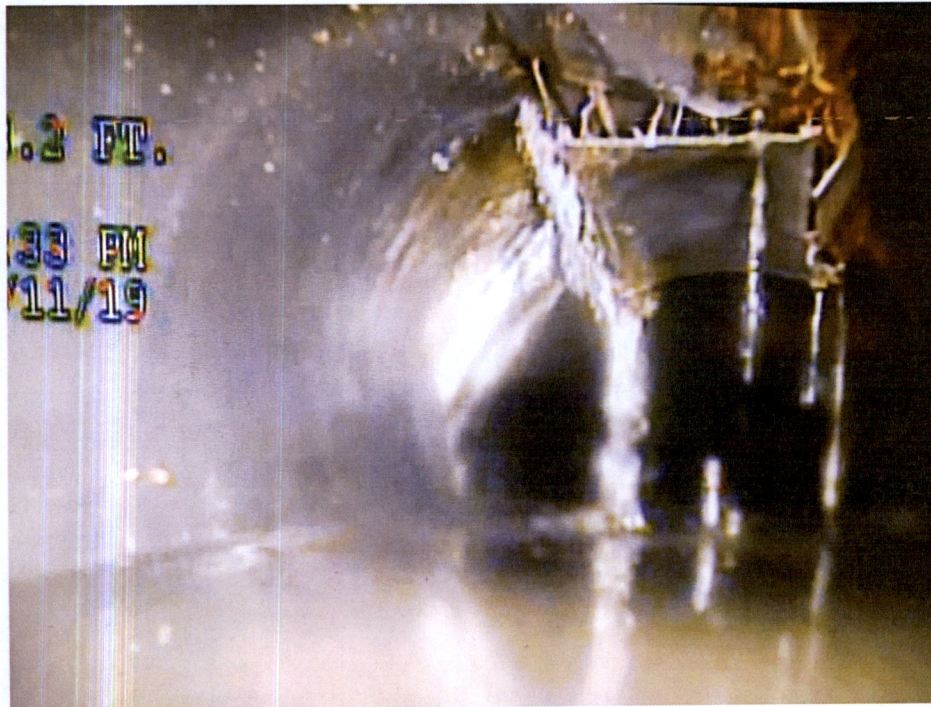
A break in the top of a Truss pipe sewer main, groundwater infiltration is occurring.

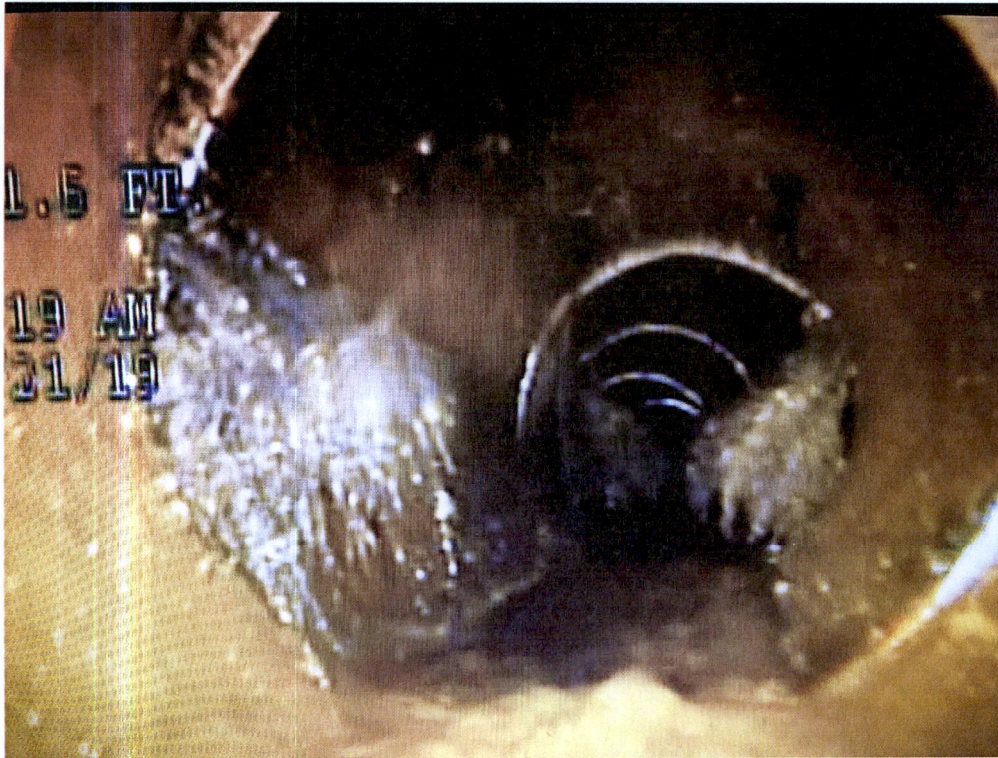
Clay Sewer Main with root intrusion at each joint

- **Maintain Sewer Right-of-Ways** – As observed in recent study results, excessive vegetation along sewer mains can result in severe root intrusions. Clay and Concrete sewer mains are more likely to deteriorate at joints over time which can be caused by root intrusion. This task is best performed during summer months.

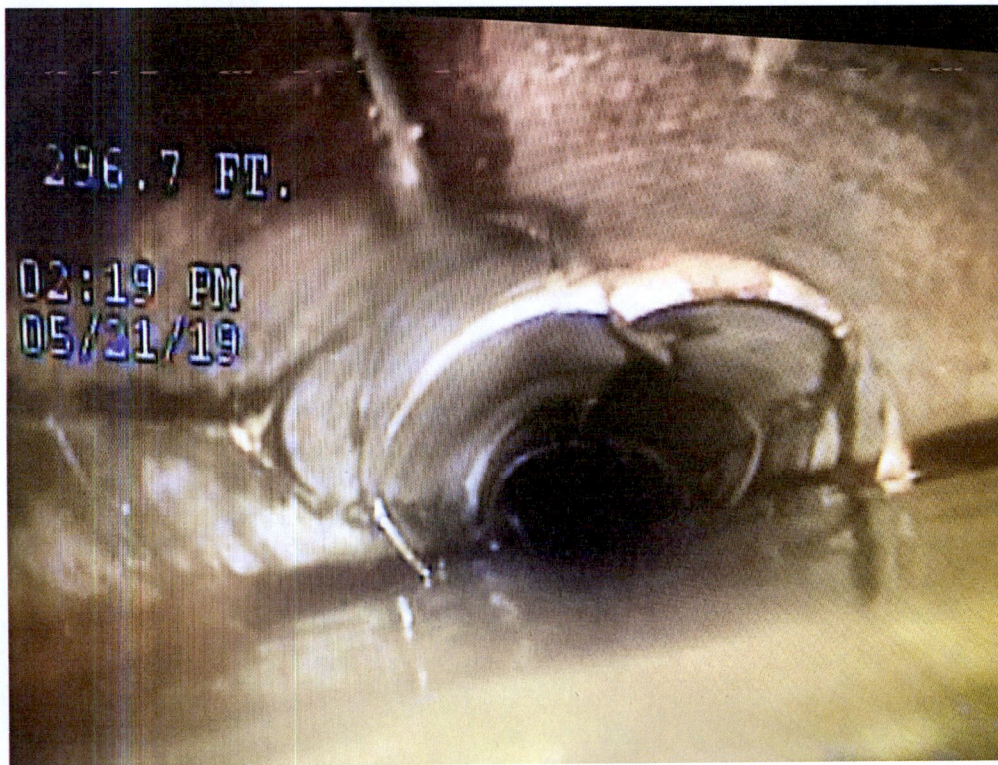
Clay Sewer Main with broken pipe, severely deformed, likely to collapse.

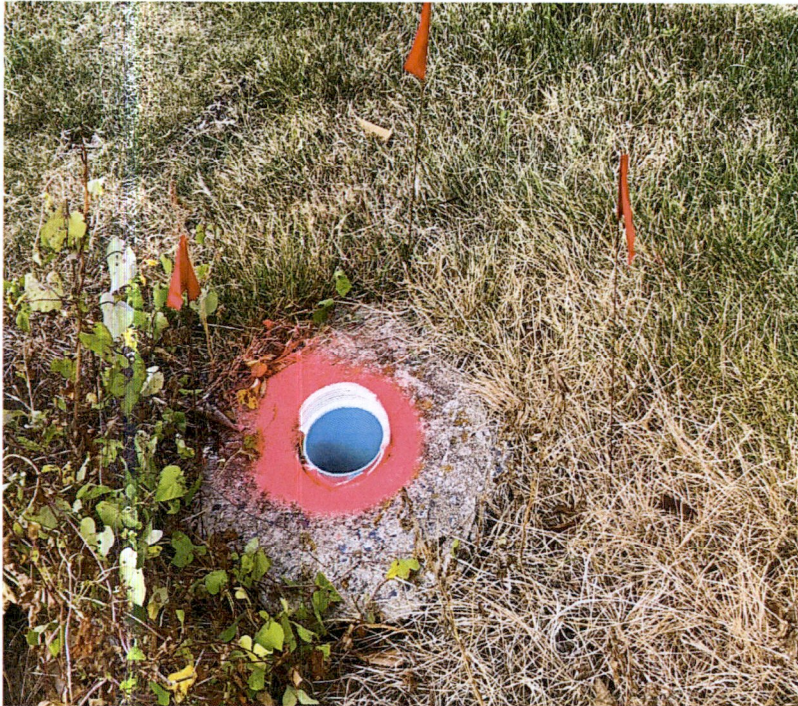
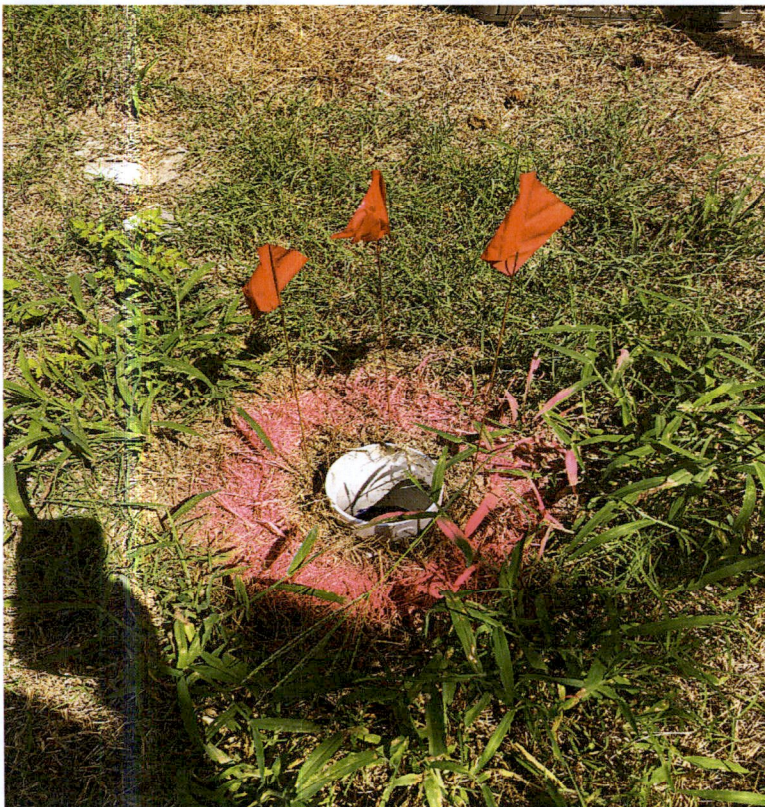
Typical Private Service Line Leaks that are easily corrected.

The Utility should at a minimum began an evaluation of these to further clarify the source of the problem if it is a private service or main line leak. Simple items such as replacing cleanout caps should be completed considering extreme ease and minimal costs.

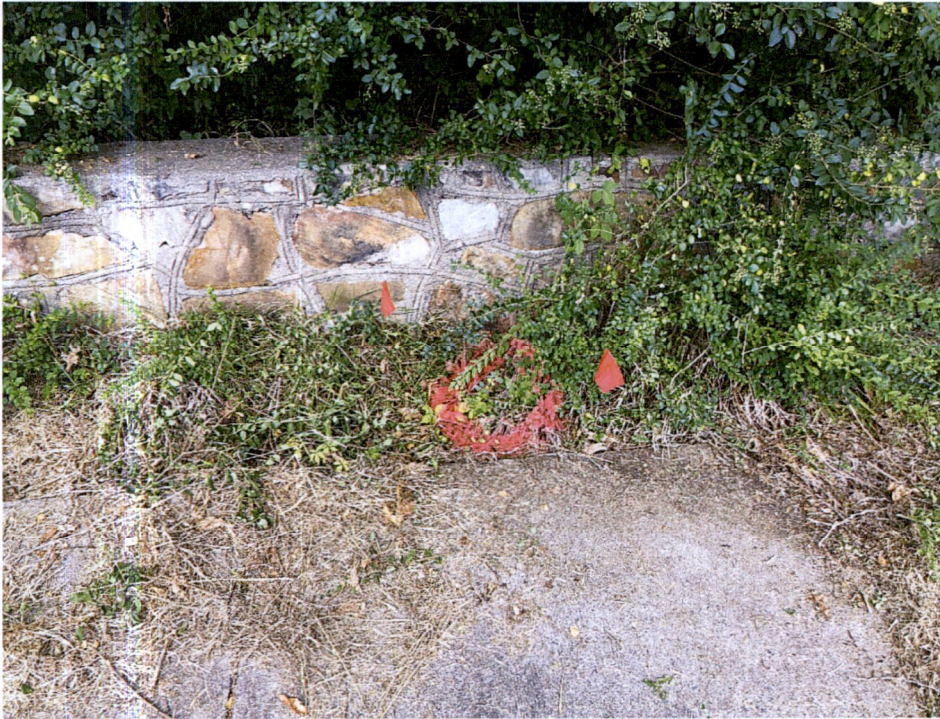
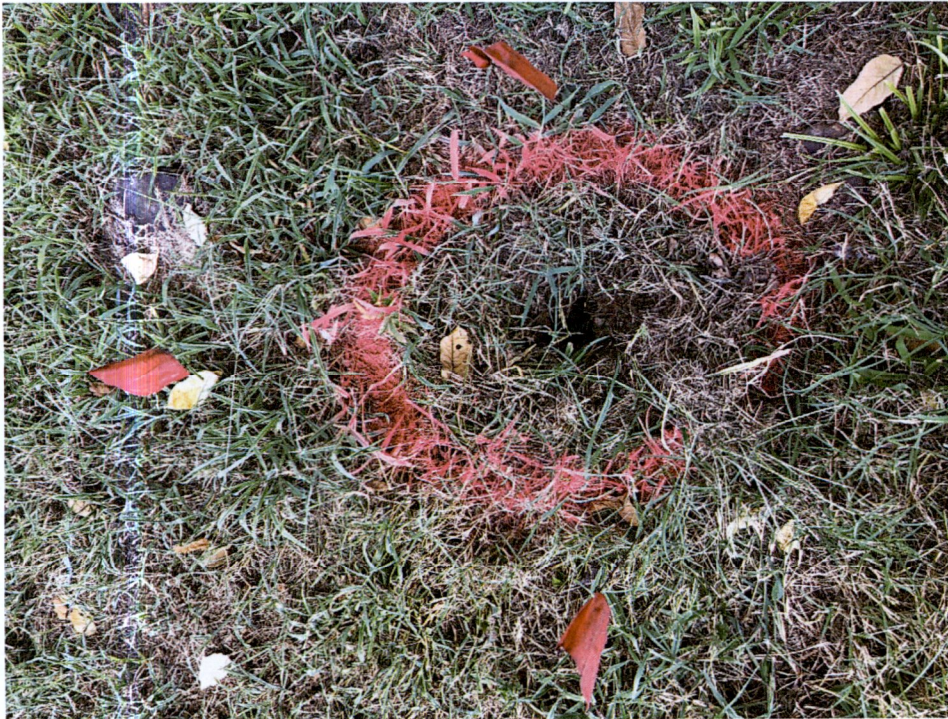
Private Service Line leaks that will require additional effort for repair.

- **Implement an Ordinance / Plan for private service leaks** – The City of Mena should develop and implement an ordinance to enforce homeowners to maintain sewer services in good working condition. As previously noted well over 100 leaks have been documented from private side service lines.
