From: Brian Sartain <BrianSartain@rwu.org>
Sent: Tuesday, July 24, 2018 1:40 PM
To: Anderson, Alan
Cc: Brent Dobler; Todd Beaver; Earl Rausch; King, Kara
Subject: RE: Collapsed 30" Sewer Main
Attachments: Groundwater Pumping (3) (600x800).jpg; wastewater pumping.jpg

From: Johnny Lunsford
Sent: Monday, May 14, 2018 1:59 PM
To: 'ANDERSON@adeq.state.ar.us'
Cc: Brent Dobler; Brian Sartain; Todd Beaver; Earl Rausch
Subject: Collapsed 30" Sewer Main

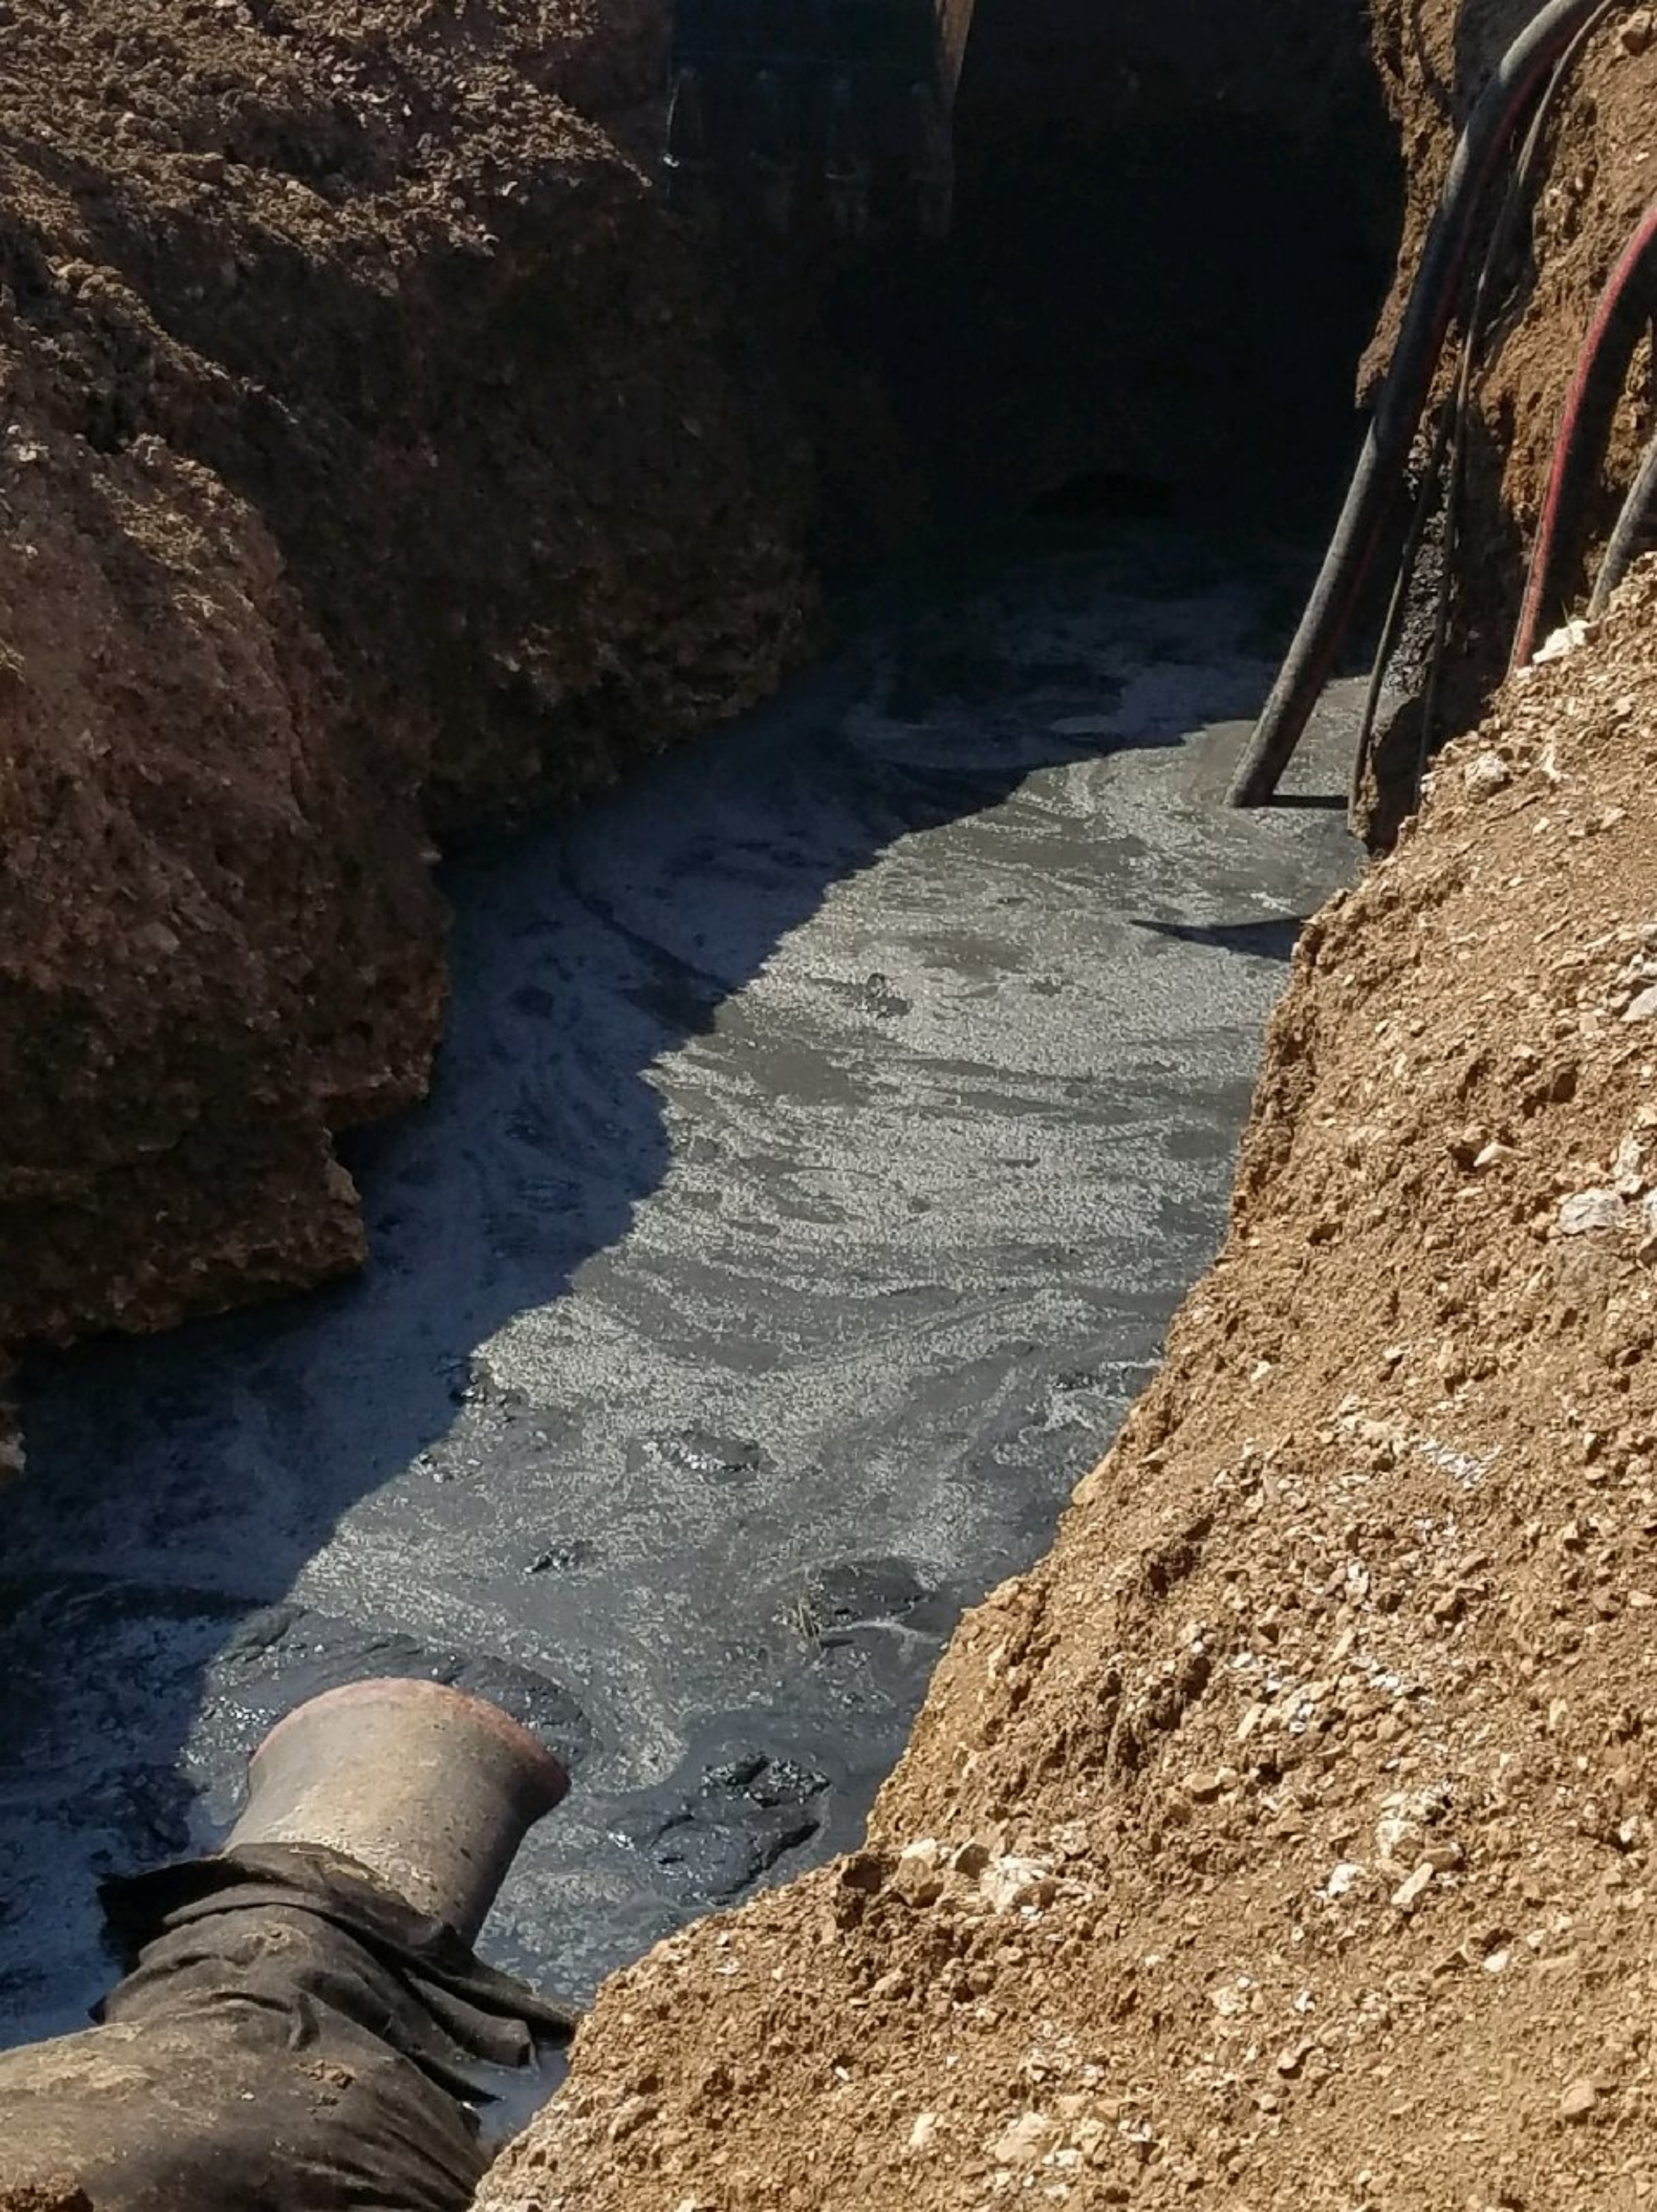
RWU hired a contractor (Seven Valleys Construction) to repair the collapsed 30" sewer main per plans developed by RWU's engineering department. The repair includes the replacement of approximately 200 LF of 30" fiberglass reinforced pipe with 30" ductile iron pipe, with new manholes at each end of the repair. The contractor excavated the sewer downstream of the collapsed area, where high rates of groundwater were encountered. This groundwater was running clear, showed no sign of wastewater intrusion and was pumped out of the trench and allowed to flow overland and into Blossom Way Creek during construction hours. This trench dewatering allowed the contractor to begin to lay the new ductile iron pipe. When trenching operations reached upstream to the point that the pipe had collapsed, wastewater that had been trapped behind the collapsed area began to flow into the open trench. When this was observed today (7/24/18), dewatering operations to the stream immediately stopped, and the wastewater mixture is currently being diverted to the sanitary sewer for treatment at the plant, with floatable solids removed using vacuum excavation equipment. I have attached photos of groundwater pumping operations taken last week and today's wastewater pumping operation.

We will continue to work with our contractor to remove all wastewater and residual solids before commencing any trench dewatering operations, and ensure that best management practices are implemented to the fullest extent practicable. Please do not hesitate to contact me if you have any questions or concerns.
