Stormwater Management Department

Date/Time of report: 11/25/2014 1400

Location of discharge (Closest intersection or address; GPS Coordinates): Supermercado Las Americas  
400 S. 8th St. Suite A

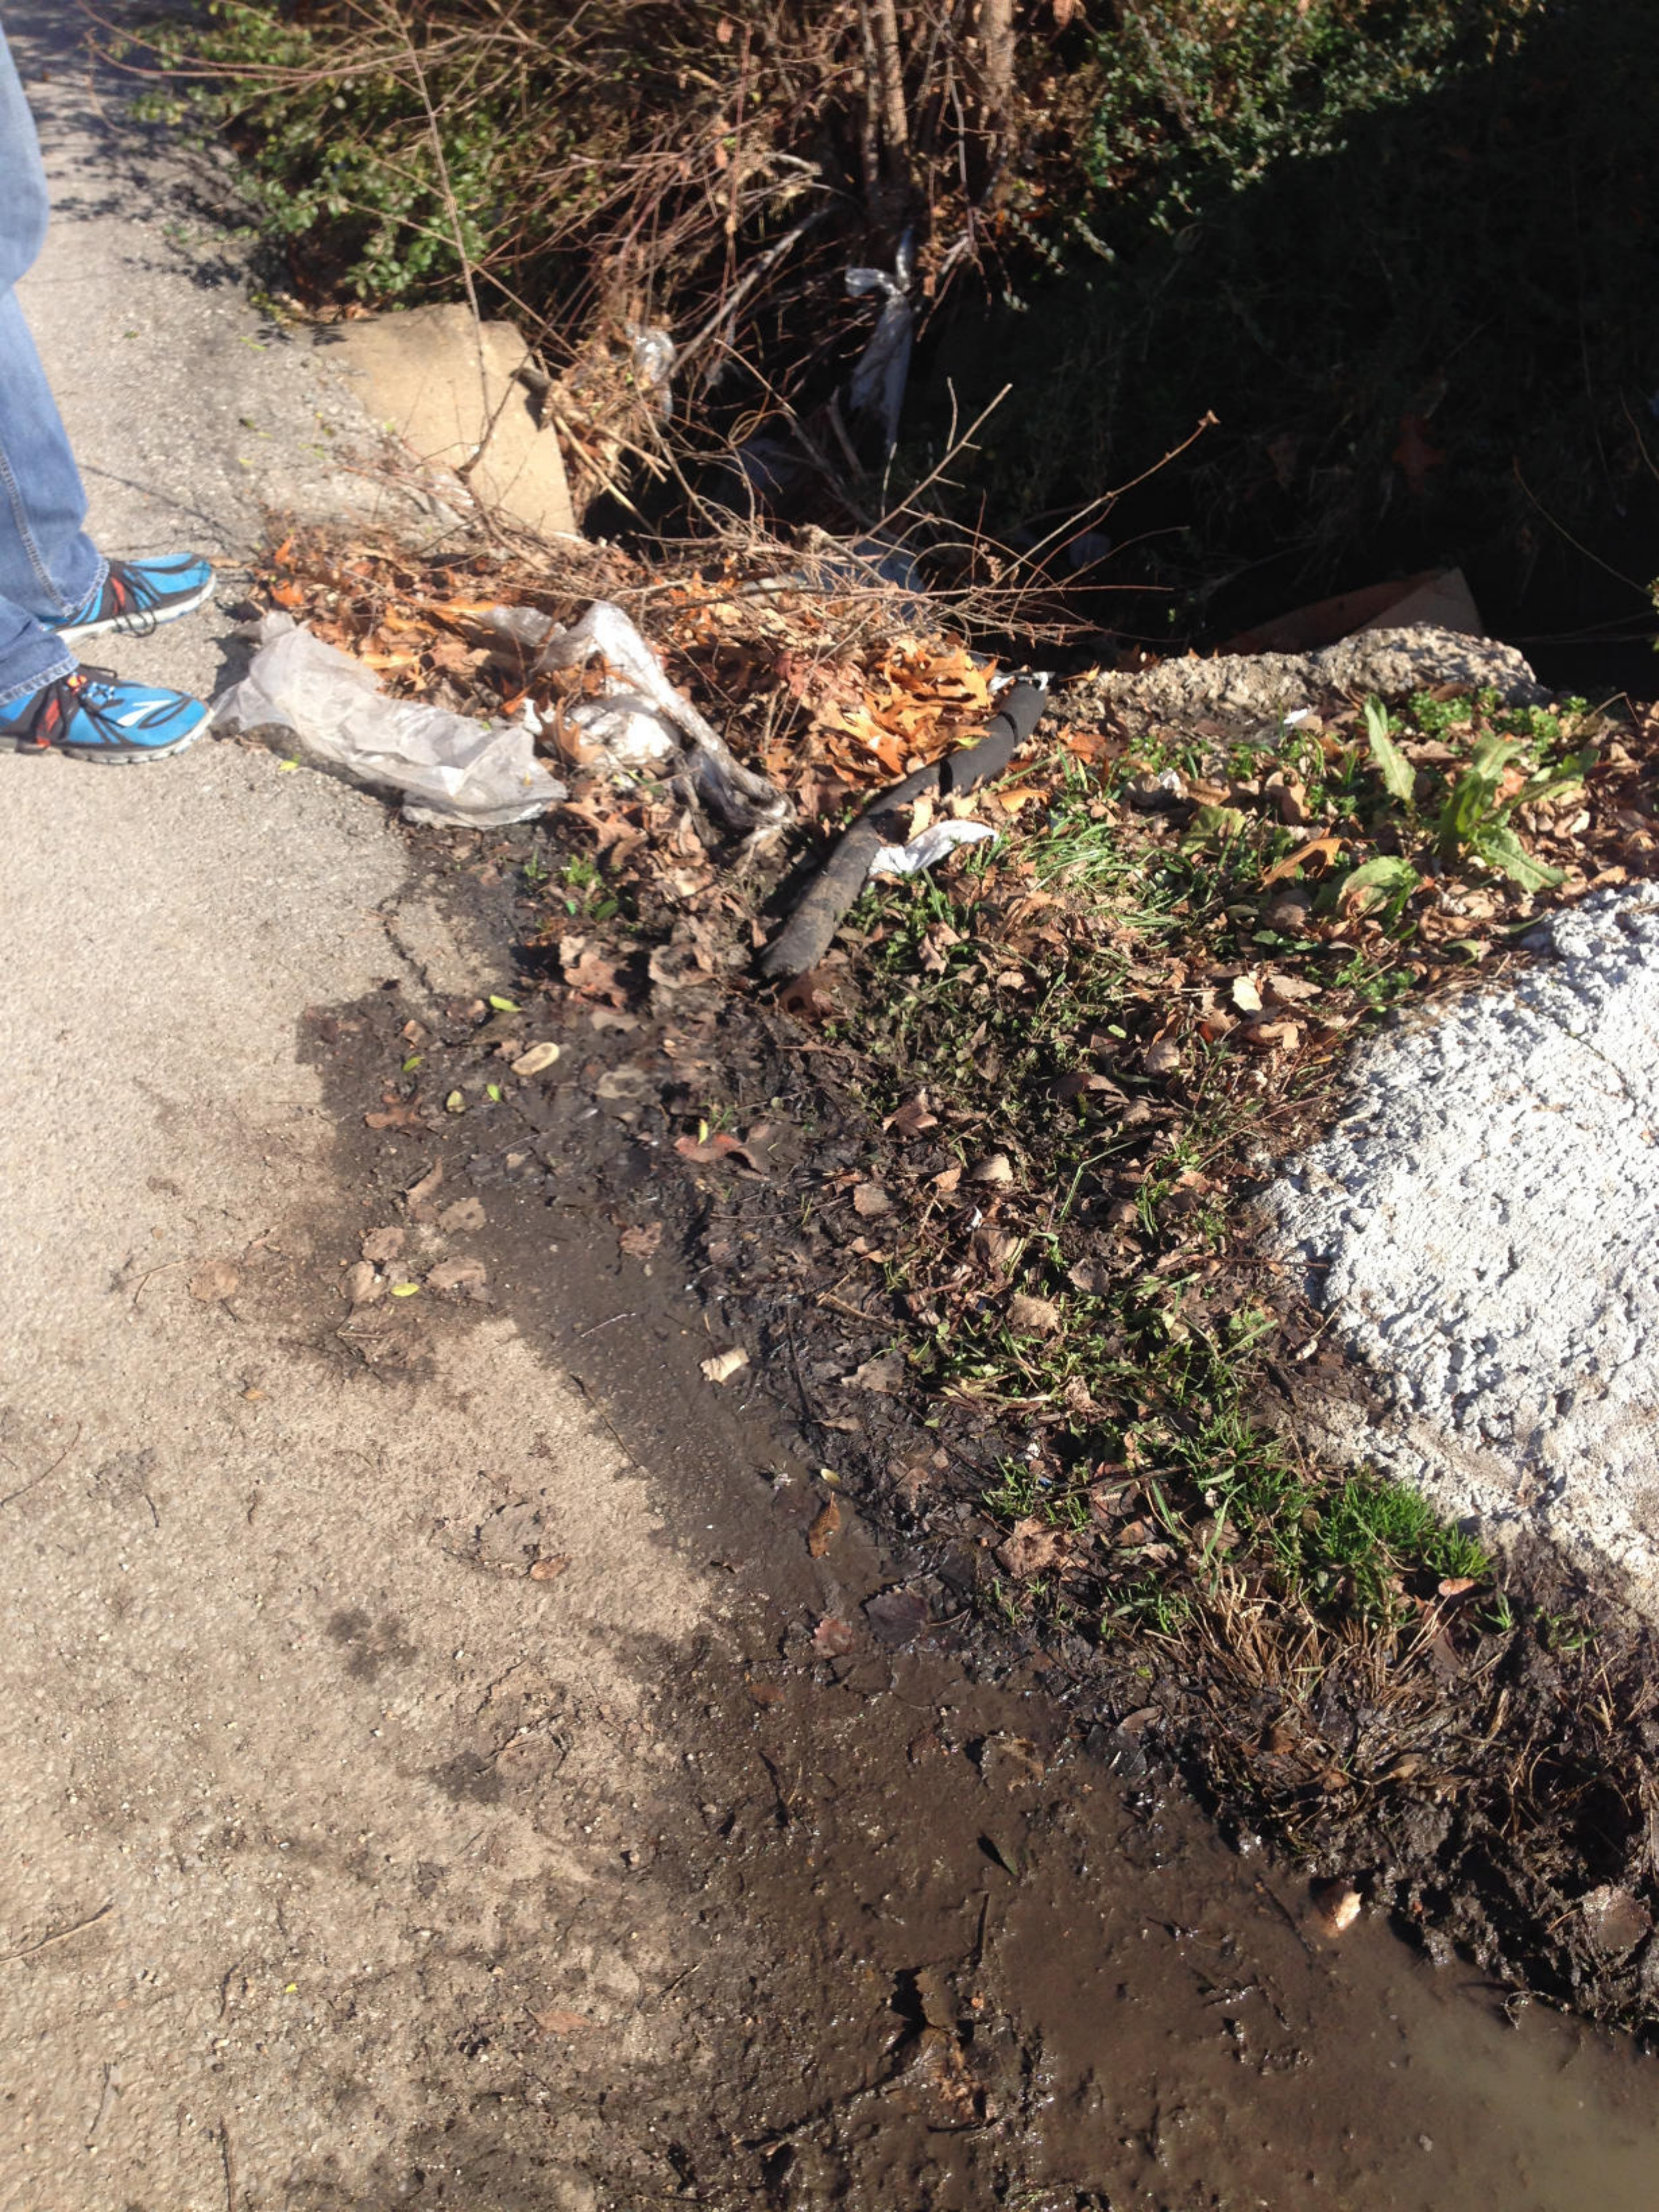
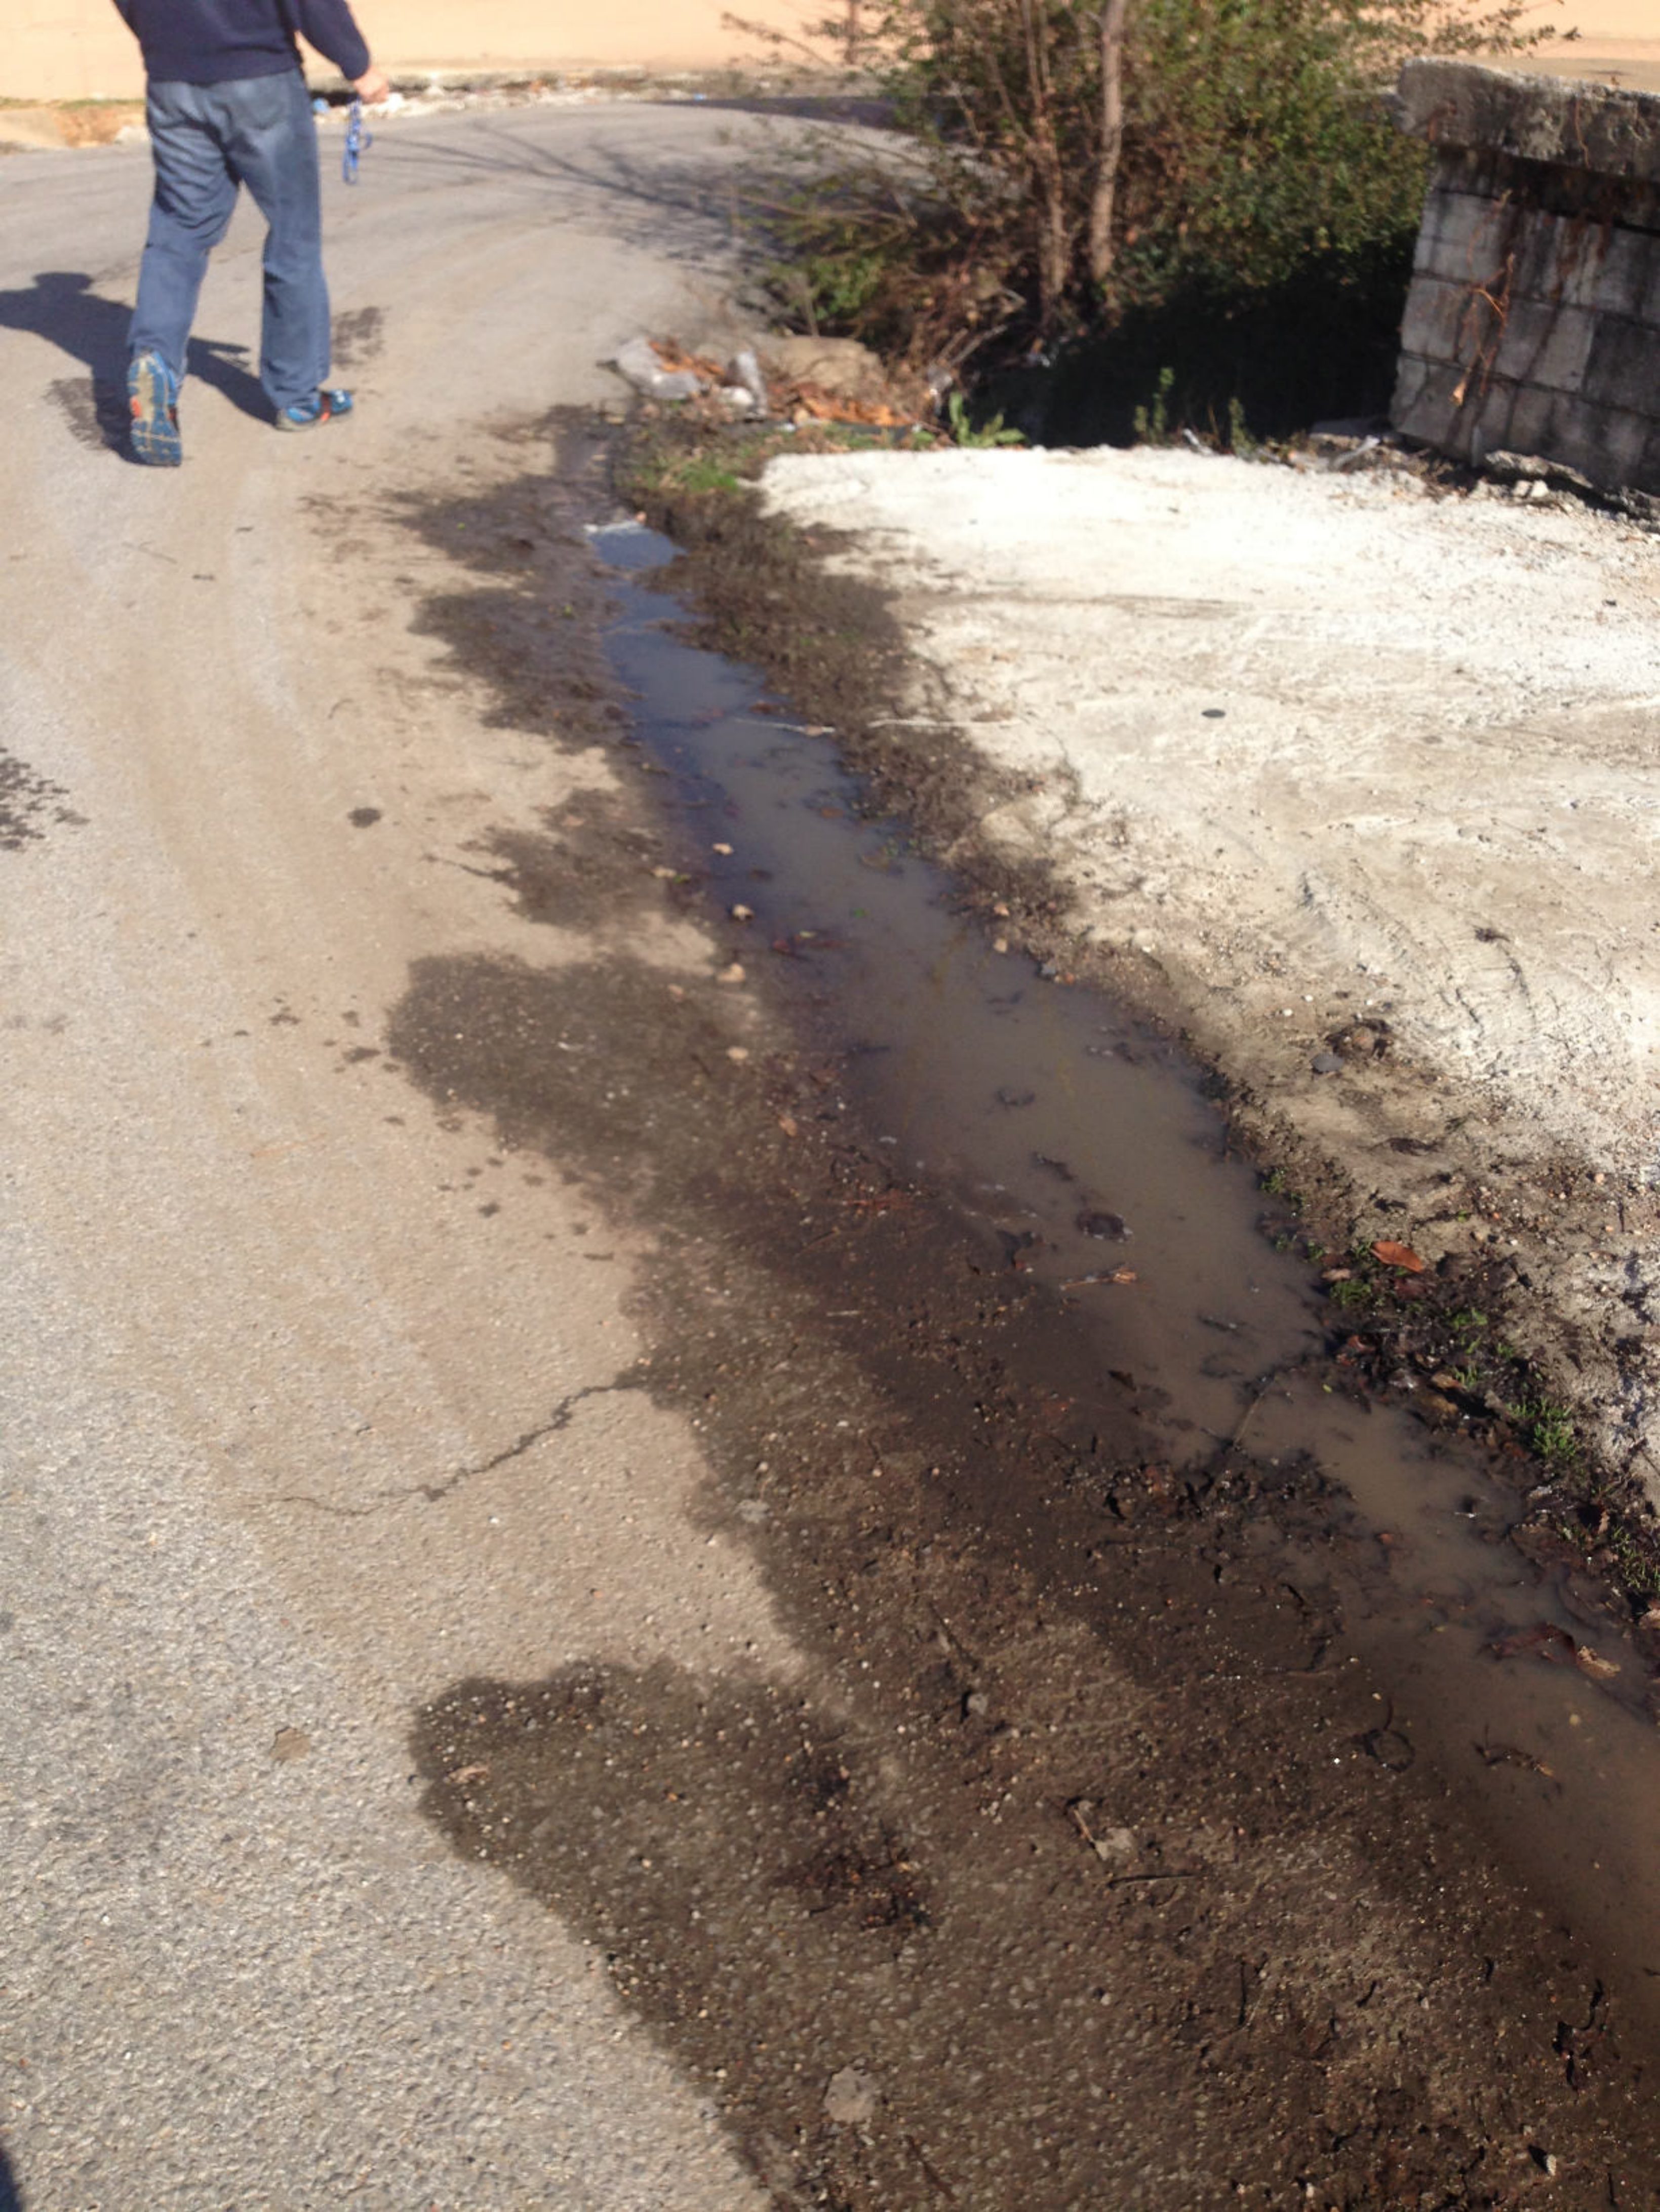
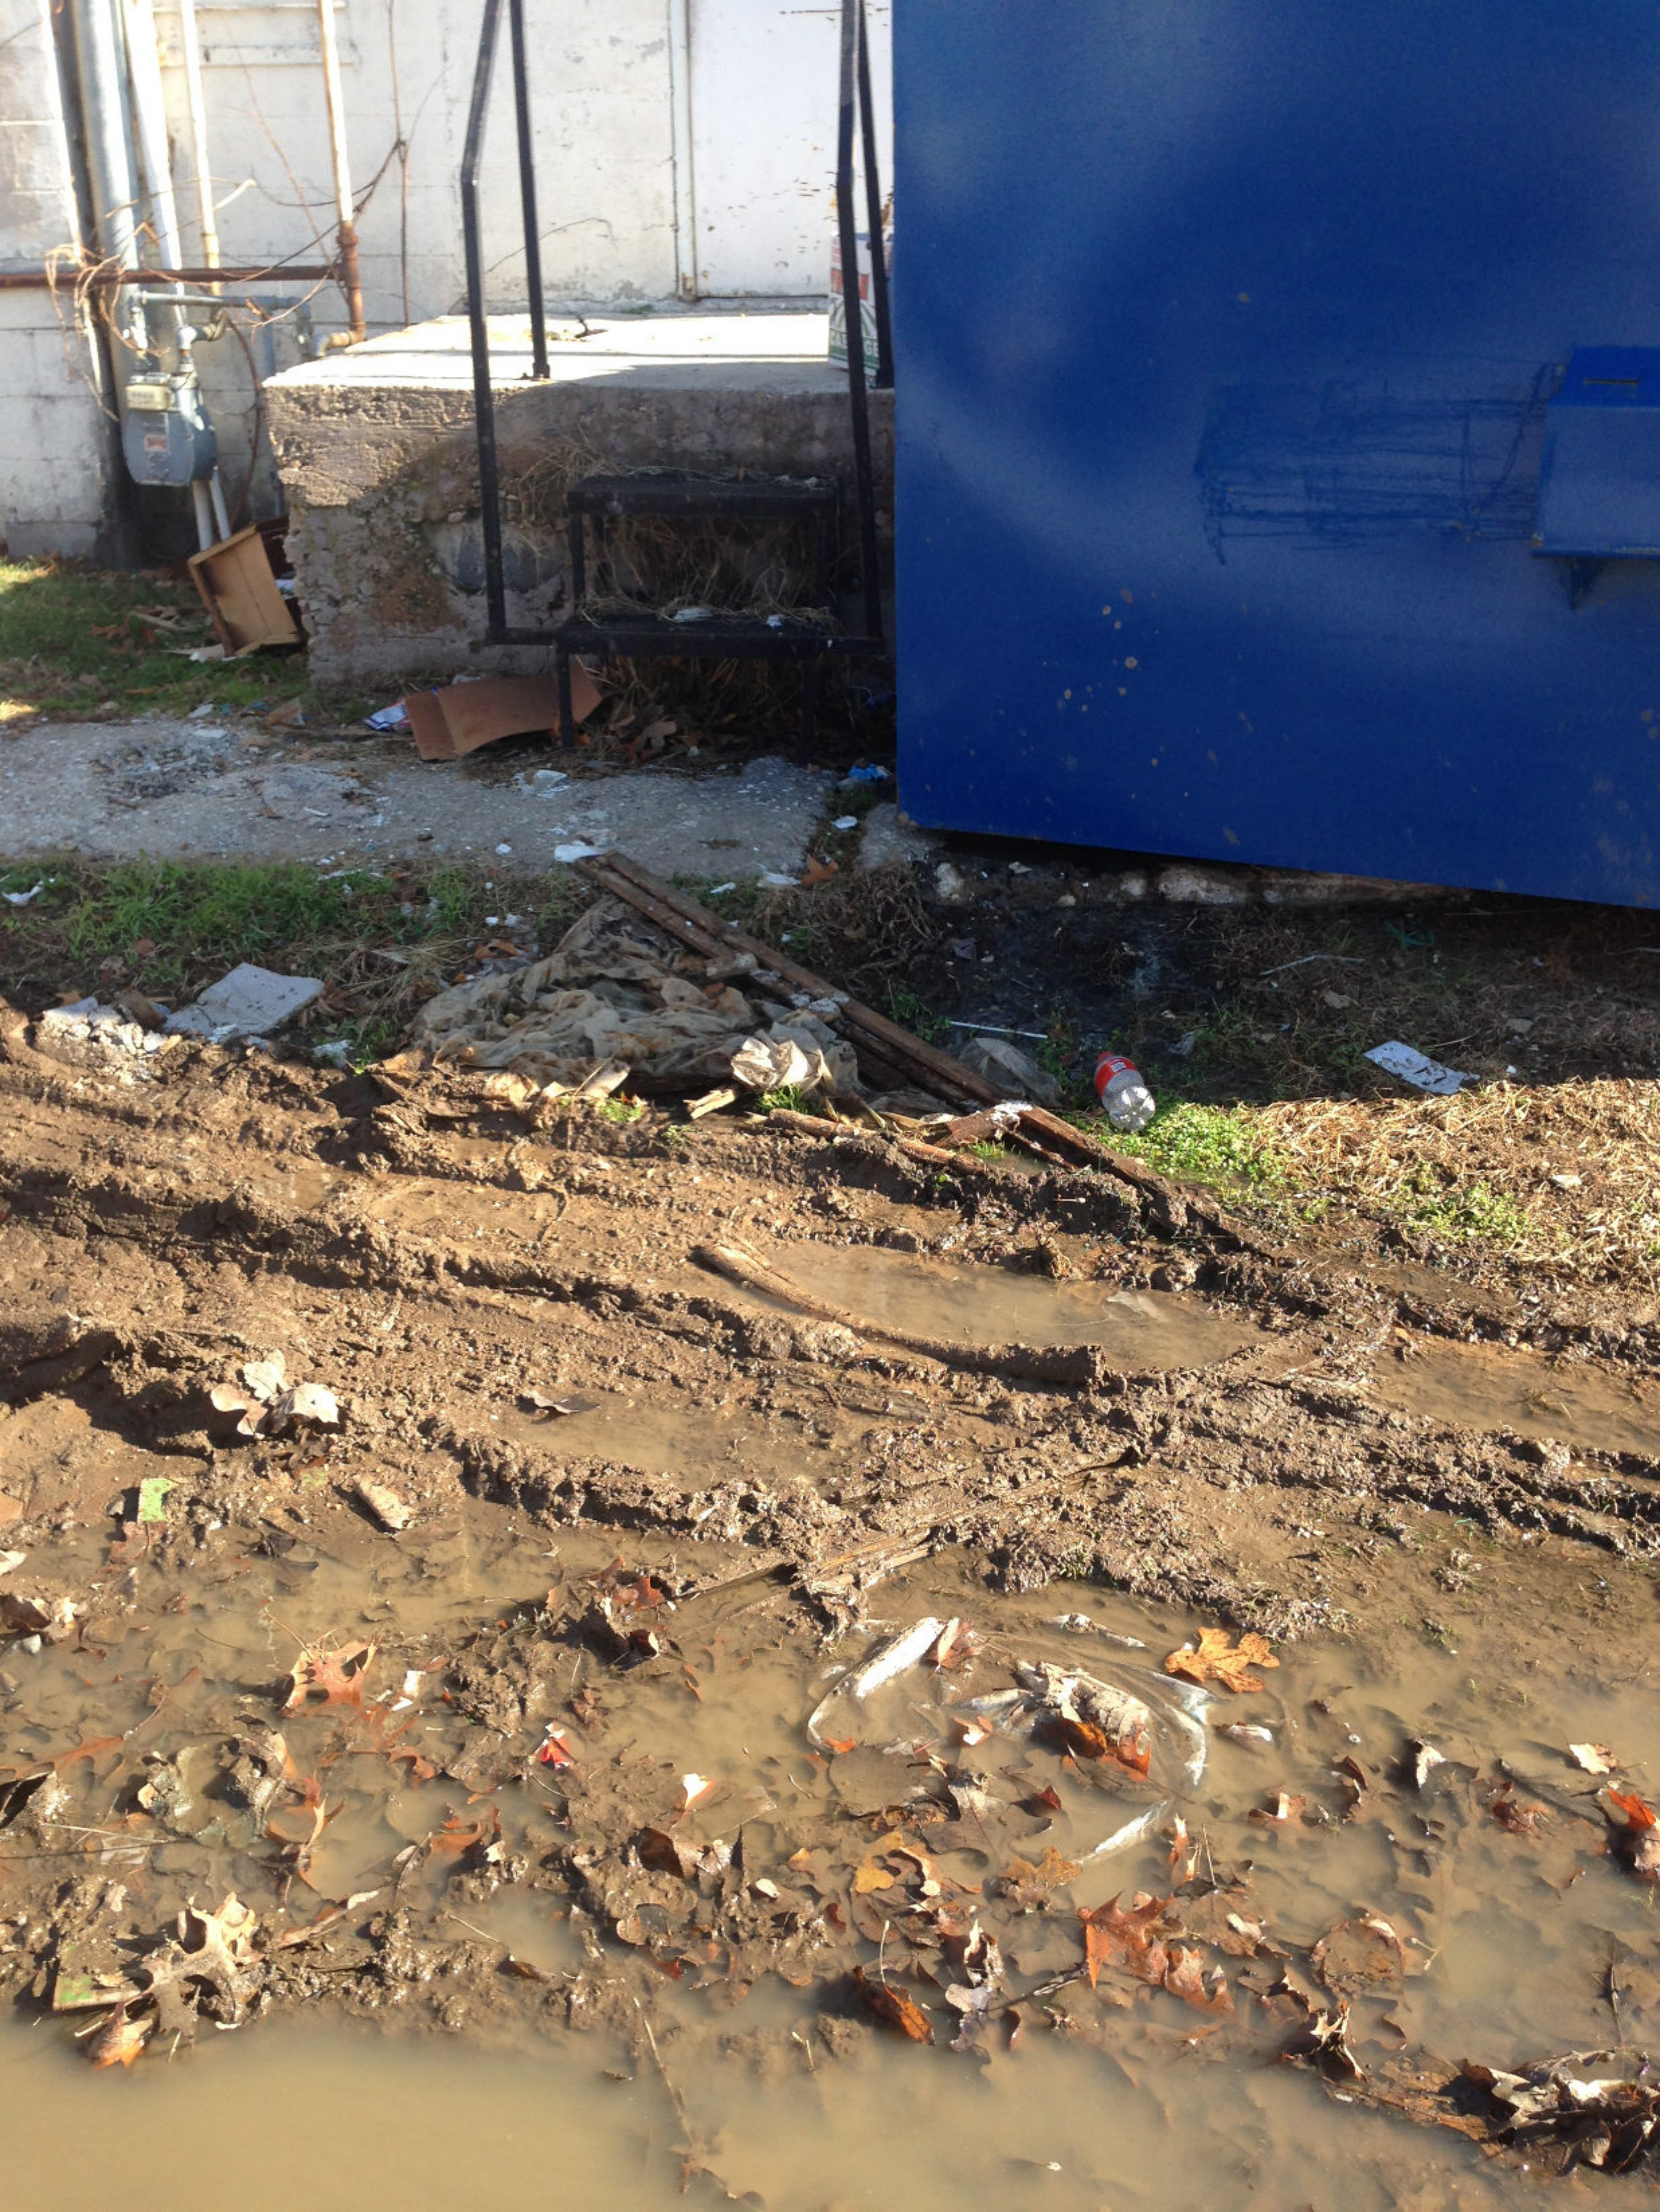
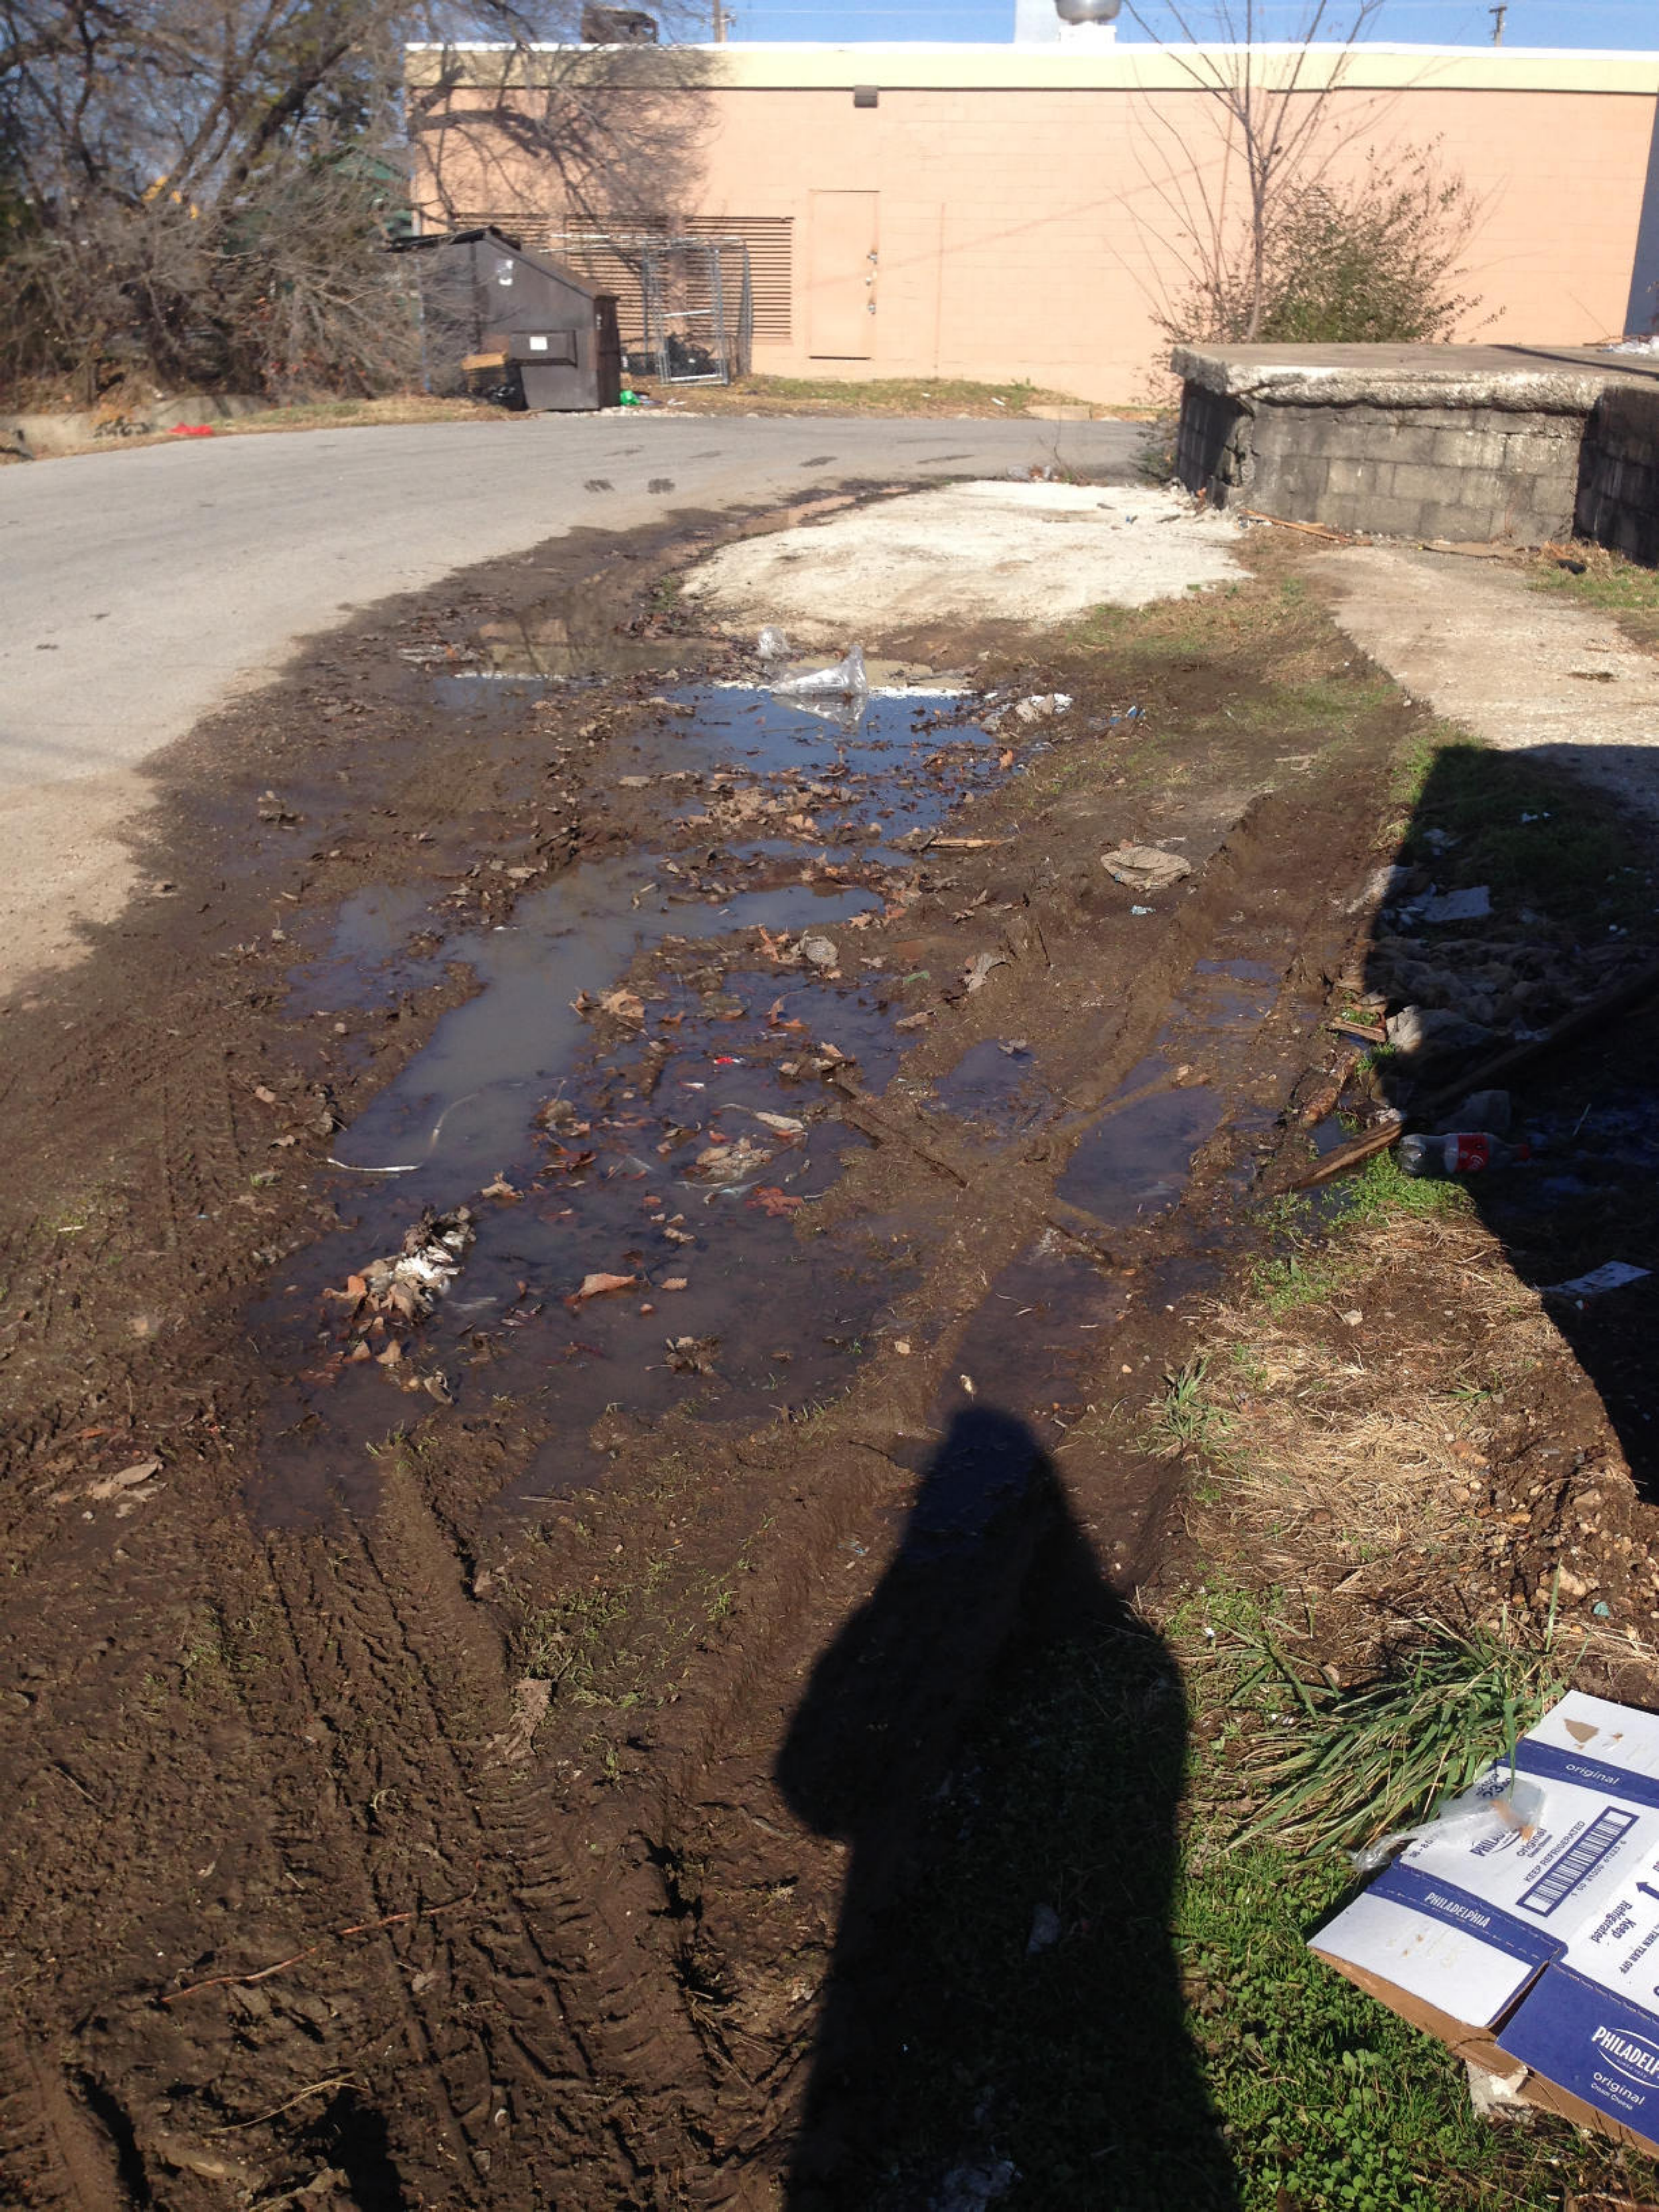
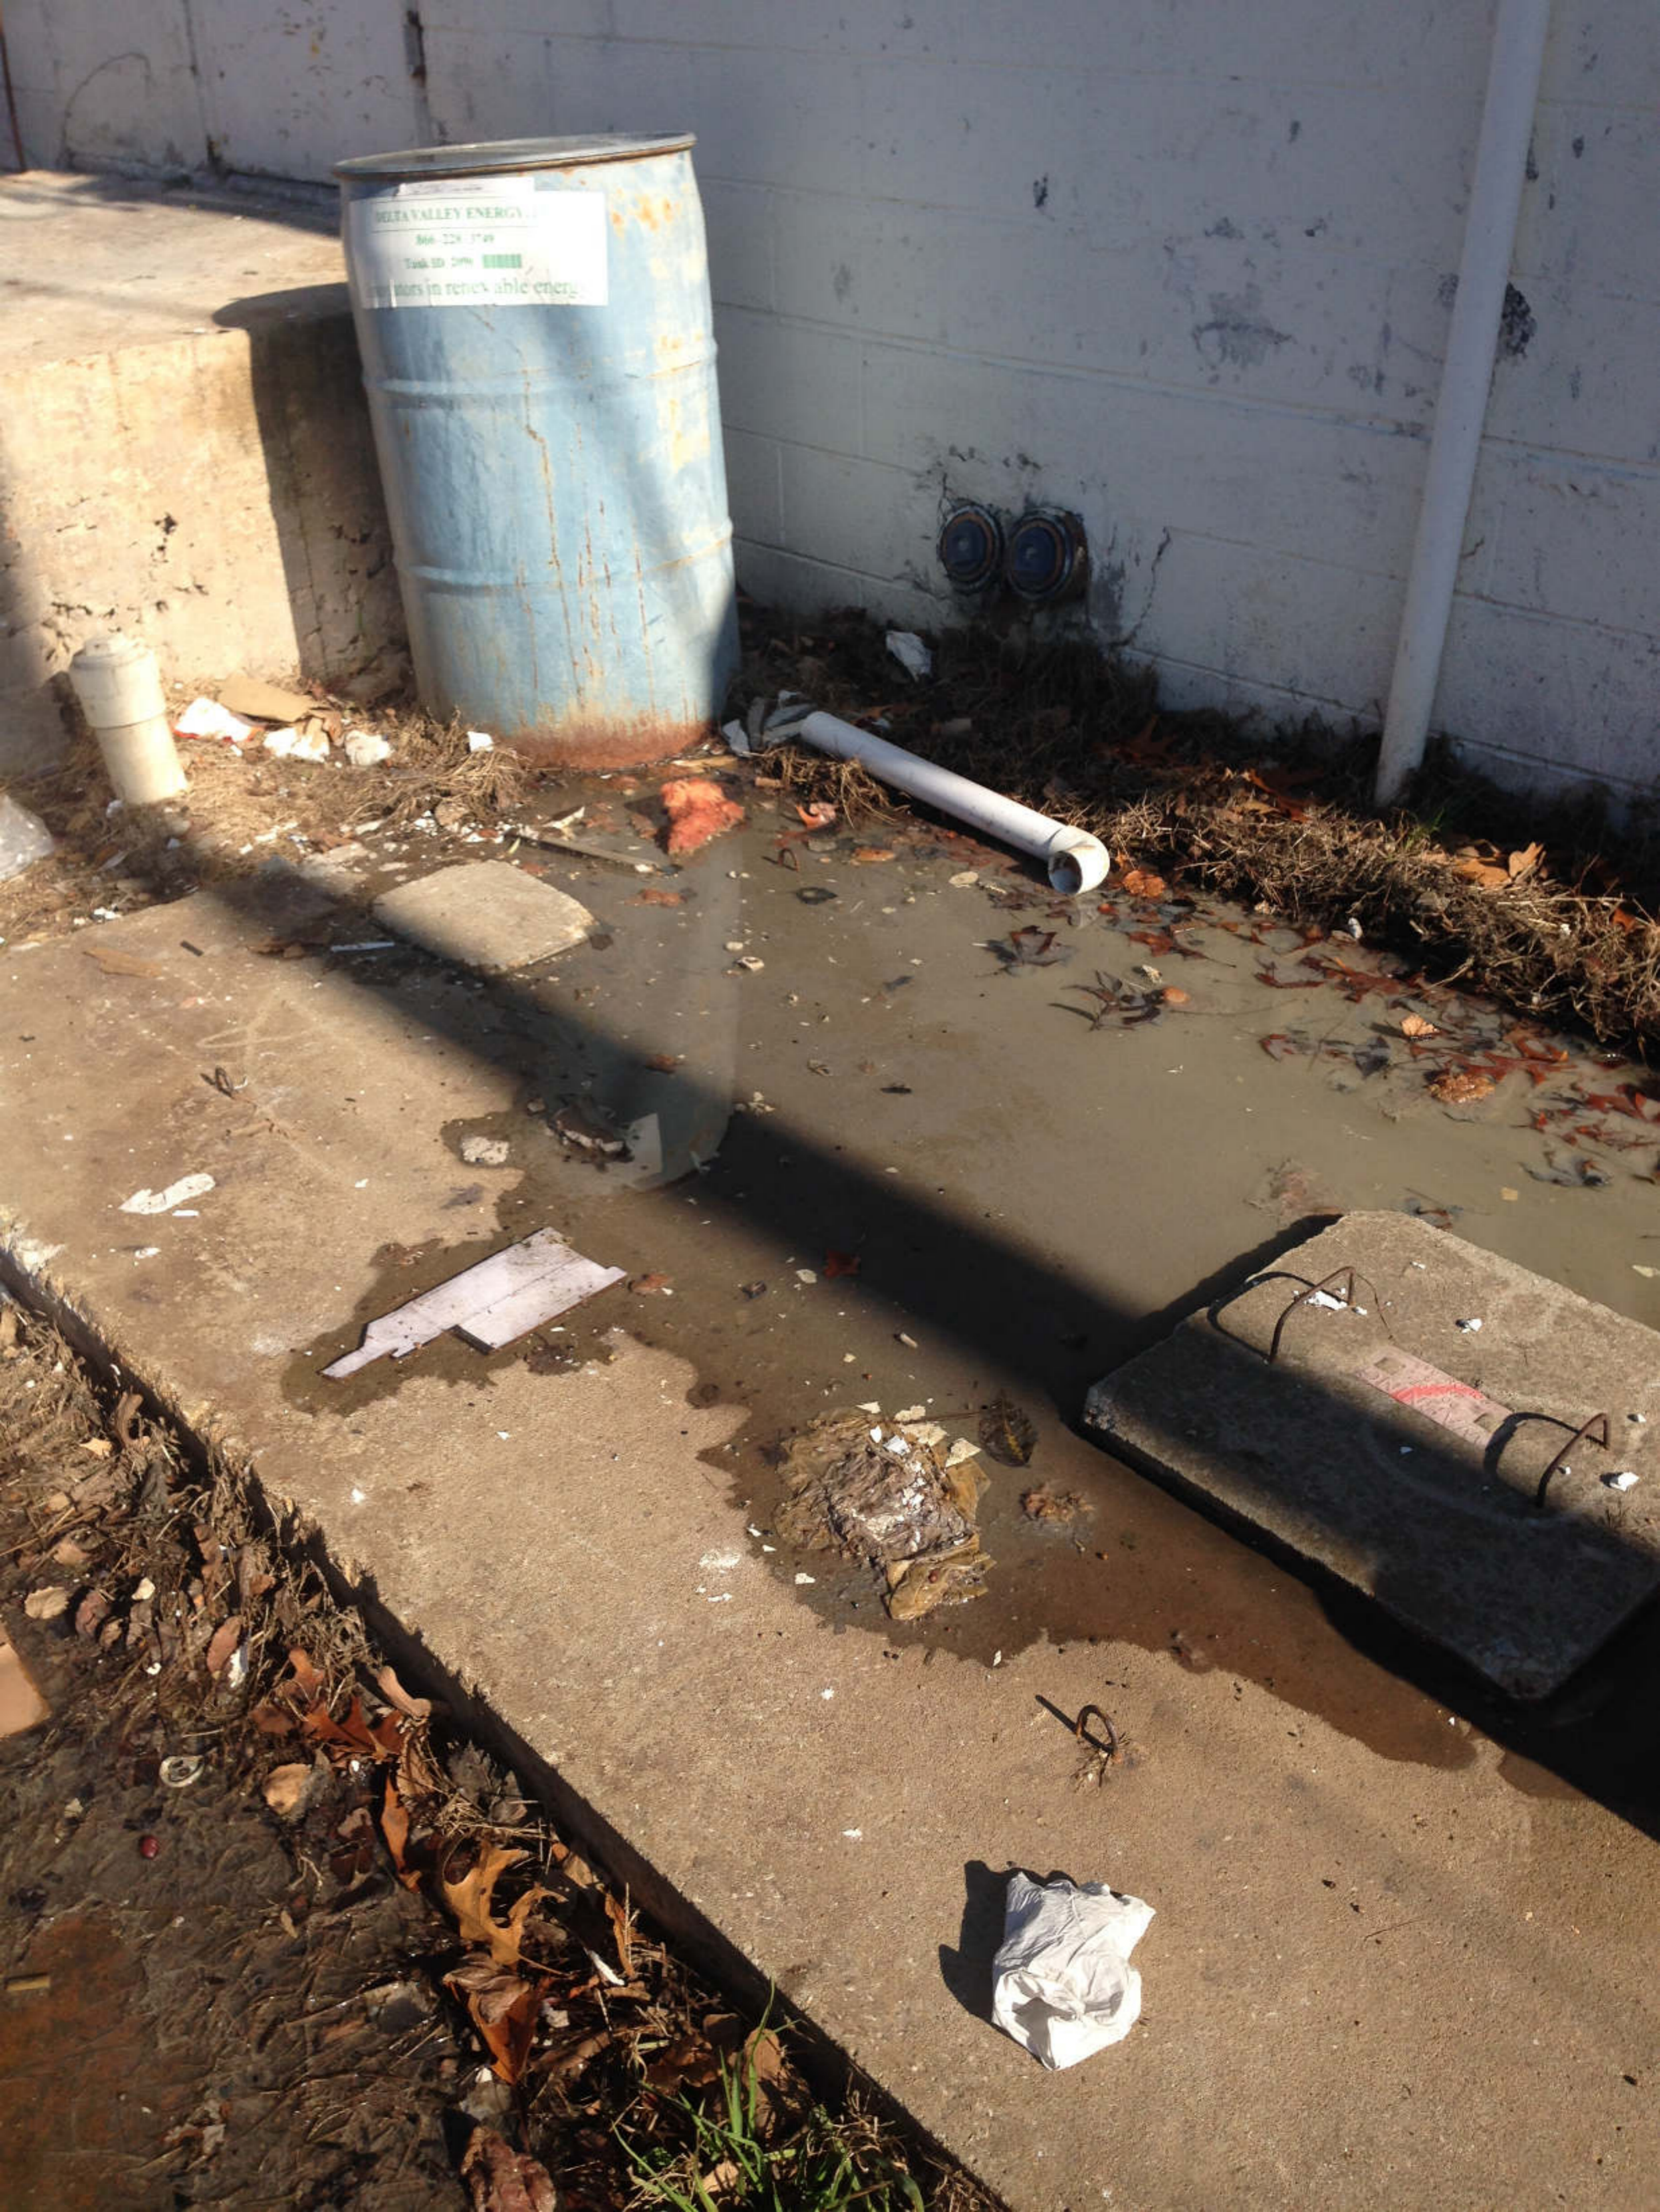
The grease interceptor is overflowing and all of the sewage is flowing into the storm drain.

The whole area is wet with the sewage with trash everywhere.

You can see the layer of grease in the storm drain. Pictures are attached to the e-mail.

Photo details (notes concerning attached photos): Photo 1-11 shows the flow of the water Beginning with the grease interceptor, moving to the side of the road, into the storm drain, And to the other side of the road in the storm drain.

Actions taken: On 11/18, I requested the G.I. be pumped. Pumping was confirmed on 11/20. However, the GI was still overflowing and on 11/25 I requested that a plumber be called in order to determine the problem with the line directly after the GI. This has been requested for 2 weeks. A plumber was called today 12/9 while I was on site.

Additional monitoring recommended: Follow up inspection on 12/11 to confirm plumbing issue is fixed.
