SEWER SYSTEM EVALUATION

FOR CONSENT ADMINISTRATIVE ORDER (CAO) LIS 11-066

WILMOT SEWER COLLECTION SYSTEM & WASTEWATER TREATMENT FACILITY
CITY OF WILMOT, ARKANSAS

DATE: August 31, 2016

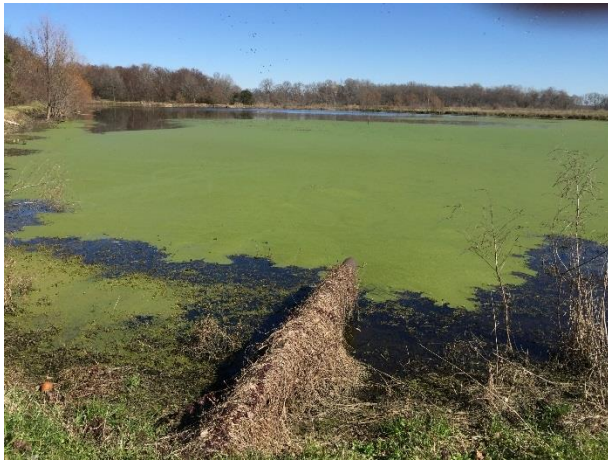
Figure 1 - Original Treatment Pond (Abandoned)

The original sewer pond should be rehabilitated for its use as a high flow storage facility. A new pond connection structure should be installed to allow for high flows to be diverted into the holding pond. Once flows have reduced, the stored volume can then be pumped back into Pond 1 for treatment. A floating pond decant pump should be installed to provide the return of the storage volume to Pond 1 for treatment. The interior levees of the original pond need to be denuded of brush and trees and any issues with rodent burrows should be repaired prior to placement of the road surface material. The levees around Ponds 1 and 2 should also be cleared of rodent burrows and repairs made prior to placement of road surface materials and riprap. A drawing showing the proposed treatment facility improvements has been included as Attachment 6.

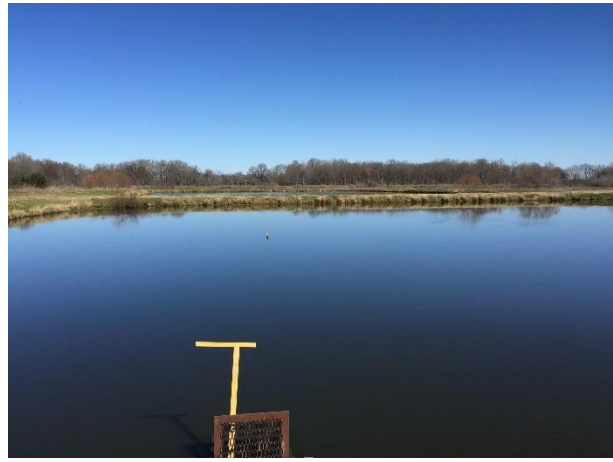
Figure 2 - Ponds 1 and 2 looking north from outlet

Pond 1 and 2 combined have the ability to hold approximately 7.5 million gallons of water (Pond 1 – 4.2 MG, Pond 2 – 2.3 MG). Inspection of the pond levees showed a fair level of deterioration with the most notable problem being the burrowing of rodents into the earth levees. The interior slopes of the ponds lack any riprap protection to prevent wave erosion and burrowing. Burrows did not appear to extend below the water surface, but several burrows were observed on the tops of the existing levees. The outlet structure is still functioning but a temporary flow measuring device was being used as the original appeared to be missing. No data logging of flows is present.

We are recommending the installation of four (4) 7.5 HP floating aerators be installed in Pond 1. These aerators will provide the aeration needed to reduce the BOD to below permit limits. A new pond connection structure will be installed between ponds 1 and 2 to control the transfer rate between ponds. Pond 2 will be used as a settling basin. The type aerators proposed should not cause upheaval of sediment on the pond bottom and thereby not cause an increase in TSS. Baffling can also be installed in Pond 2 to increase the travel distance inside Pond 2 to allow for additional settling.

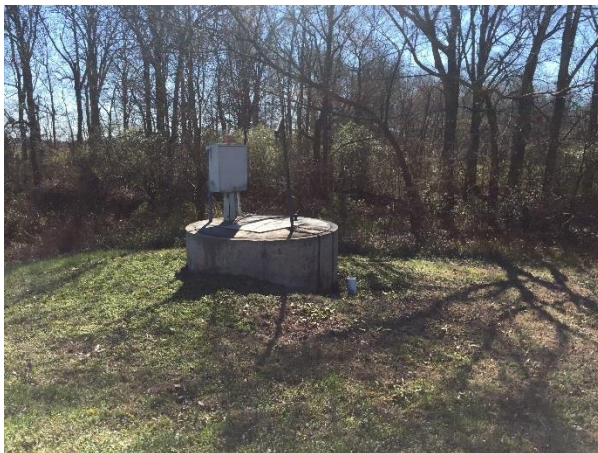
Figure 3 -Existing Effluent Pump Station

The existing effluent pump station appeared to be in good working order and did not show signs of any previous malfunctions. The associated control panel was also in good working order. The existing chlorine treatment building and equipment is dated and uses chlorine gas as the chemical delivery method.

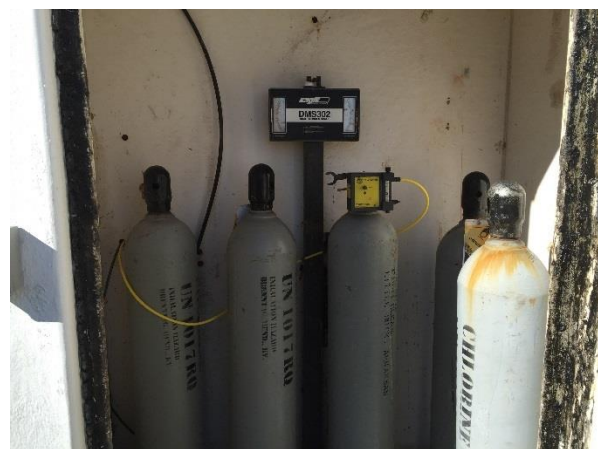
Figure 4 -Interior of existing chlorine building

We also recommend a new package chlorine disinfection system to replace the existing chlorine system building. A new package system will replace the feed controls and feed line to make the disinfection system reliable.

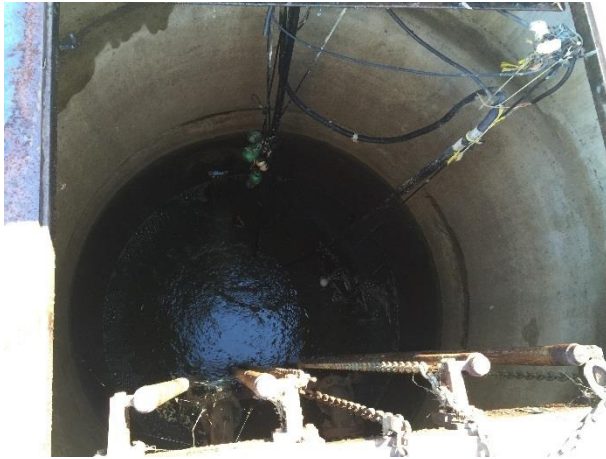
Figure 5 -Interior view of existing pump station

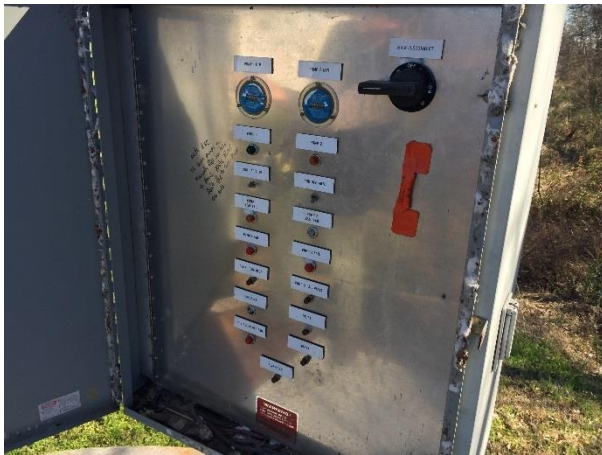
Figure 7 -Interior pump station control panel

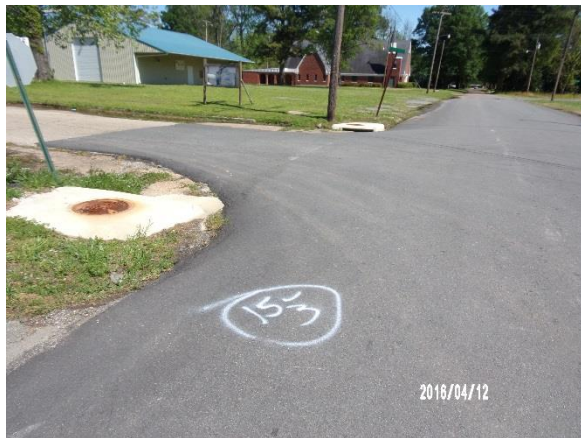
During the field survey portion of the CSE it was discovered that a significant portion of the manholes on the system have been paved over during street rehabilitation projects. This made the manholes inaccessible for inspection. Using the records available and a metal detector, the Engineer was able to locate the majority of the covered manholes and mark them in the field.

Figure 8 – Example of covered manhole

As previously stated, there are 73 manholes that have either been paved over or inaccessible. The lids of these manholes need to be uncovered and the ring and lid raised to grade. The 6 existing manholes that have lids below grade in wet areas also need to be raised to prevent intrusion of storm water into the system. Once the inaccessible manholes are raised to grade, another round of smoke testing should be conducted to locate problems in the untested areas. Approximately one leak was found for every 1500 linear feet of main in the portion of the system that was tested. This suggests that an equal number of problems will be found in the remaining 50 percent of the system that was not tested. A list of the problems found in the smoke testing was provided to the City and they were to begin correcting the issues immediately.

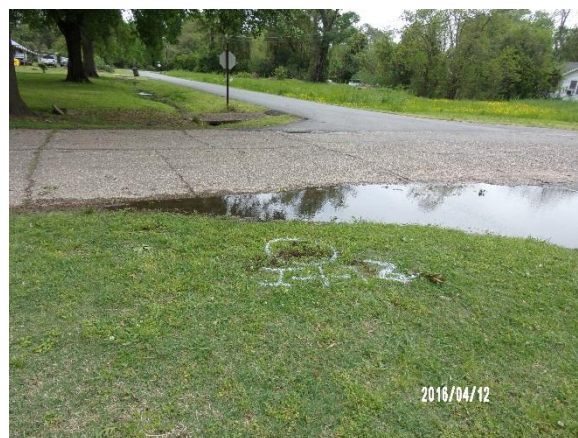
Figure 9 -Example of low manhole lid

A copy of the Wilmot system map is enclosed in Attachment 4. The Wilmot system has a total of 118 manholes. Of the total, 73 of the manholes were covered and not accessible, leaving only 45 that were accessible for inspection. The majority of the manholes inspected were clay brick that had been grouted over with concrete. All of the inspected manholes were in fair condition and no noticeable infiltration through the walls. Several of the inspected manholes are located in grassy areas. The majority of the manhole lids were at grade and not subject to intrusion around the lid. There is a total of 6, such as the one shown in Figure 9, that are located in low areas that they have become buried with soil and grass and or so low that are subject to intrusion.

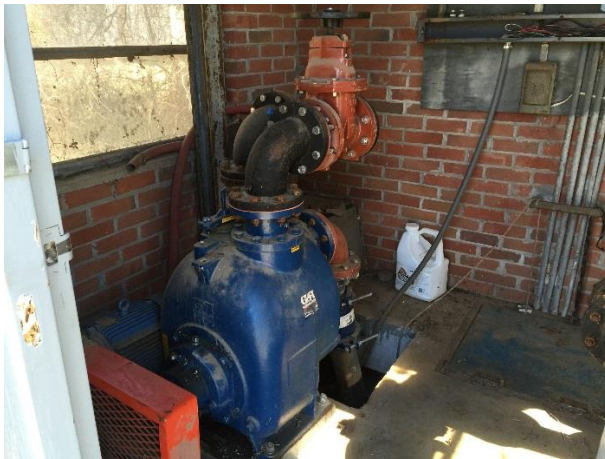
An inspection and evaluation of the existing lift stations was conducted as part of the overall system evaluation. Both of the stations utilize self-priming type pumps mounted over a wet well which were operating nosily, indicating excessive wear. Several safety issues were noted at each lift station including open hatches either without covers or not properly secured. The controls and power supply panels are old and in poor working order. Fuse boxes did not have covers and working conditions inside of the stations are not safe. Access to electrical panels does not meet code and the hazard serious injury is high.

Figure 10 - Interior of Lift Sta. 2

Both of the collection lift stations are dated and in disrepair. The structures are old and while the controls are still functioning, they contain several safety issues for workers performing maintenance or repairs to the stations. We therefore recommend the installation of two new duplex submersible lift stations and wet wells. The existing station can stay in operation until the new units are installed and operational. At that point the influent can be rerouted into the new stations and the old pumps, building and wet well be demolished. A drawing of the proposed pump station rehabilitations is included in Attachment 7.

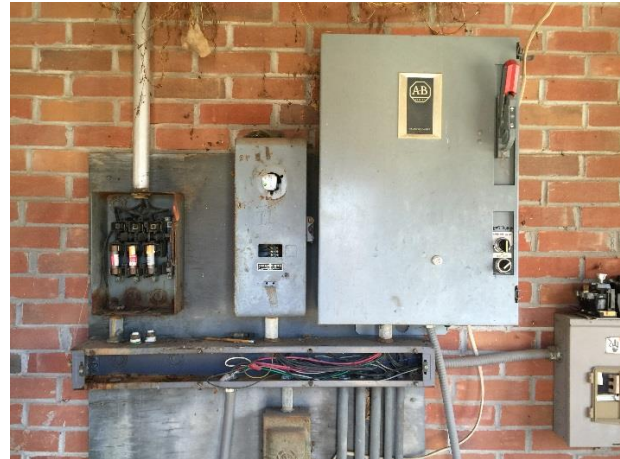
Figure 11 – Control panel at Lift Sta. 1

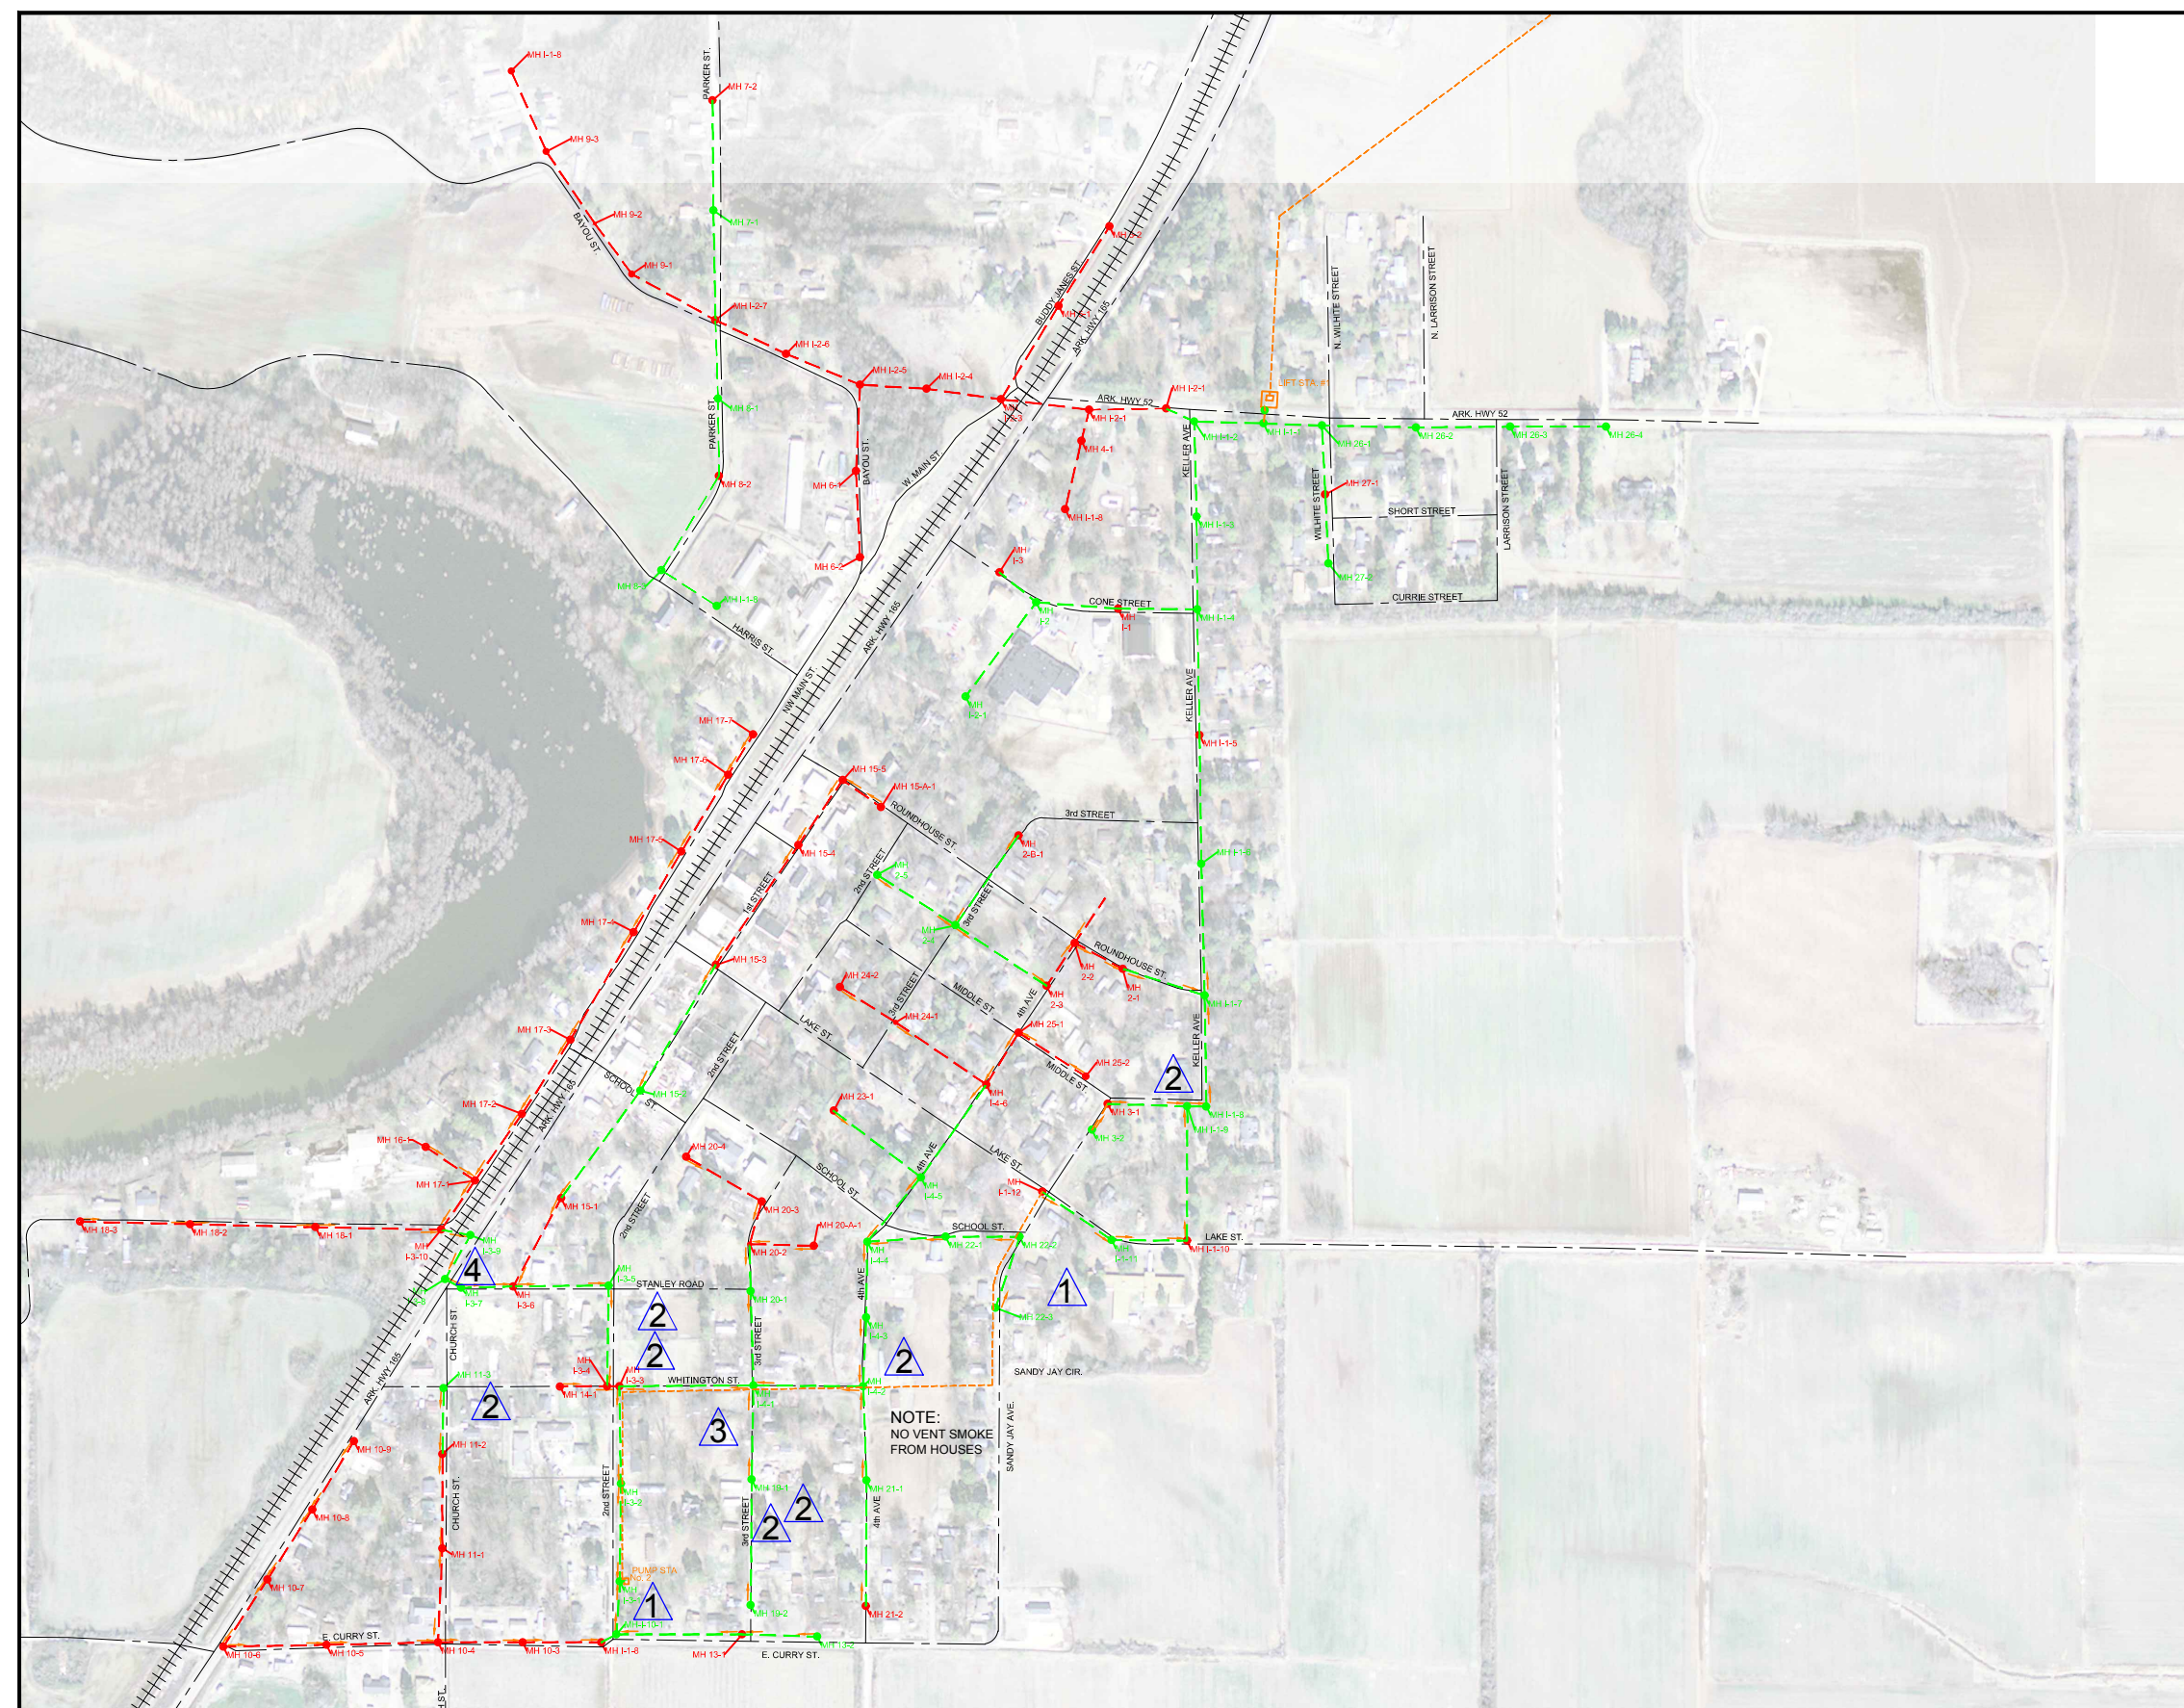
MANHOLE INVENTORY MAP
SMOKE TEST FINDINGS
CITY OF WILMOT, ARKANSAS

As previously stated, only 45 of the system manholes were accessible or not paved over. Smoke testing of the system was conducted utilizing these 45 manholes. Using these manholes over 50 percent of the system was able to be smoke tested. The smoke testing of 16,401 linear feet of main produced a total of 11 sources of infiltration detected. The majority of the problems found were open services that had not been capped but one large open main intrusion was also located. A copy of the smoke test findings map with locations of problems found has been included as Attachment 5.
