### Site Visit Report

**Facility Name:** Georgia-Pacific, LLC – Crossett Paper Operations

**Permit Number:** AR0001210

**Date of Site Visit:** August 4, 2015

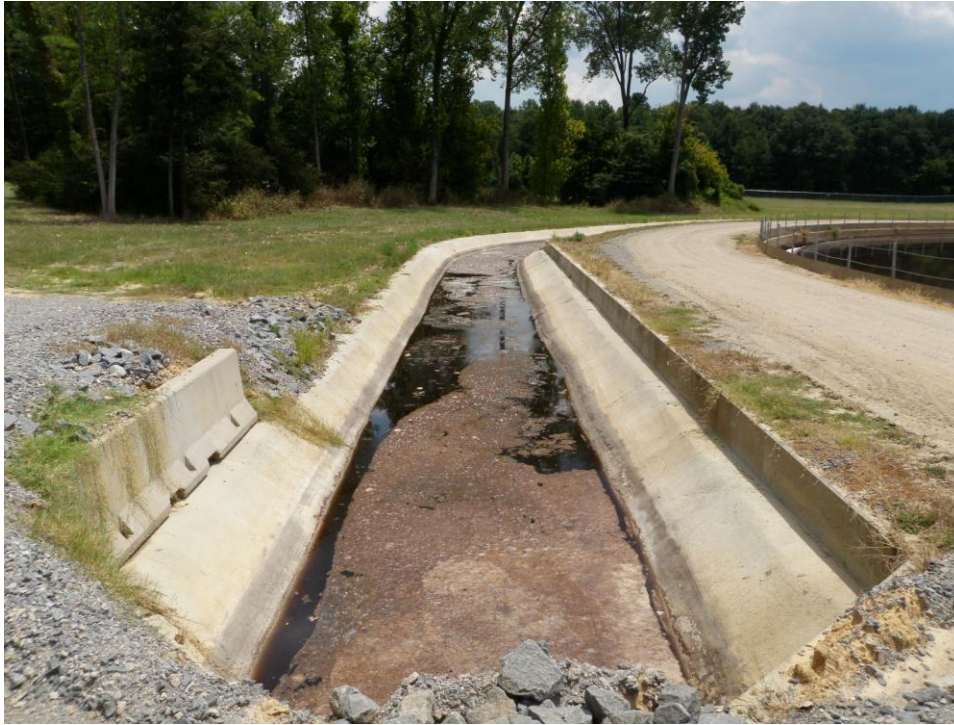
Clarifier Bypass. This is used only in emergency situations.

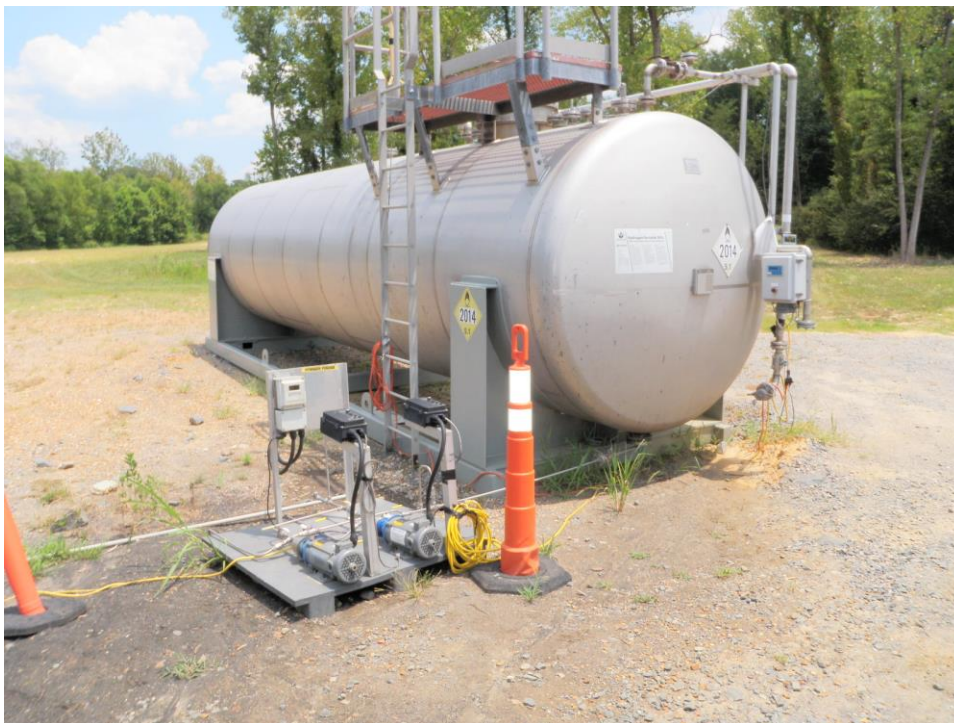
Hydrogen Peroxide and Iron catalyst feed system at clarifier.

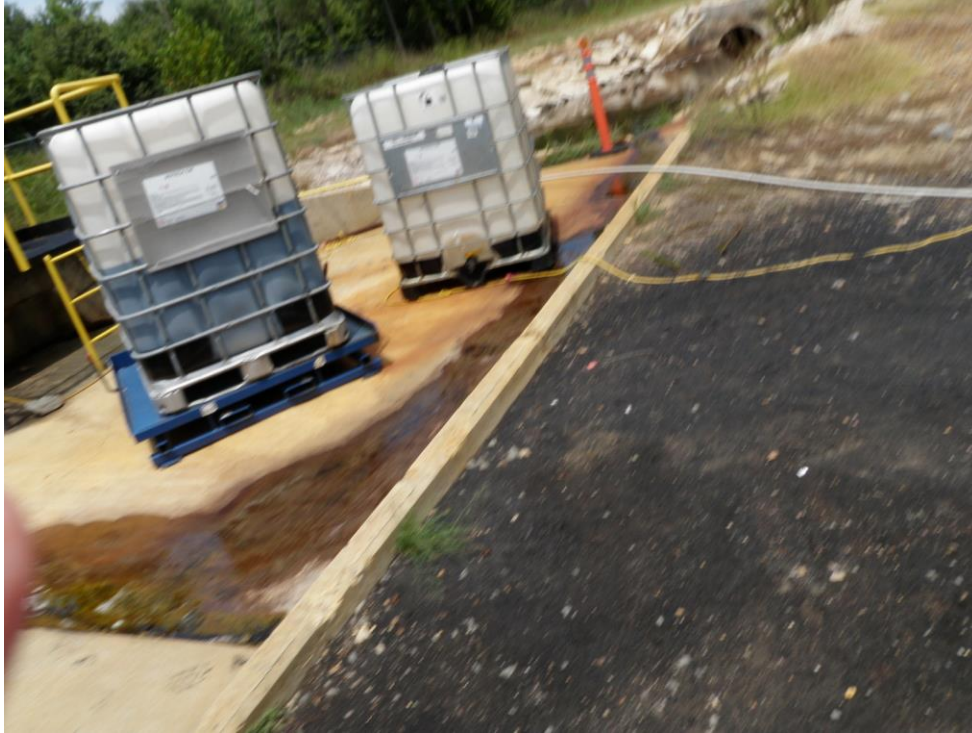
Hydrogen Peroxide and Iron catalyst feed system at clarifier.

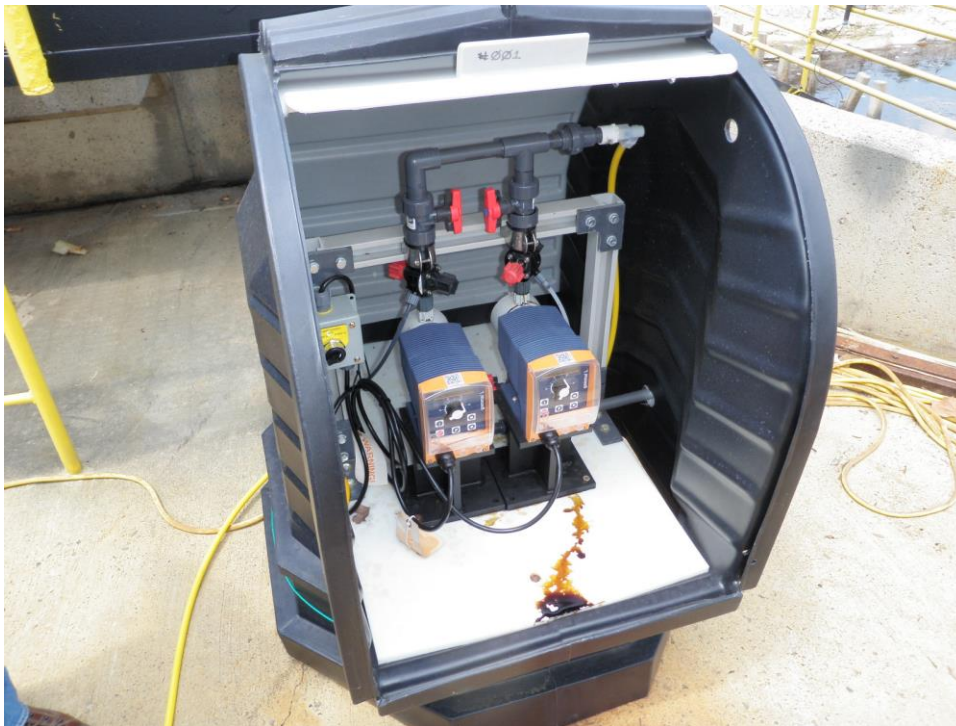
Pumps for feeding Hydrogen Peroxide and Iron catalyst at clarifier.

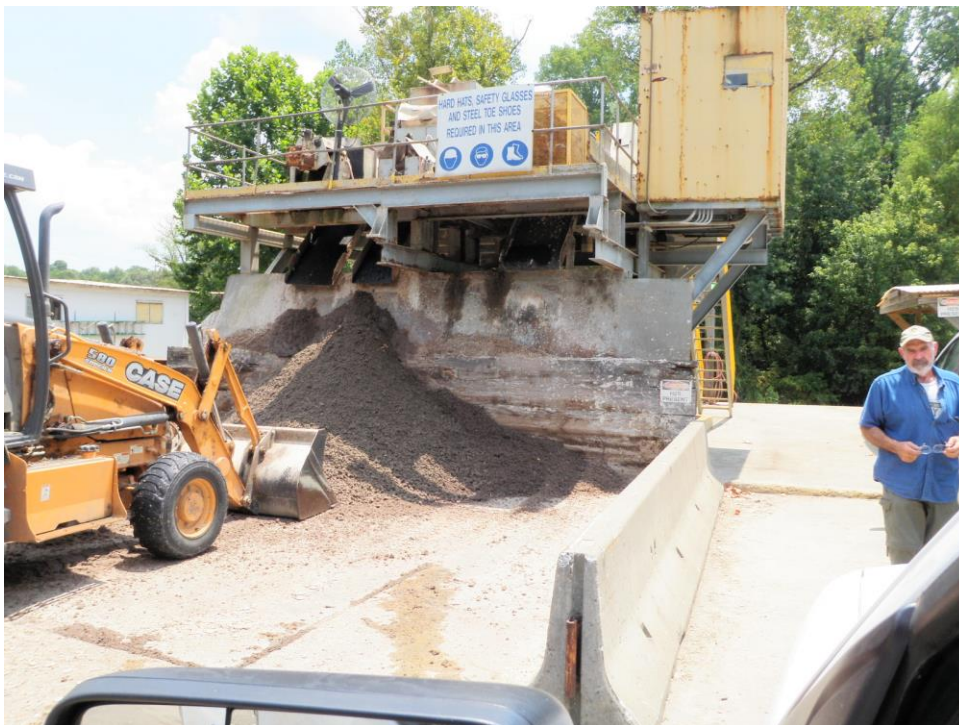
Dewatering of solids from the clarifier

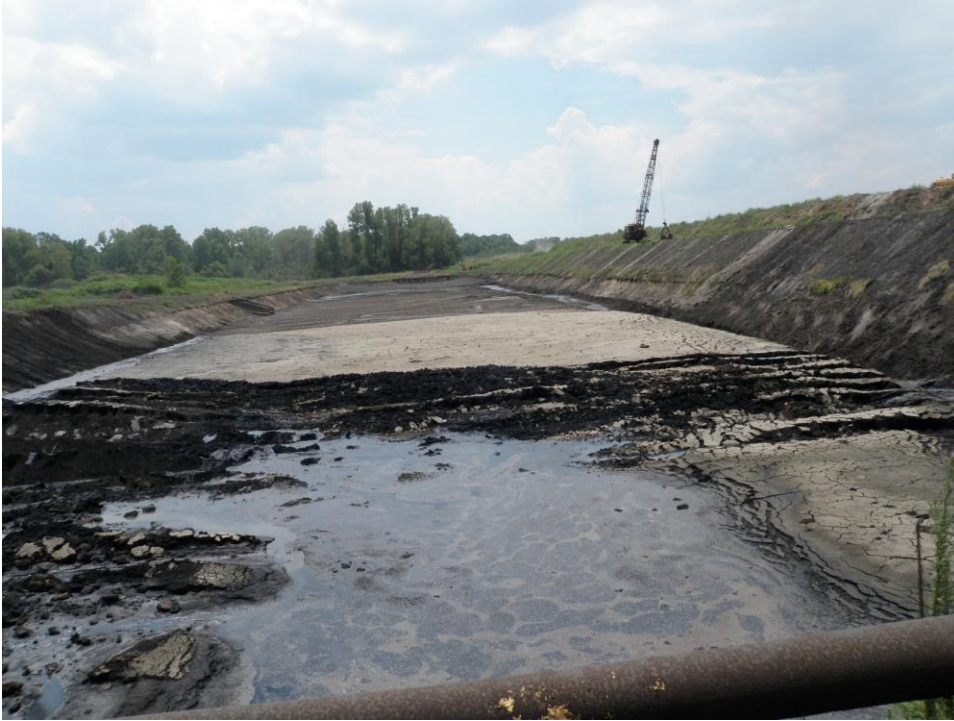
West Ash Pond – permittee is in the process of cleaning out solids

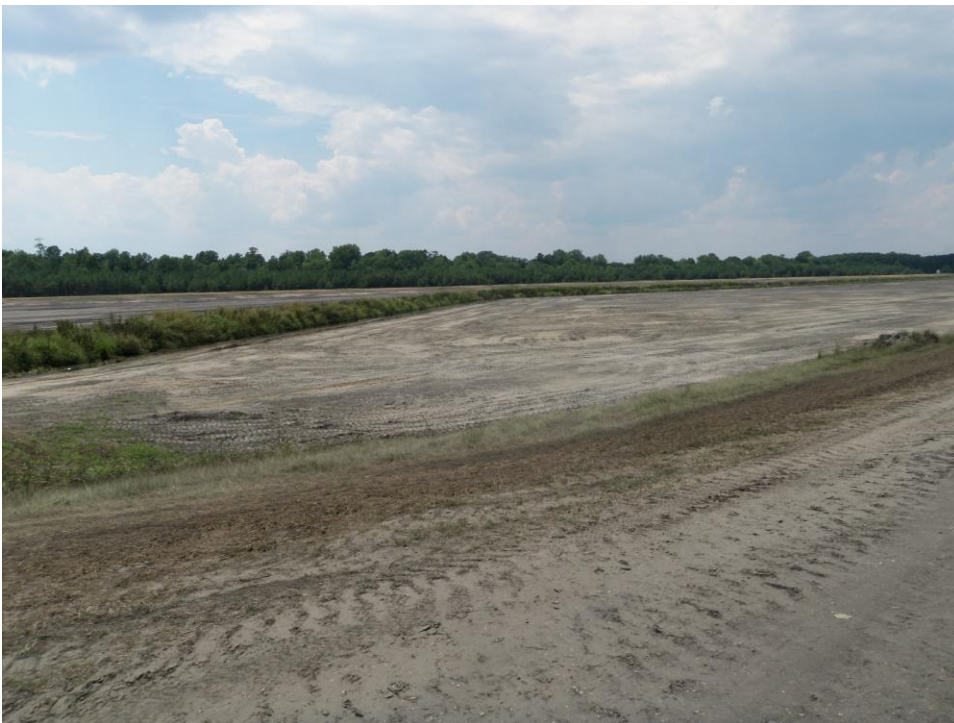
Empty Surge Basin

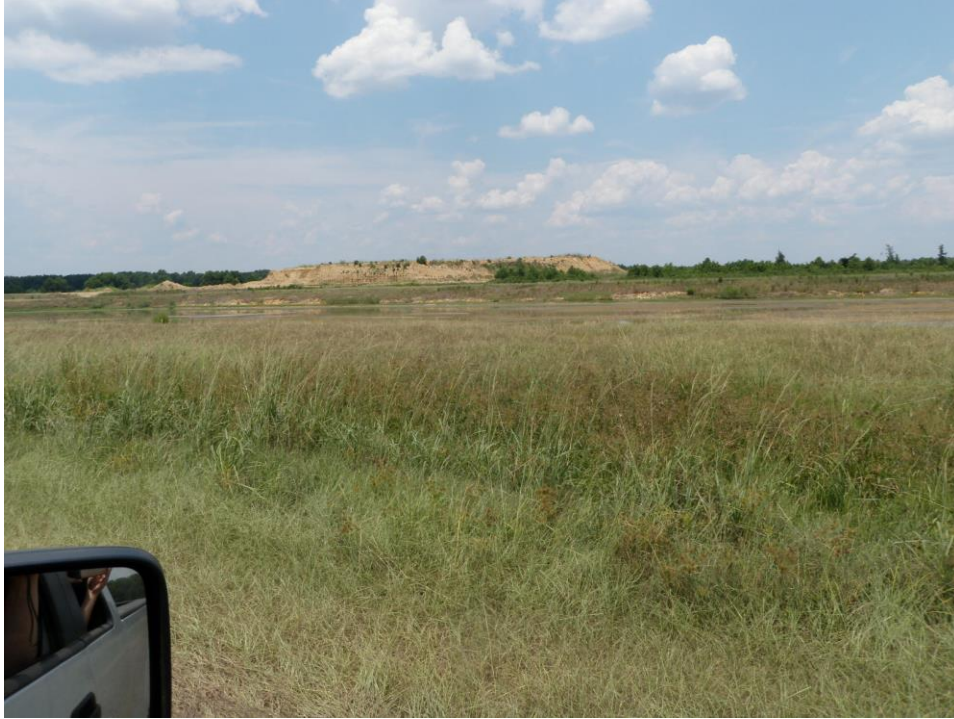
Second Empty Surge Basin

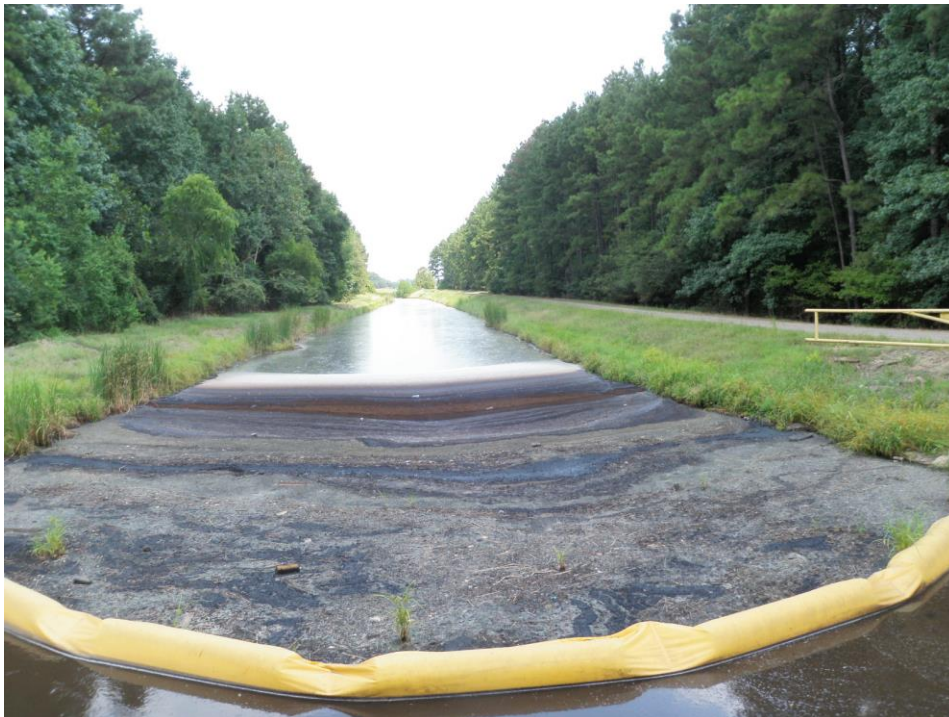
Channel from Surge Basin to ASB

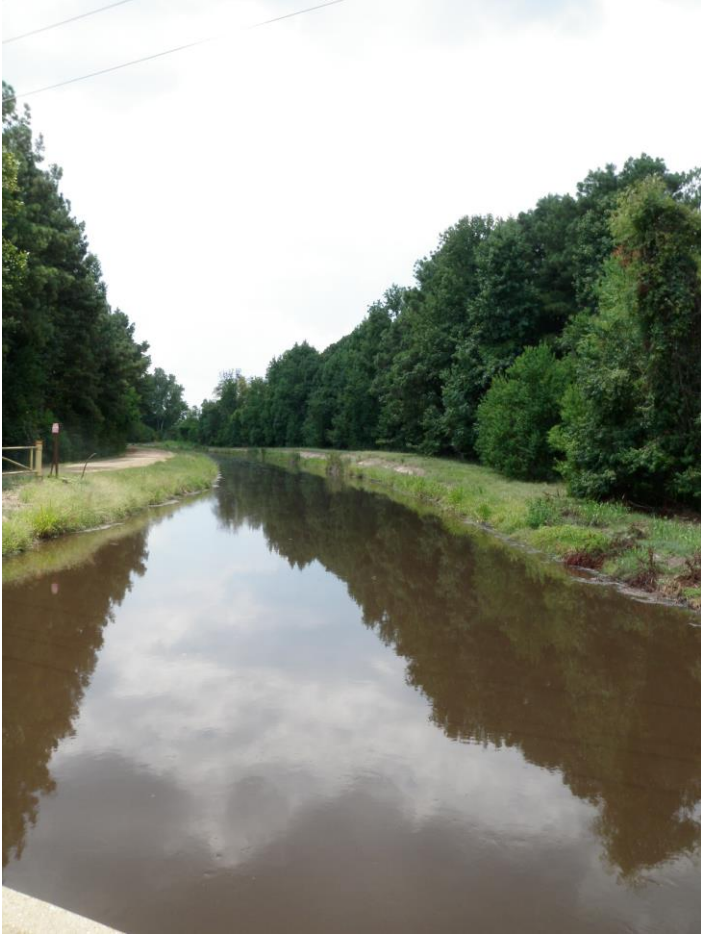
Surge Basin Channel looking towards ASB

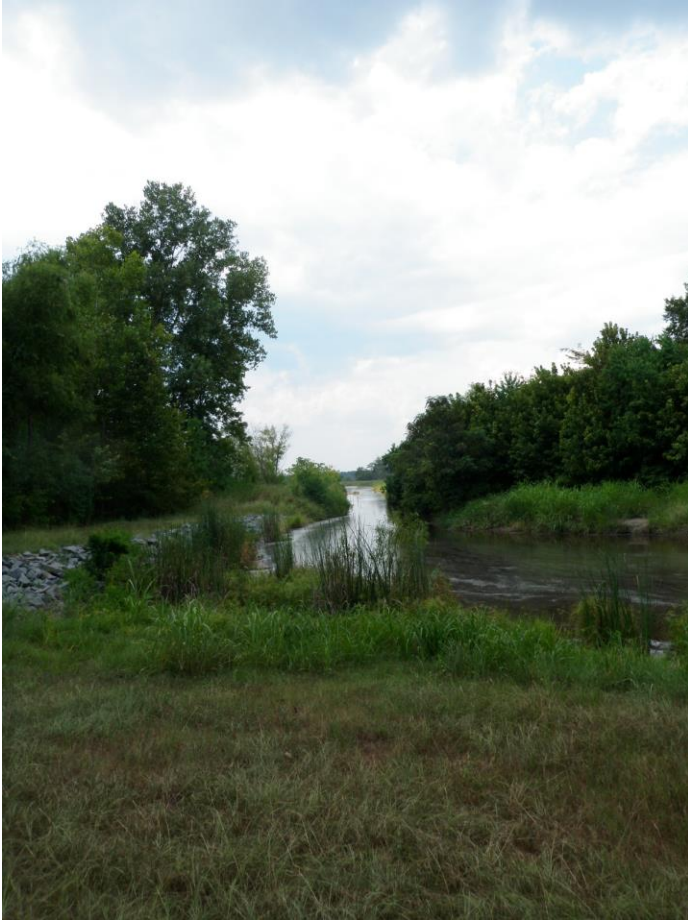
Surge Basin Channel turning towards ASB

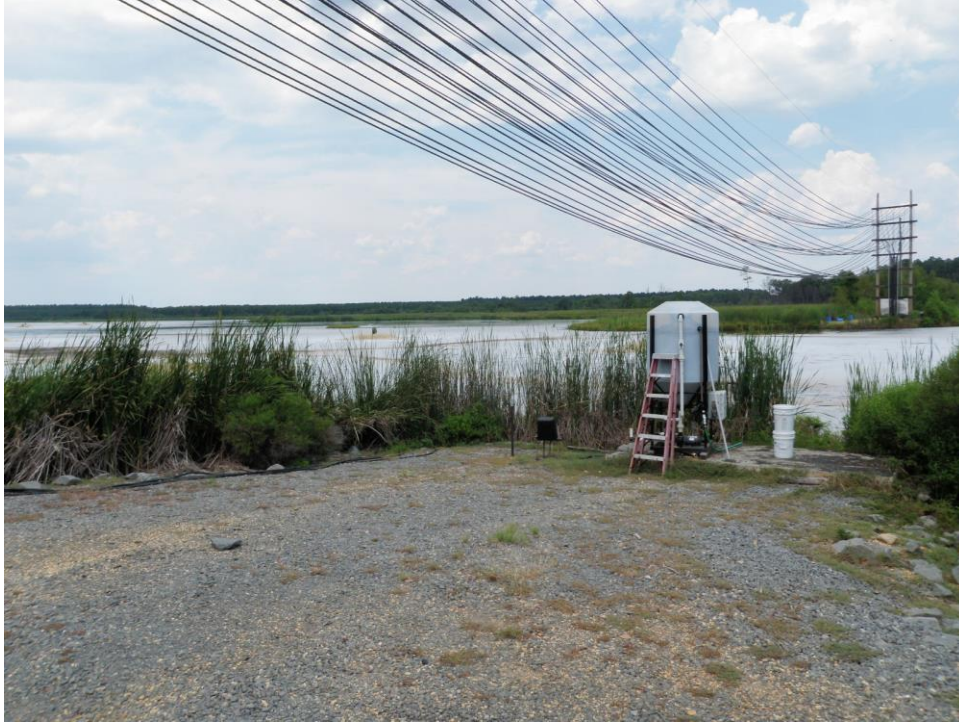
Upper ASB with bacteria feed system

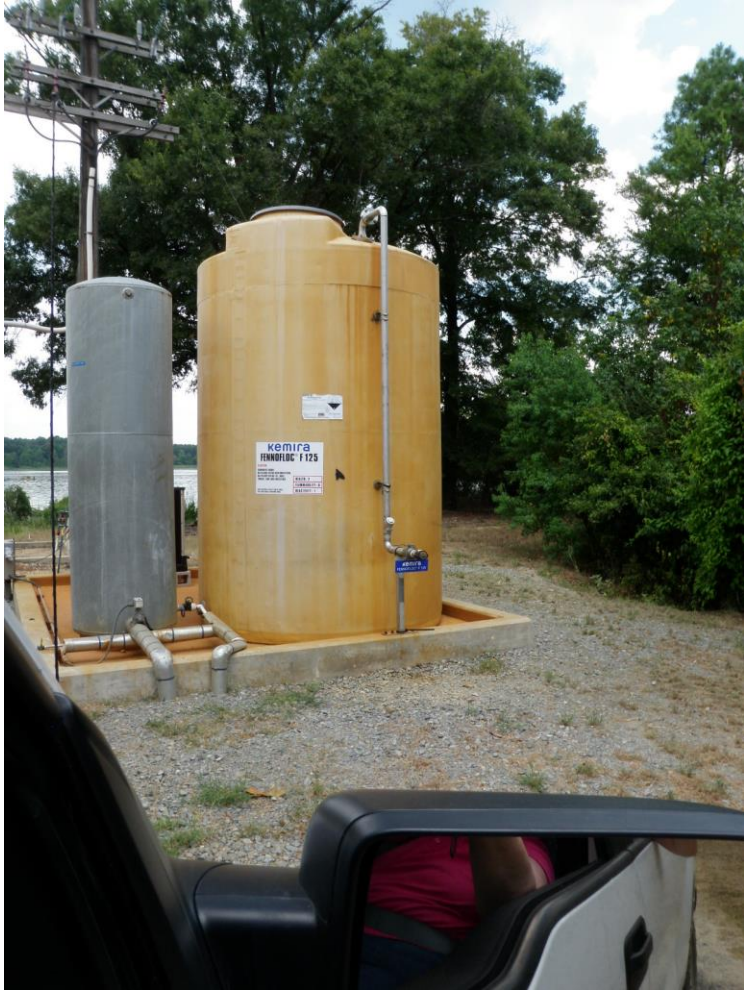
Tanks for Iron feed at ASB

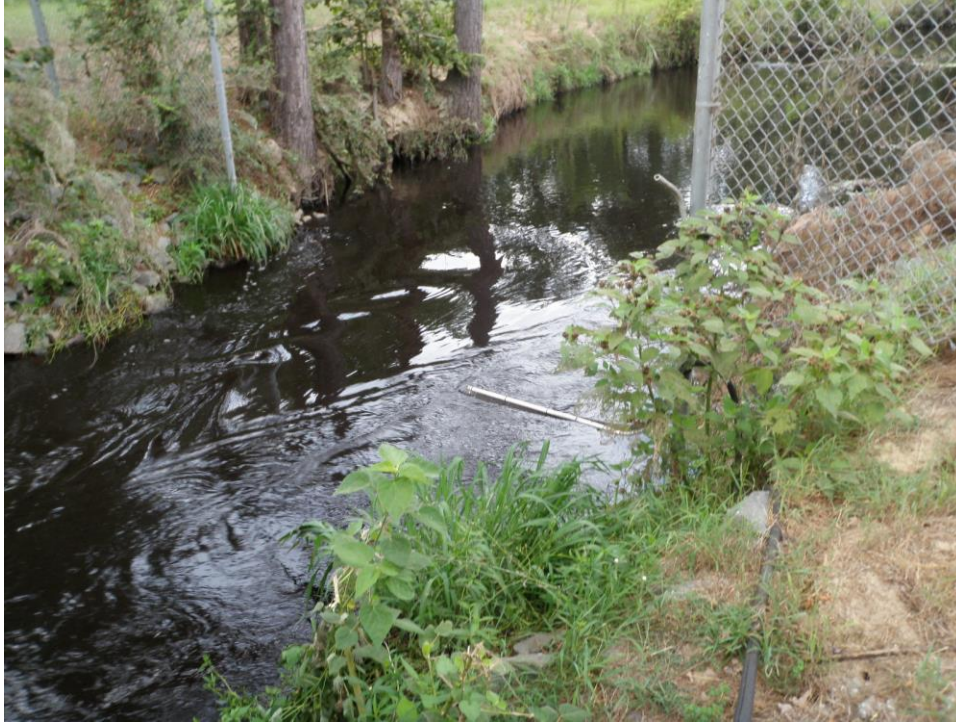
Defoamer addition at Outfall 001

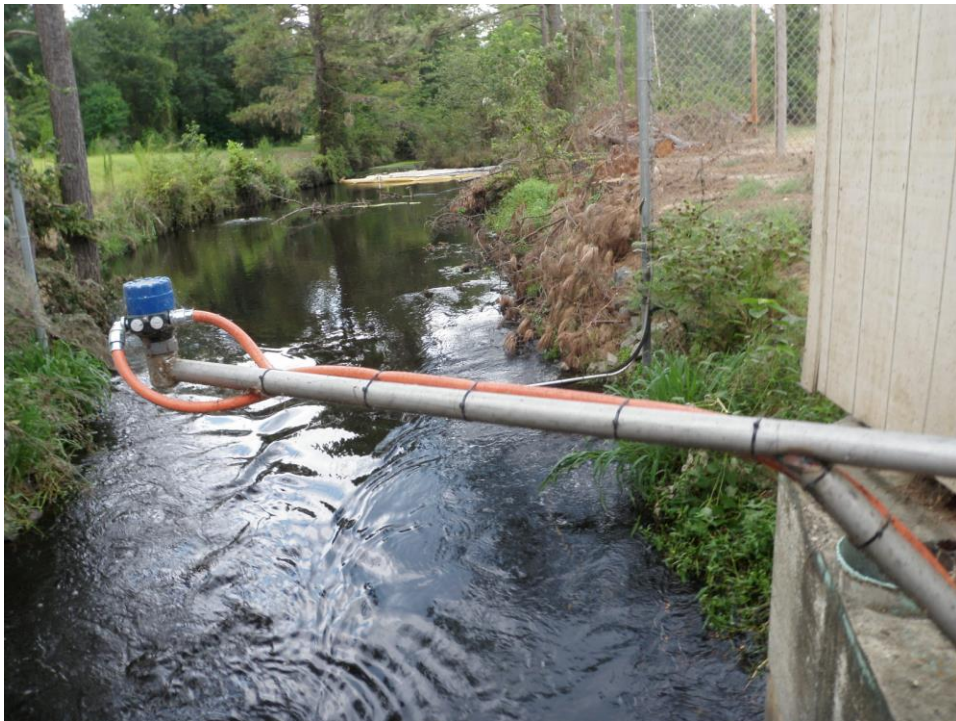
View at defoamer addition looking towards ASB and foam curtain

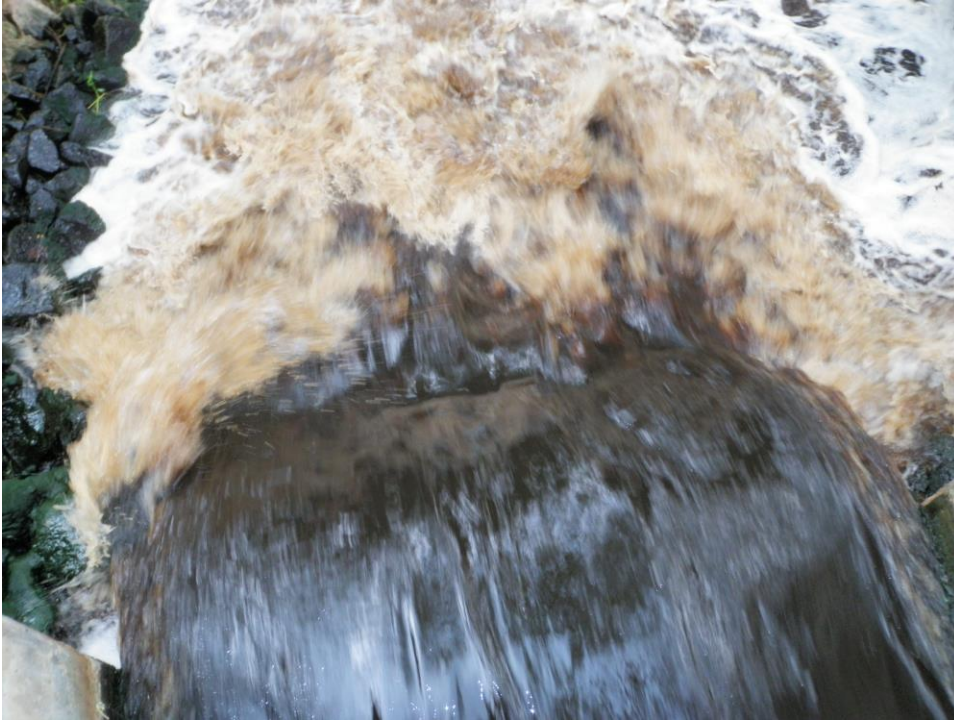
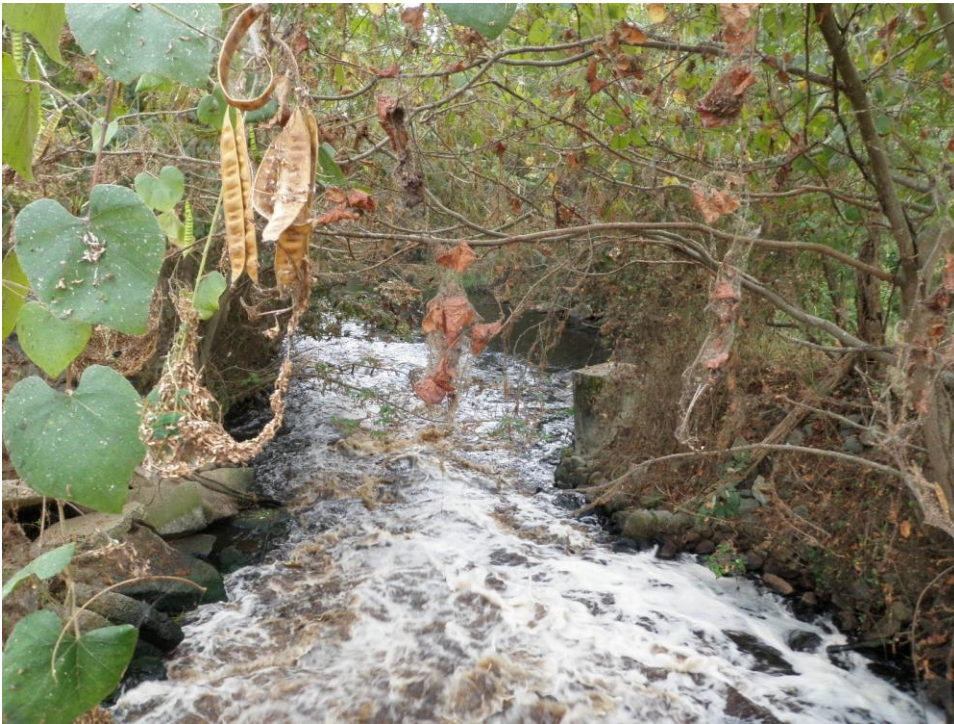
Pictures at Outfall 001 – foam is caused by change in elevation and quickly dissipates.

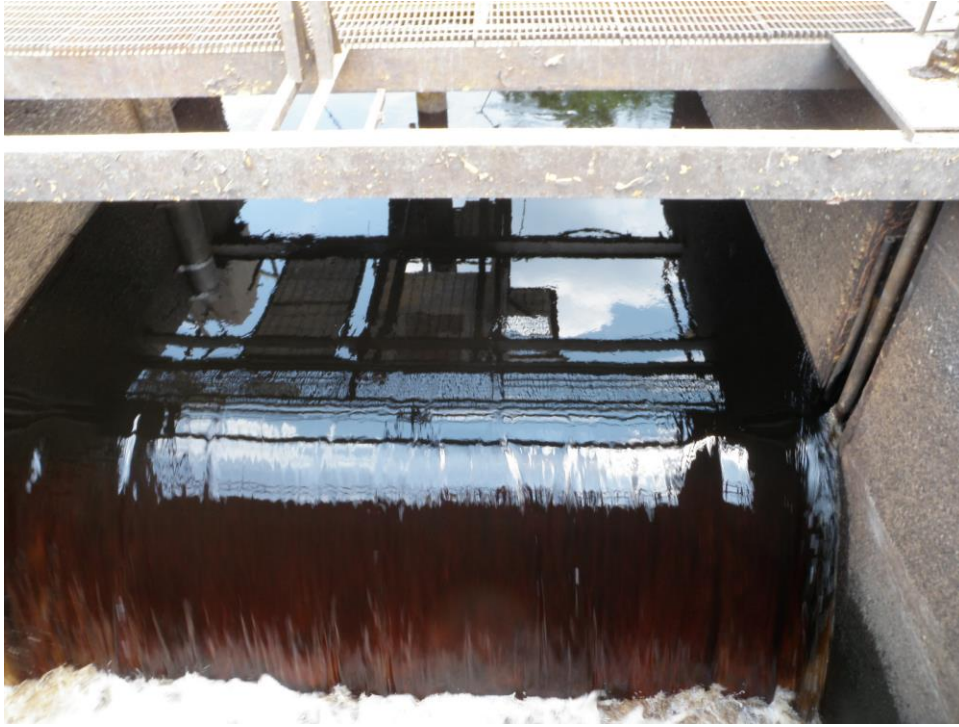
Outfall 001 – effluent flowing off the edge is causing foam to appear in the stream but the foam quickly dissipates.

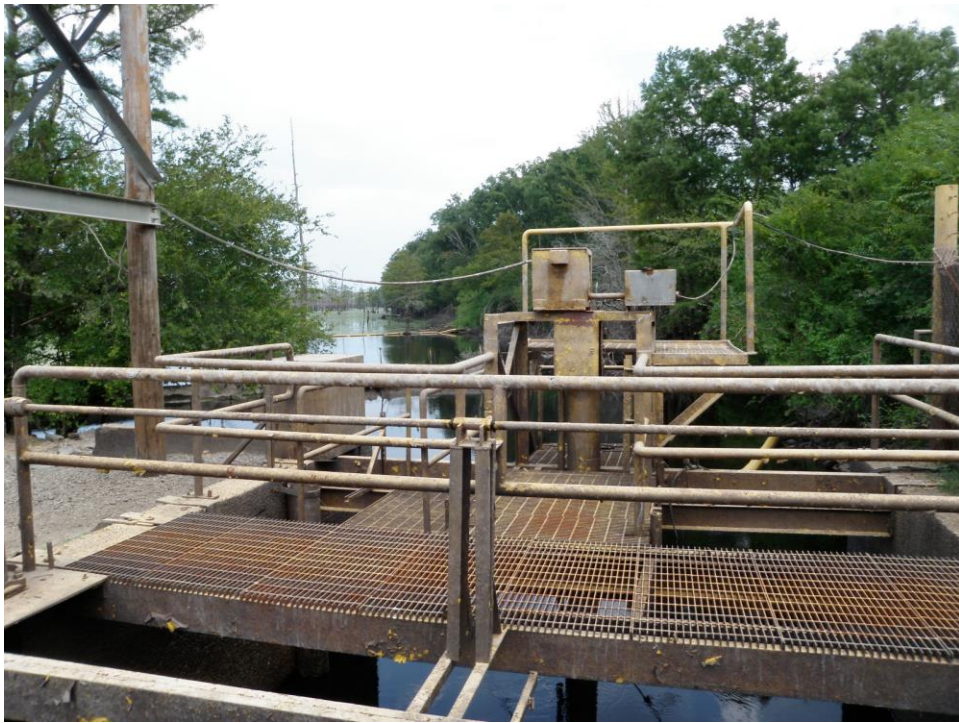
SMS002

There is "push back" from the river above this level which prevents the permittee from obtaining representative samples.

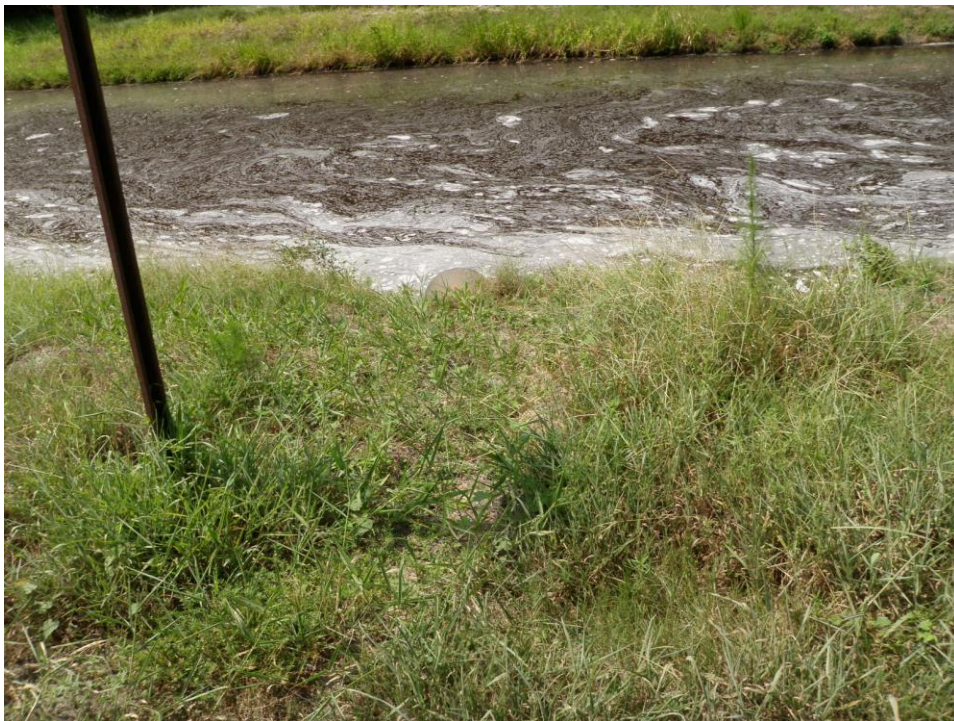
City of Crossett wastewater pipe discharging into GP system

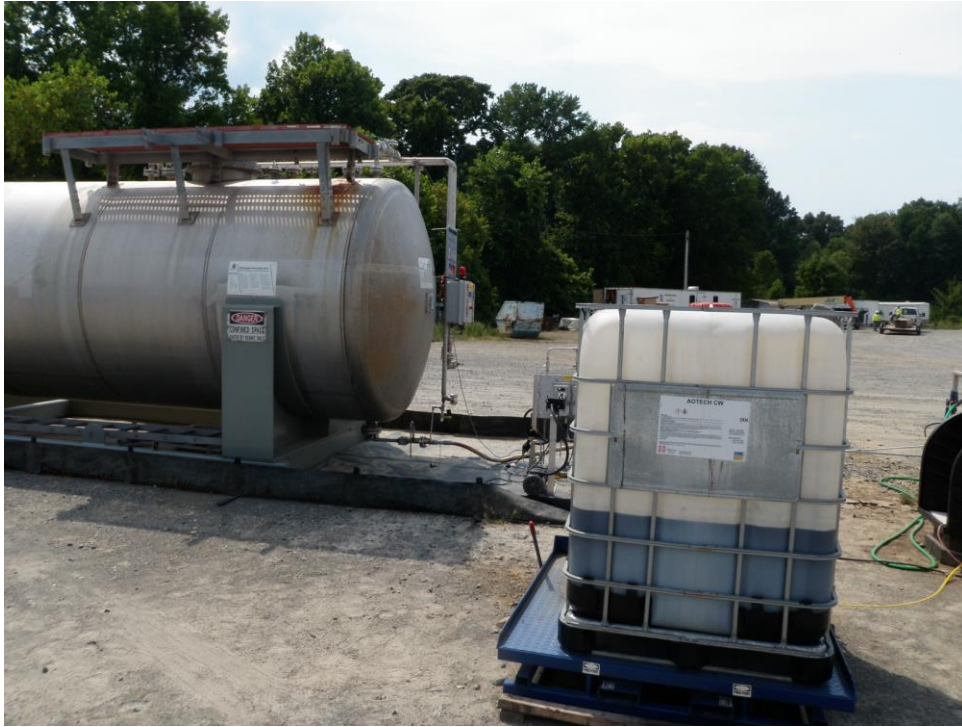
Hydrogen Peroxide and Iron catalyst feed into P2 sewer

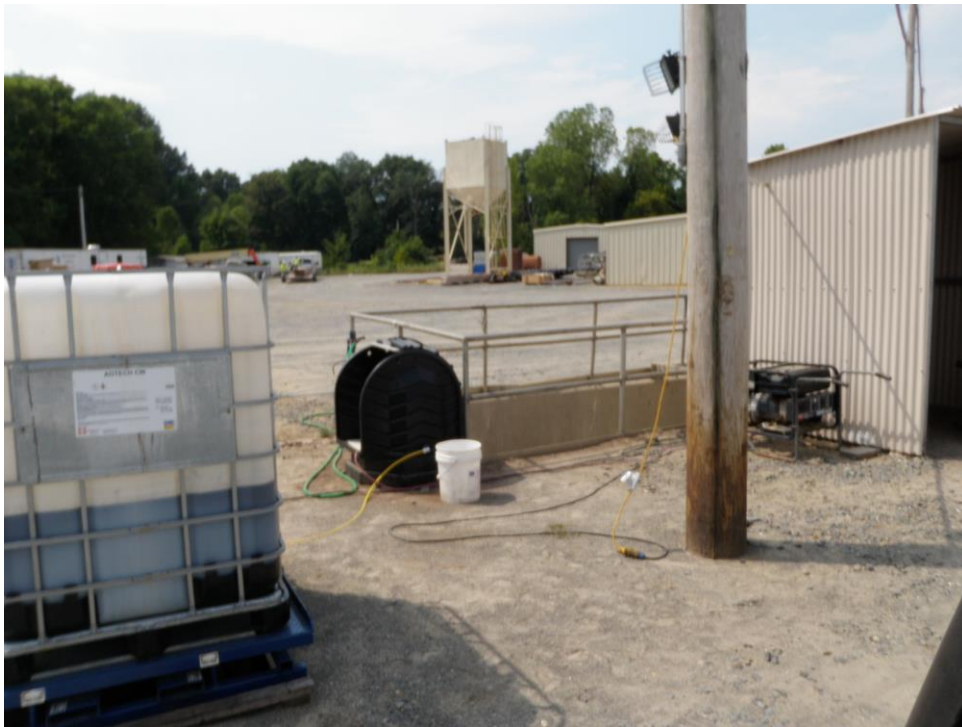
Hydrogen Peroxide and Iron catalyst feed into P2 sewer
