PRELIMINARY ENGINEERING REPORT

***WASTEWATER SYSTEM
IMPROVEMENTS***

***MARBLE FALLS SEWER IMPROVEMENT
DISTRICT NUMBER ONE***

***MAY 2010
(REVISED JUNE 2010)***

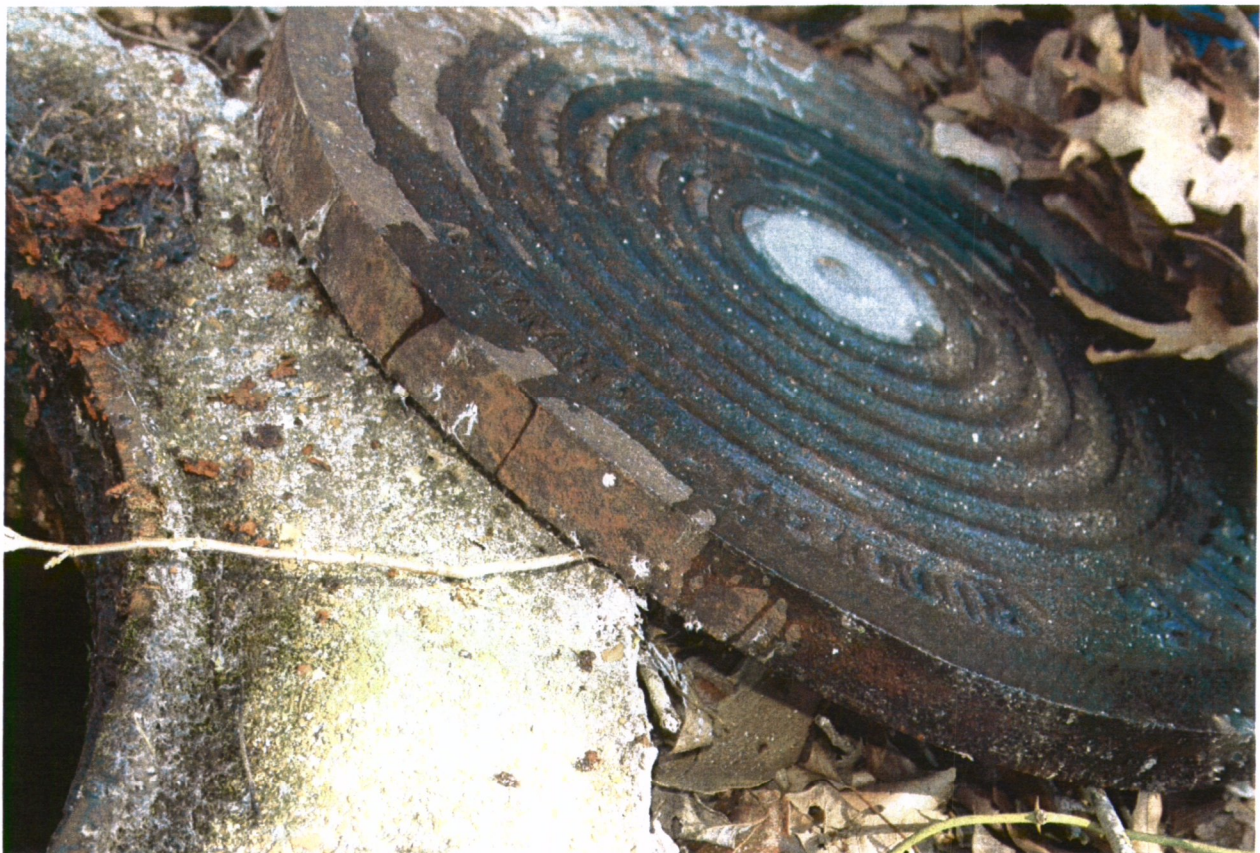
Figure 3.5 Manhole 1-R (ARWA MH #31)

Smoke testing was conducted on MH 1-R (ARWA MH #31), and revealed no clogs, leaks, or manhole deficiencies. However, debris on the manhole lid and rim indicated the manhole had previously overflowed, as shown in Figures 3.4 and 3.5. The most likely cause of the overflow is a previous blockage in the section of pipe between MH 1-R and MH 1-Q. In addition, although the line was not clogged at this time, residue at MH 1-T indicated a previous blockage of the sewer main downstream of the manhole.

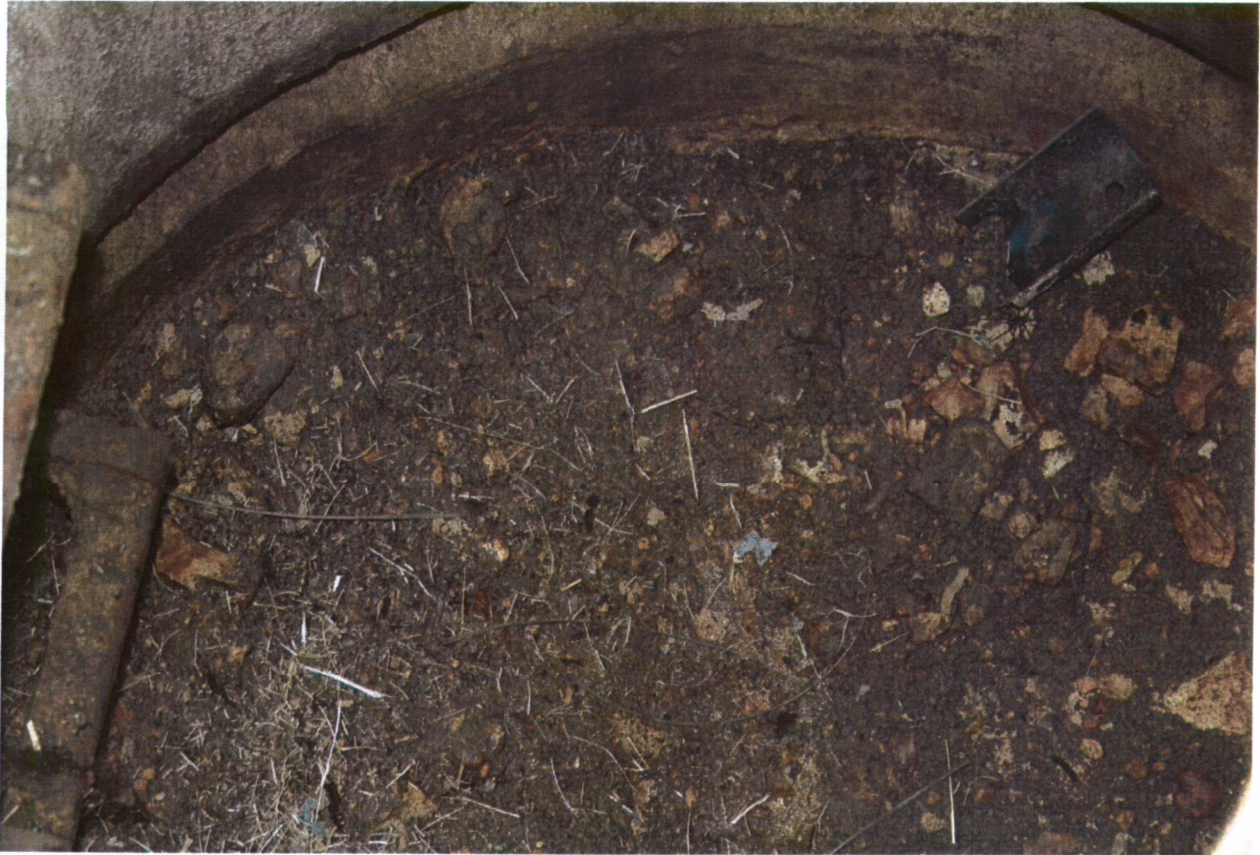
Figure 3.7 Manhole 1-O

Smoke testing of MH 1-P (ARWA MH #30) revealed no clogs or leaks of the main line, however, the eastern edge of MH 1-P's rim is damaged. Two of the three manholes immediately downstream from MH 1-P (MH 1-O and MH 1-M) leaked, indicating they are damaged and need rehabilitation. In addition, MH 1-O has a large amount of gravel and debris in the bottom, as indicated in Figure 3.6. The third manhole (MH 1-N) has a root growing into it, according to Mr. Hefley. Due to the multiple damaged manholes, debris, and root intrusion, it is probable that the entire section of sewer main from MH 1-M through 1-P is in need of rehabilitation. These manholes are within a site intended as an RV campsite and there are multiple sewer stubouts for the use of the RV's.

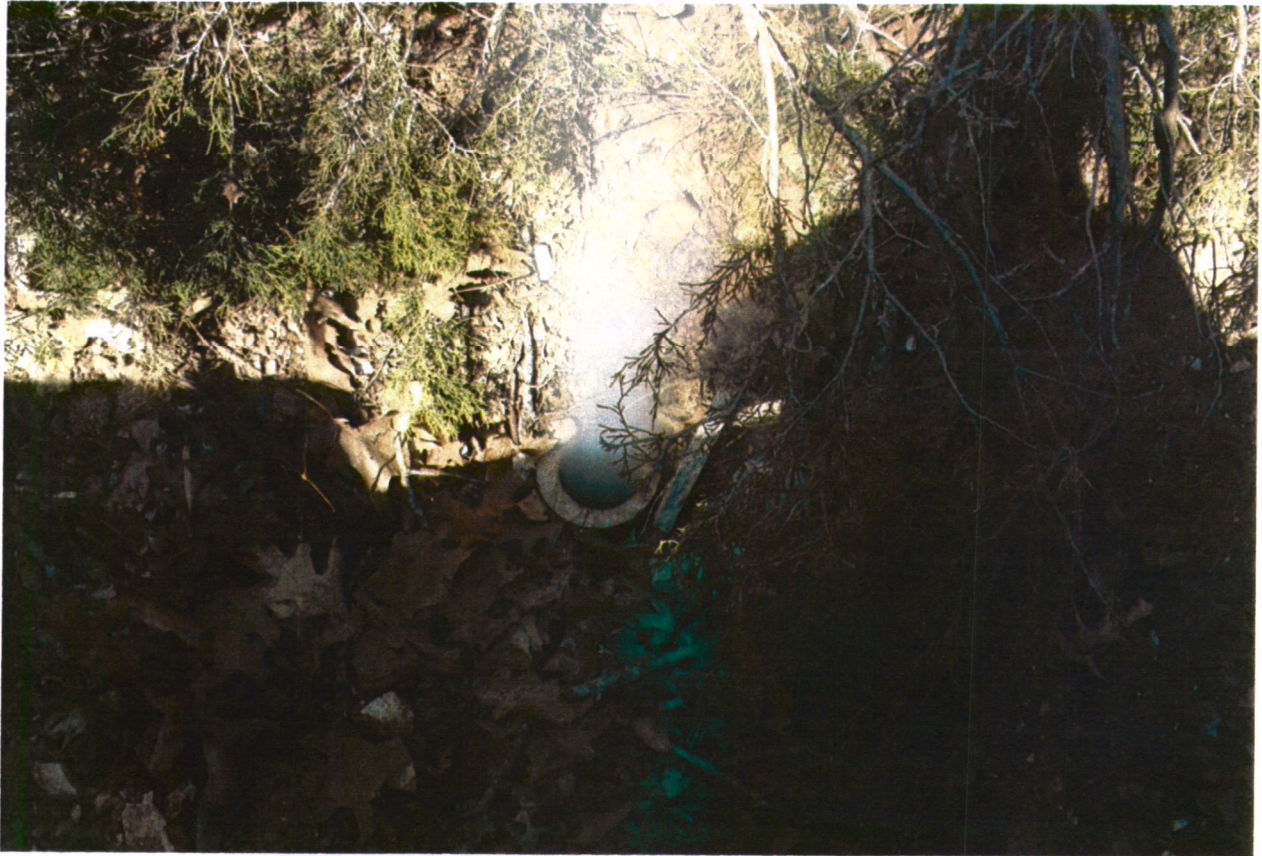
Figure 3.8 Broken Concrete Stubout

Smoke testing on MH 1-D (ARWA MH #34) revealed two broken concrete stubouts between MH 1-D and MH 1-E. These stubouts present an opportunity for inflow and should be repaired and capped or removed, with the connection to the main sewer line sealed closed. One of the broken stubouts is shown in Figure 3.8. MH 1-D itself showed evidence of a large sewer overflow, which is illustrated by Figures 3.9 and 3.10. The overflow left a trail of debris down the edges of the manhole and downhill for several feet toward a service road. Due to the evidence of overflow, the section of sewer main below this manhole should be replaced.

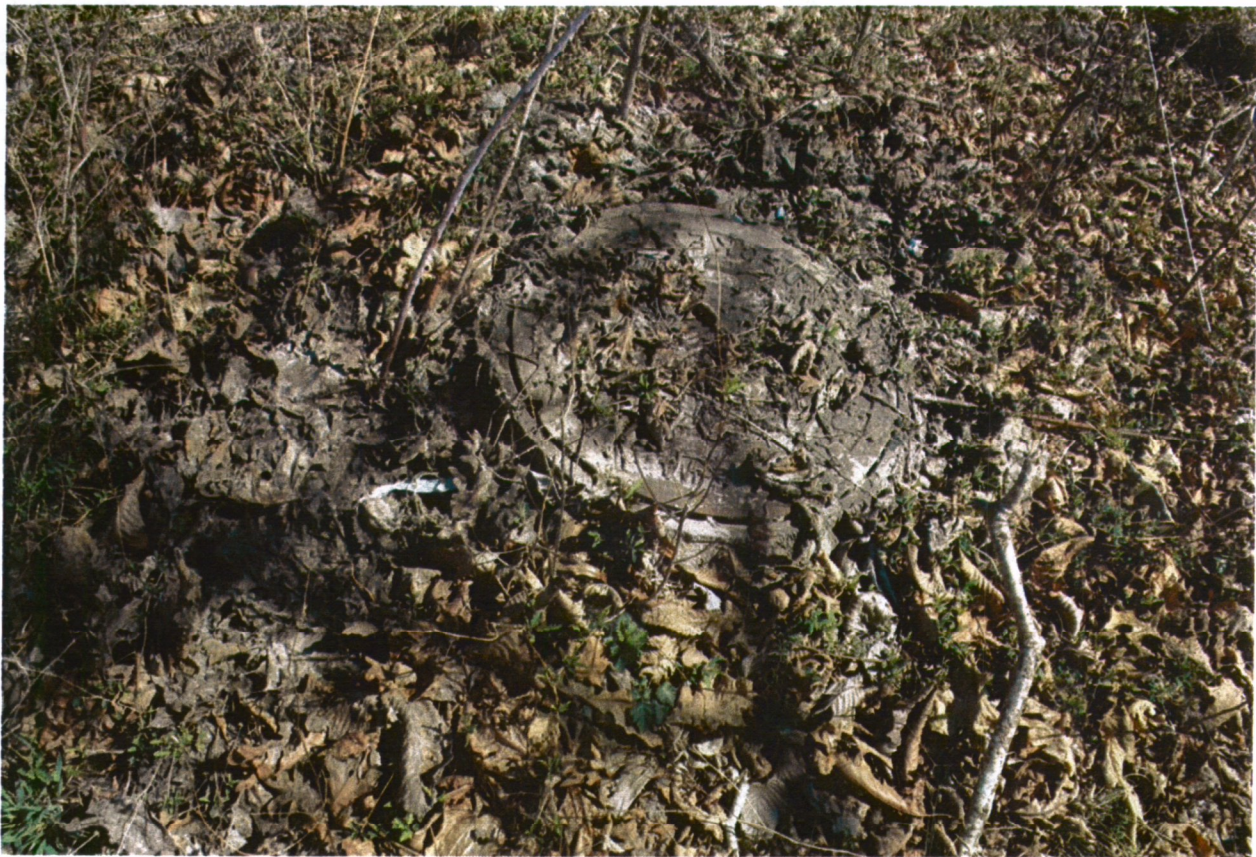
Figure 3.11 Manhole 1-A

Manhole 1-A showed evidence of a large amount of overflow, with a debris trail extending downhill toward the treatment plant access road and polishing pond. This is likely due to a blockage in the section of sewer main between MH 1-A and the inlet box near the treatment unit. This blockage was cleared following testing. MH 1-A is shown in Figure 3.11.

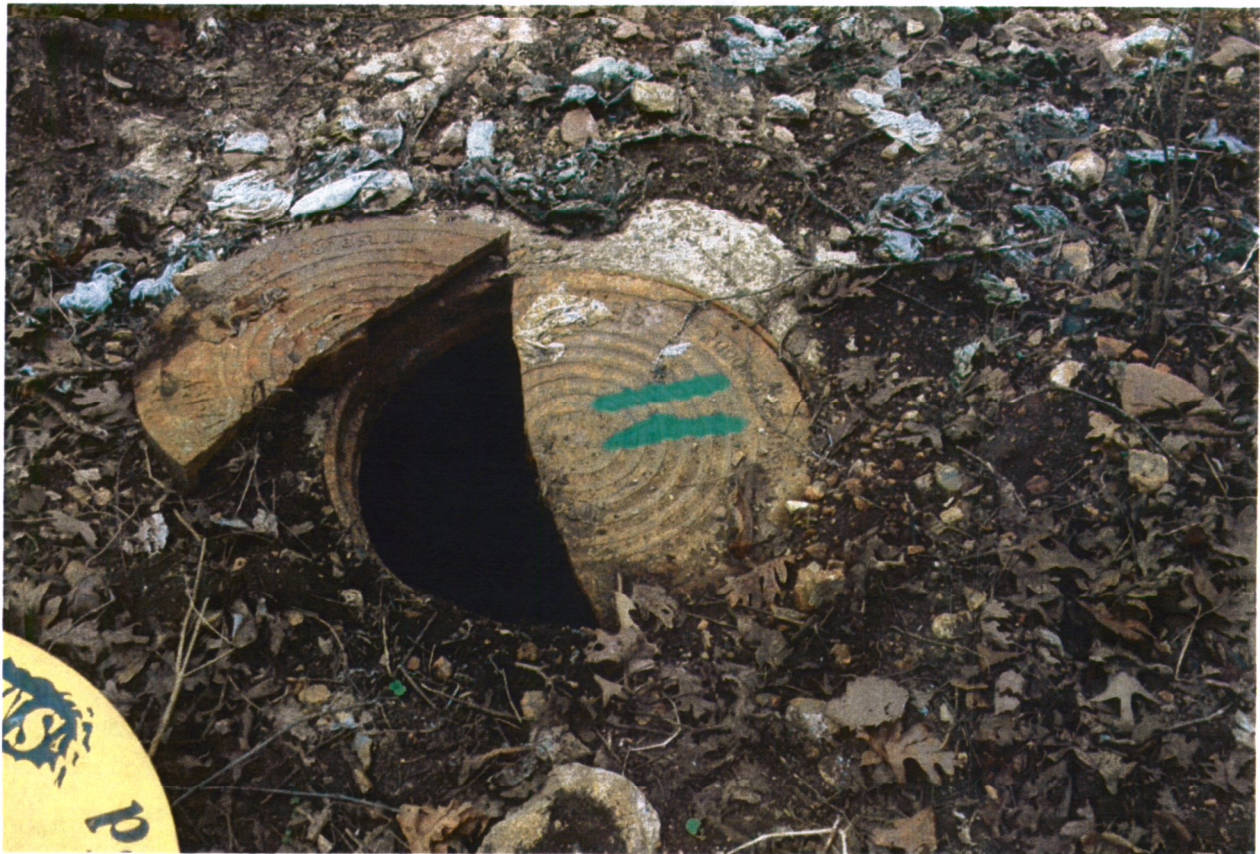
Figure 3.12 Manhole 4-Q (ARWA MH #11)

Manhole 4-Q (ARWA MH #11) has a broken lid and there was evidence of a large sewer overflow from this manhole, as shown in Figures 3.12 and 3.13. The overflow residue was very long and extended toward a ditch between the sewer main and the access road. Also, Manhole 4-Q was full to within a few inches of the rim with sewage. The likely cause of the overflow is a blockage in the line between MH 4-Q and MH 4-P, because MH 4-P was dry with no evidence of overflow. The blockage was cleared after the overflow was observed. However, the multiple problems with this section of line are concerning and it is recommended that the sewer mains and manholes in this section be rehabilitated.

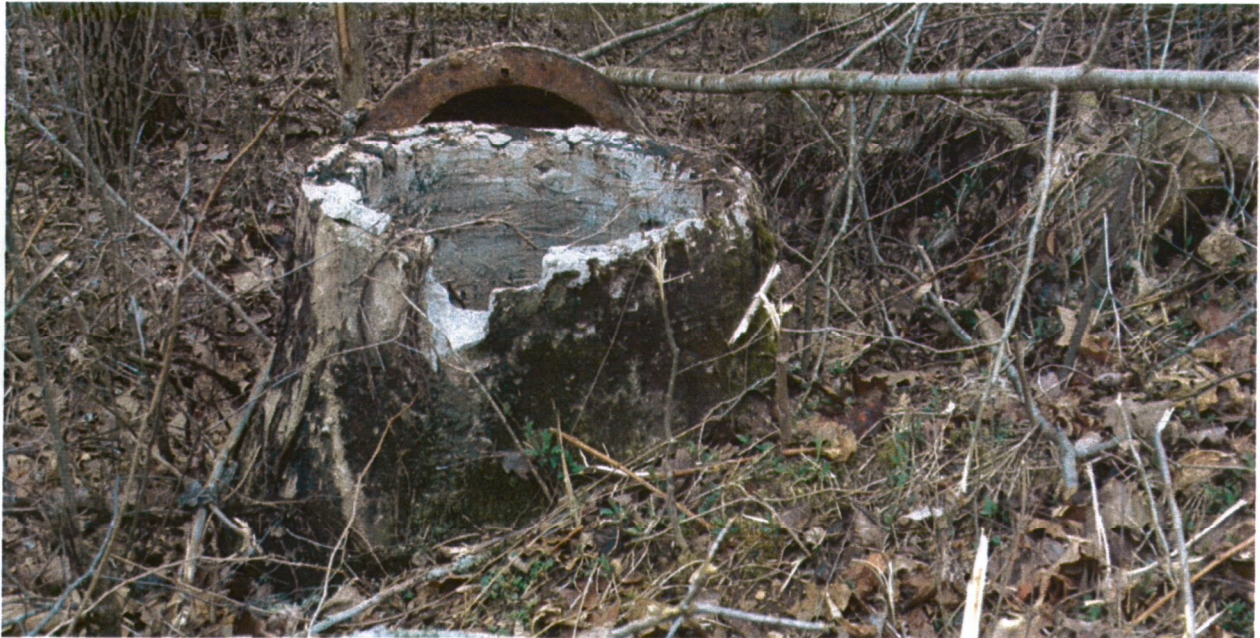
Figure 3.14 Manhole 4-O (ARWA MH #13)

Manhole 4-O is situated at the south edge of a power company right-of-way, which had recently been cleared during smoke testing. The top of the manhole was completely broken, possibly during the clearing process. The manhole is heavily damaged and in need of replacement. In addition, there was evidence the manhole had overflowed and there was a large volume of sewage still in the manhole. The sewage in the manhole likely indicates the section of sewer main downstream of MH 4-O is blocked. The blockage was cleared following the observations. Manhole 4-O is shown in Figures 3.14 and 3.15.

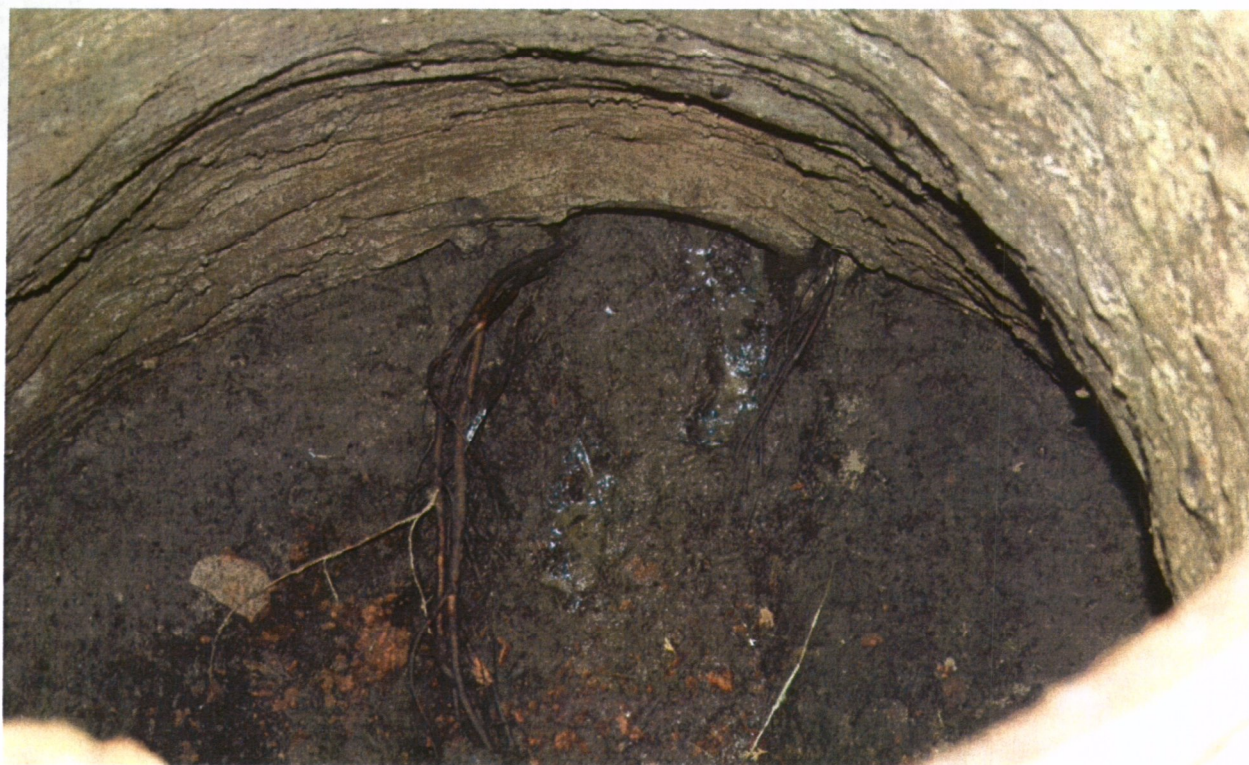
Smoke testing of Manhole 4-N (ARWA MH #14) indicated that MH 4-M (ARWA MH # 15) is damaged and leaking. There was some evidence of a previous overflow, indicating a possible blockage downstream of the manhole. Roots could be seen entering Manhole 4-N from the upstream sewer main, a likely cause of the blockage in that segment, resulting in the overflow observed at MH 4-O. The roots intruding into the manhole are shown in Figure 3.16.

Figure 3.16 Root Intrusion in Manhole 4-N (ARWA MH #14)

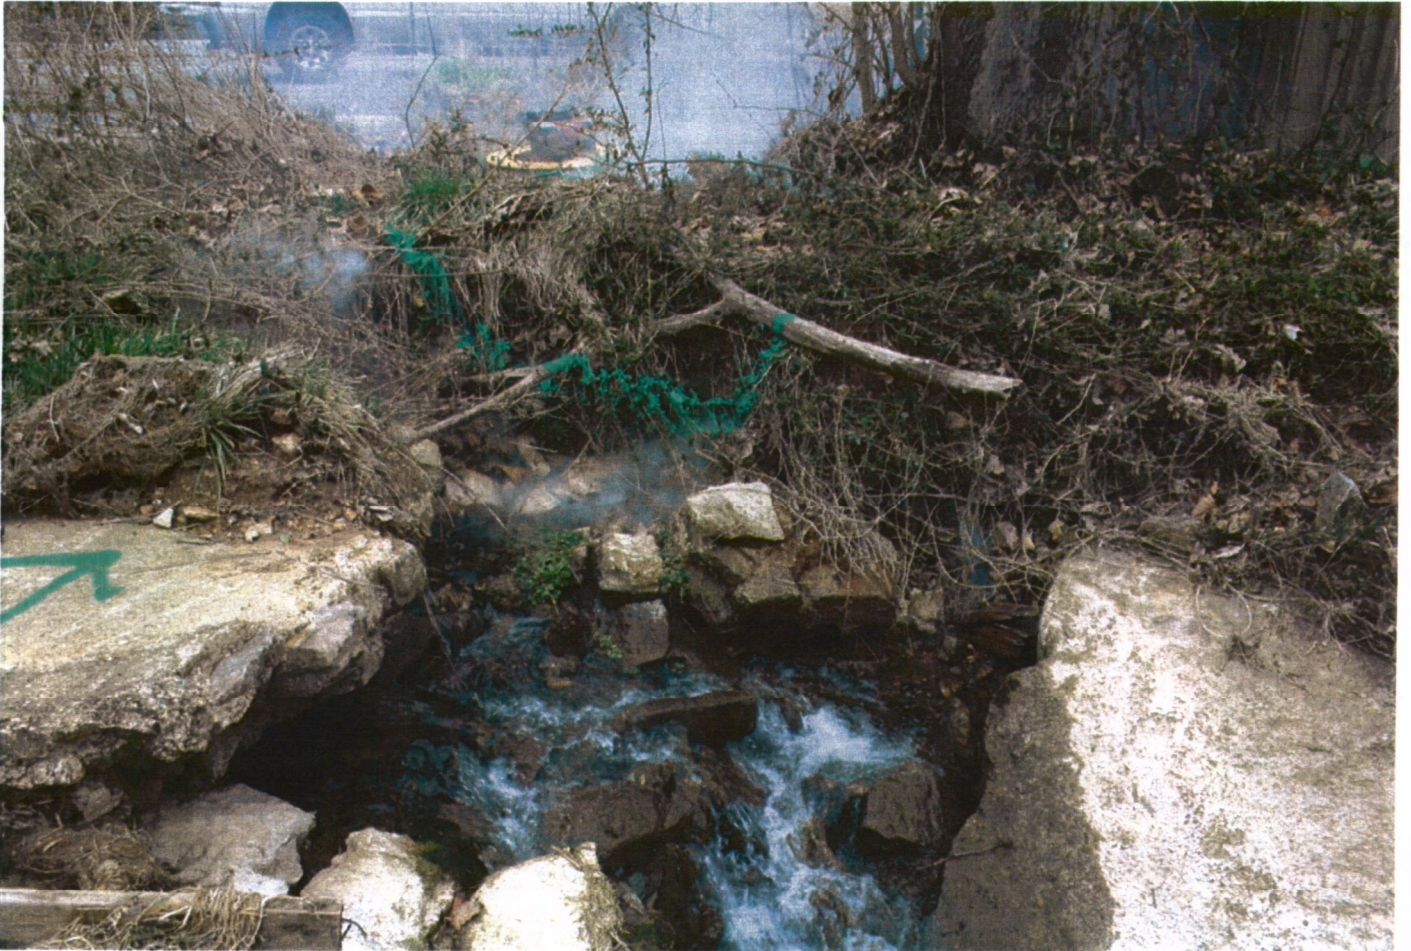
Smoke testing at Manhole 4-K (ARWA MH # 17) indicated several areas of leakage around the manhole. Manhole 4-K is located near a stream and smoke was observed leaking through the exposed creek bank, as well as in a broad area around the manhole, especially on the south side of the manhole near a large tree. There was a large amount of gravel in the bottom of this manhole. Smoke testing at MH 4-K also showed that MH 4-L (ARWA MH #16) leaks. From MH 4-K, the sewer main turns and crosses under the stream to MH 4-J, which does not have a lid. No leakage was observed in the sewer main crossing under the stream, but if this line was compromised, it is likely that an extraordinarily large amount of flow would be observed in the manholes downstream of that section of sewer main from infiltration by the stream. No such flows were observed. Smoke near Manhole 4-K is illustrated in Figure 3.17.

Figure 3.17 Smoke Escaping Near Manhole 4-K (ARWA MH #17)

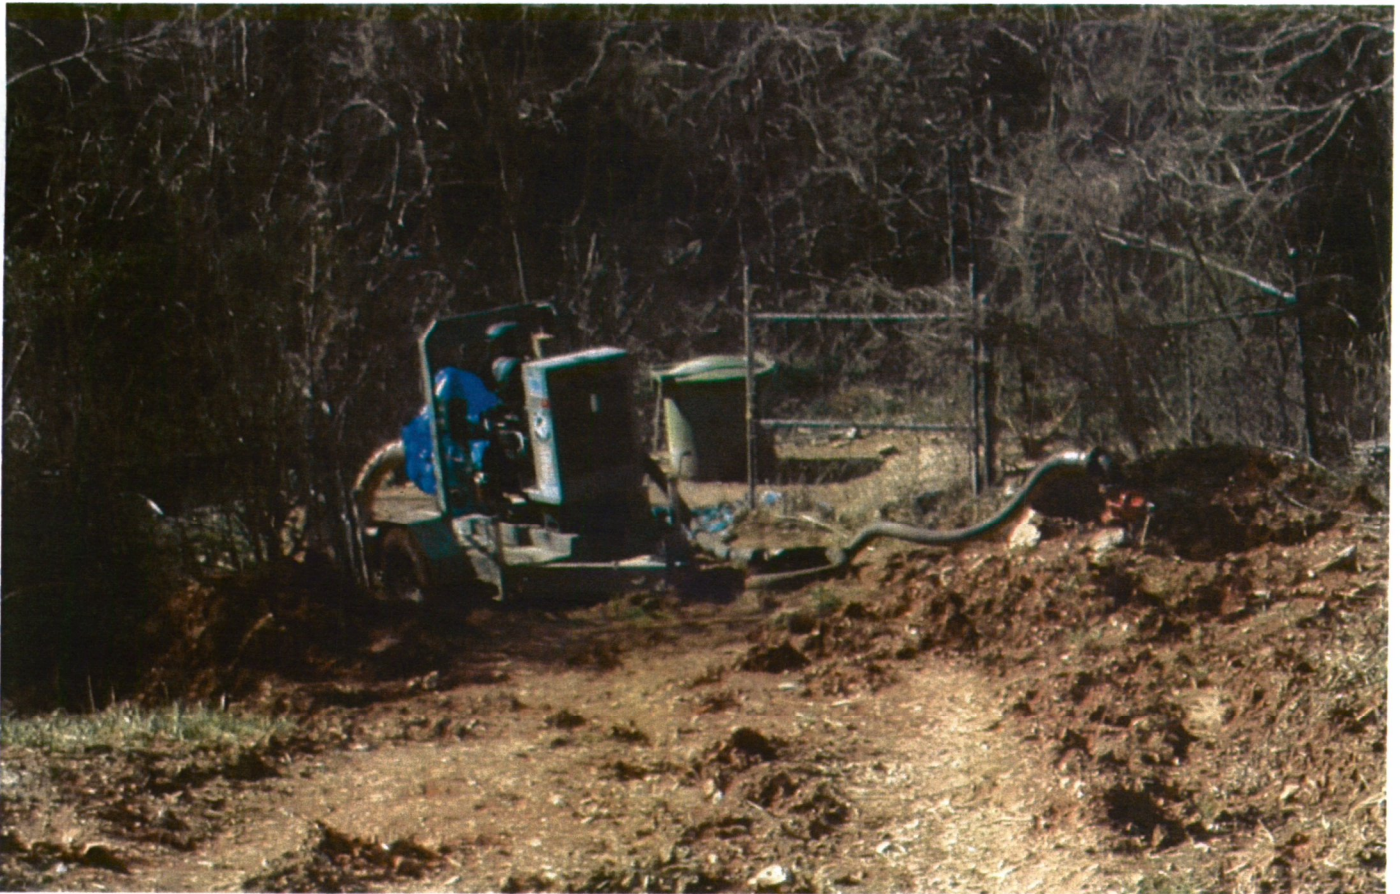
Lift Station 1 and the temporary pump installed by ARWA are shown in Figure 3.18.

Figure 3.18 Lift Station 1 and ARWA-Installed Temporary Pump

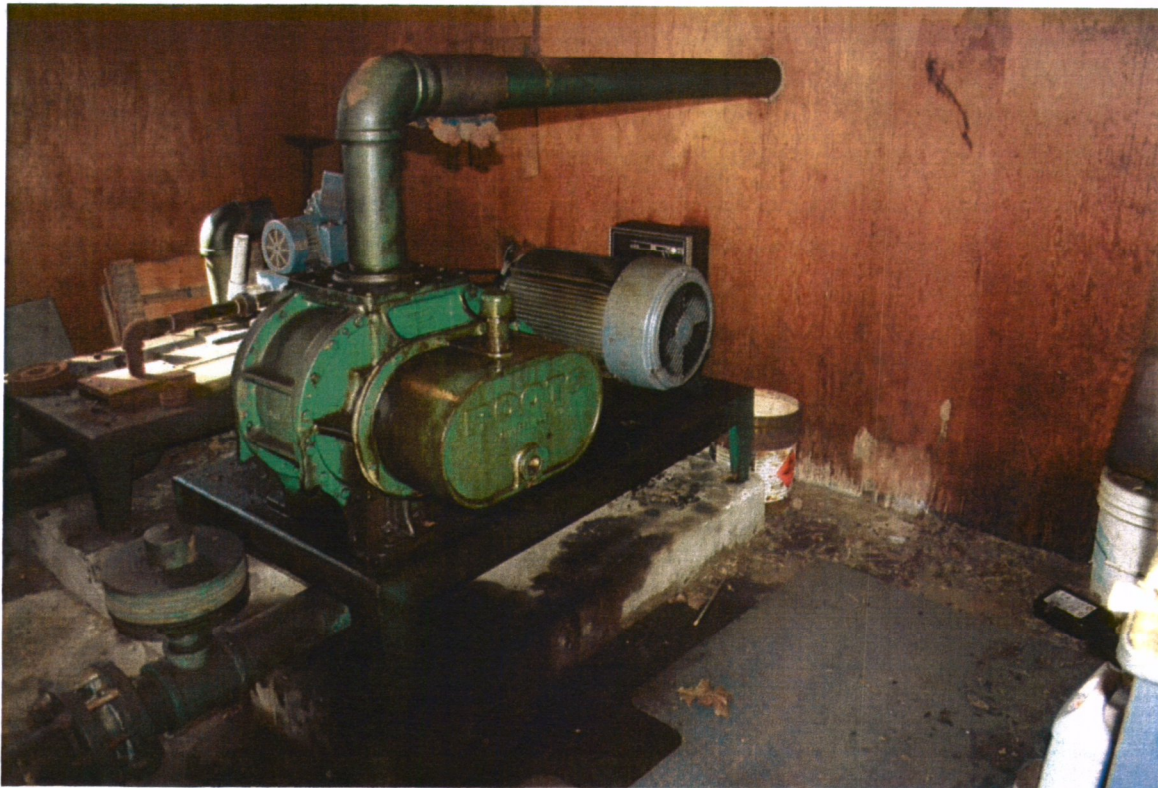
The southern unit has no intake line to draw air from outside the building, but instead appears to draw air from inside the main room of the equipment building through a 2 inch diameter PVC pipe. The western equipment building wall has been patched where the air intake line to the original southern unit passed through the wall. The electric motor and blower are combined into a single mechanism on this unit, and piping has been added to connect the new unit to the existing air piping.

Figure 3.25 Northern Blower (Green) / Southern Blower (Blue)

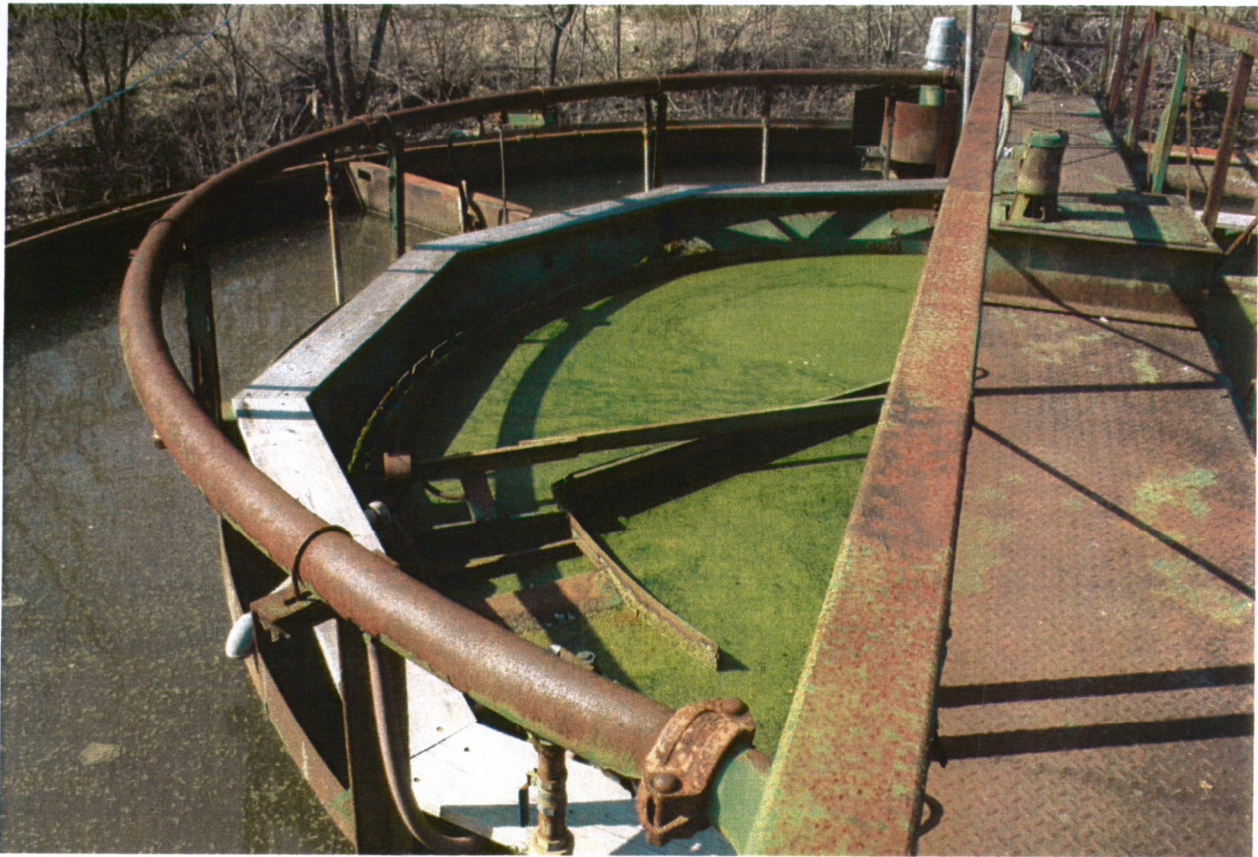
A skimmer arm is present at the surface of the clarifier chamber. The arm runs from a chain-driven gear at the center of the clarifier chamber under the middle of the catwalk to a steel rim near the exterior of the chamber. A wheel at the end of the arm rolls along the steel rim, allowing the skimmer arm to rotate smoothly around the chamber. An electric motor which protrudes from an access lid at the center of the catwalk provides the power to move the skimmer arm. A photo of the skimmer arm is included as Figure 3.40, in which the electric motor can also be seen.

Figure 3.40 Skimmer Arm

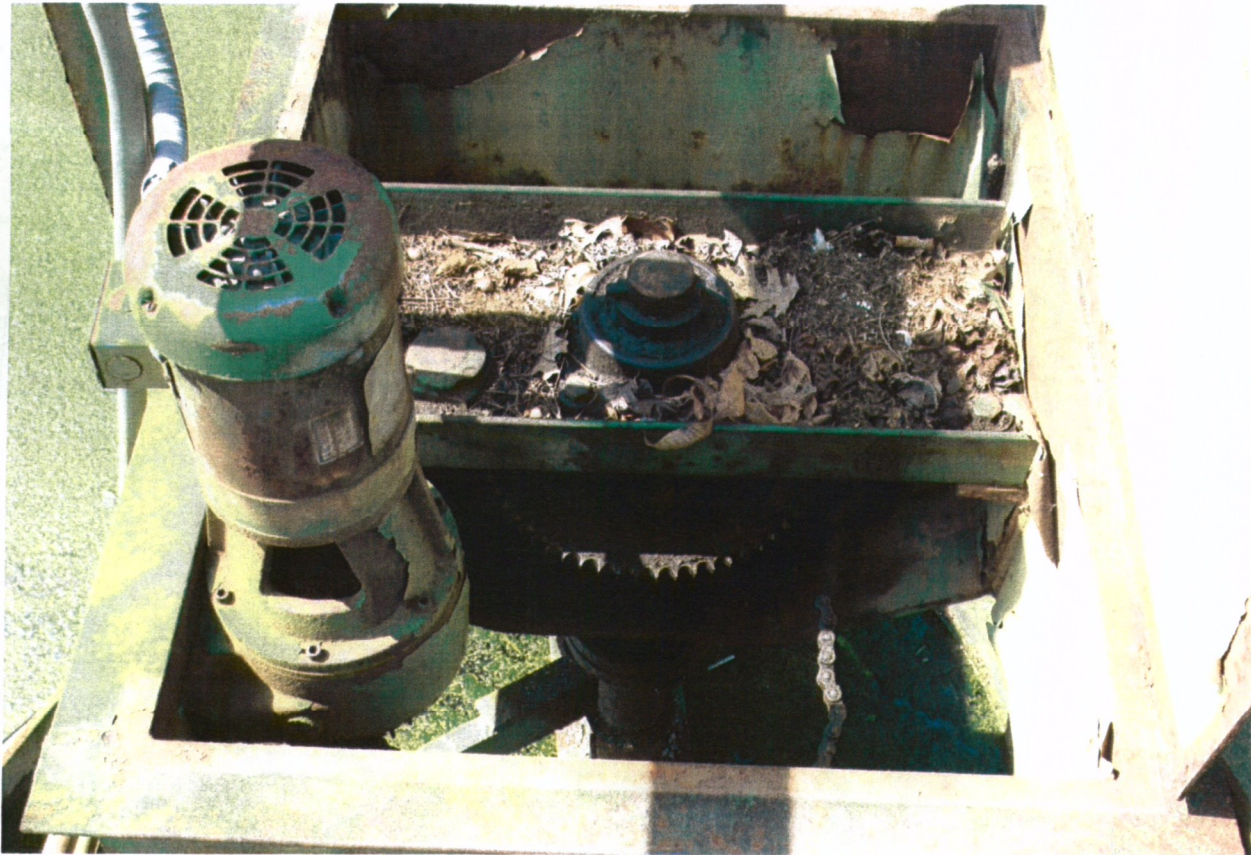
The electric motor turns a chain and gear which are located below the raised area visible at the middle of the catwalk. During the observations of the treatment unit, the chain was broken, making the skimmer arm inoperable. The chain has since been fixed and the skimmer arm is now functional.

Figure 3.41 Skimmer Arm Motor, Chain, and Gear
