COOPER TIRE & RUBBER COMPANY 3500 Washington Rd. • Texarkana, AR 71854 • Phone (870) 773-4502

Cooper Tire & Rubber Co., NPDES Permit AR0038822,

Compliance Meeting Summary

Summary of Source Identification, Source Control and Compliance Efforts for Outfall 001

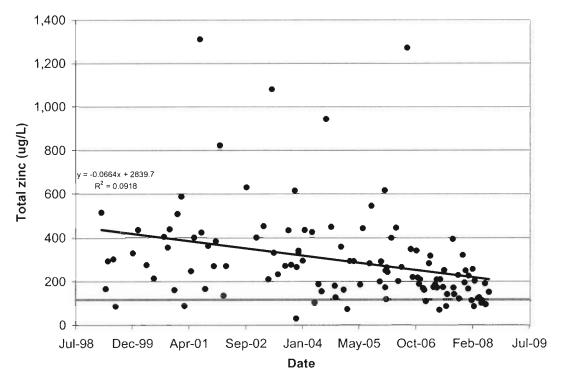
Effluent monitoring indicates that source control efforts have resulted in a substantial decrease in stormwater zinc concentrations. In particular, examination of Figure 1 indicates:

- Mean concentrations (as indicated by a line of best fit) have decreased to approximately ½ of early values, while maximum concentrations have decreased dramatically.
- Since August, 2006 all stormwater samples have been in compliance with the December May limitation of 402 μ g/L, with approximately ½ of those samples less than the December through May monthly average limitation of 200 μ g/L.
- Despite a substantial decrease in stormwater zinc concentrations, most stormwater samples exceed the June November monthly average criterion of 116 µg/L.

Figure 1. Stormwater zinc concentrations at Outfall 001. Red line indicates monthly average permit limit for June – November (116 µg/L). Black line is line of best fit through the mean.

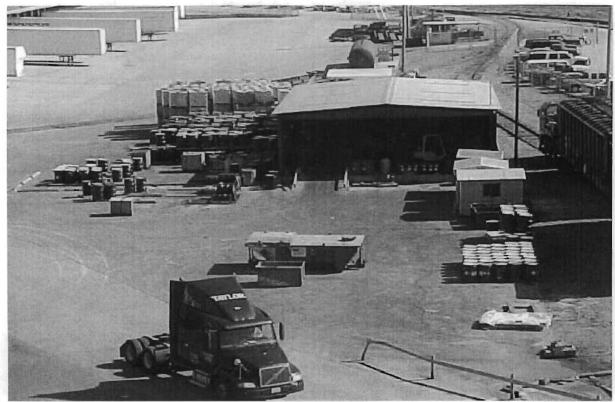
1. Oil Storage Area prior to BMPs. Containers exposed to stormwater.

- Continuing routine maintenance of Oil Shed area.
- Expanded the Oil Storage Building. This expansion has provided a roof over all new and used oil containers and reduced potential exposure of oil to storm water.

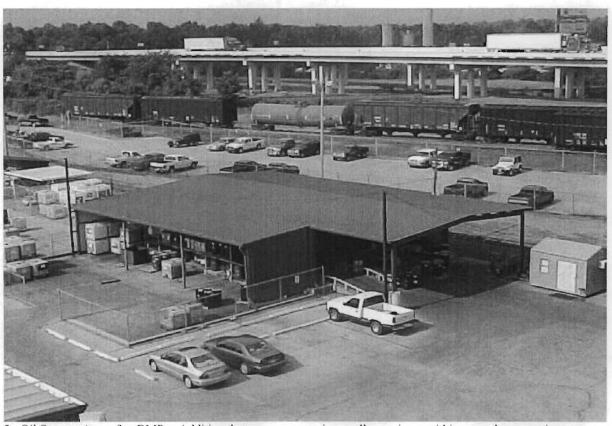
2. Oil Storage Area after BMPs. Additional cover over containers, all containers within secondary containment.

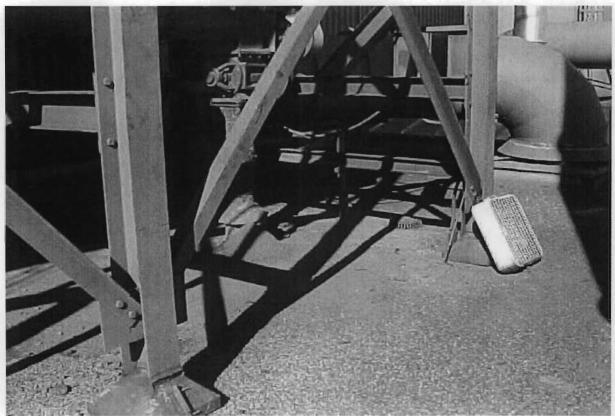
3. Facility Roof before BMPs. Dust accumulation on facility roof.

• Dedicated personnel to monitor and clean the plant roof for fugitive dust buildup.

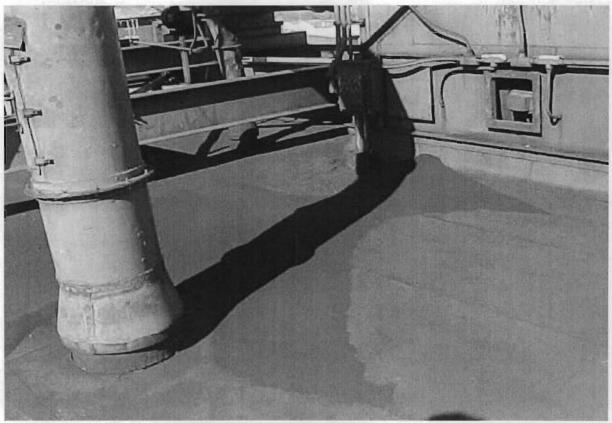
4. Facility Roof before BMPs. Dust accumulation on facility roof.

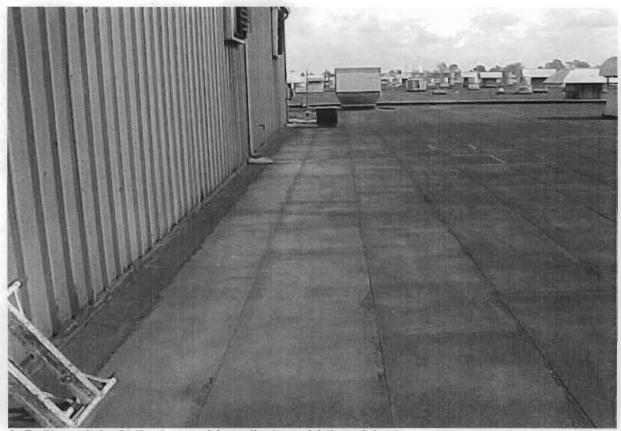
5. Facility roof after BMPs. Improved dust collection and daily roof cleaning.

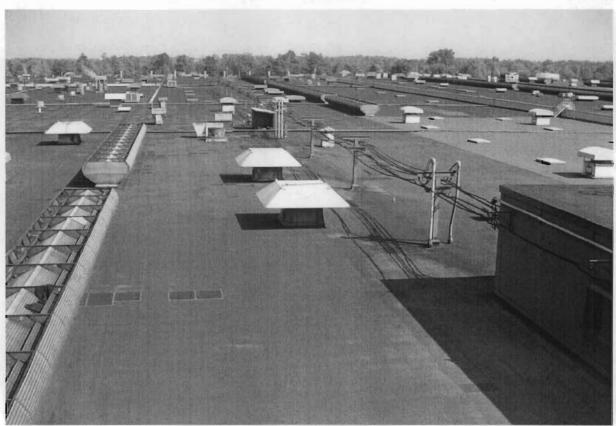
6. Facility roof after BMPs. Improved dust collection and daily roof cleaning.

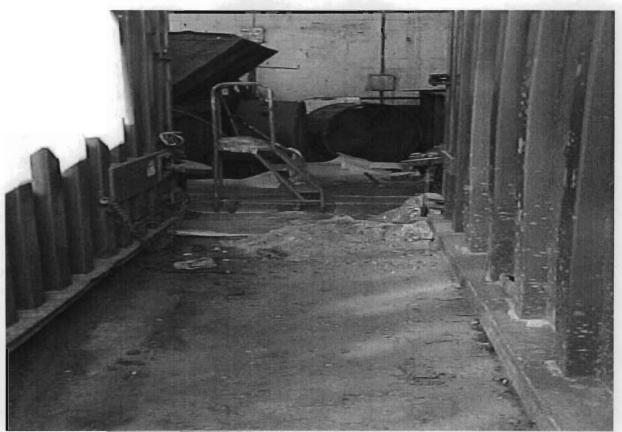
7. South Waste Compactor Area prior to BMPs. Dust and Waste potential exposure to stormwater.

- Expanded the South Trash Compactor Building. This expansion has provided additional containment and further enclosed the processing of plant waste.
- Eliminated the waste handling area on the north end of the facility by consolidating this activity under roof at the south end of the facility.
- Implemented daily cleaning of the south trash compactor and waste handling area.

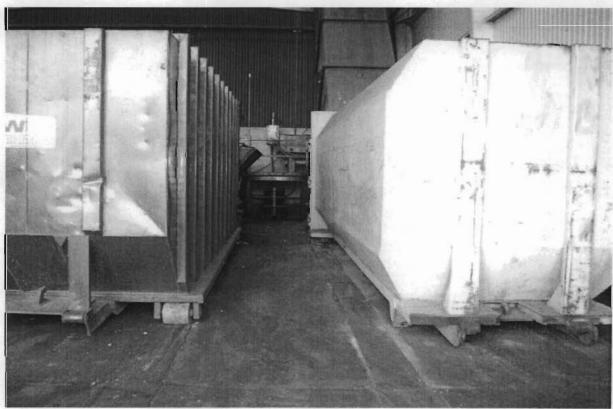
8. South Waste Compactor Area after BMPs. Under roof and daily cleaning.

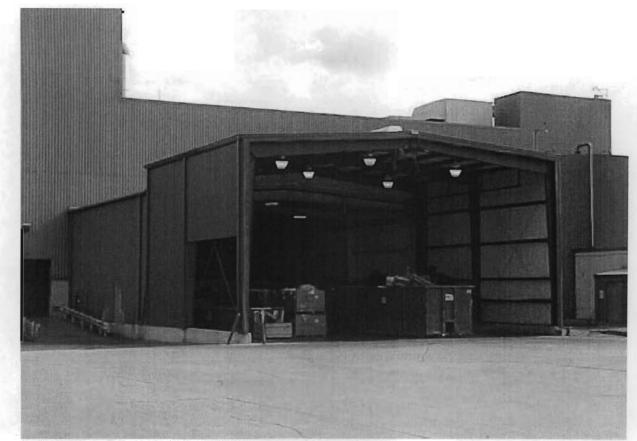
9. South Waste Compactor Area under roof and secondary containment.

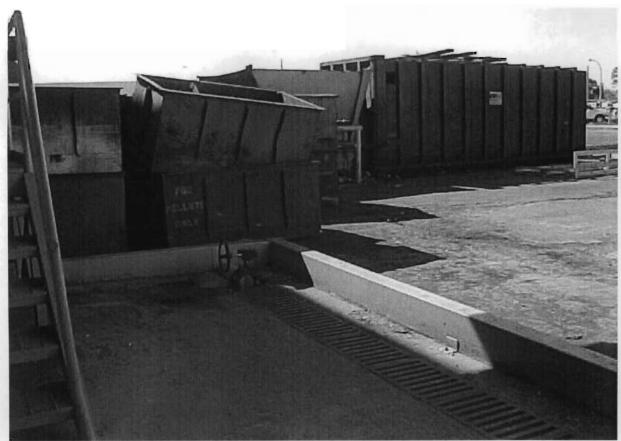
10. North Waste Compactor Area before BMPs. Potential exposure to stormwater.

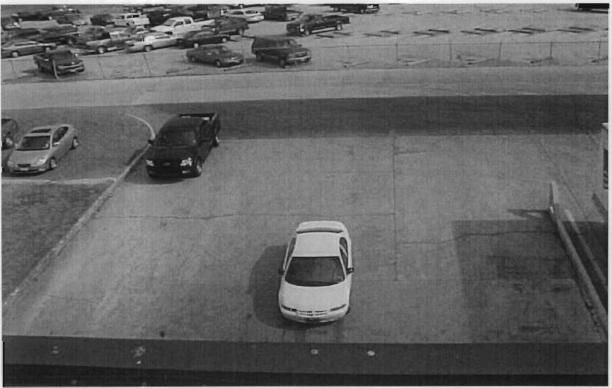
11. North Waste Compactor Area after BMPs. Relocated under cover to South Compactor Area.

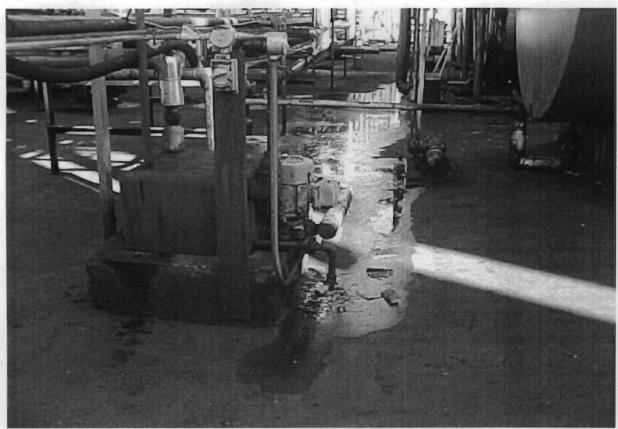
12. Tank Farm prior to BMPs. Oil leaks potential stormwater exposure.

- Developed and implemented SOP for handling oil.
- Implemented daily inspection program for the tank farm.
- Installed a prototype seal less pump on a process oil transfer tank to prevent leaks.
- Installed roof over oil unloading pumps.
- Replaced oil-soaked insulation around storage tanks.
- Implemented inspection procedure for storm water contained in the tank farm prior to its release. Individuals designated to release storm water have been trained on the inspection procedure.

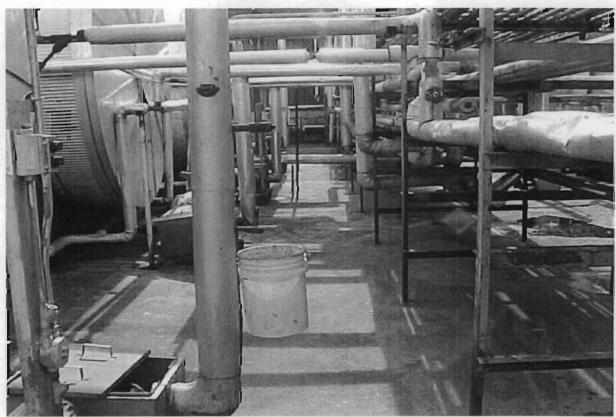
13. Tank Farm after BMPs. Pumps serviced to prevent leaks, covered to prevent exposure, daily inspections.

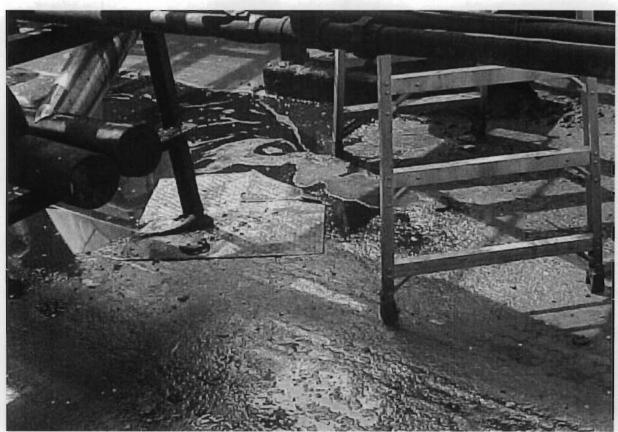
14. Tank Farm prior to BMPs. Oil leaks potential stormwater exposure.

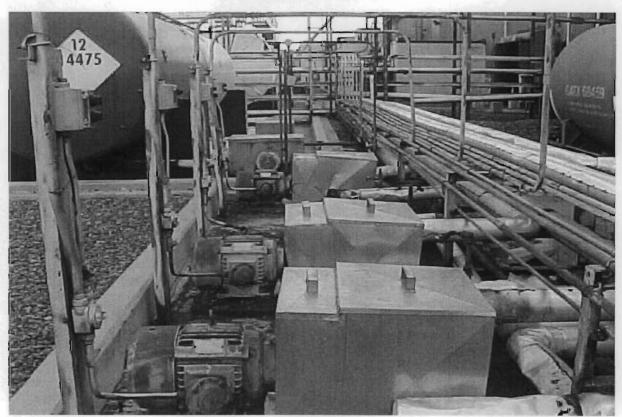
15. Tank Farm after BMPs. Pumps serviced to prevent leaks, covered to prevent exposure, daily inspections.
