RE: Cooper Tire & Rubber Company
NPDES Permit # AR0038822
FTN No. R06038-0001-004

*Evaluation of Best Management Practices and Outfall 001 Receiving Stream
Water Quality at the Cooper Tire & Rubber Company, Texarkana, AR, Facility*

**EVALUATION OF
BEST MANAGEMENT PRACTICES AND
OUTFALL 001 RECEIVING STREAM
WATER QUALITY AT THE
COOPER TIRE & RUBBER COMPANY
TEXARKANA, AR FACILITY**

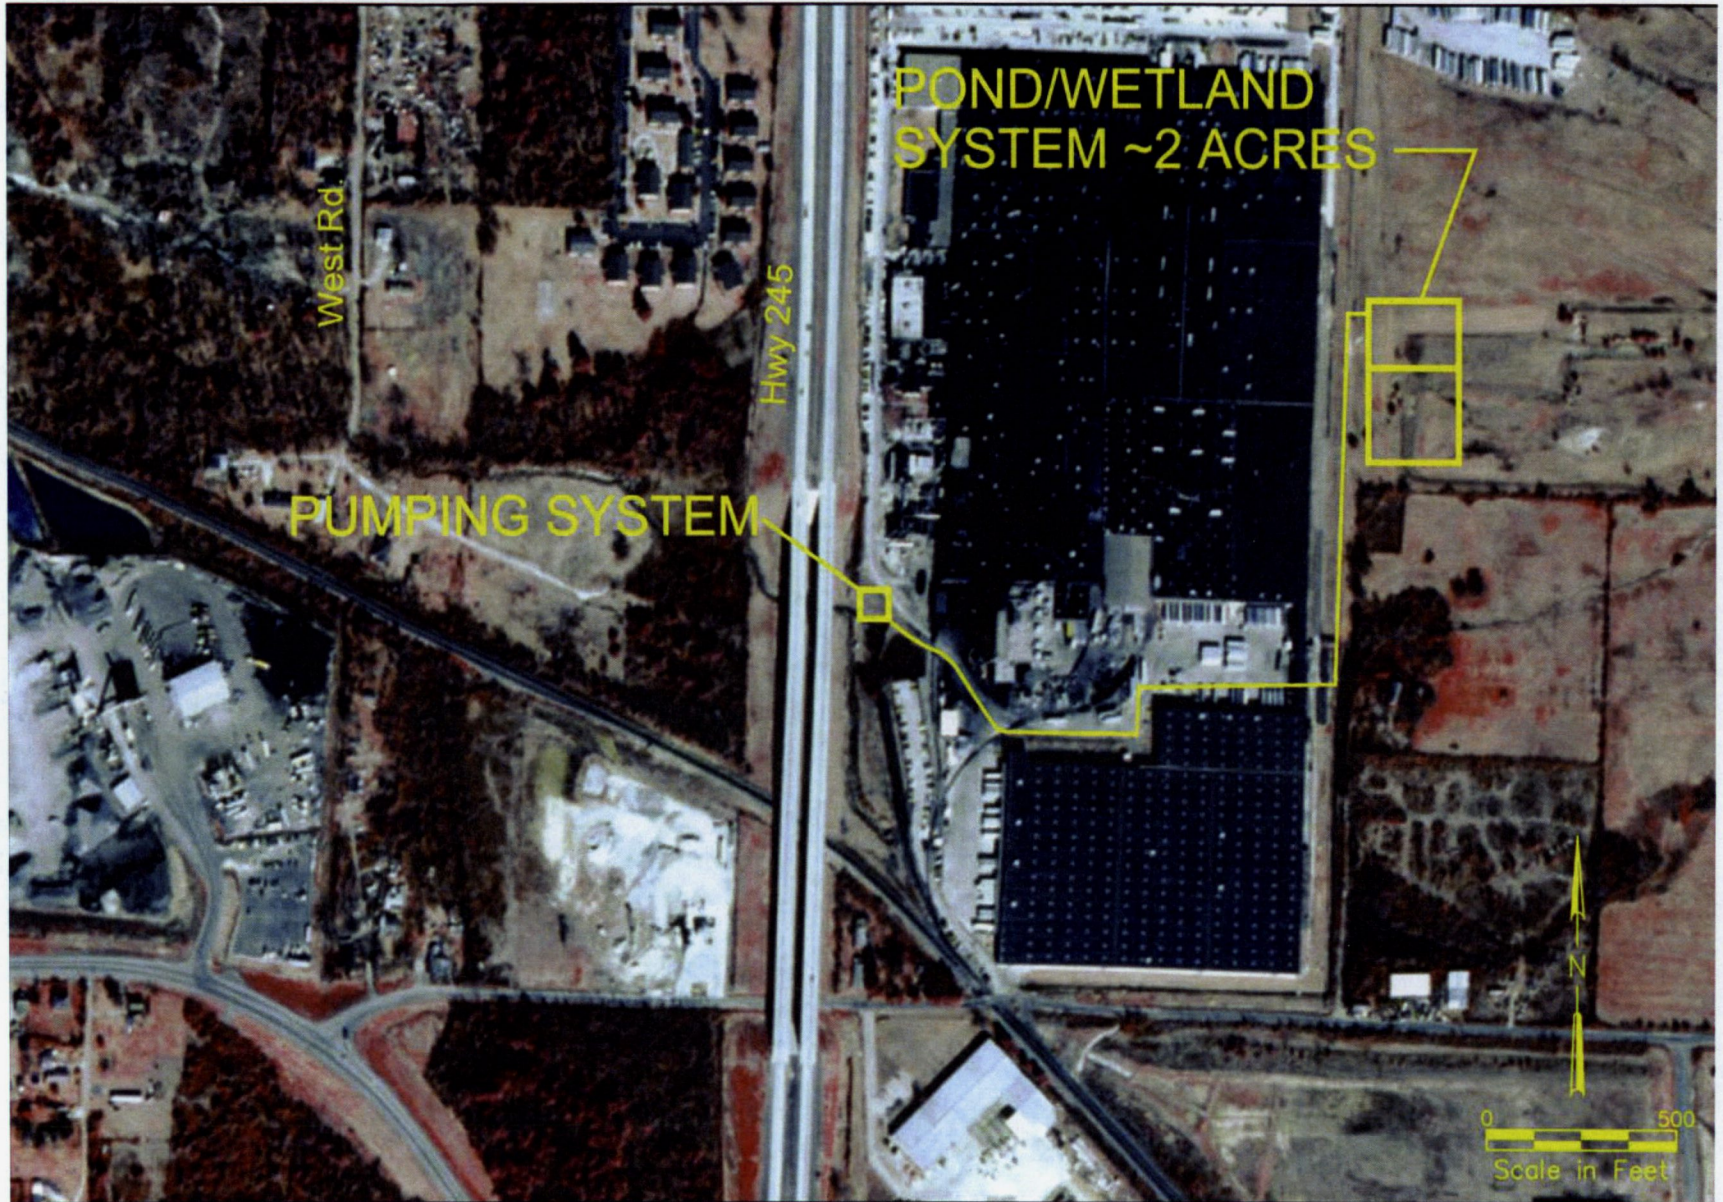
Figure 2. Layout of treatment system.

The treatment would involve first collecting the water and providing some storage to allow the construction of a reasonably sized treatment system. The first stage of this system would take the form of a large pumping station with a holding basin. The size of the holding basin would be limited by the amount of land available in this area. Given this restriction, it would not be possible to collect and treat all of the stormwater (the peak stormwater flow from a 50 acre site could easily exceed 20,000 gpm). However, it will be possible to collect the first flush of stormwater runoff and to provide a more constant stream of outflow. In this way, periodic sampling of the discharge would be required. Using the pumping system, water would be pumped to a treatment system on the east side of the plant where a pond could be installed to handle the water. For estimating purposes, a 2,000 gpm pumping system is considered along with a Pond/Wetland system with a total extent of about 2 acres. A conceptual arrangement or layout of this treatment system is shown in Figure 2.

One option for the treatment of the zinc would consist of a constructed wetland. This type of system has been used to remove heavy metals at other installations in Arkansas and provides a relatively low maintenance treatment system. Mainly due to the low cost of operation and maintenance, this system would represent the most cost effective treatment system that could be installed at this site. This system could utilize mechanisms that could settle or filter suspended solids from the water, incorporate select plants and algae that can remove dissolved metal through uptake, and could be designed to facilitate the conversion of soluble metal to the highly insoluble metal sulfide.

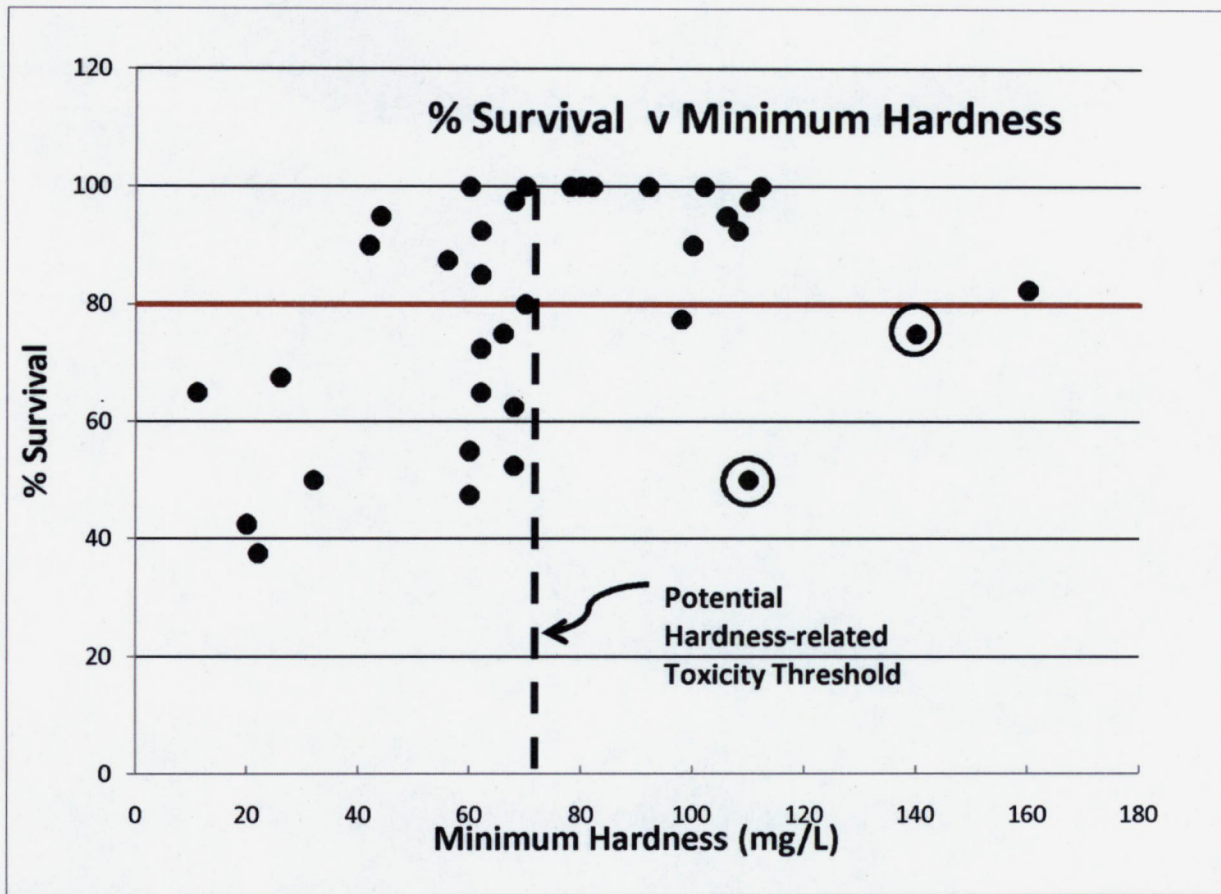
Figure 3.3 provides a plot of survival versus minimum hardness in biomonitoring tests conducted from January 2006 through February 2010. Several factors besides hardness (e.g. pH and dissolved Zn concentration) affect the pattern of the plot on Figure 3.3. However, assuming that 80% survival represents an approximate conservative “pass/fail” threshold in the toxicity tests, it is apparent from the figure that the probability of a passing test increases above a minimum hardness of approximately 70 mg/L. In fact, with the exception of two tests (a clearly toxic result from September 7, 2007, and a marginally toxic result from April 20, 2008), all tests conducted since January 2006 having a minimum hardness of approximately 70 mg/L were “passing” tests.

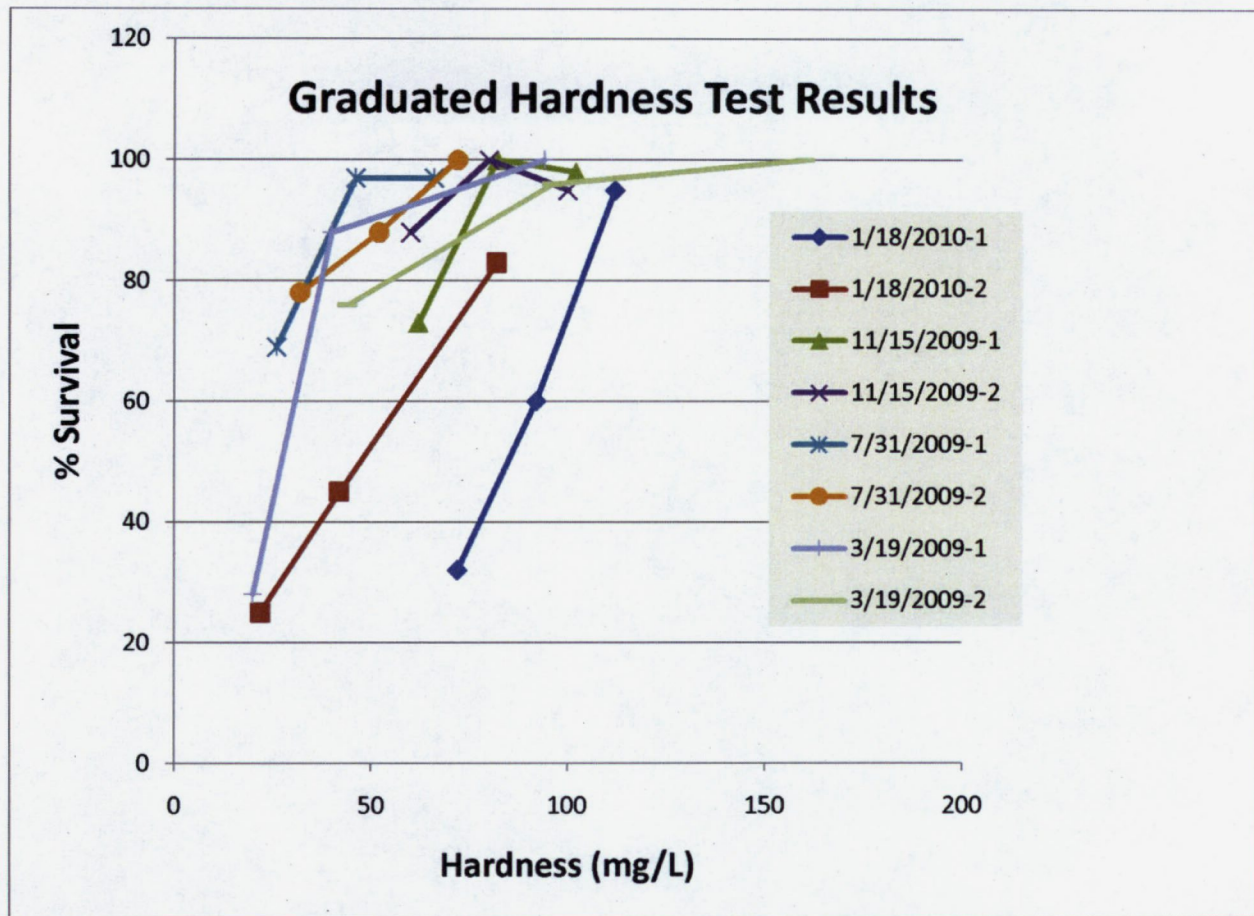
Figure 3.4. Percent survival of *P. promelas* vs hardness in “Graduated Hardness” experiments.

concentration series per set), there was a significant reduction in toxicity at the low hardness addition and elimination of toxicity at the high hardness addition (Figure 3.4). Figure 3.5 presents a comparison of hardness and survival at comparable Zn concentrations (120 to 134 $\mu\text{g/L}$) and indicates a “pass/fail” threshold of approximately 75 mg/L hardness over that range of Zn concentrations. This result is in close agreement with the routine biomonitoring results summarized on Figure 3.3.
