CORRECTIVE ACTION ORDER UPDATE

BLYTHEVILLE NORTH WASTEWATER TREATMENT FACILITY
ASSESSMENT AND RECOMMENDED PLAN FOR CORRECTIVE MEASURES

Blytheville North Wastewater Treatment Facility
Assessment and Recommended Plan for Corrective Measures

SSR Project No.:
14-41-027.1

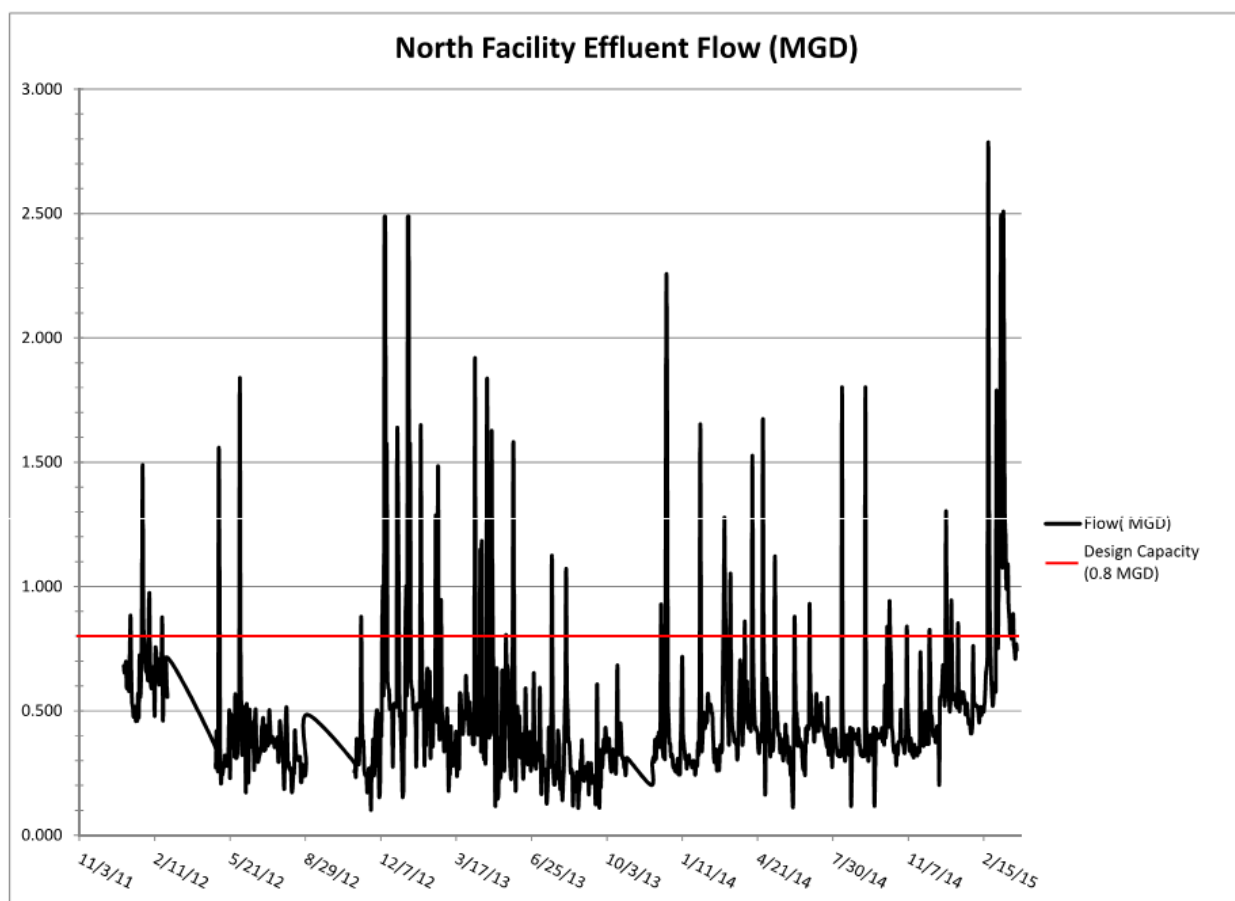
Figure 2.1 – Daily Effluent Flows

Flow Condition	North Plant (million gallons)
Minimum Day	0.101
Average Day	0.487
Maximum Day	2.778

These flow excursions are directly related to rainfall events as identified in the Daily Operation Report Calculations (DOR's) provided by the City. During these spikes, the plant loses a majority of its microbial treatment ability due to the washout of the nitrifying organisms from the treatment basins. This is confirmed by the Daily Monitoring Reports (DMRs) that show lower-than-normal mixed liquor suspended solids (MLSS) concentrations in the primary mixing basin (as compared to pre-rainfall concentrations) and high total suspended solids (TSS) concentrations in the effluent after every rain event that increased plant flow. The carbonaceous biochemical oxygen demand (CBOD) loading in the influent flow also drops significantly during and immediately after every rainfall event that affects flow due to dilution by inflow and infiltration. This diluted CBOD loading further promotes degradation of the biomass used to treat the wastewater.

The facility was originally designed to have a hydraulic residence time of between 24 and 48 hours to allow for adequate treatment. When the plant receives flows in excess of the design flow, three conditions occur that affect the treatment capabilities of the plants: (1) the hydraulic residence time is reduced such that there is not adequate time for treatment to occur; (2) the additional flow has a very low concentration of CBOD, sharply decreasing the strength of the waste stream, and depriving the biomass of needed nutrients for growth and treatment abilities; and (3) the MLSS concentration in the treatment basin is significantly reduced due to washout of the biomass from the basins, thereby preventing adequate treatment of subsequent incoming flows. As a result of these conditions, the facility could possibly be out of compliance for several days while the biomass attempts to reestablish itself.

1. Based on Appendix A, from a report titled "Sanitary Sewer Collection System Report" issued to ADEQ in February of 2012 by Smith, Seckman, Reid, Inc. (SSR), the city shall focus on fixing the sections of pipe listed as "high priority", as funds become available. The City shall also continue efforts to identify additional inflow and infiltration locations within the collection system. This action shall be an immediate and continuous effort. Inflow and infiltration should show signs of reduction by June 2016.

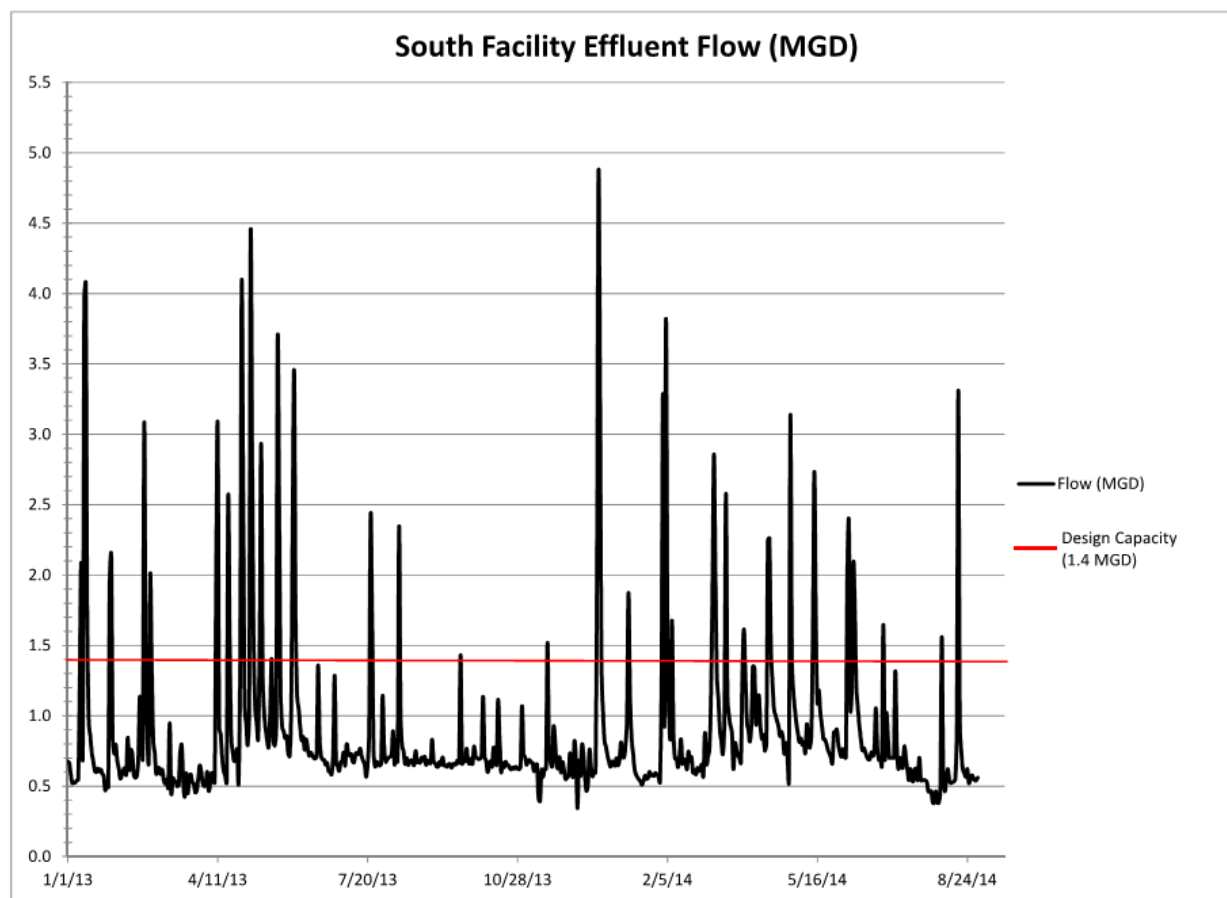
Figure 2.1 – Daily Effluent Flows

Flow Condition	South Plant (million gallons)
Minimum Day	0.343
Average Day	0.854
Maximum Day	4.851

These flow excursions are directly related to rainfall events as identified in the Daily Operation Report Calculations (DOR's) provided by the City. During these events, the plant loses a majority of its microbial treatment ability due to the washout of the nitrifying organisms from the treatment basins. This is confirmed by the Daily Monitoring Reports (DMRs) that show lower-than-normal mixed liquor suspended solids (MLSS) concentrations in the primary mixing basin (as compared to pre-rainfall concentrations) and high total suspended solids (TSS) concentrations in the effluent after every rain event that increased plant flow. The carbonaceous biochemical oxygen demand (CBOD) loading in the influent flow also drops significantly during and immediately after every rainfall event that affects flow due to dilution by inflow and infiltration. This diluted CBOD loading further promotes degradation of the biomass used to treat the wastewater.

The facility was originally designed to have a hydraulic residence time of between 24 and 48 hours to allow for adequate treatment. When the plant receives flows in excess of the design flow, three conditions occur that affect the treatment capabilities of the plants: (1) the hydraulic residence time is reduced such that there is not adequate time for treatment to occur; (2) the additional flow has a very low concentration of CBOD, sharply decreasing the strength of the waste stream, and depriving the biomass of needed nutrients for growth and treatment abilities; and (3) the MLSS concentration in the treatment basin is significantly reduced due to washout of the biomass from the basins, thereby preventing adequate treatment of subsequent incoming flows. As a result of these conditions, the facility could possibly be out of compliance for several days while the biomass attempts to reestablish itself.

1. Based on Appendix A, from a report titled “Sanitary Sewer Collection System Report” issued to ADEQ in February of 2012 by Smith, Seckman, Reid, Inc. (SSR), the city shall focus on fixing the sections of pipe listed as “high priority”, as funds become available. The City shall also continue efforts to indentify additional inflow and infiltration locations within the collection system. This action shall be an immediate and continuous effort. Inflow and infiltration should show signs of reduction by June 2016.

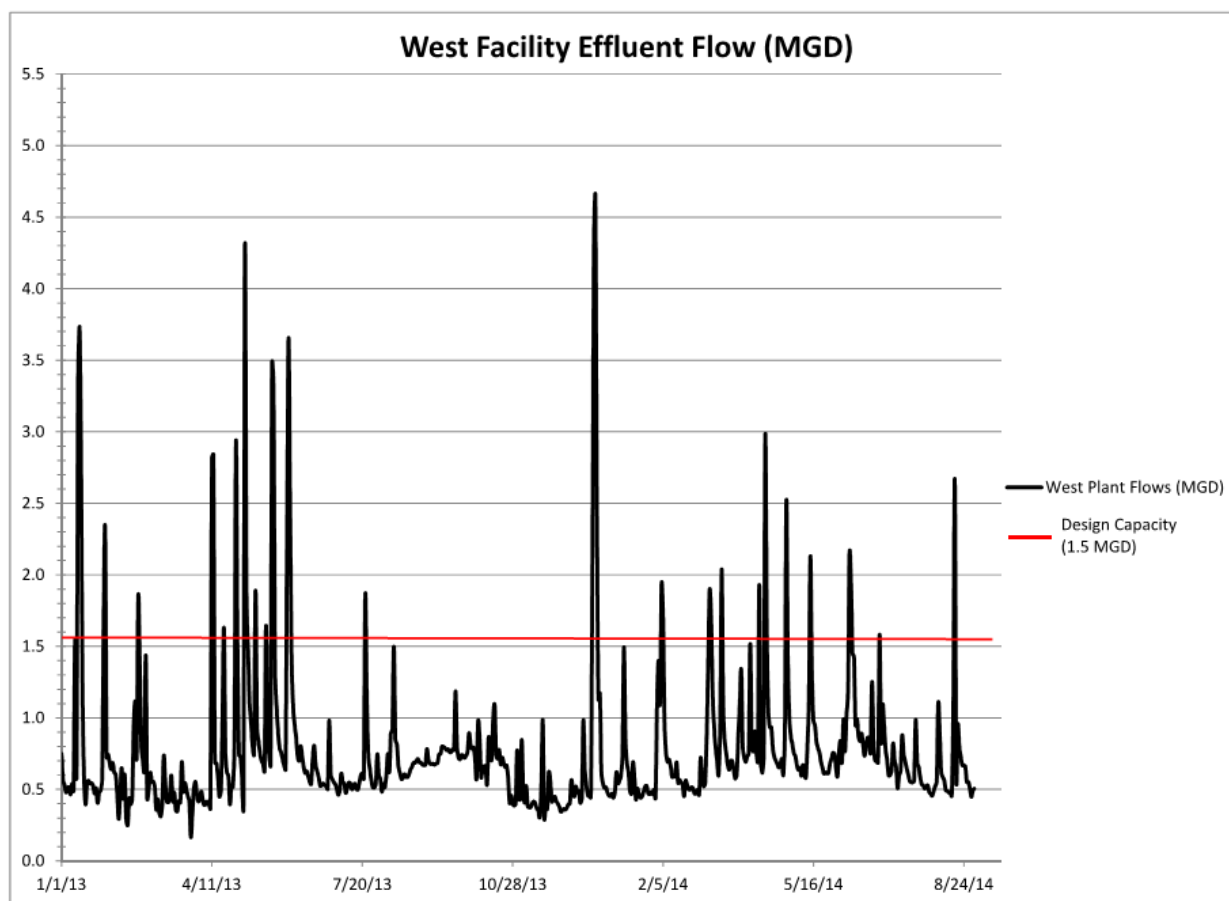
Figure 2.1 – Daily Effluent Flows

Flow Condition	West Facility (million gallons)
Minimum Day	0.148
Average Day	0.687
Maximum Day	5.274

These flow excursions are directly related to rainfall events as identified in the Daily Operation Reports (DOR's) provided by the City. During these spikes, the plant loses a majority of its microbial treatment ability due to the washout of the nitrifying organisms from the treatment basins. This is confirmed by the Daily Monitoring Reports (DMRs) that show lower-than-normal mixed liquor suspended solids (MLSS) concentrations in the primary mixing basin (as compared to pre-rainfall concentrations) and high total suspended solids (TSS) concentrations in the effluent after every rain event that increased plant flow. The carbonaceous biochemical oxygen demand (CBOD) loading in the influent flow also drops significantly during and immediately after every rainfall event that affects flow. This is due to dilution by inflow and infiltration. This diluted CBOD loading further promotes degradation of the biomass used to treat the wastewater.

The facility was originally designed to have a hydraulic residence time of between 24 and 48 hours to allow for adequate treatment. When the facility receives flows in excess of the design maximum flow, three conditions occur that affect the treatment capabilities of the facility: (1) the hydraulic residence time is reduced such that there is not adequate time for treatment to occur; (2) the additional flow has a very low concentration of CBOD, sharply decreasing the strength of the waste stream, and depriving the biomass of needed nutrients for growth and treatment abilities; and (3) the MLSS concentration in the treatment basin is significantly reduced due to washout of the biomass from the basins, thereby preventing adequate treatment of subsequent incoming flows. As a result of these conditions, the facility could possibly be out of compliance for multiple permit limits for several days while the biomass attempts to reestablish itself.
