Re: Monitoring Point Inspection – May 2024

NABORS Landfill (AFIN 03-00051)

1320 Landfill Road, Mountain Home, Arkansas 72653

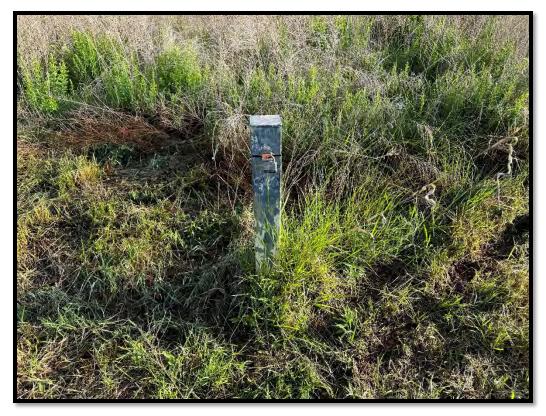
**Photo No.** 1 **Date:** 5/13/2024 **Well ID:** CAO-1

Contract No.: 4600043737									
Monitoring Well ID	Latitude	Longitude	TD (feet below TOC)	Sampled (Y/N)	Needs ATV (Y/N)	May 2024 Status	Repairs Required - May 2024	October 2022 Status	
CAO-1	36.460000	-92.449167	36.8	Y	N	Well intact and accessible by vehicle	Consider adding well identification labeling/painting	Well intact and accessible by vehicle	
CAO-2	36.458889	-92.450833	45.6	Y	Y	This well was extended vertically during the landfill closure. The casing is bent slightly and is situated on the side of a steep slope. Access is via all terrain vehicle (ATV) only along sloped pathway.	Slightly bent, still functioning, no repairs required at this time	Well has been extended and is accessible by ATV — behind new chain-link fence	
CAO-3	36.458333	-92.449722	23.1	Υ	N	Well intact and accessible by vehicle	Consider adding well identification labeling/painting	Well intact and accessible by vehicle/ATV

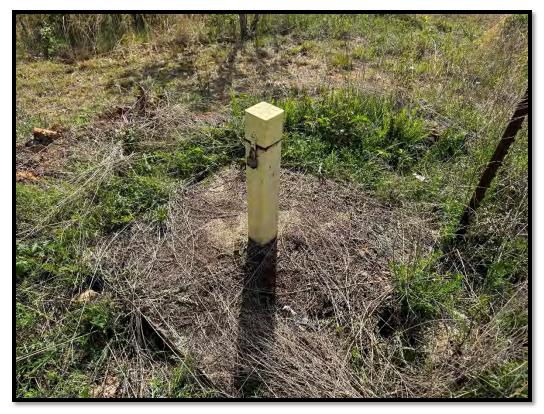
**Photo No.** 13 **Date:** 5/13/2024 **Well ID:** MW-577

MW-577	36.459722	-92.443056	55.2	Υ	Y	Well intact and accessible by ATV only via difficult, sloped pathway	Consider adding well identification labeling/painting	Well on top of topographic mound, but mostly accessible by ATV — grading would help access	
MW-633D	36.458056	-92.447222	88.1	Υ	N	Well intact and accessible by vehicle; however, ATV access preferable but vehicle is fine	_	Well intact and accessible by vehicle	
MW-689D	36.457500	-92.443333	43.8	Y	N	Well intact and accessible by vehicle; however, ATV access preferable	_	Well intact and accessible by ATV — access road needs clearing	
NAB-2	36.460556	-92.445000	102.8	Y	Y	This is one of the wells extended during the landfill closure. The casing is bent slightly and is situated on the side of a steep slope, but can still be sampled. Access is via ATV only along a sloped pathway.	_	Well has been extended and is accessible by ATV	
NAB-3	36.458333	-92.442778	46.3	Y	N	Well intact and accessible by vehicle; however, ATV access preferable	Consider adding well identification labeling/painting	Well intact and accessible by ATV — access road needs clearing

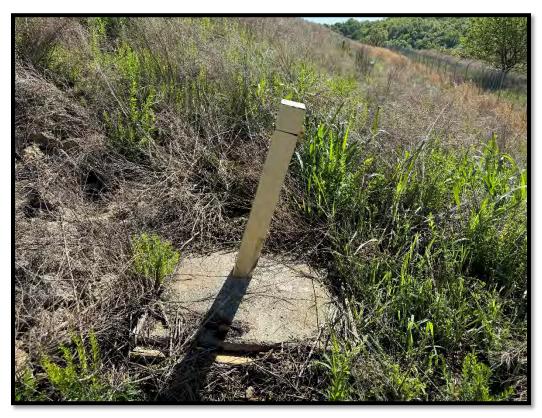
**Photo No.** 18 **Date:** 5/13/2024 **Well ID:** NAB-4

- Landfill groundwater monitoring well NAB-4 is damaged. The well casing is bent and cannot be locked; however, the well can still be sampled.
- Landfill gas monitoring well GP-16R is damaged. The well casing is bent and cannot be locked and the concrete pad is significantly cracked. The integrity of this location has been compromised.
- A number of monitoring wells lack identification.
- A number of well casings and bollards show signs of deteriorating or peeling/cracked paint.

NAB-4	36.458056	-92.445833	140.0	Y	Y	This is one of the wells extended during the landfill closure. The casing is severely bent (but can be sampled) and is situated on the side of a steep, rocky slope. The well lid can not be closed. Access is on foot via a gate.	It is recommended that the existing well completion (3-foot by 3-foot above grade completion) be reinstalled as an above grade completion so that the well lid can be closed and the integrity of the well can be confirmed.	Well has been extended but is on steep slope with dense vegetation; partially accessible by ATV — behind new chainlink fence	
NAB-7	36.462500	-92.446667	43.7	Υ	Υ	Well intact and accessible by vehicle; however, ATV access is preferable. This well is located in a dense cedar grove and is hard to locate.	Consider adding well identification labeling/painting	Well intact and accessible by ATV — access road needs clearing

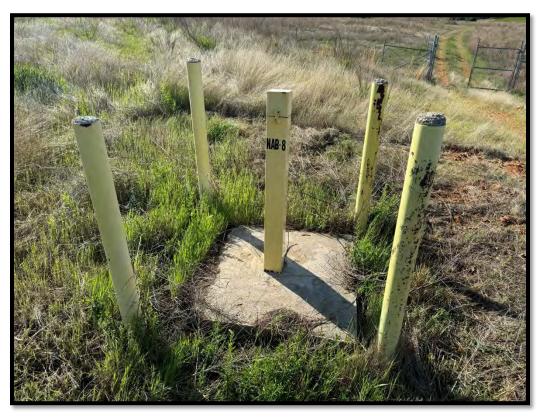
**Photo No.** 20 **Date:** 5/13/2024 **Well ID:** NAB-8

NAB-8	36.461111	-92.451944	85.6	Y	Y	The well is accessible by vehicle, with less than 3 feet of water, and is purged and sampled with a bailer. The well goes dry and recovers slowly. It is typically sampled on the next day.	_	Well accessible by vehicle — purged and sampled with bailer	
NE-2	36.460833	-92.444167	63.0	Y	Υ	Well intact and accessible by ATV only via difficult, sloped pathway	_	Well intact and accessible by foot only — need better access The well is purged and sampled with a bailer.	
NE-3	36.455000	-92.443056	27.8	Υ	Y	Well intact and accessible by vehicle; however, ATV access preferable — access is from NAB-3	_	Well intact and accessible by ATV — access road needs clearing	
NE-4	36.461762	-92.444888	112.2	Y	Y	Well intact and accessible by ATV only via difficult, sloped pathway	_	Well intact and accessible by foot only — need better access	
NE-6	36.457222	-92.452500	18.2	Υ	Υ	Well intact and accessible by ATV only via steeply sloped pathway along power easement.	_	Well intact and mostly accessible by ATV.

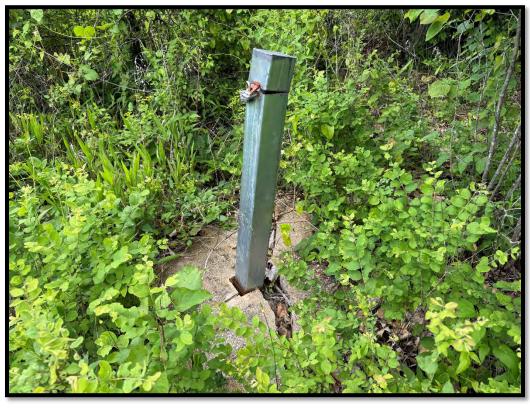
**Photo No.** 18 **Date:** 5/13/2024 **Well ID:** GP-16R

GP-9		-92.443443	Υ	N	Well intact and accessible by vehicle	N N	
GP-10		-92.443669	Υ	N	Well intact and accessible by vehicle	N N	
GP-11		-92.442778	Y	N	Well intact and accessible by vehicle	N N	
GP-12		-92.443333	Y	Y	Well intact and accessible by ATV only	N N	
GP-13		-92.445556	Y	Y	Well intact and accessible by ATV only	N N	Lock was rusted and well could not be opened or measured
GP-14	36.465000		Y	Y	Well intact and accessible by ATV only	N	
GP-14R	36.466111		Υ	Y	Well intact and accessible by ATV only	N N	
GP-15		-92.451111	Υ		Well intact and accessible by vehicle	N N	
GP-16		-92.451086	Y		Well intact and accessible by vehicle	N N	
GP-16R		-92.452500	Υ		Well was damaged a few years back by someone clearing electrical utility easement. The concrete pad is cracked and the stick-up well casing is bent preventing locking. The integrity of the well is compromised.	It is recommended that the existing well completion (3-foot by 3-foot above grade completion) be reinstalled as an above grade completion so that the well lid can be closed and the integrity of the well can be confirmed.
