DATE: December 9, 2024

RE: Bi-weekly Site Inspection
NABORS Landfill
Mountain Home, AR
Harbor Project No: ENSF-23299

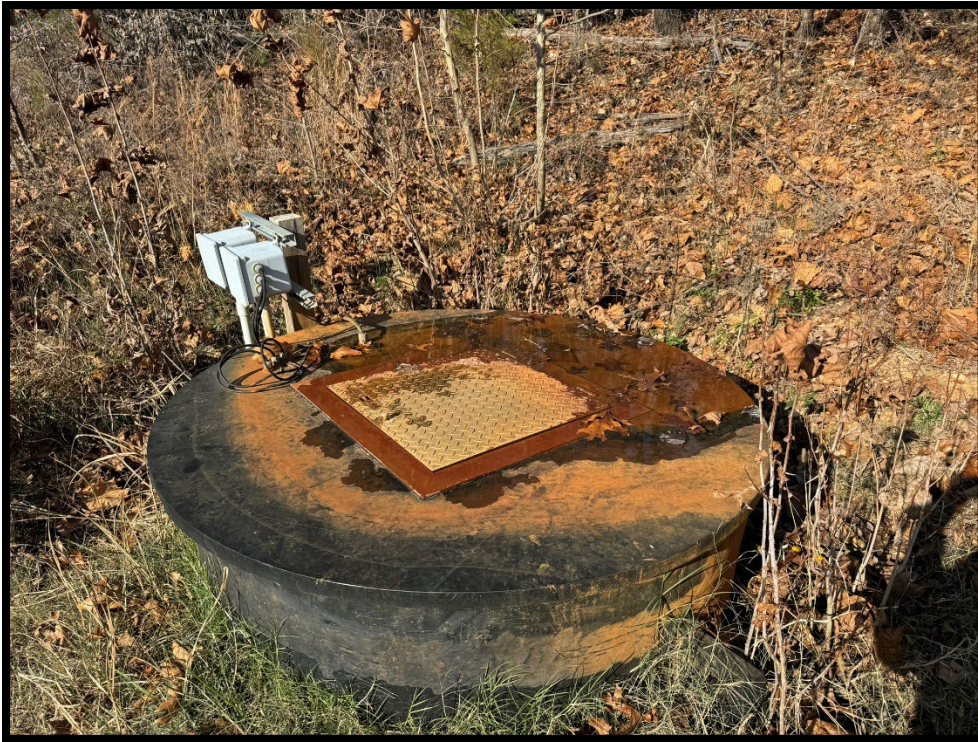
- Vertical leachate collection sump (VLCS)-1 is not functioning correctly and was observed at capacity and beginning to overflow (see photograph 1).
 - VLCS-2 appeared to be functioning correctly, and the sump was at approximately 1/2 capacity.
 - No stormwater was observed in the leachate tank battery containment. As such, no stormwater was released while Harbor was on-site (see photograph 2).
 - Landmarc was actively repairing LCS-2 during the site visit.
 - The panel displays were off at LCS-1 through LCS-5, and LCS-7 through LCS-9. The VFDs did not activate when the sump was placed in "hand" or "auto" mode.
 - LCS-7 displayed a pump fault.
-

Photograph 1: View of VLCS-1 at capacity and beginning to overflow.

- sump at capacity

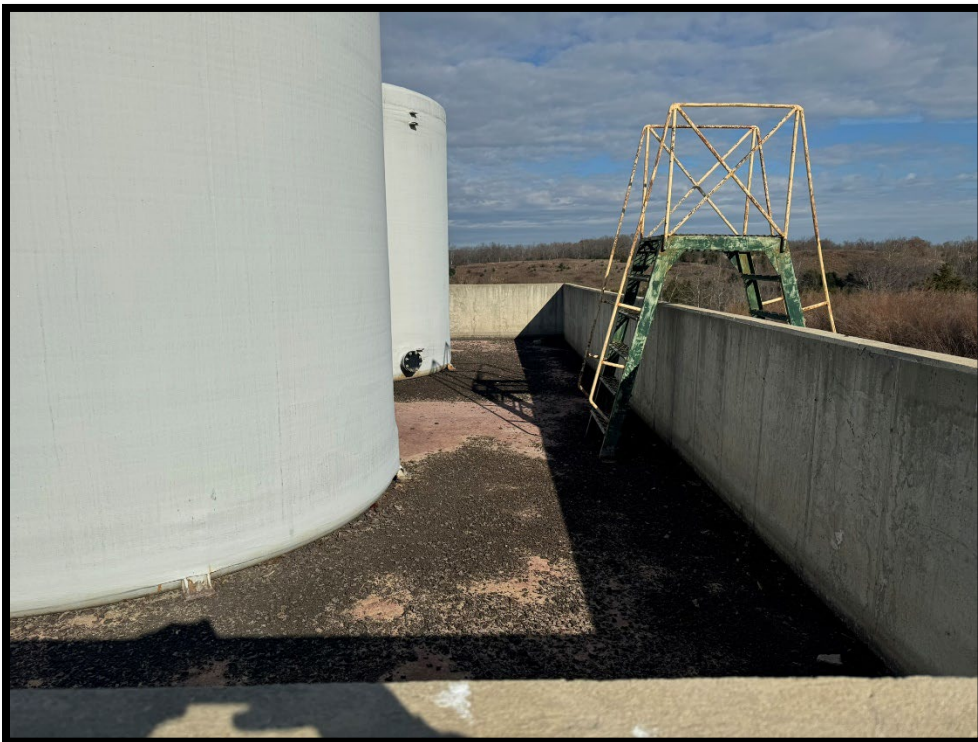
Photograph 2: View of no stormwater in leachate tank containment.

- no stormwater in containment
