**DATE:** December 9, 2024

**RE:** Bi-weekly Site Inspection  
NABORS Landfill  
Mountain Home, AR  
*Harbor Project No: ENSF-23299*

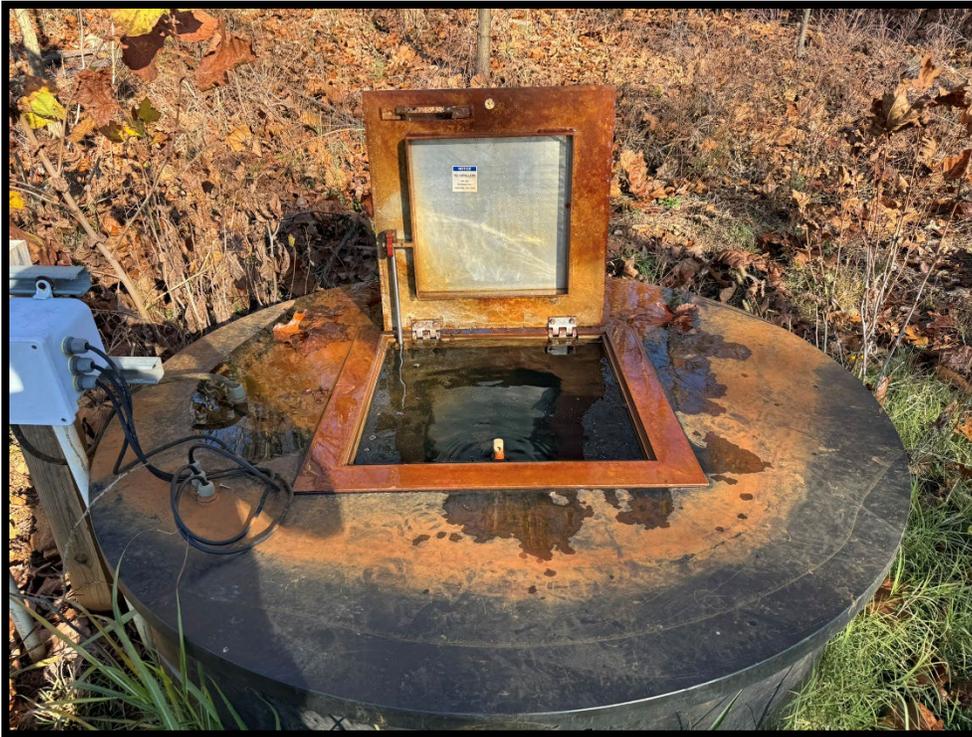
- Vertical leachate collection sump (VLCS)-1 is not functioning correctly and was observed at capacity and beginning to overflow (see photograph 1).
  - VLCS-2 appeared to be functioning correctly and the sump was at approximately 1/2 capacity.
  - Minimal stormwater was observed in the leachate tank battery containment. As such, no stormwater was released while Harbor was on-site (see photograph 2).
  - The panel displays were off at LCS-1 through LCS-5, and LCS-8 through LCS-9. The VFDs did not activate when the sump was placed in "hand" or "auto" mode.
  - LCS-6 displayed a pump fault. The red and green strobes were both active.
  - LCS-7 displayed a pump fault; and the red strobe was active.
-

**Photograph 1:** View of VLCS-1 at capacity and beginning to overflow.

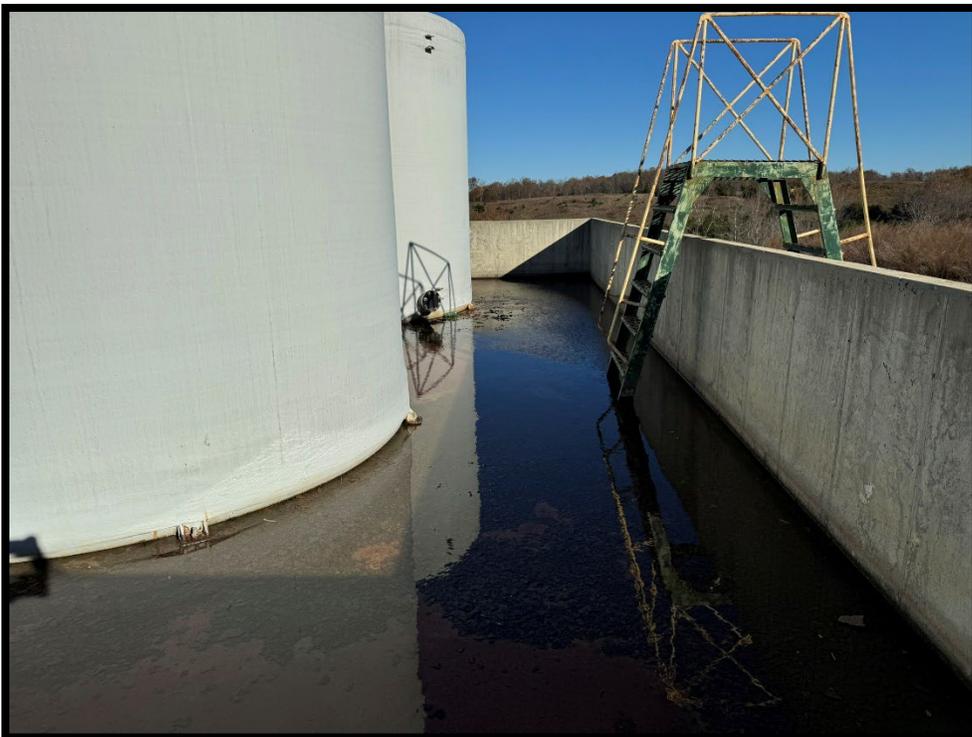
**Photograph 2:** View of minimal stormwater in leachate tank containment.
