DATE: August 12, 2024

RE: Bi-weekly Site Inspection
NABORS Landfill
Mountain Home, AR
Harbor Project No: ENSF-23299

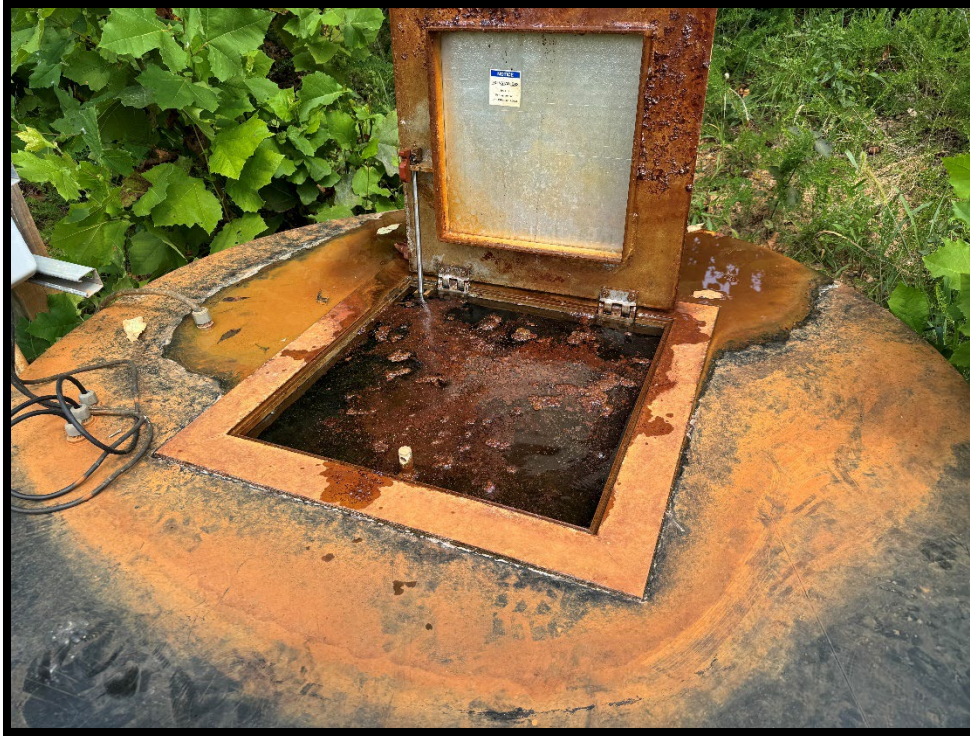
- Vertical leachate collection sump (VLCS)-1 was at capacity and overflowing into the nearby area (see photographs 1-2).
 - VLCS-2 appeared to be functioning correctly. The sump was at approximately half capacity.
 - No stormwater was observed in the leachate tank battery secondary containment (see photograph 3).
 - The panel displays were off at LCS-1 – LCS-5, LCS-7, and LCS-8. The displays were completely off and the VFDs did not activate when the sump was placed in "hand" or "auto" mode.
 - LCS-6 displayed a pump fault. However, the green strobe was activated and remain activated when the sump was cycled through the "hand" and "auto" functions.
 - LCS-7 also displayed a pump fault, and the red strobe was activated.
 - The closure turf is damaged around several vent pipes near LCS-4. A turbine vent near LCS-8 has also detached.
-

Photograph 1: View of VLCS-1 at capacity.

- sump overflowing, panel making buzzing noise

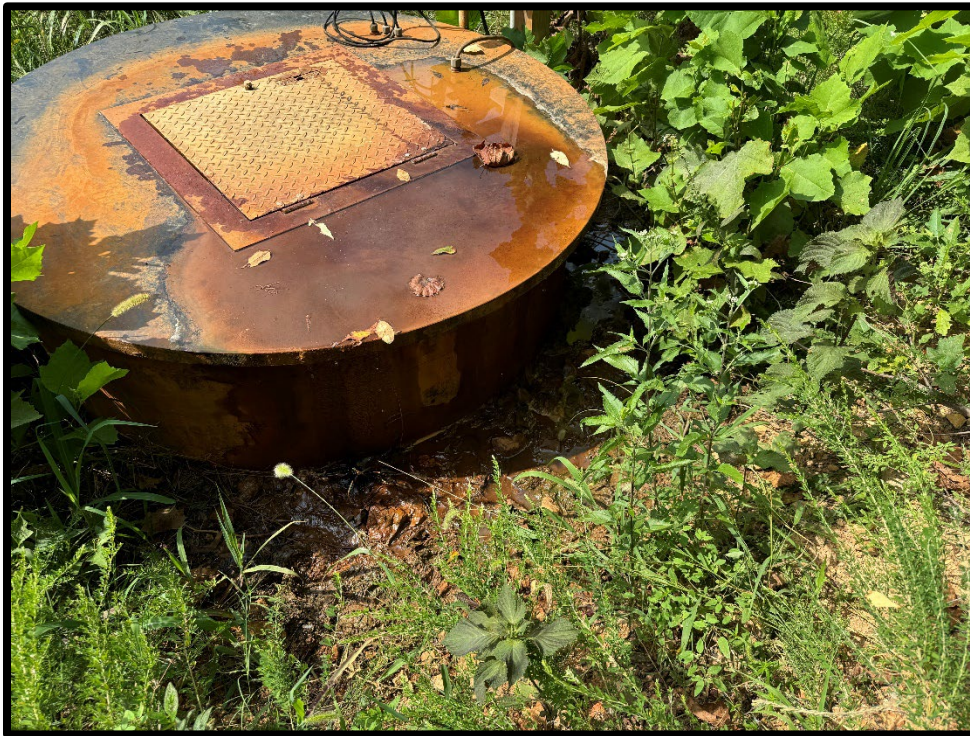
Photograph 2: View of VLCS-1 overflowing to ground.

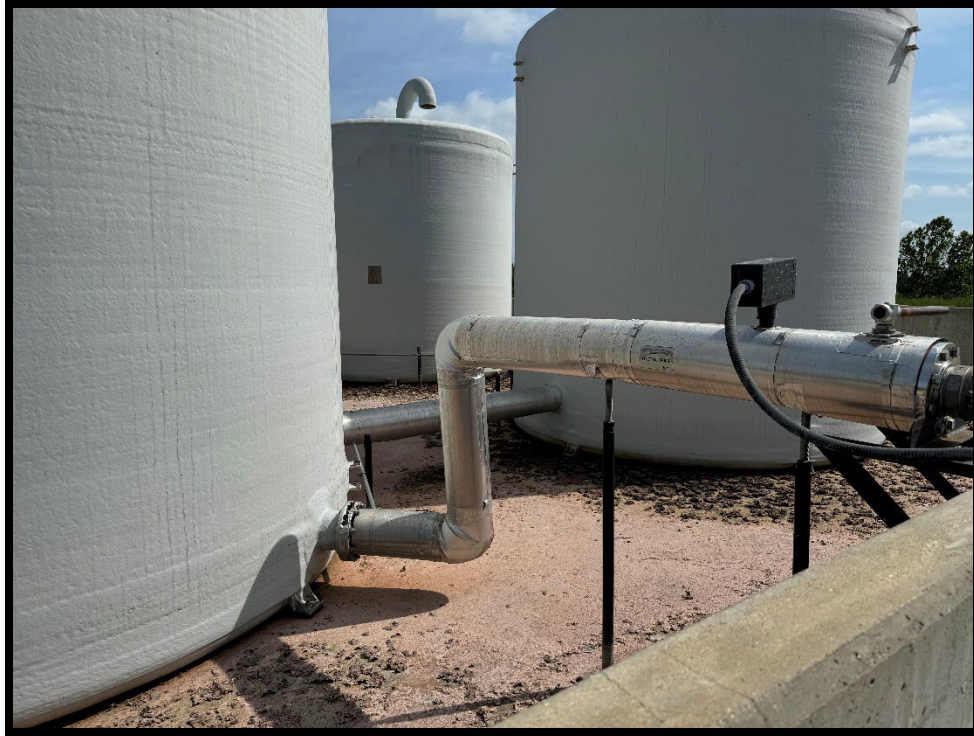
Photograph 3: View of dry leachate tank battery secondary containment.

- no stormwater

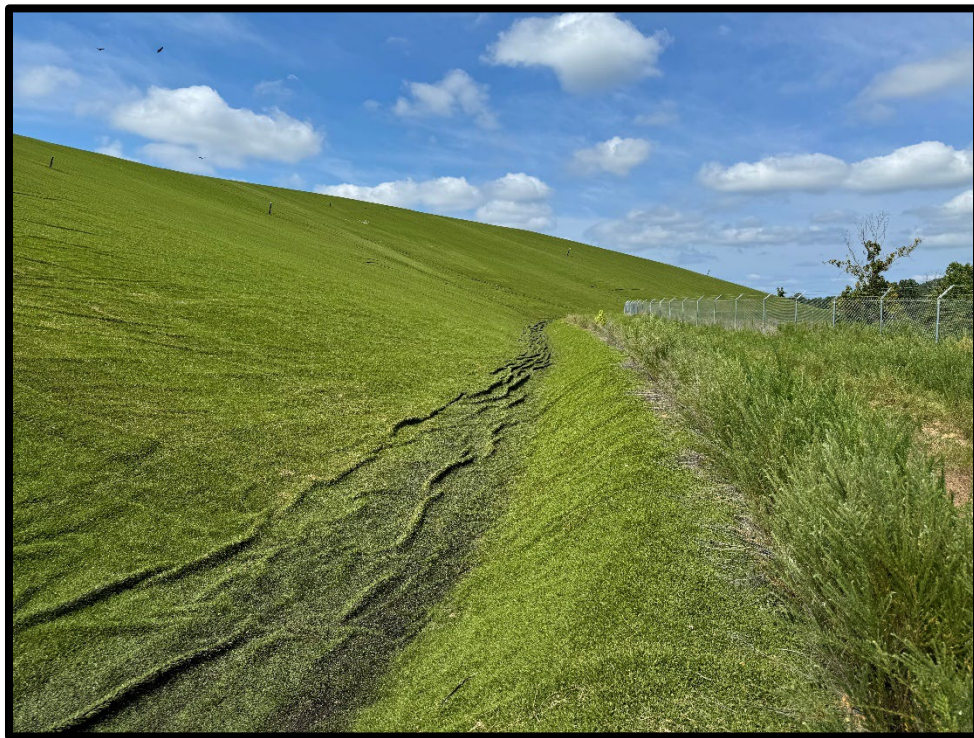
- The closure turf has some significant rills present between LCS-1 and LCS-2, on the north side of Area 1-2. These rills have sediment deposited in them which is allowing vegetation to grow. Woody vegetation is growing on the edges of the liner throughout the landfill. An erosional washout is present along the road between LCS-4 and LCS-5 (see photographs 4-16).

Photograph 4: View of rills present in closure turf of north side of Area 1-2.

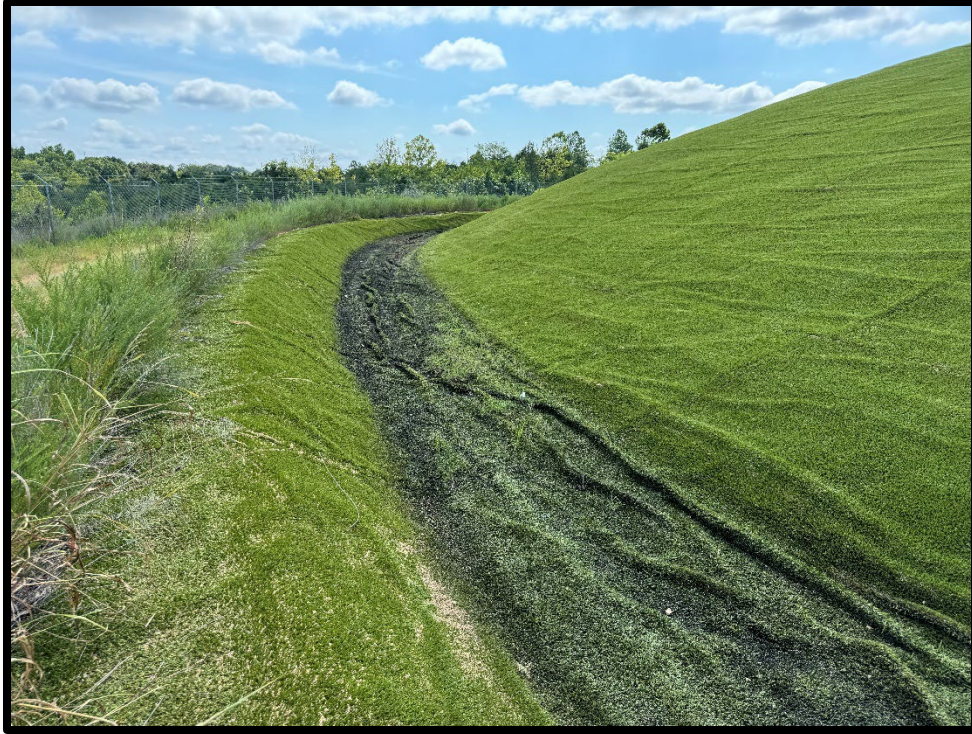
Photograph 5: View of rills present in closure turf of north side of Area 1-2.

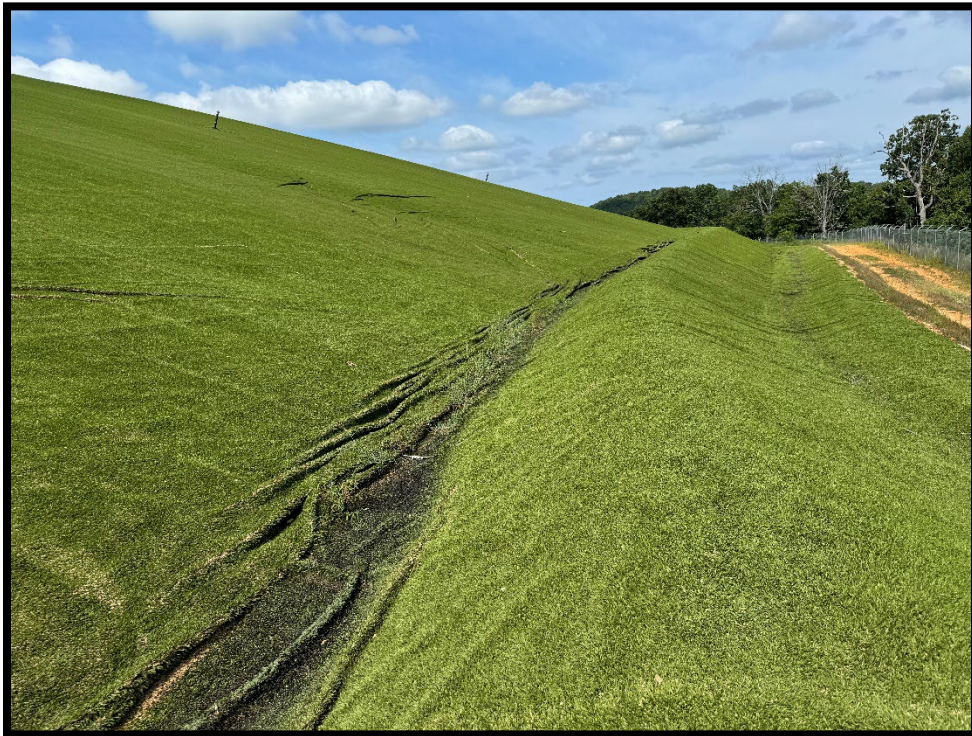
Photograph 6: View of rills present in closure turf of north side of Area 1-2.

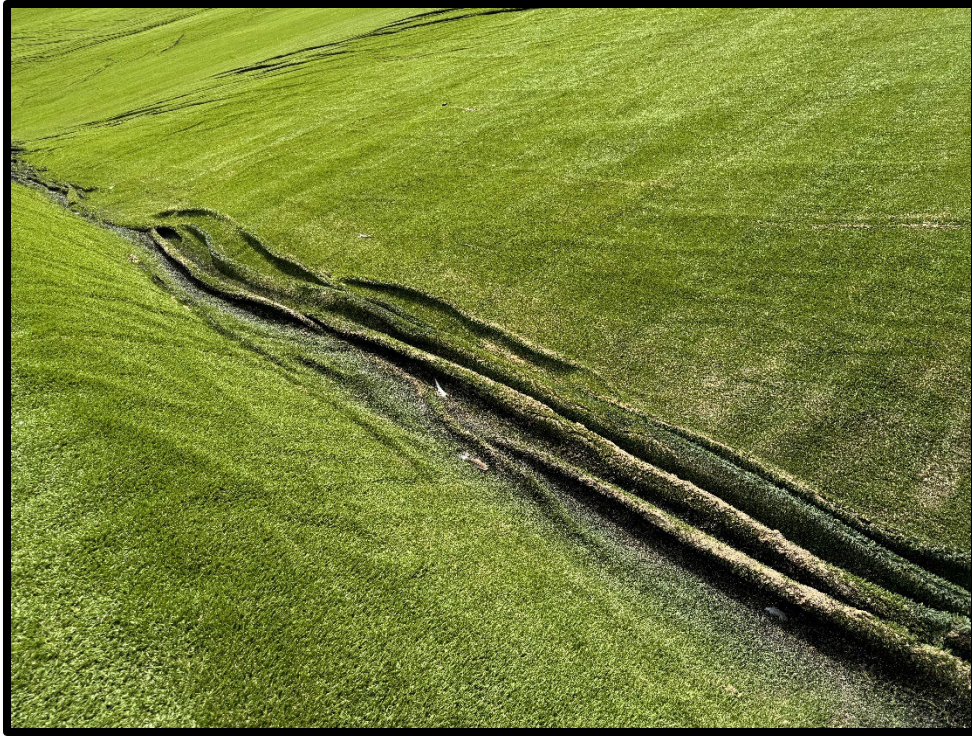
Photograph 7: View of rills present in closure turf of north side of Area 1-2.

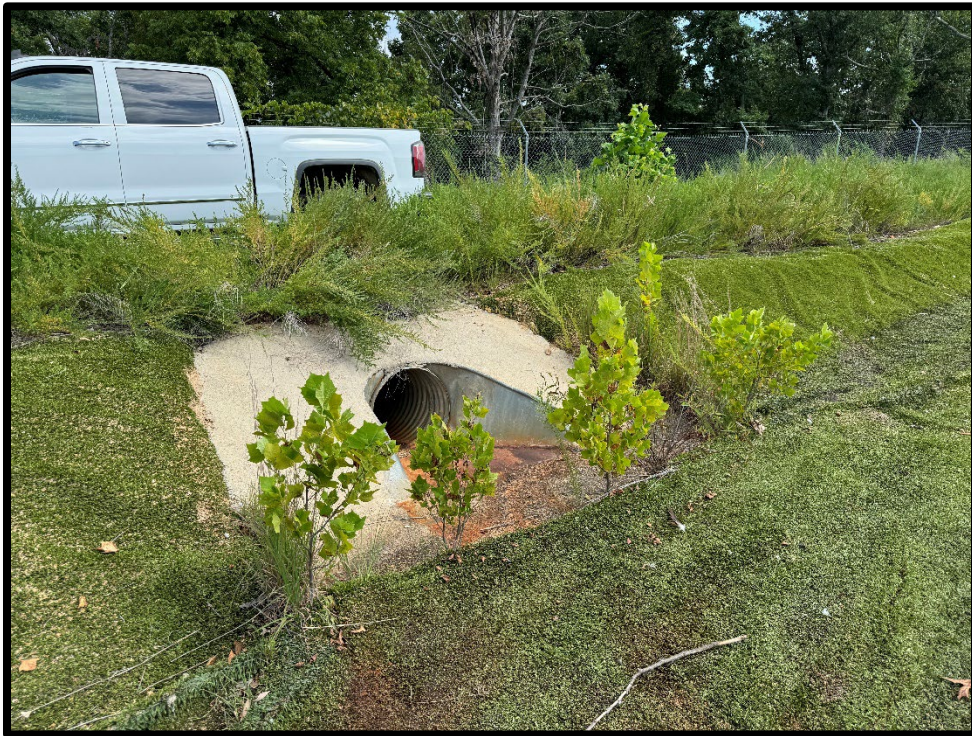
Photograph 8: View of woody vegetation growing in closure turf on north side of Area 1-2.

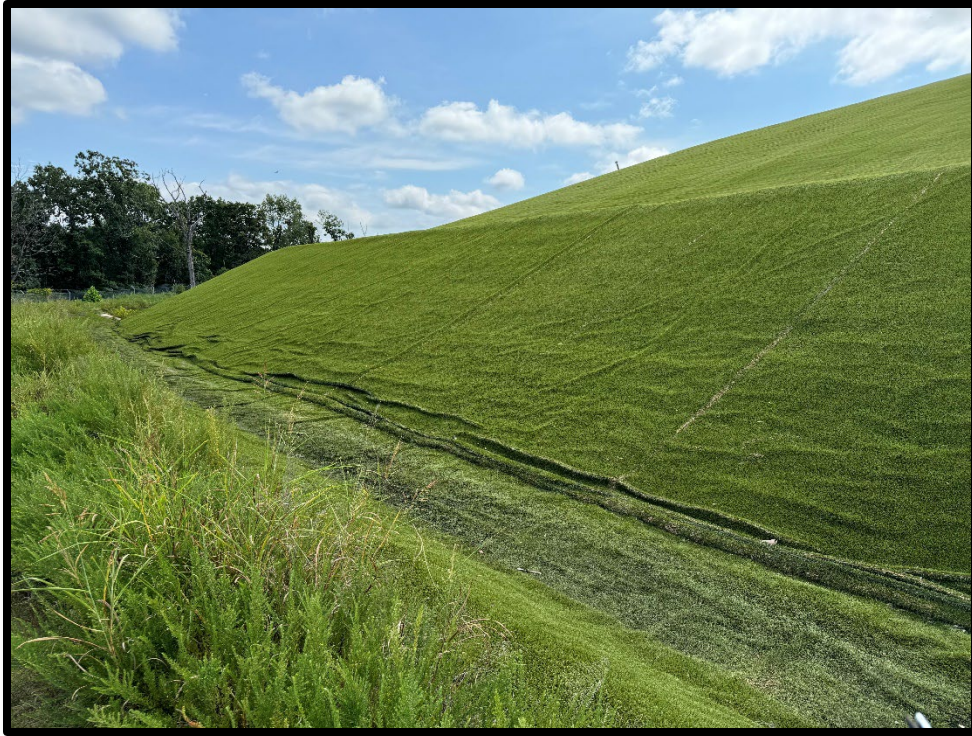
Photograph 9: View of rills present in closure turf of north side of Area 1-2.

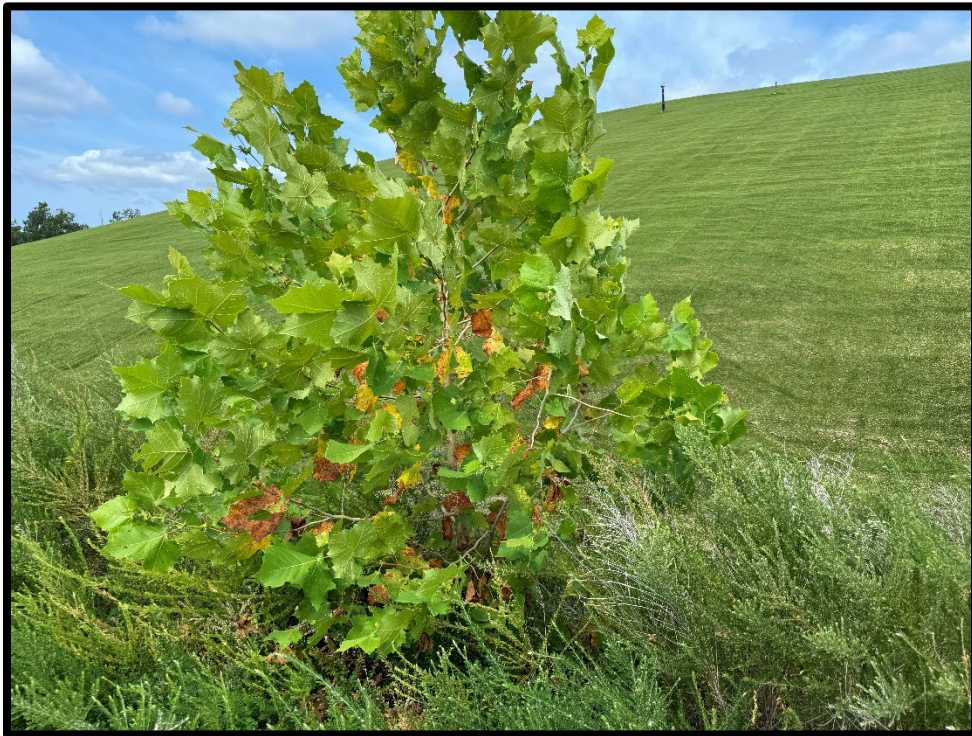
Photograph 10: View of woody vegetation growing in closure turf on north side of Area 1-2.

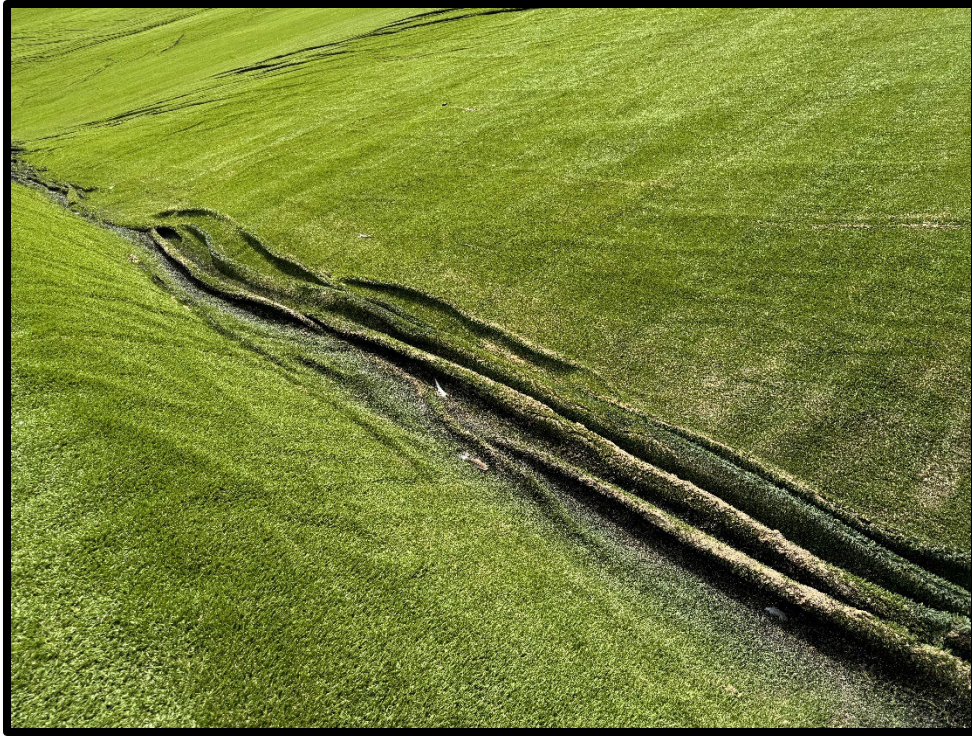
Photograph 11: View of rills present in closure turf of north side of Area 1-2.

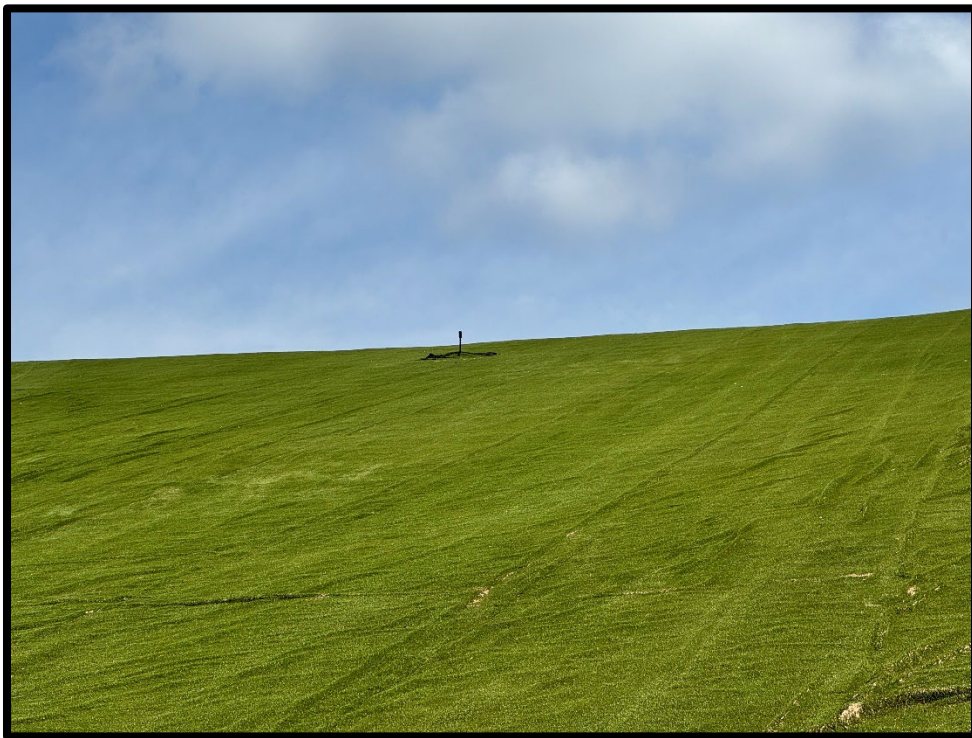
Photograph 12: View of damaged closure turf around vent near LCS-4.

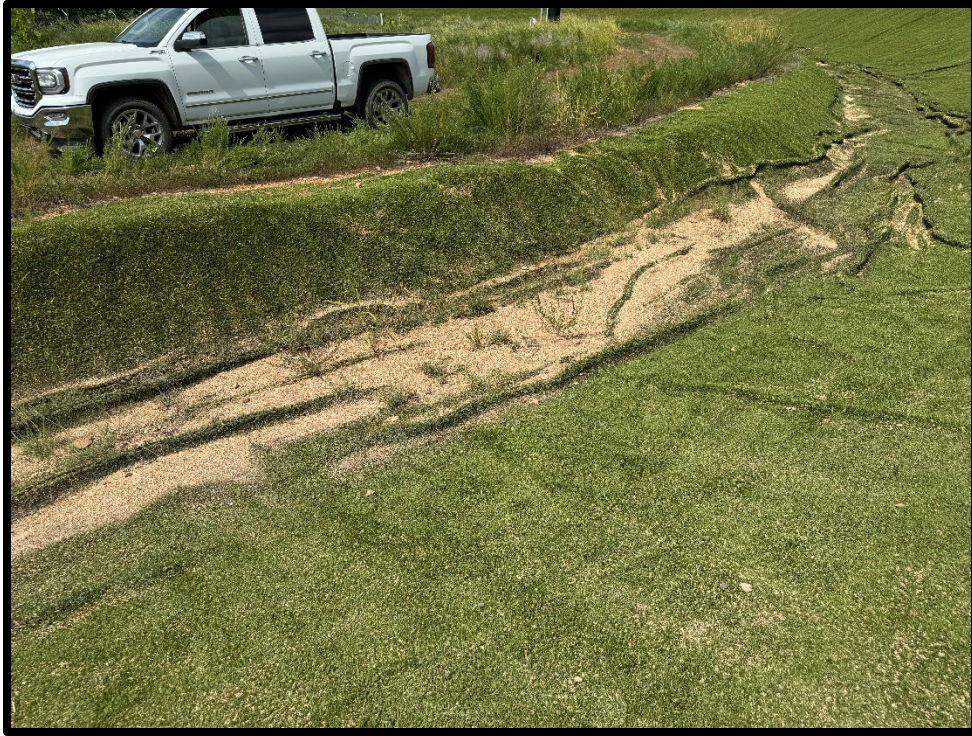
Photograph 13: View of sediment present on closure turf near LCS-4.

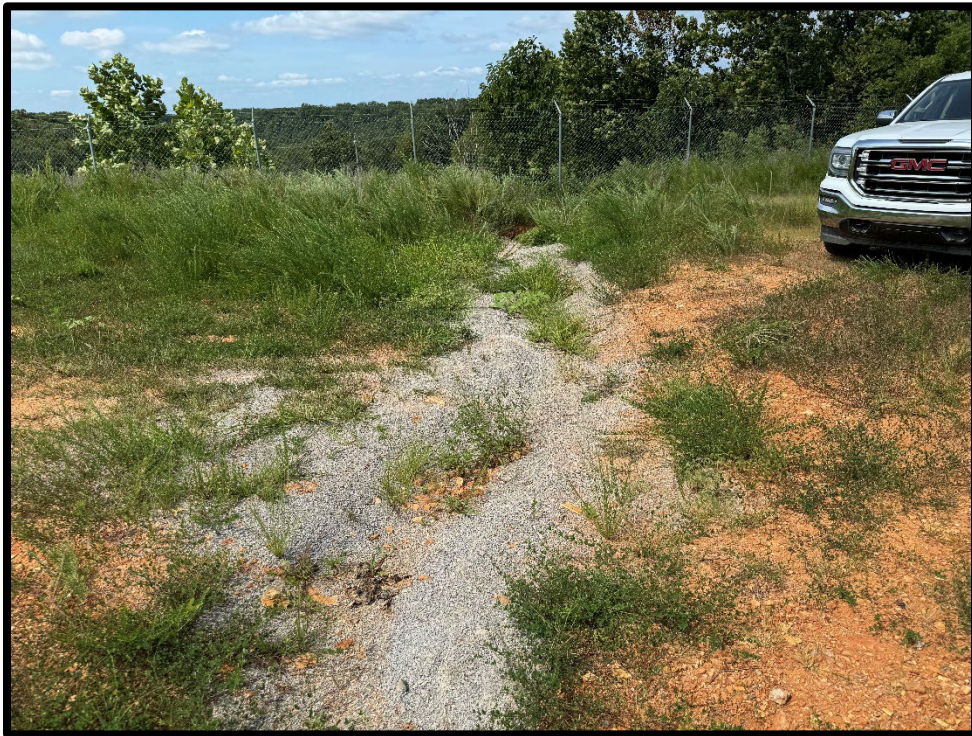
Photograph 14: View of washout present in road between LCS-4 and LCS-5.

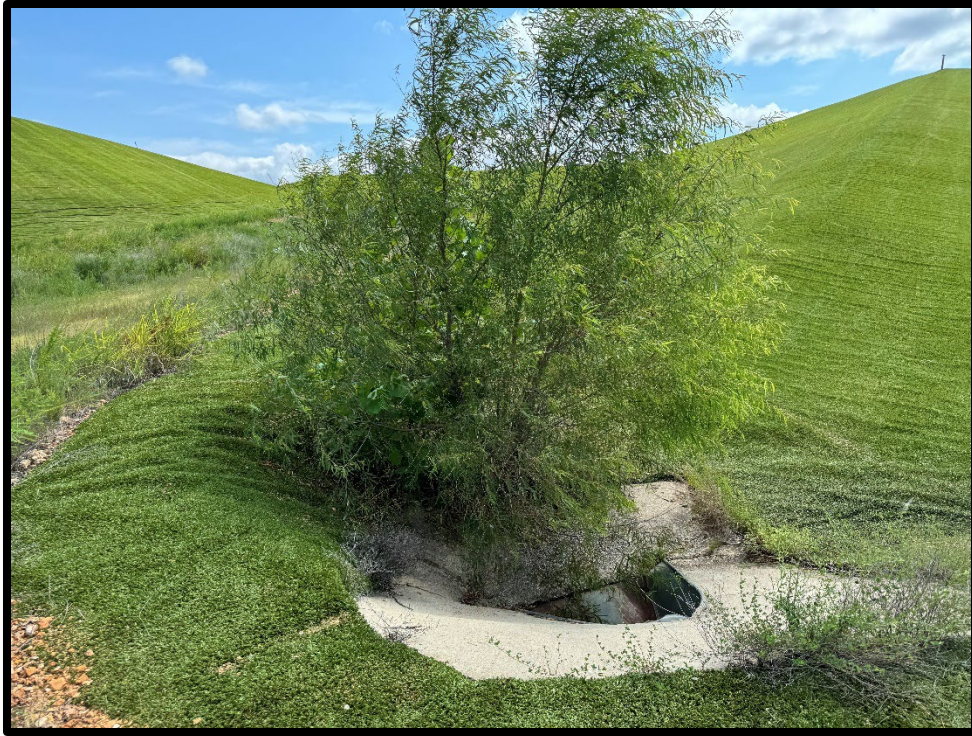
Photograph 15: View of woody vegetation growing in closure turf near LCS-5.

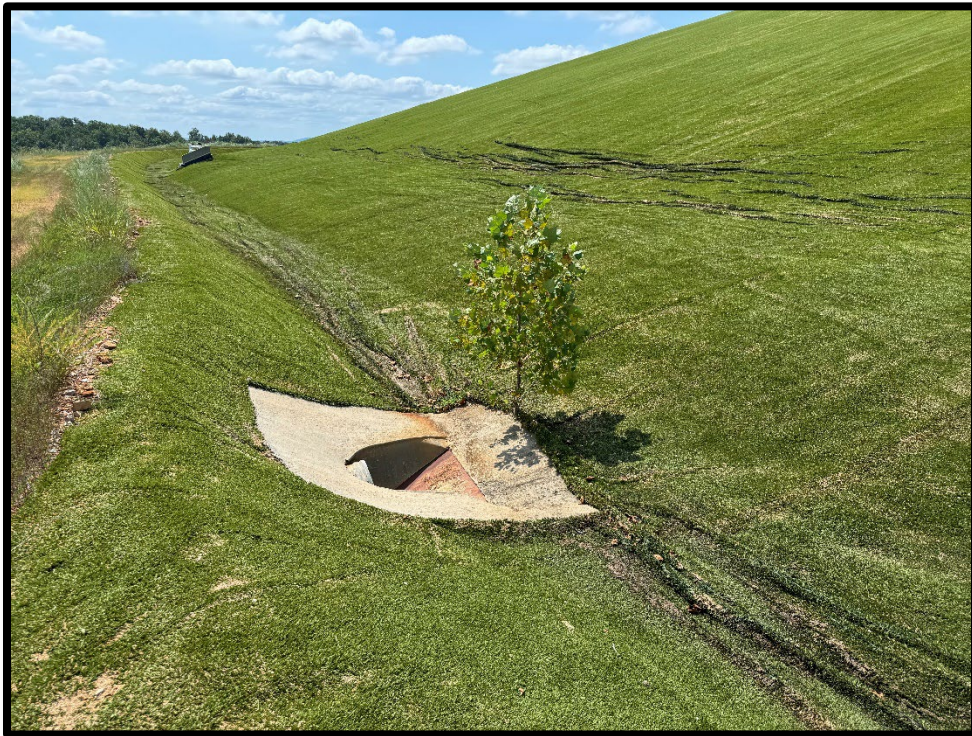
Photograph 16: View of woody vegetation growing in closure turf near LCS-7.
