DATE: August 27, 2024

RE: Bi-weekly Site Inspection
NABORS Landfill
Mountain Home, AR
Harbor Project No: ENSF-23299

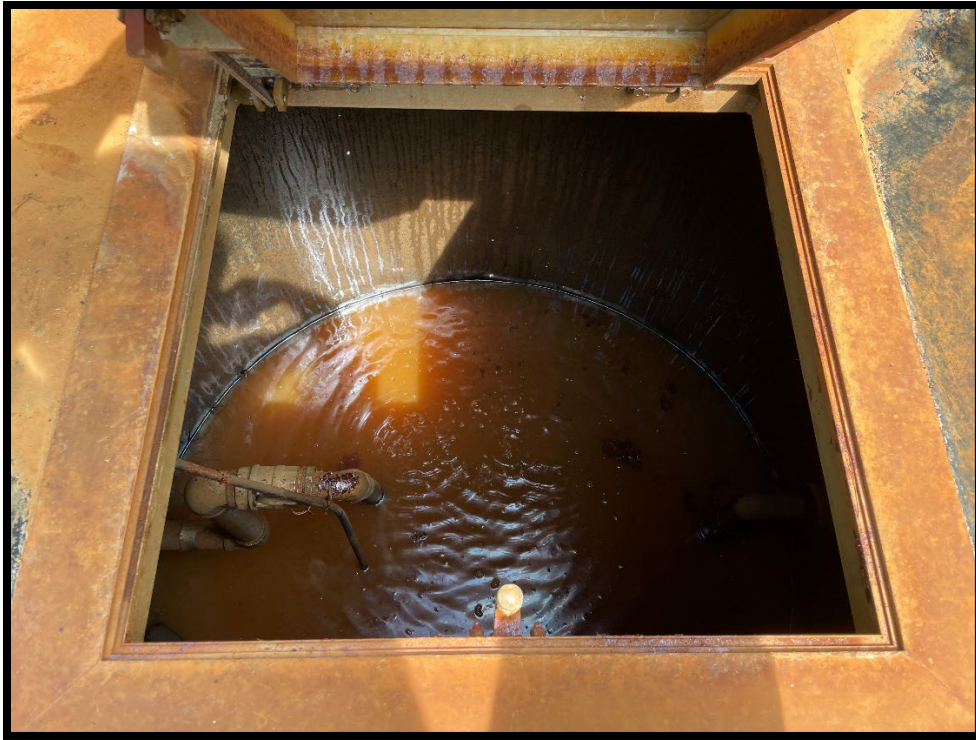
- Vertical leachate collection sump (VLCS)-1 was at 3/4 capacity (See photograph 1).
- VLCS-2 appeared to be functioning correctly. The sump was at approximately 1/4 capacity.

Photograph 1: View of VLCS-1 near capacity.

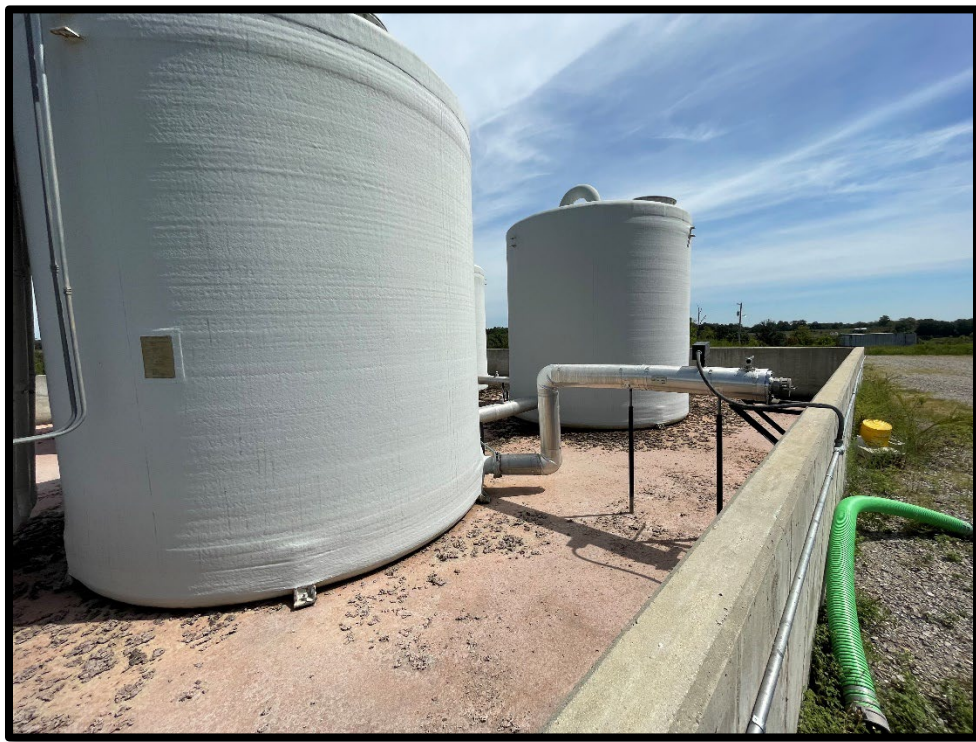
- No stormwater was observed in the leachate tank battery secondary containment (See photograph 2).
- The panel displays were off at LCS-1 through LCS-5, and LCS-7 through LCS-9. The VFDs did not activate when the sump was placed in “hand” or “auto” mode.

Photograph 2: View of dry leachate tank battery secondary containment.

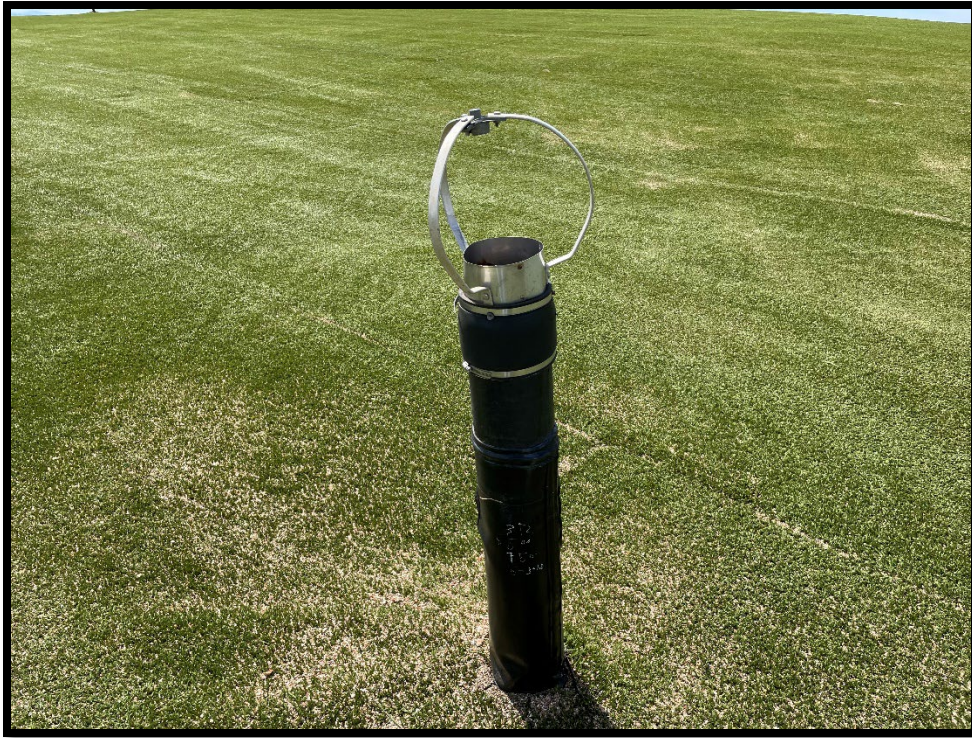
- LCS-6 displayed a pump fault; however, the green and red strobes were active.
- The closure turf is damaged around several vent pipes near LCS-4. A turbine vent near LCS-8 has also detached. A turbine vent near LCS-6 has also detached (See photograph 3).

Photograph 3: View of detached turbine vent near LCS-6.

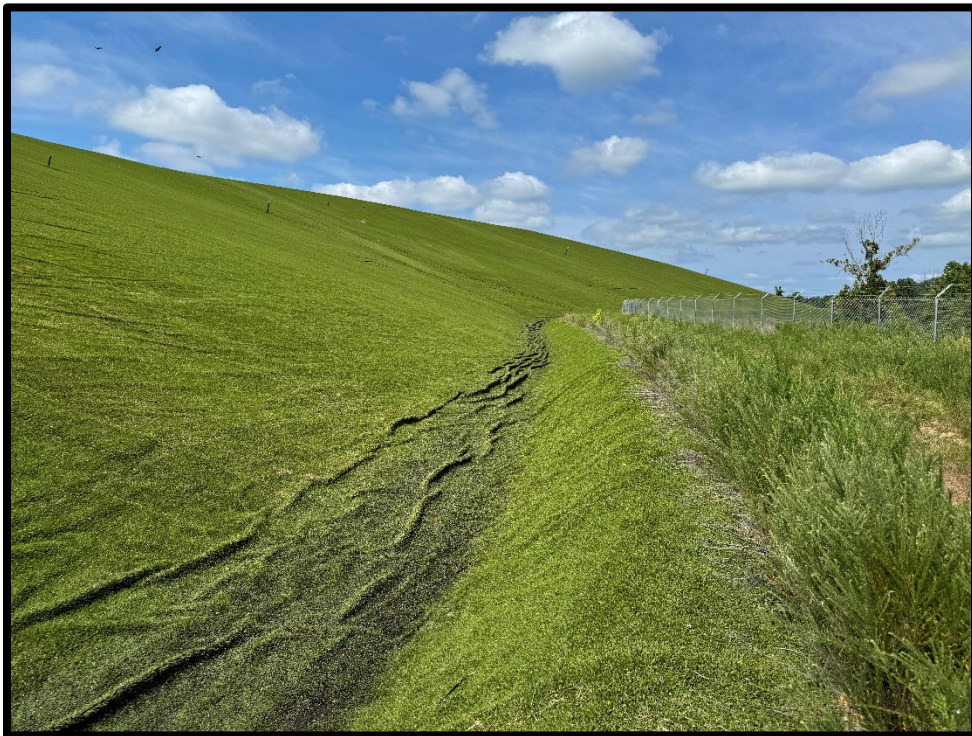
- The closure turf has some significant rills present between LCS-1 and LCS-2 on the north side of Area 1-2. These rills have sediment deposited in them which is allowing vegetation to grow. Woody vegetation is growing on the edges of the liner throughout the landfill. An erosional washout is present along the road between LCS-4 and LCS-5 (see photographs 4-17).

Photograph 4: View of rills present in closure turf of north side of Area 1-2.

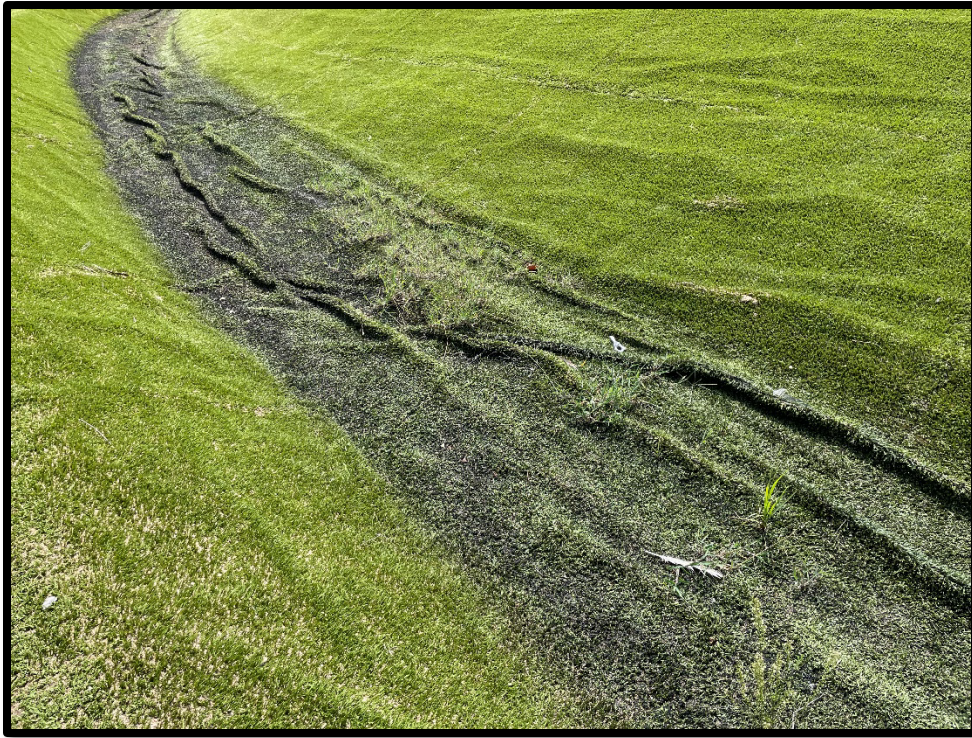
Photograph 5: View of rills present in closure turf of north side of Area 1-2.

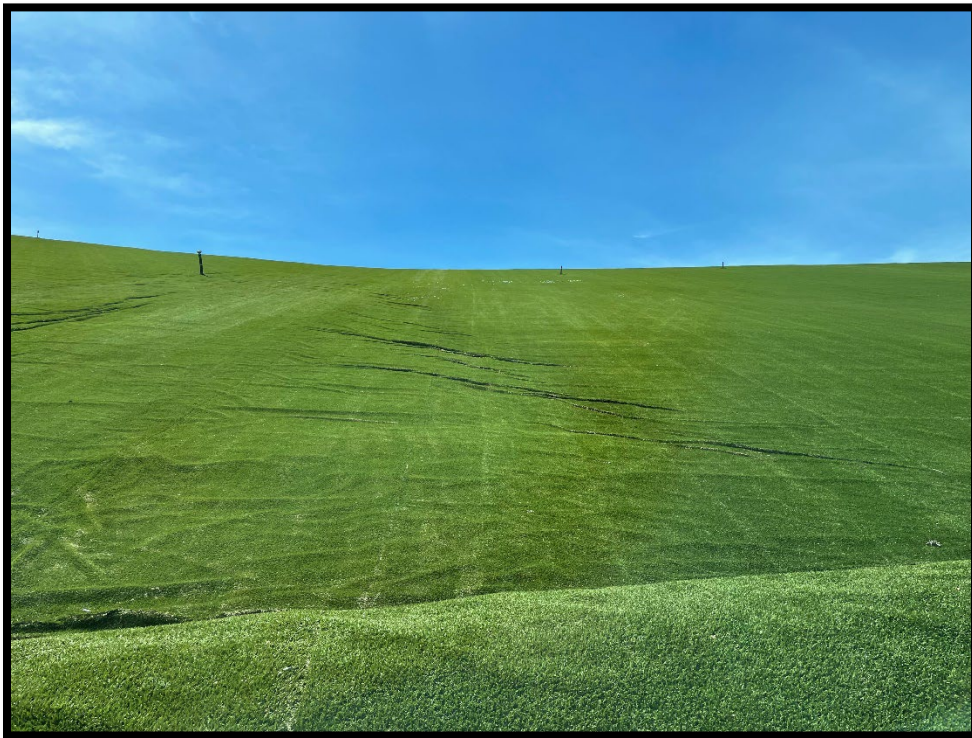
Photograph 6: View of rills present in closure turf of north side of Area 1-2.

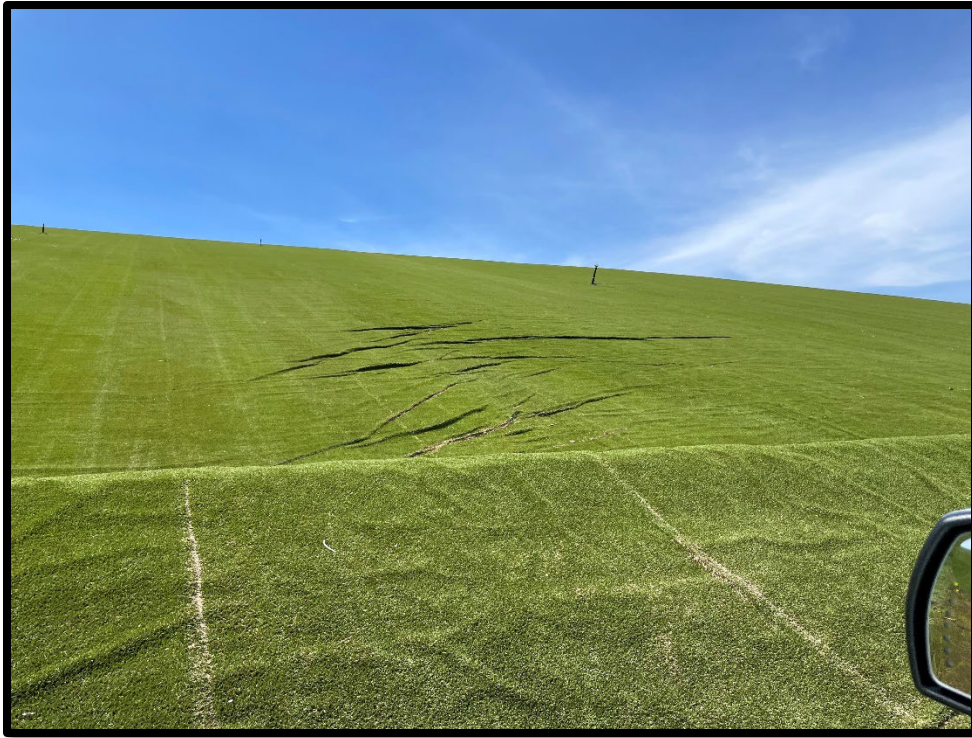
Photograph 7: View of rills present in closure turf of north side of Area 1-2.

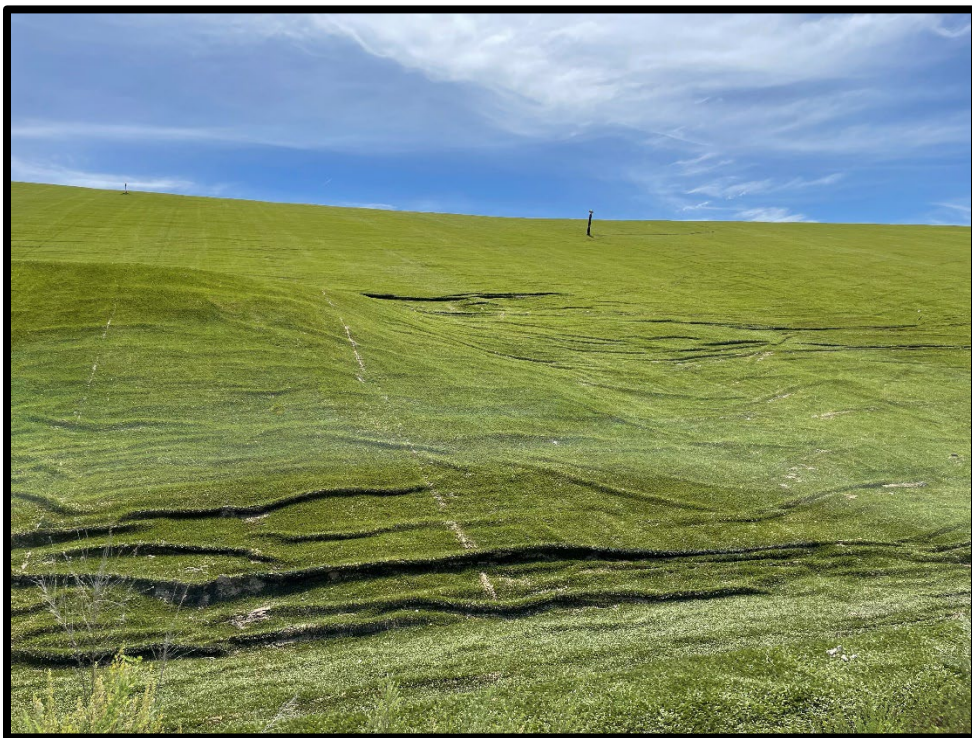
Photograph 8: View of rills present in closure turf of north side of Area 1-2.

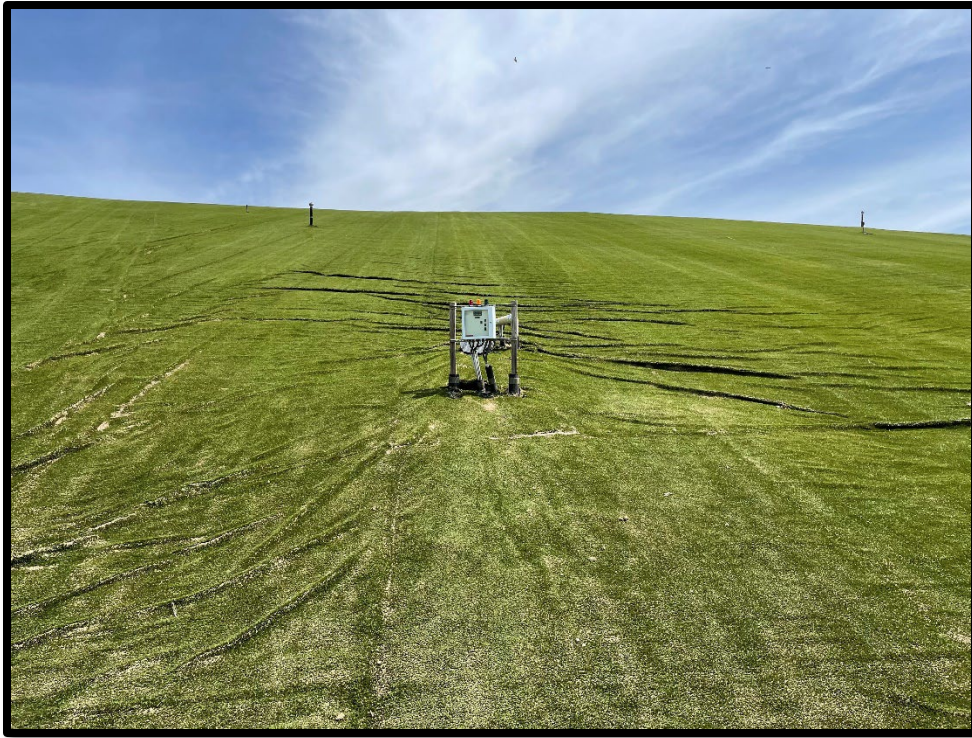
Photograph 9: View of rills present in closure turf near LCS-3.

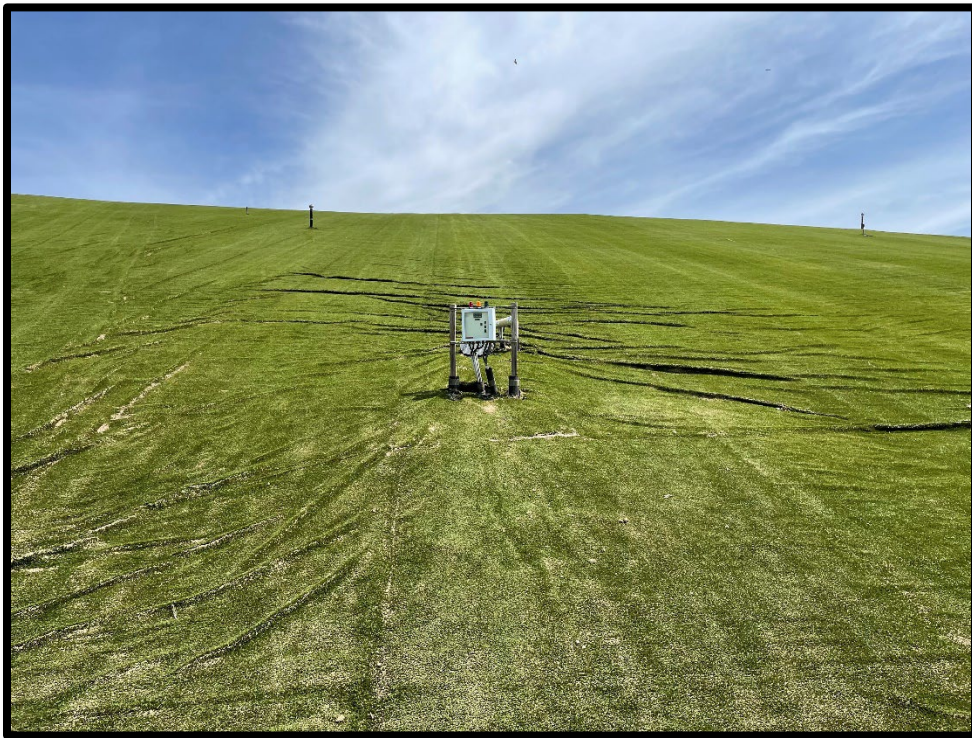
Photograph 10: View of rills present in closure turf near LCS-3.

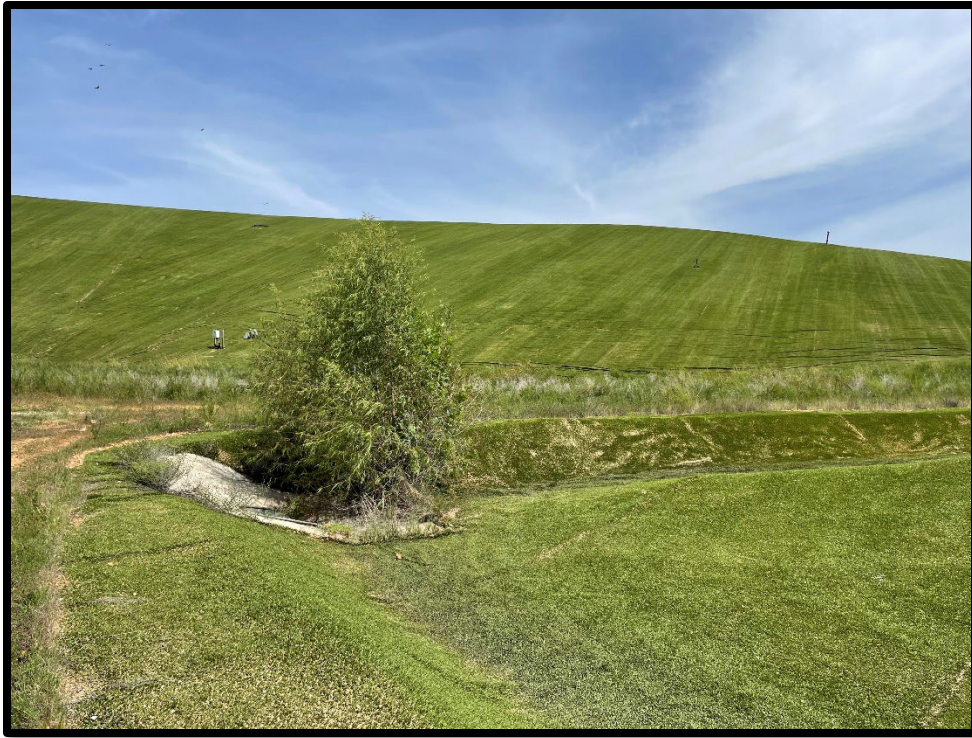
Photograph 11: View of woody vegetation near LCS-4.

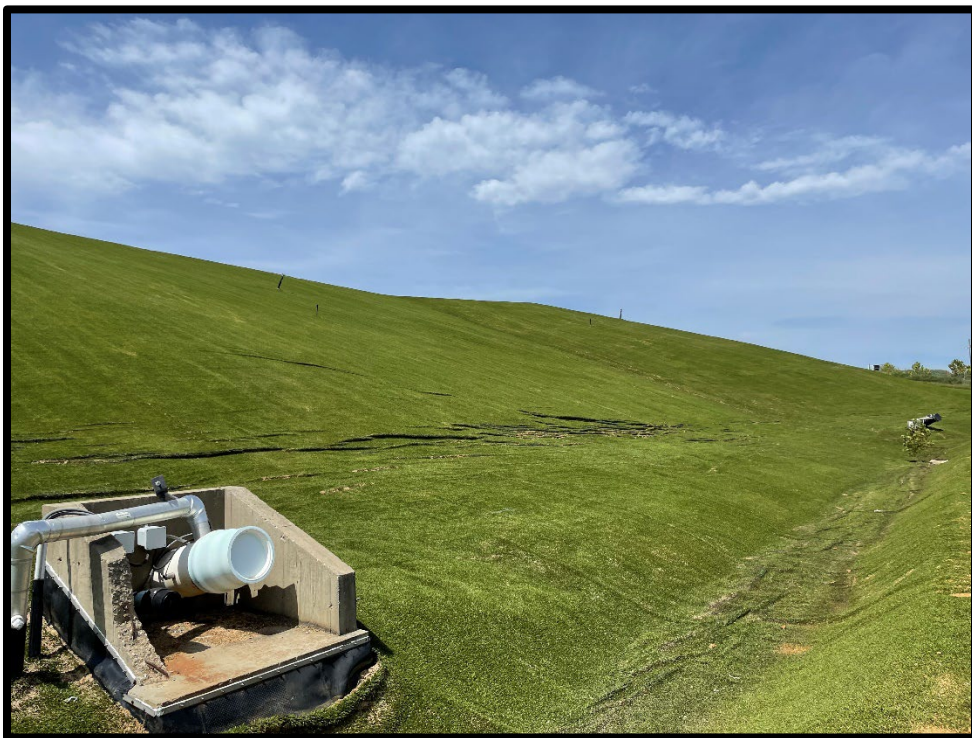
Photograph 12: View of rills near LCS-8.

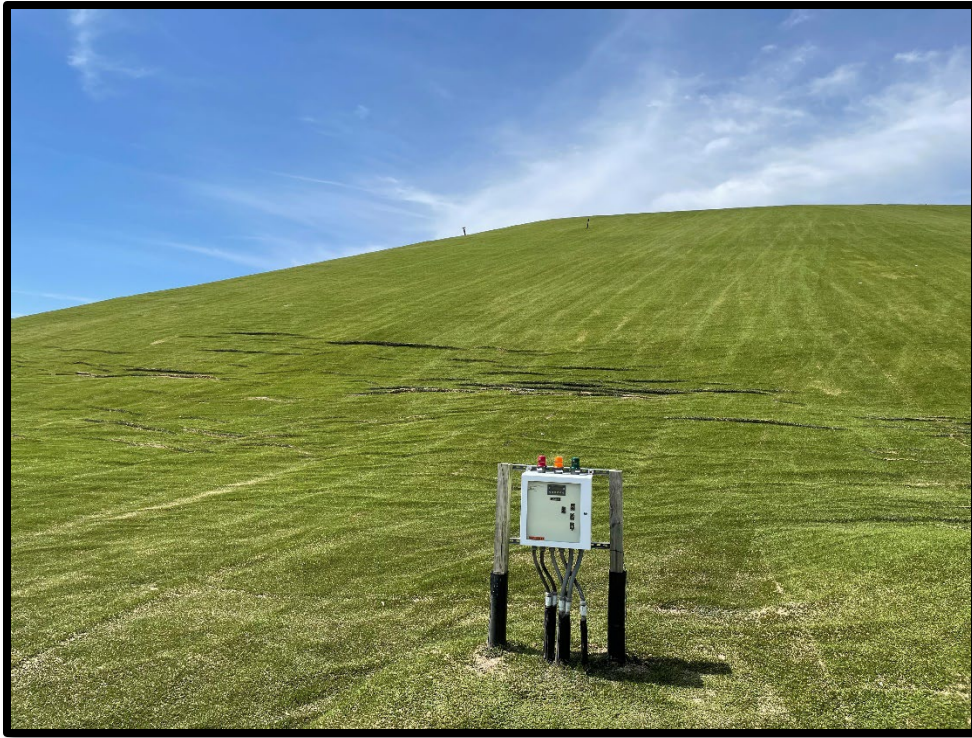
Photograph 13: View of rills near LCS-7.

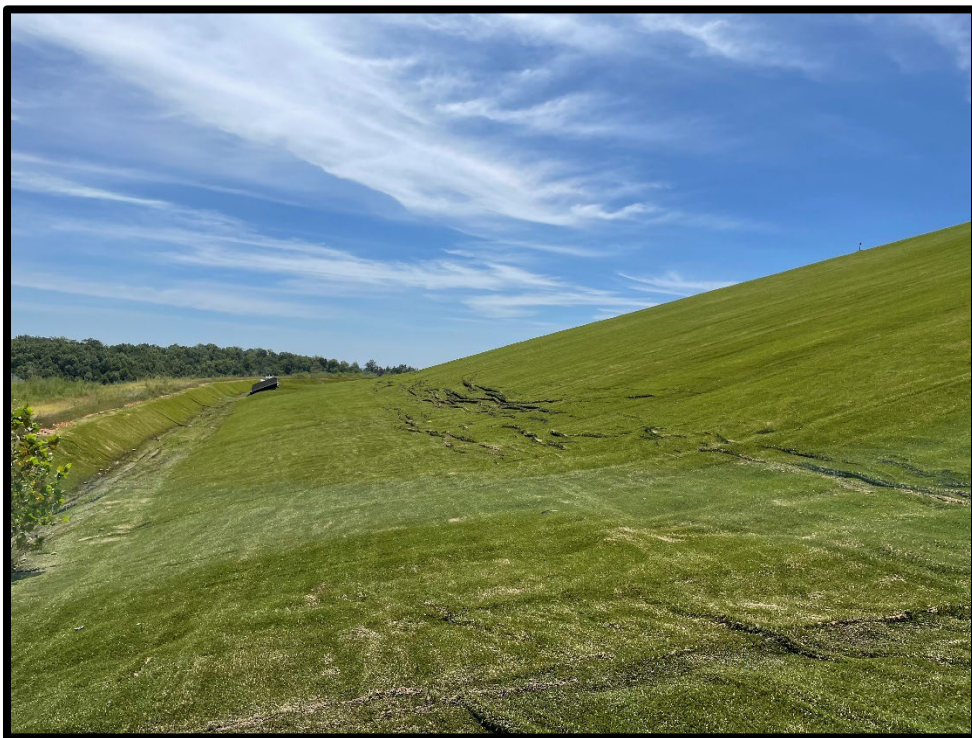
Photograph 14: View of rills near LCS-6.

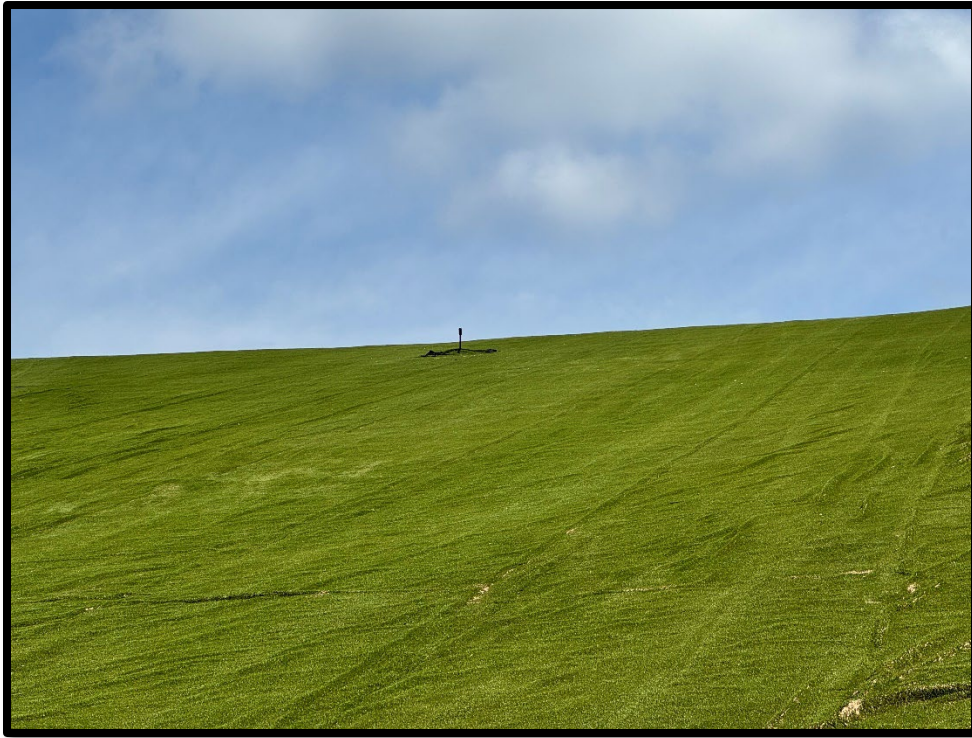
Photograph 15: View of damaged closure turf around vent near LCS-4.

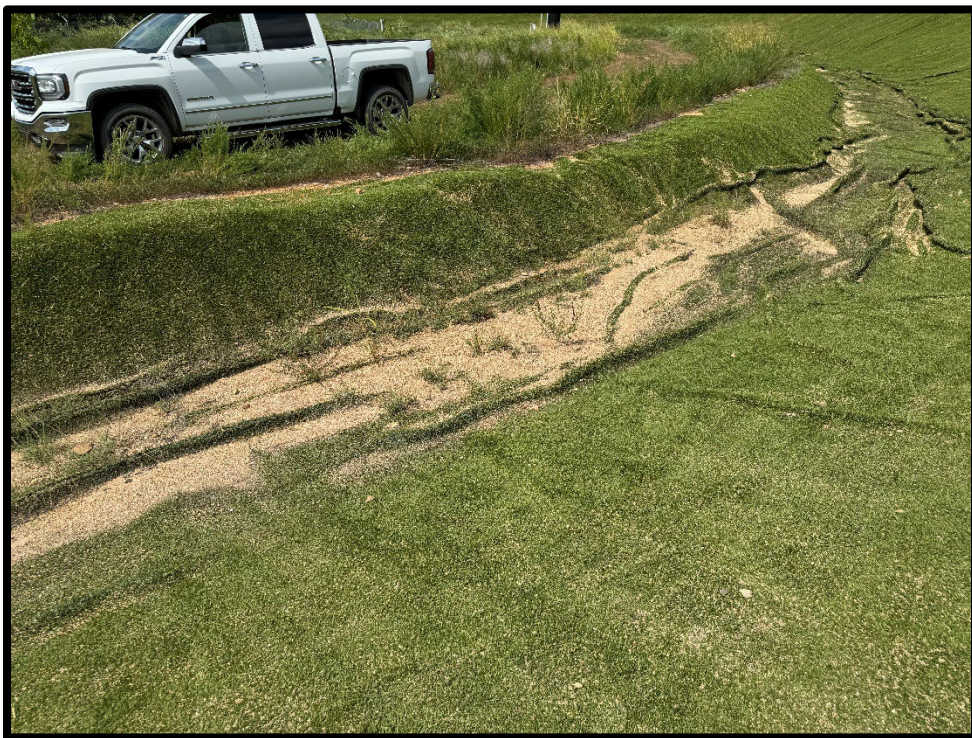
Photograph 16: View of sediment present on closure turf near LCS-4.

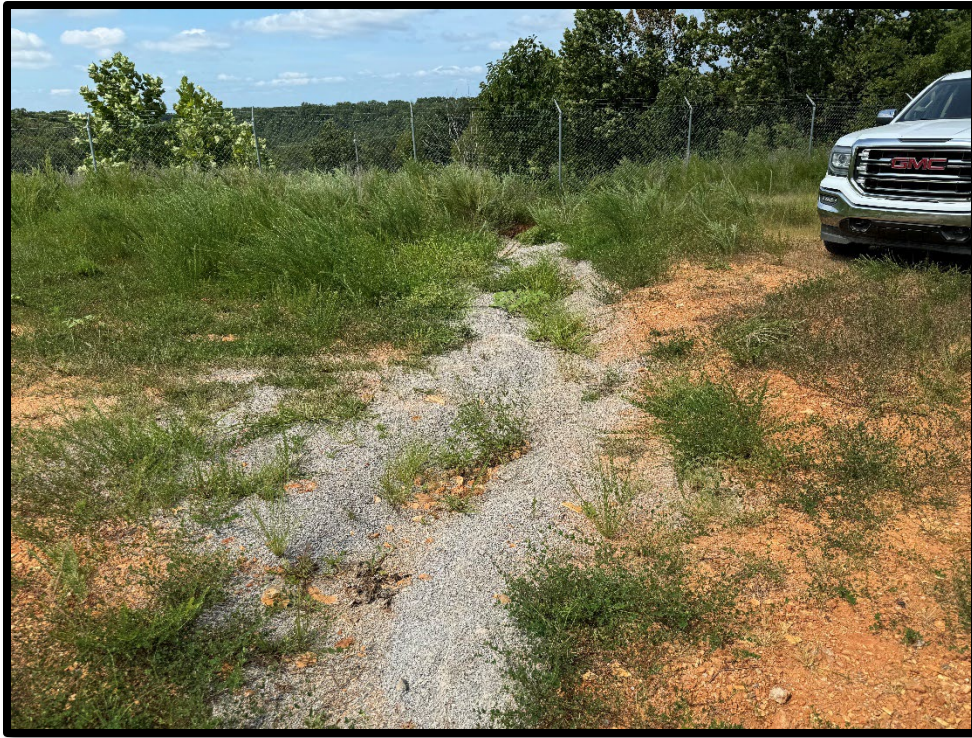
Photograph 17: View of washout present in road between LCS-4 and LCS-5.
