**DATE:** September 19, 2024

**RE:** Bi-weekly Site Inspection  
NABORS Landfill  
Mountain Home, AR  
*Harbor Project No: ENSF-23299*

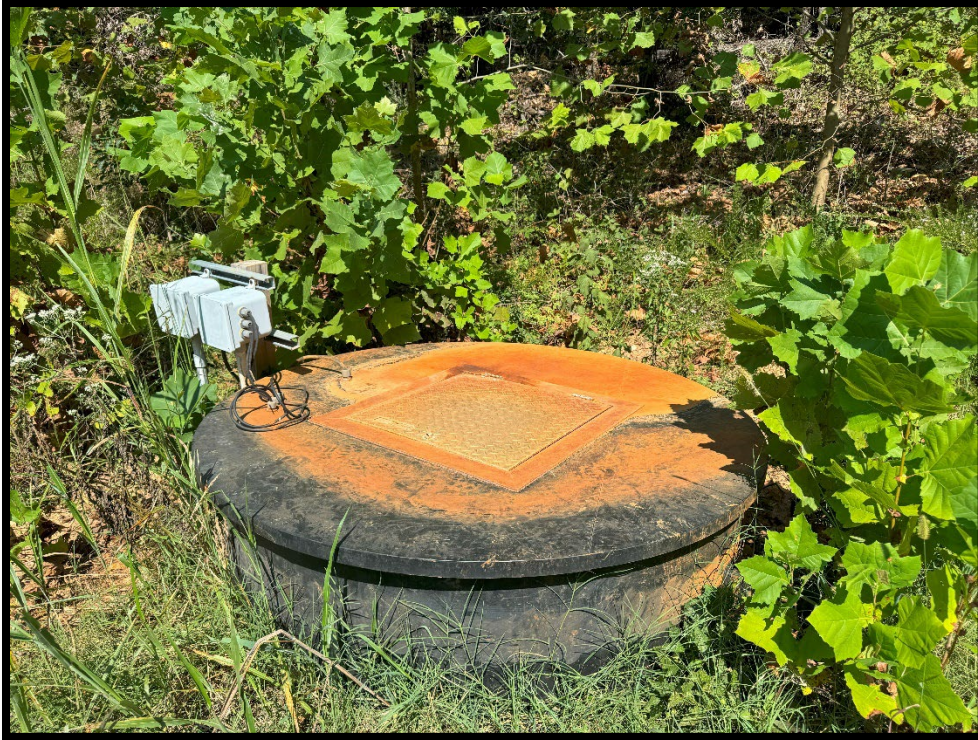
**Photograph 1:** View of VLCS-1.

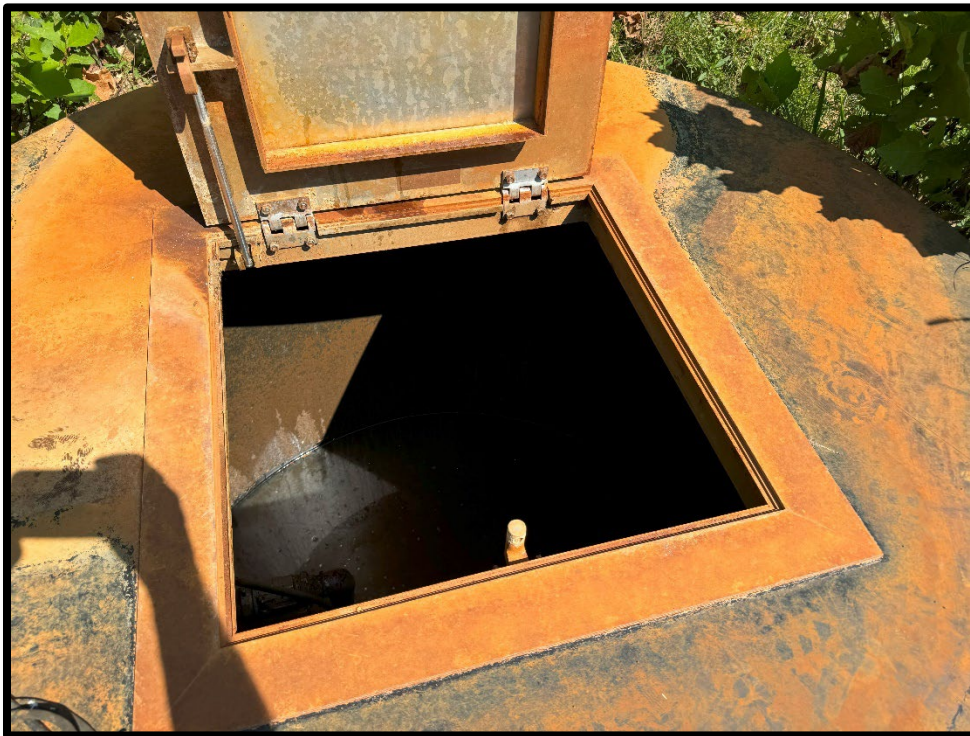
- Vertical leachate collection sump (VLCS)-1 was at approximately 1/2 - 2/3 capacity (see photographs 1 and 2).
- VLCS-2 appeared to be functioning correctly and the sump was at approximately 1/4 – 1/3 capacity (see photographs 3 and 4).
- Minimal stormwater was observed in the leachate tank battery secondary containment (See photographs 5 and 6).

**Photograph 2:** View of VLCS-1 sump at 1/2 - 2/3 capacity.

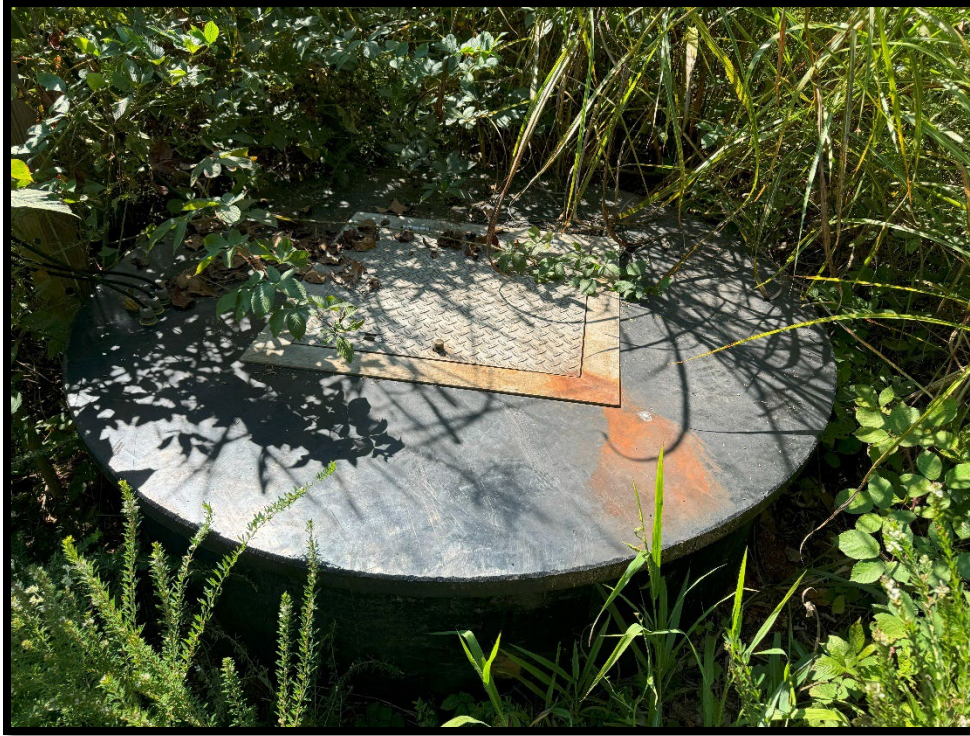
**Photograph 3:** View of VLCS-2.

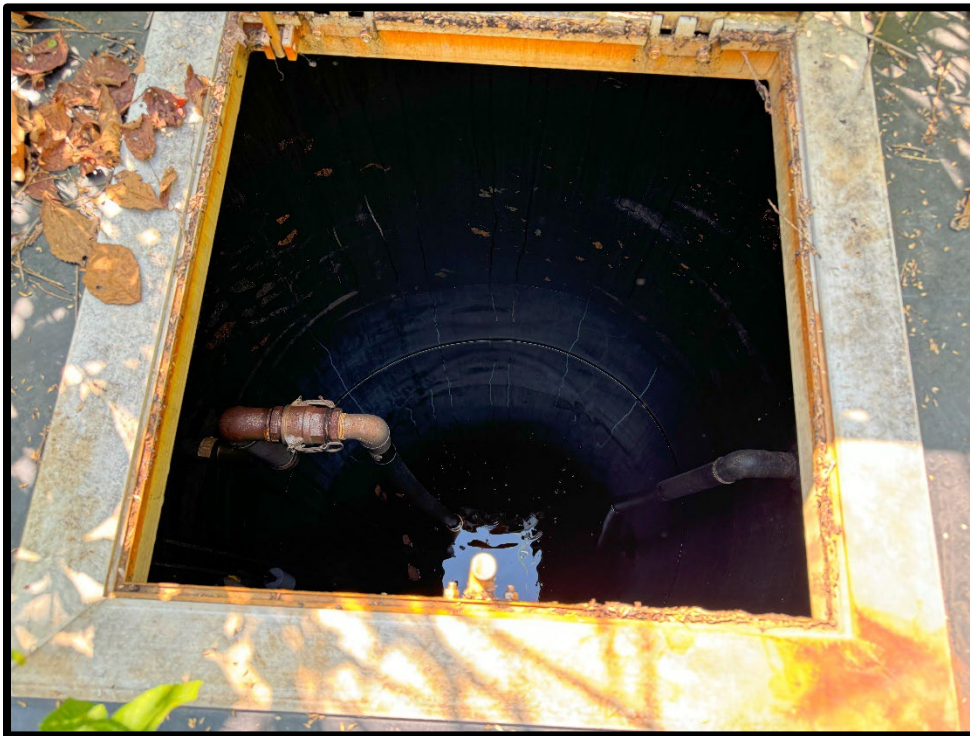
**Photograph 4:** View of VLCS-2 sump at 1/4 – 1/3 capacity.

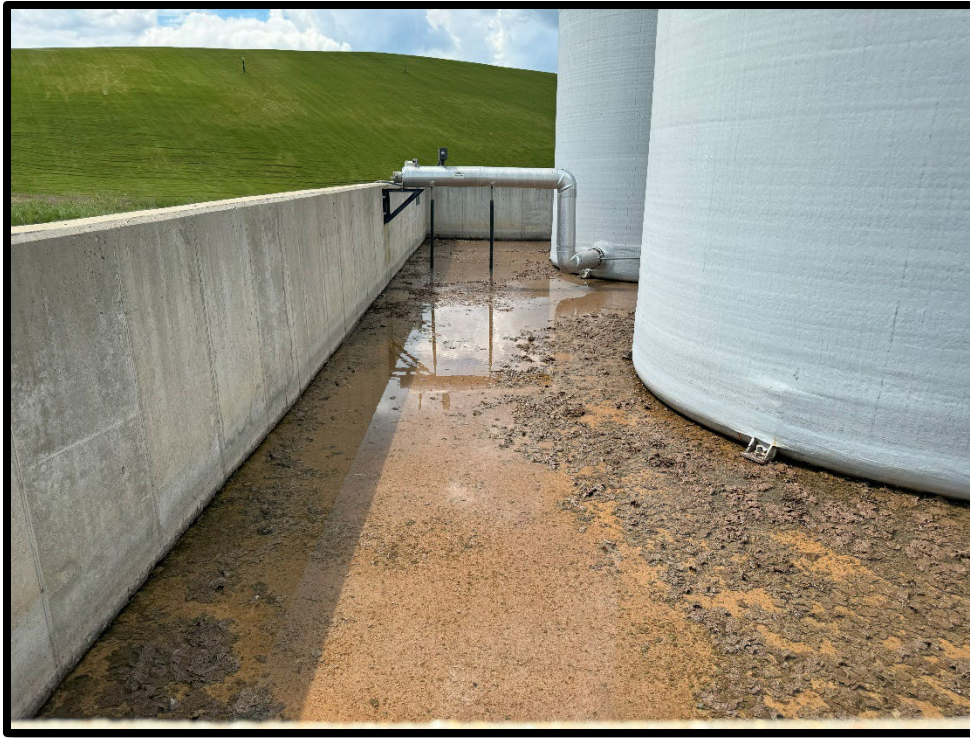
**Photograph 5:** View west of minimal stormwater in leachate tank secondary containment.

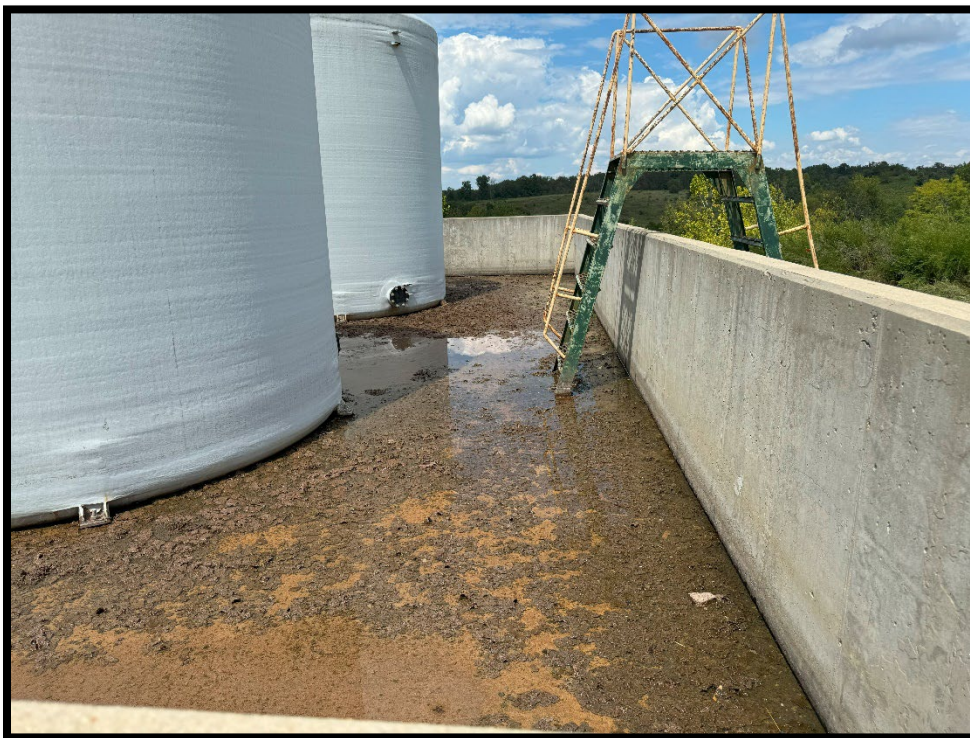
**Photograph 6:** View north of minimal stormwater in leachate tank secondary containment.
