**DATE:** September 20, 2024

**RE:** Bi-weekly Site Inspection  
NABORS Landfill  
Mountain Home, AR  
*Harbor Project No: ENSF-23299*

Harbor visited the NABORS landfill in Mountain Home, Arkansas on September 18, 2024, to conduct the bi-weekly site inspection to assess the general condition of the landfill and the leachate collection system. The leachate collection system was last fully repaired by Advanced Fluid Technologies (AFT) in October and November of 2022; however, within a few weeks of these repairs, the system began malfunctioning. By March 2023, most of the leachate collection points were malfunctioning. A quote was then requested and received from AFT to again repair the system. No authorization for the subsequent repairs was provided prior to the expiration of Harbor's contract with DEQ in June 2023.

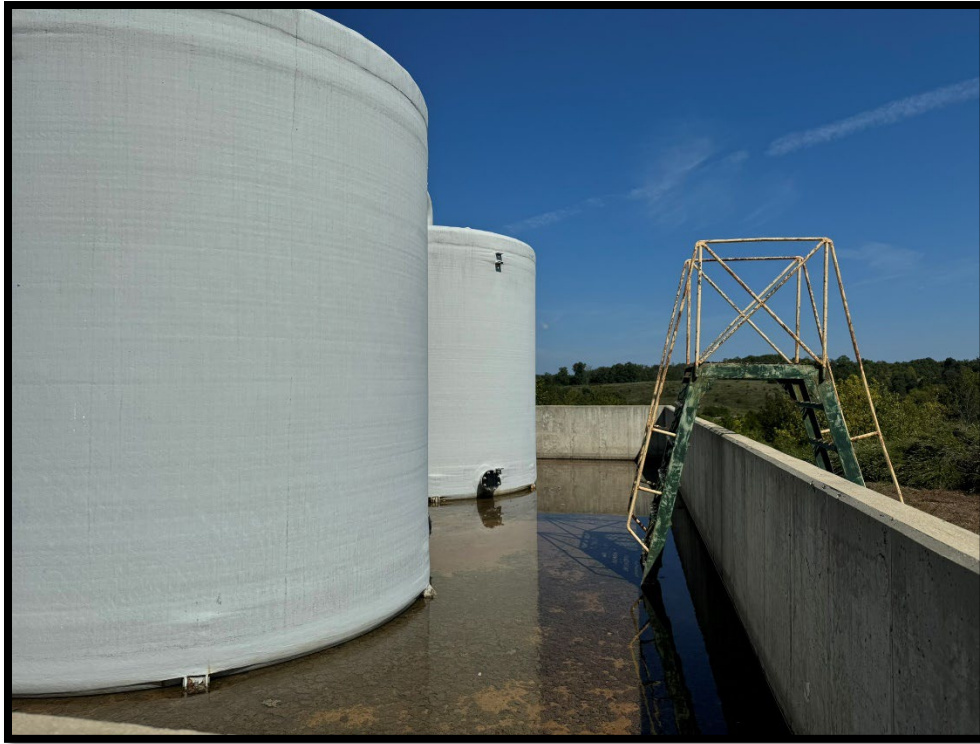
**Photograph 1:** View of minimal stormwater in leachate tank battery.

- minimal sw in containment

- none released

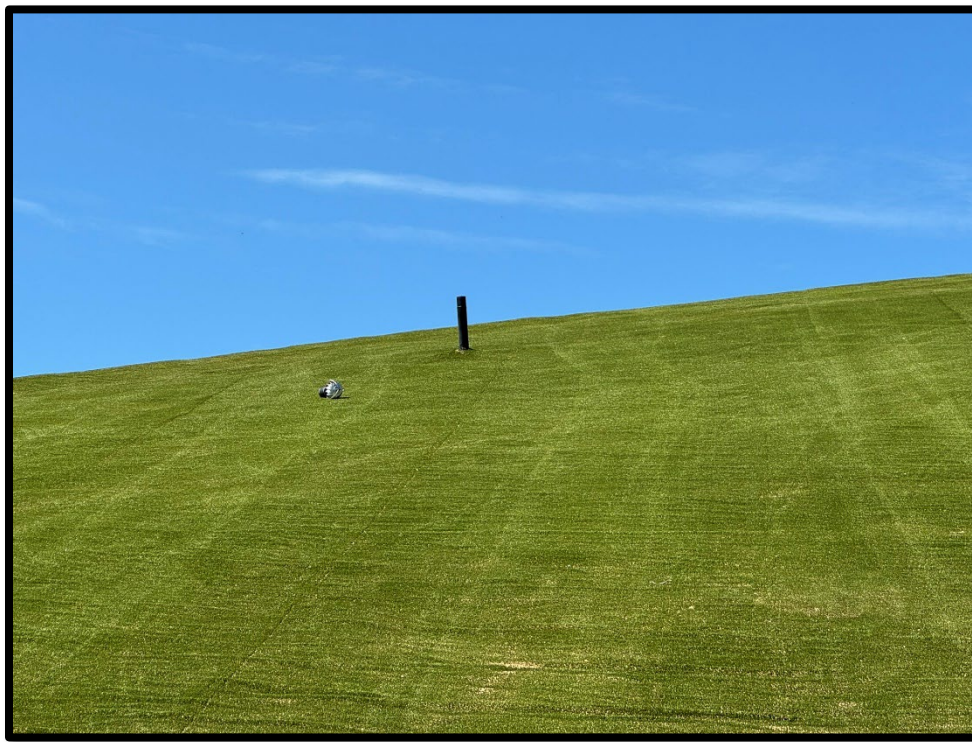
**Photograph 2:** View of detached turbine vent near LCS-8.

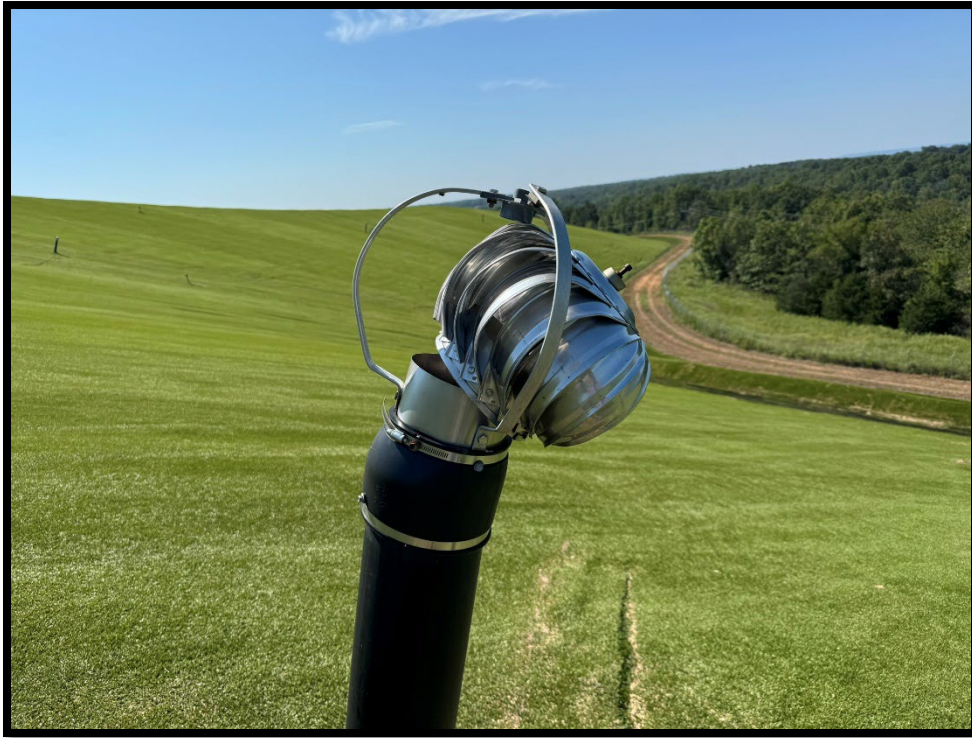
**Photograph 3:** View of damaged turbine vent on north side of Area 1-2.

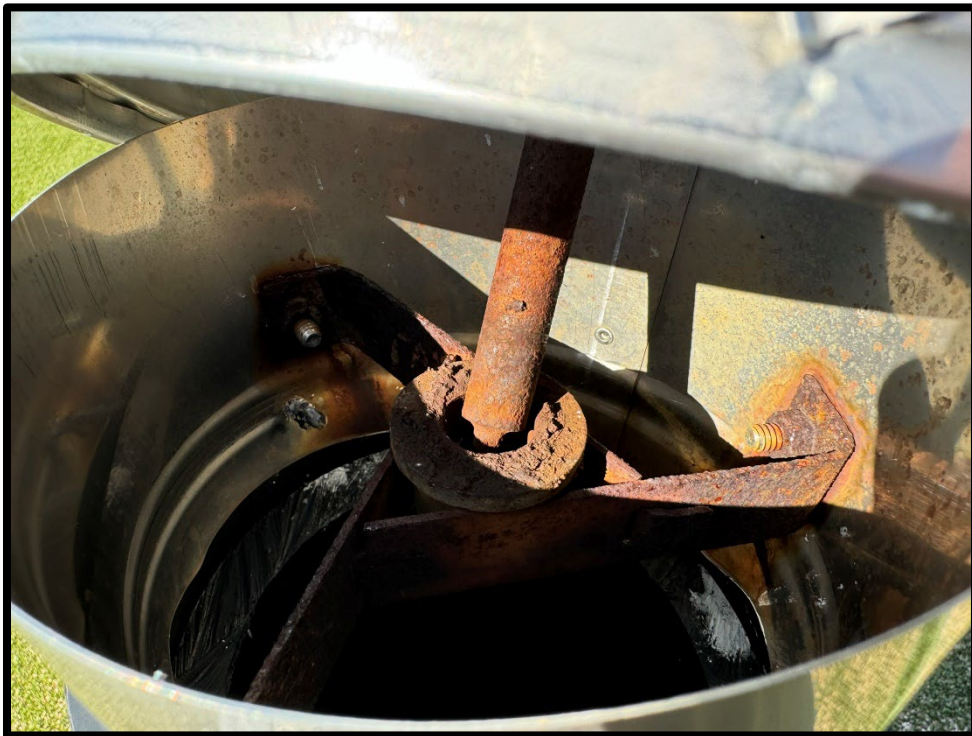
**Photograph 4:** View of damaged turbine vent on north side of Area 1-2.
