DATE: October 9, 2024

RE: Bi-weekly Site Inspection
NABORS Landfill
Mountain Home, AR
Harbor Project No: ENSF-23299

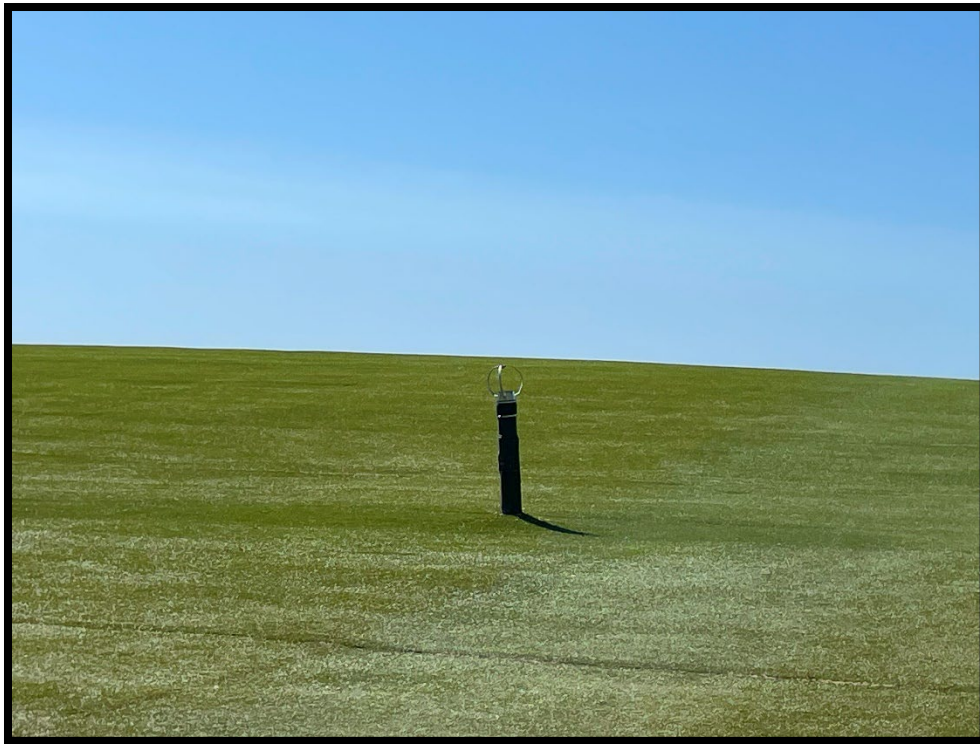
- A turbine vent near LCS-6 has also detached (see photograph 1). A turbine vent near LCS-8 has detached as well (see photograph 2).
- Another damaged turbine vent was observed on the north side of Area 1-2 near coordinates 36.461550, -92.451120 (see photographs 3-4).
- The closure turf has some significant rills present between LCS-1 and LCS-2 on the north side of Area 1-2. These rills have sediment deposited in them which is allowing vegetation to grow. An erosional washout is present along the road between LCS-4 and LCS-5.

Photograph 1: View of detached turbine vent near LCS-6.

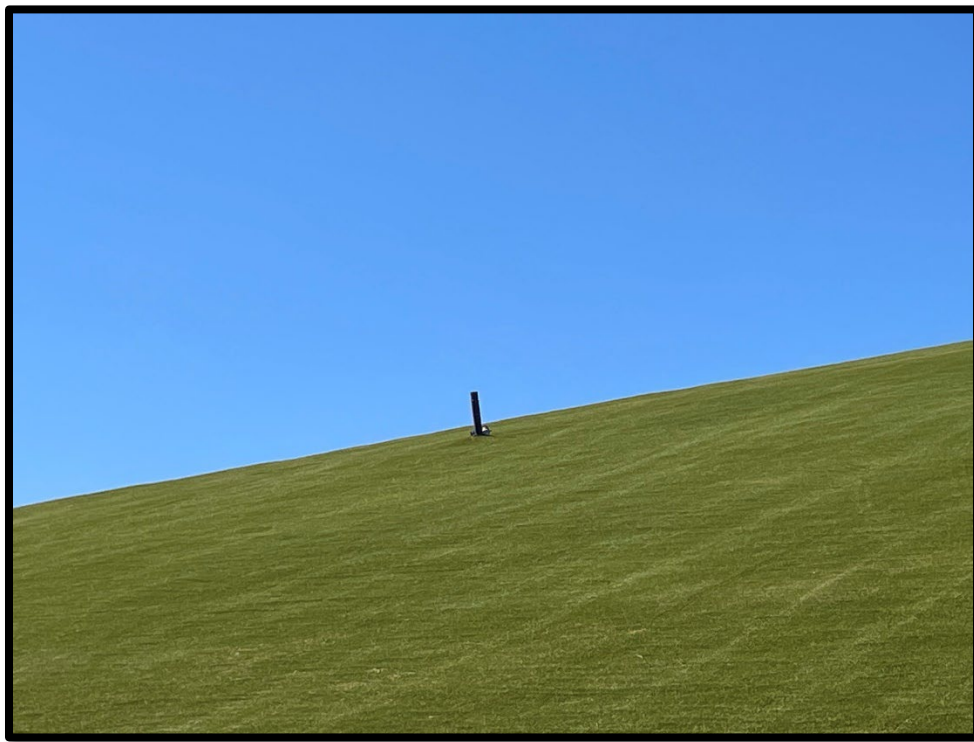
Photograph 2: View of detached turbine vent near LCS-8.

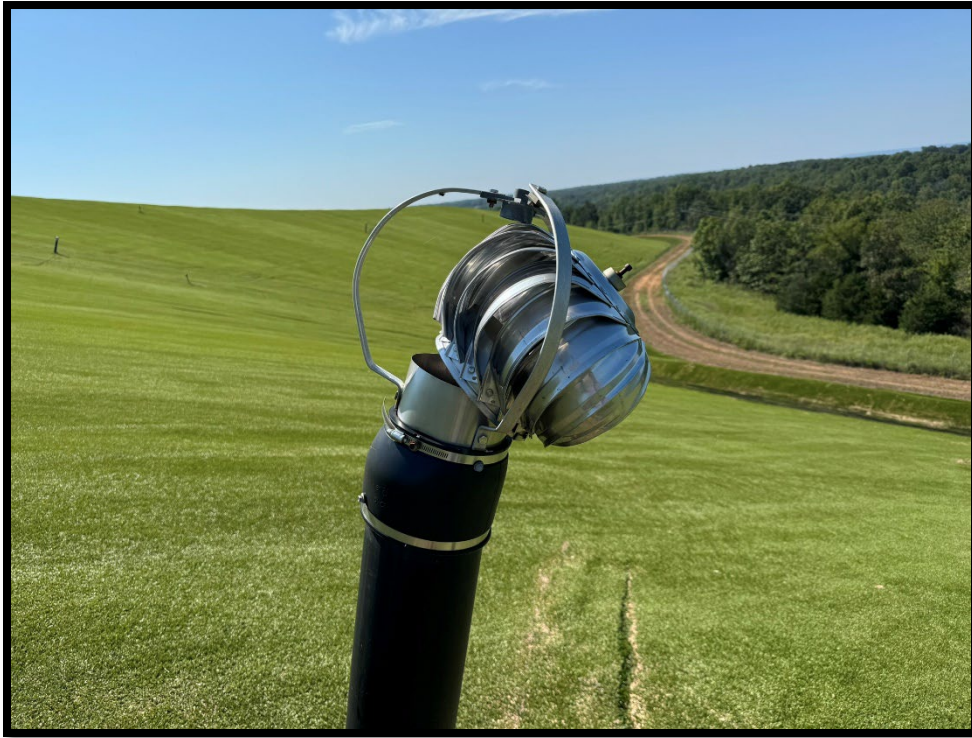
Photograph 3: View of damaged turbine vent on north side of Area 1-2.

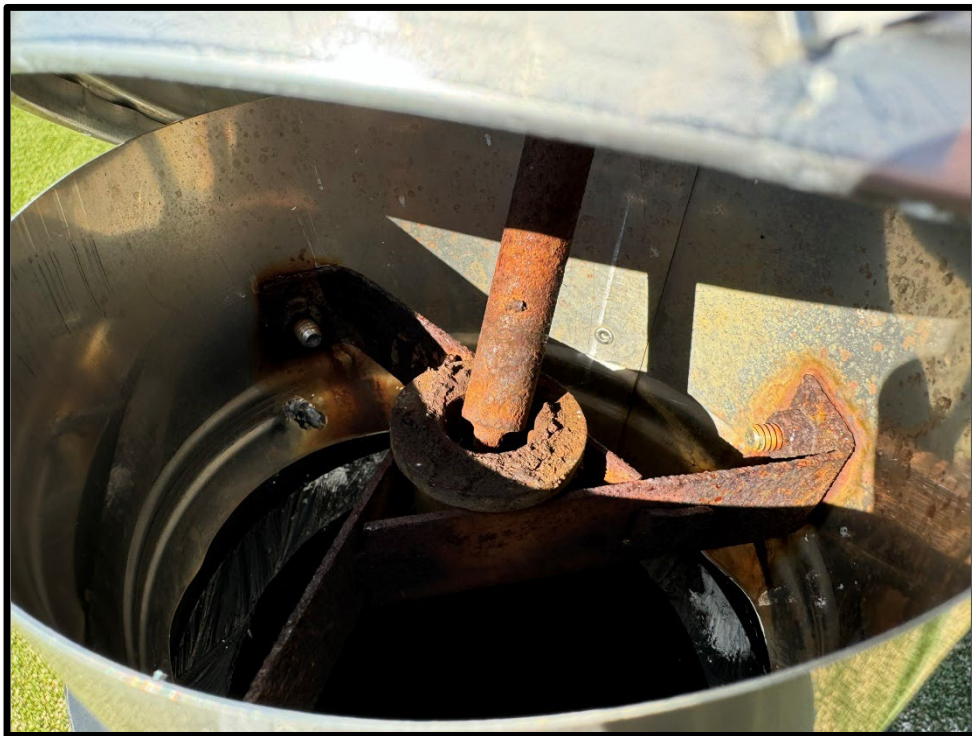
Photograph 4: View of damaged turbine vent on north side of Area 1-2.
