DATE: October 18, 2024

RE: Bi-weekly Site Inspection
NABORS Landfill
Mountain Home, AR
Harbor Project No: ENSF-23299

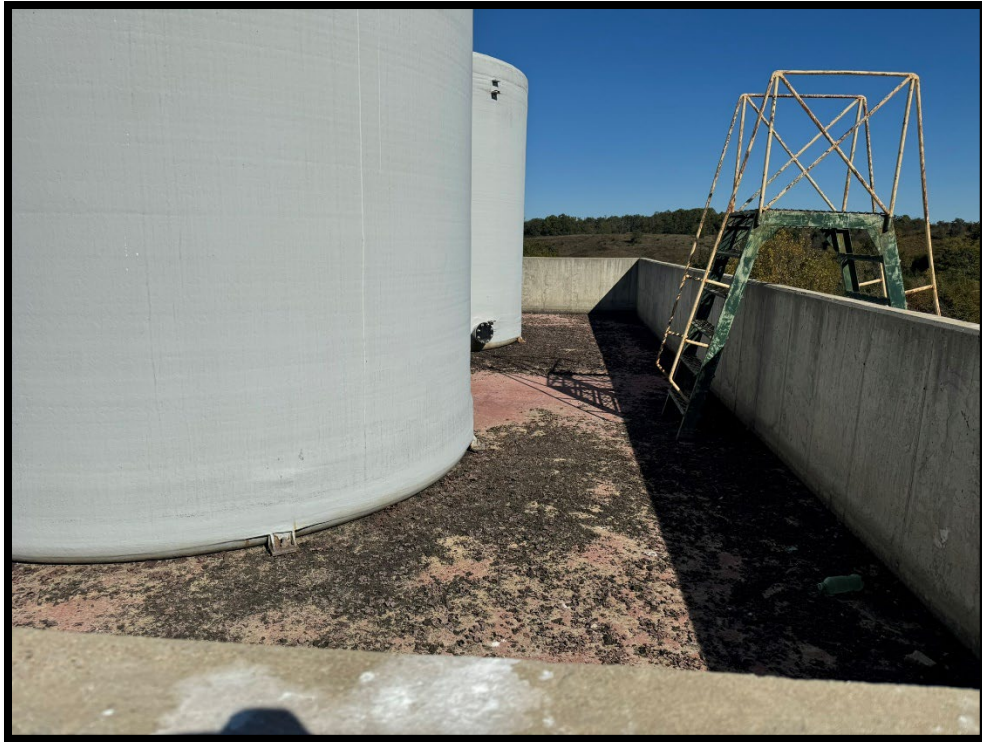
- Minimal stormwater was observed in the leachate tank battery secondary containment. As such, no stormwater was released (see photograph 1).
 - The panel displays were off at LCS-1 through LCS-5, and LCS-8 through LCS-9. The VFDs did not activate when the sump was placed in "hand" or "auto" mode.

Photograph 1: View of no stormwater observed in the leachate tank containment.

- no stormwater in containment
