DATE: July 2, 2024

RE: Bi-weekly Site Inspection
NABORS Landfill
Mountain Home, AR
Harbor Project No: ENSF-23299

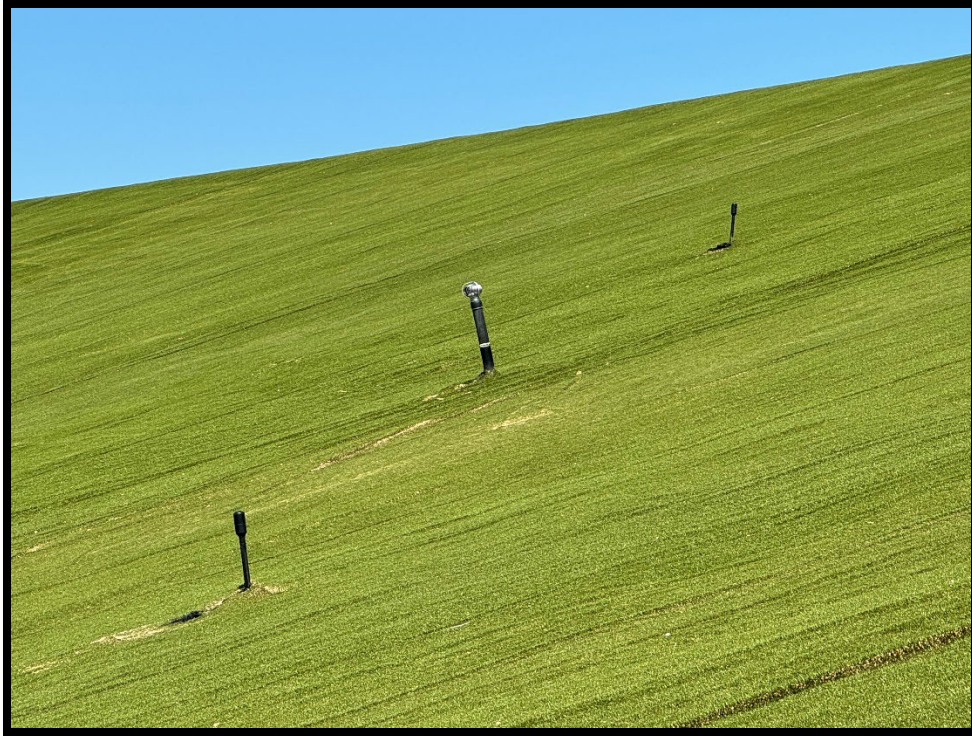
- LCS-4, LCS-7, LCS-8, and LCS-9 had pump faults and were not functioning.
- LCS-5 and LCS-6 appear to be functioning correctly.
- The closure turf is damaged around several vent pipes near LCS-4. A turbine vent near LCS-8 has also detached (see photographs 1-2).

Photograph 1: Damaged closure turf around vent pipe near LCS-4.

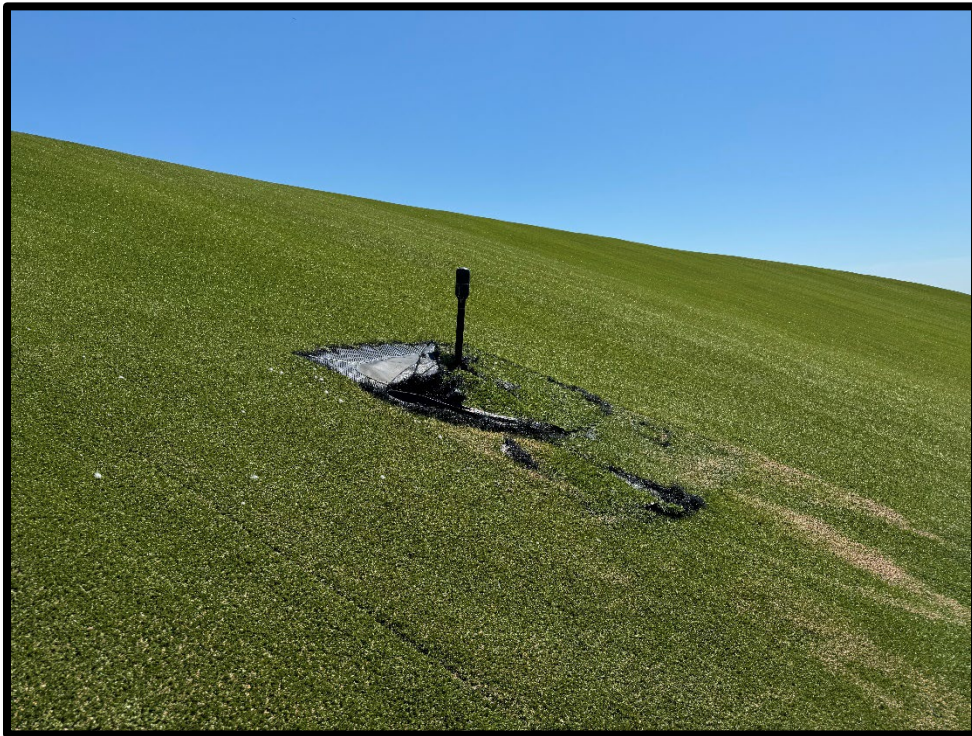
Photograph 2: Damaged closure turf around vent pipe near LCS-4.

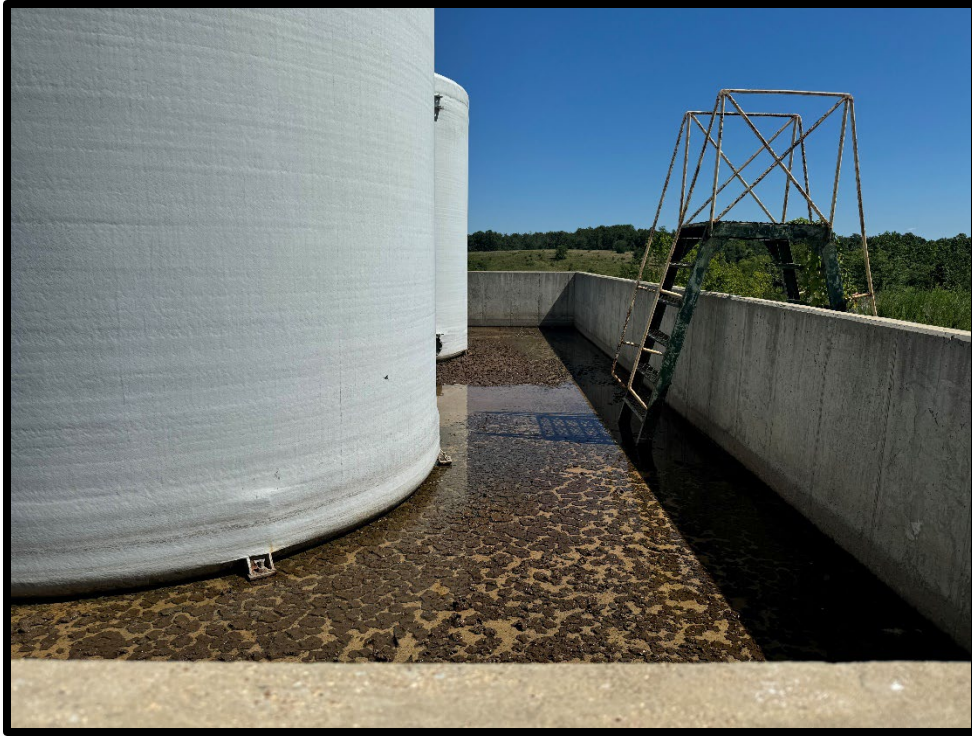
- Minimal stormwater was observed in the leachate tank battery containment. As such, no stormwater was released (see photograph 3).
- A turbine vent remains detached near LCS-8 (see photograph 4).

Photograph 3: View North of minimal stormwater within tank battery containment.

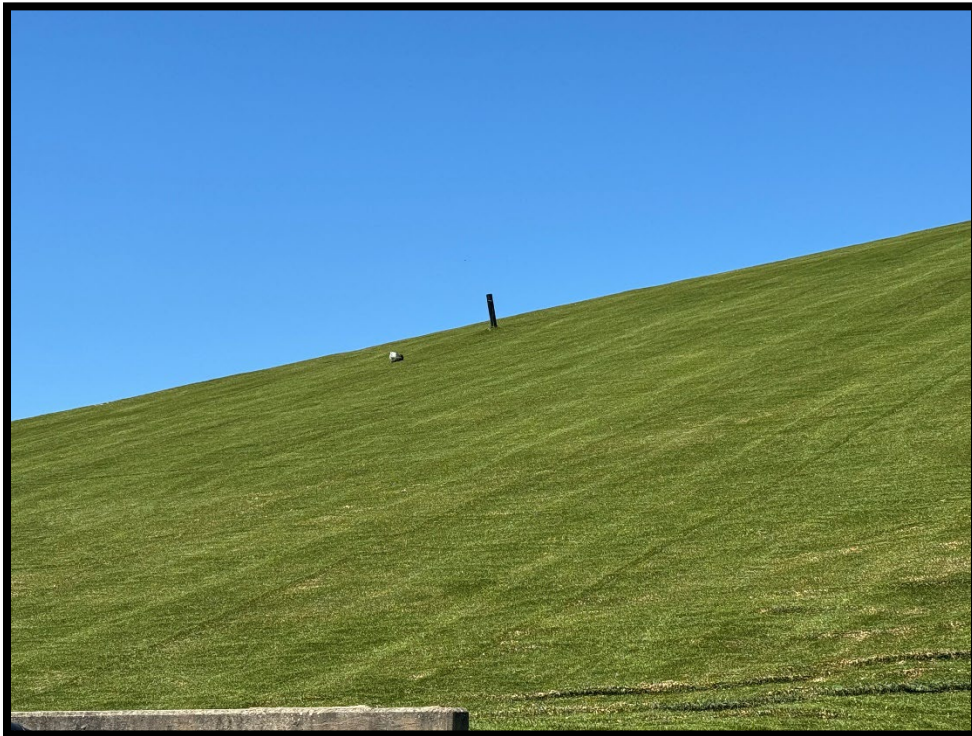
Photograph 4: View of damaged turbine vent near LCS-8.
