**DATE:** October 18, 2024

**RE:** Post Vegetation Clearing and Landfill Maintenance Site Inspection  
NABORS Landfill  
Mountain Home, AR  
*Harbor Project No: ENSF-23299*

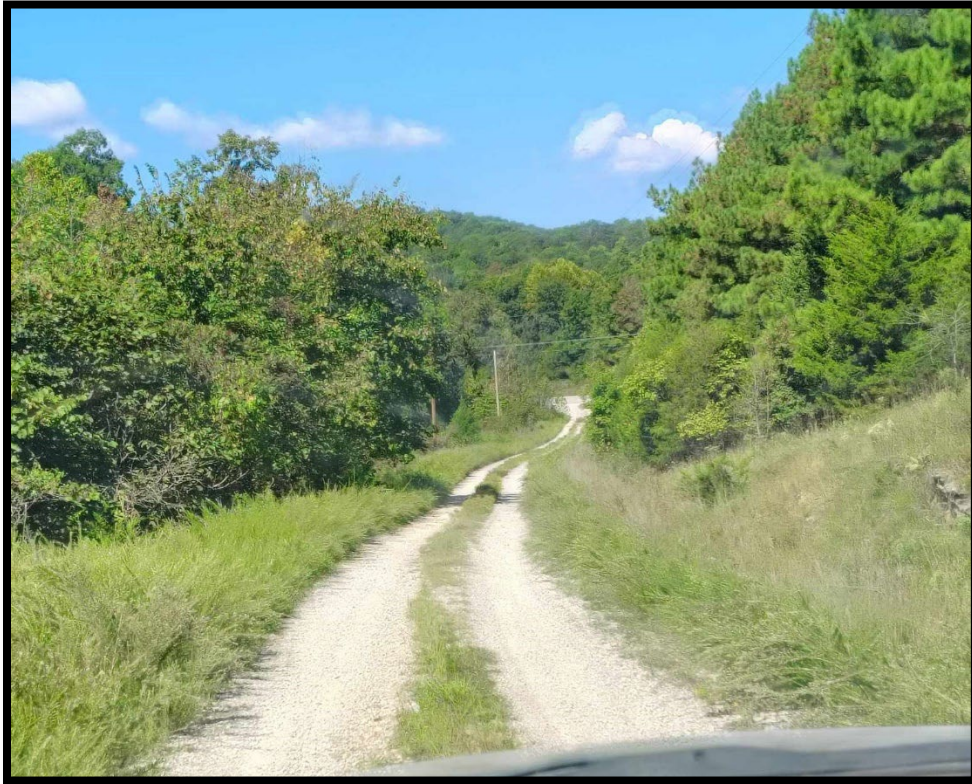
**Photograph 1:** View of landfill entrance road pre-clearing.

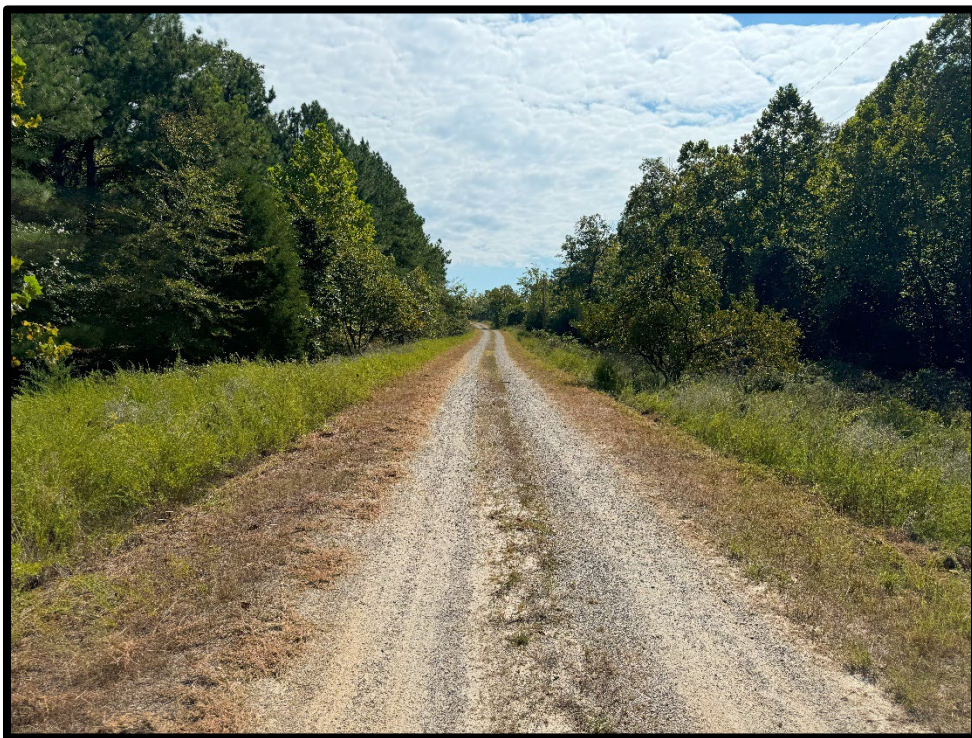
**Photograph 2:** View of entrance road post-clearing.

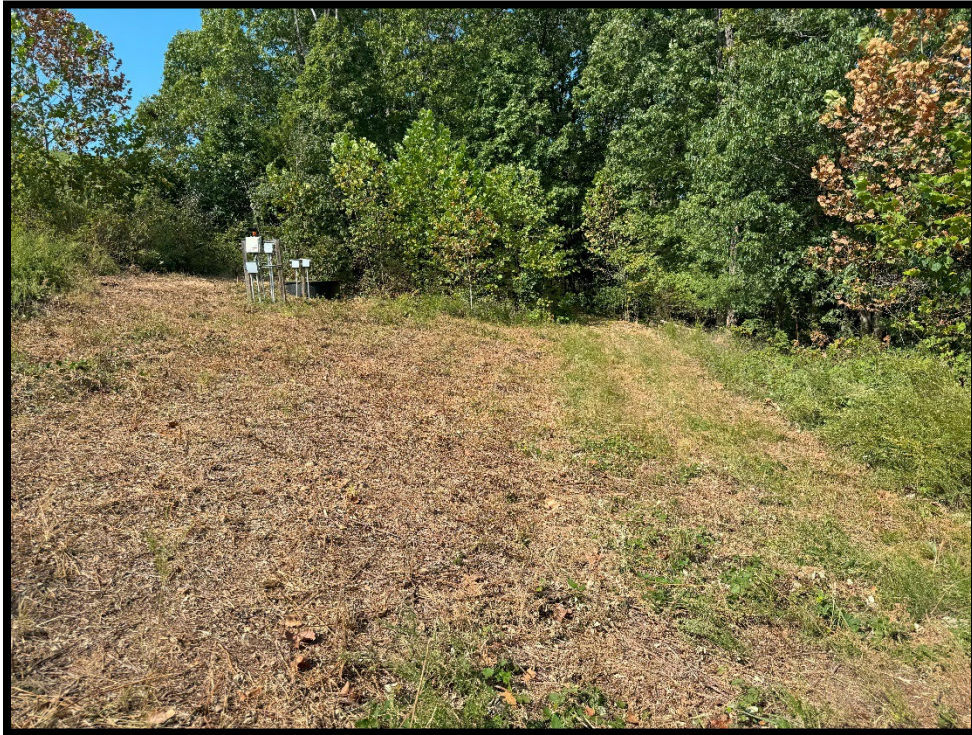
**Photograph 3:** View of VLCS-2 area post-clearing.

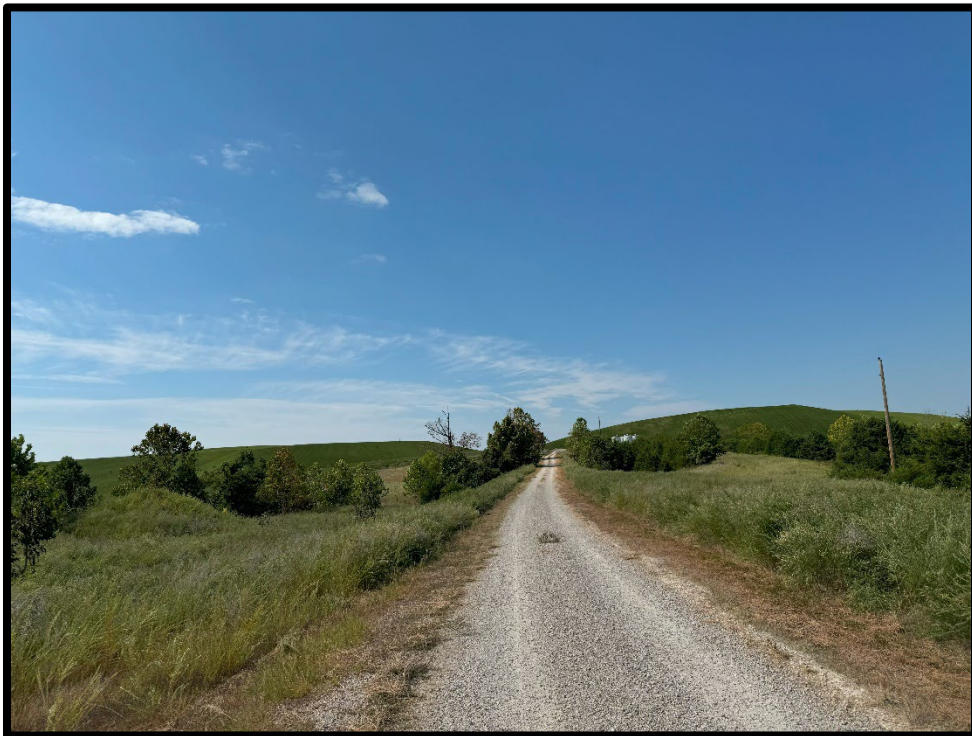
**Photograph 4:** View of access road to leachate containment tank battery.

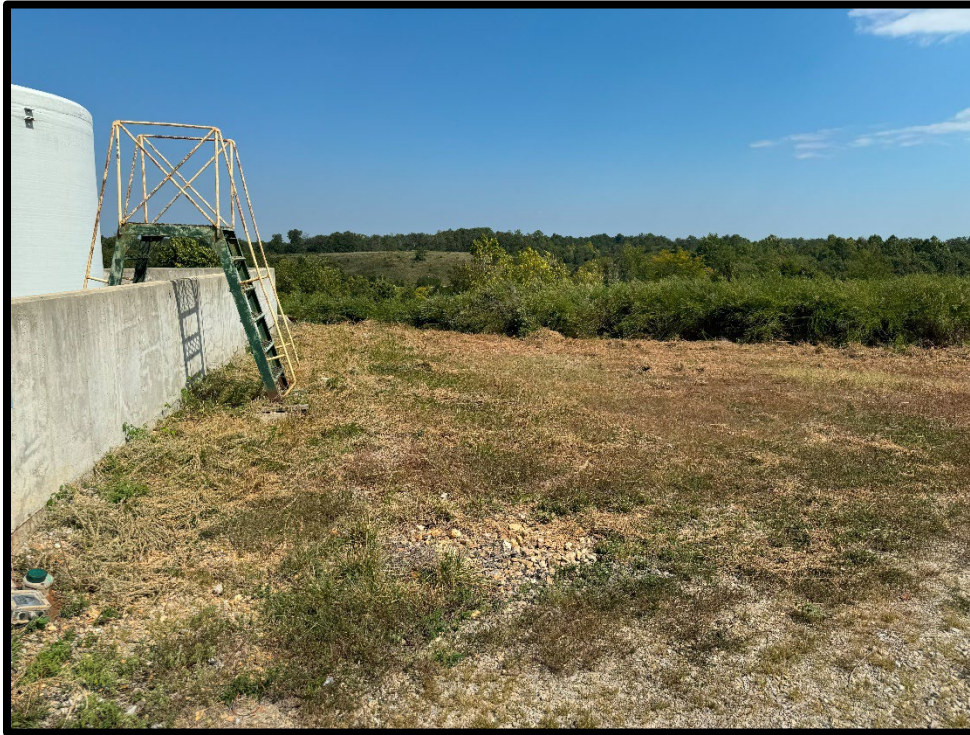
**Photograph 5:** View around leachate tank battery secondary containment post-clearing.

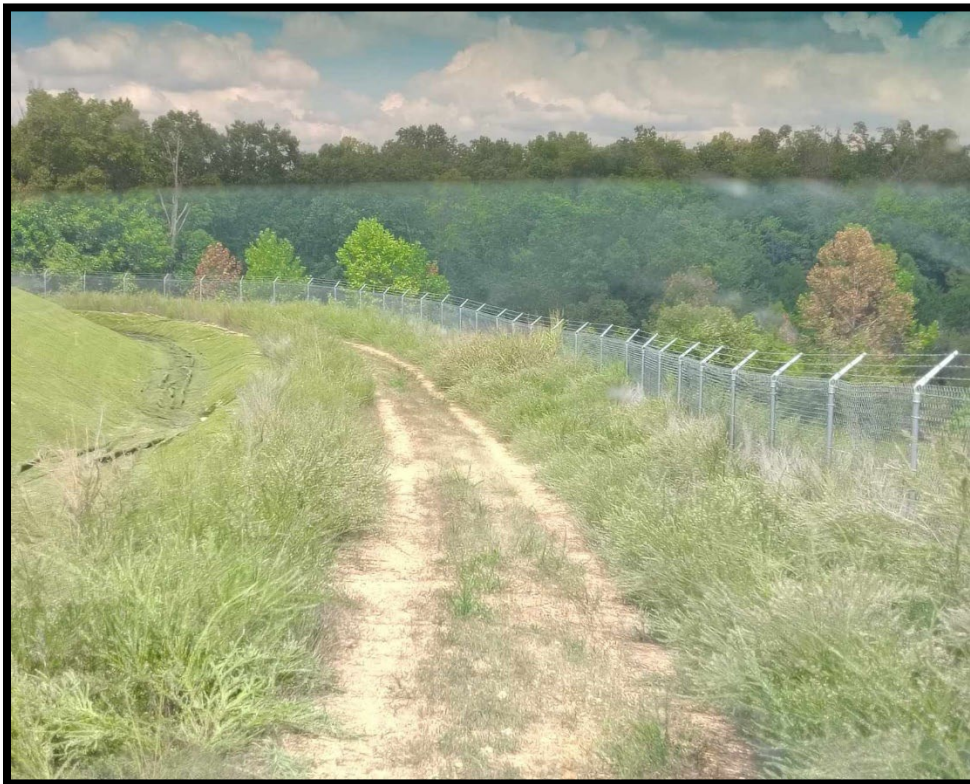
**Photograph 6:** View of north side of Area 1-2 pre-clearing.

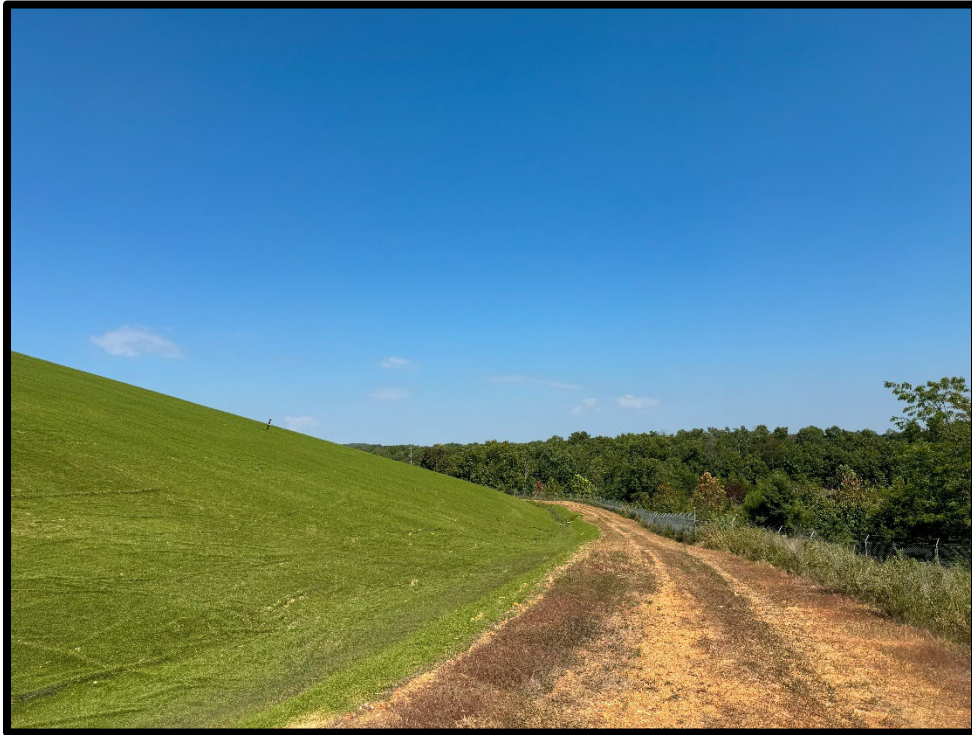
**Photograph 7:** View of north side of Area 1-2 post-clearing.

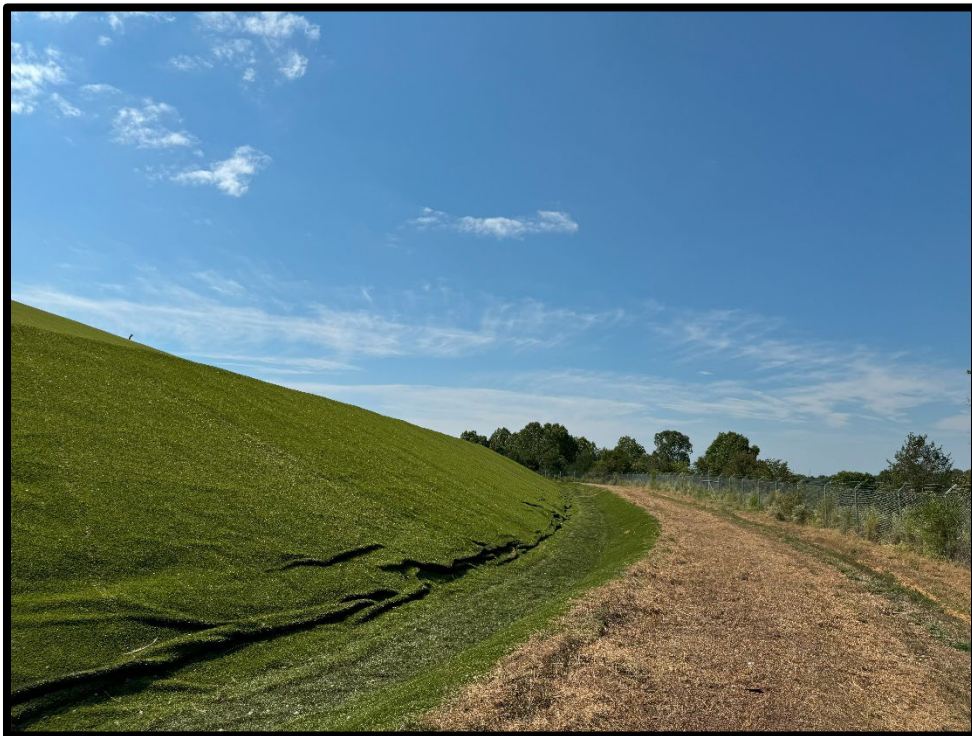
**Photograph 8:** View of north side of Area 1-2 post-clearing.

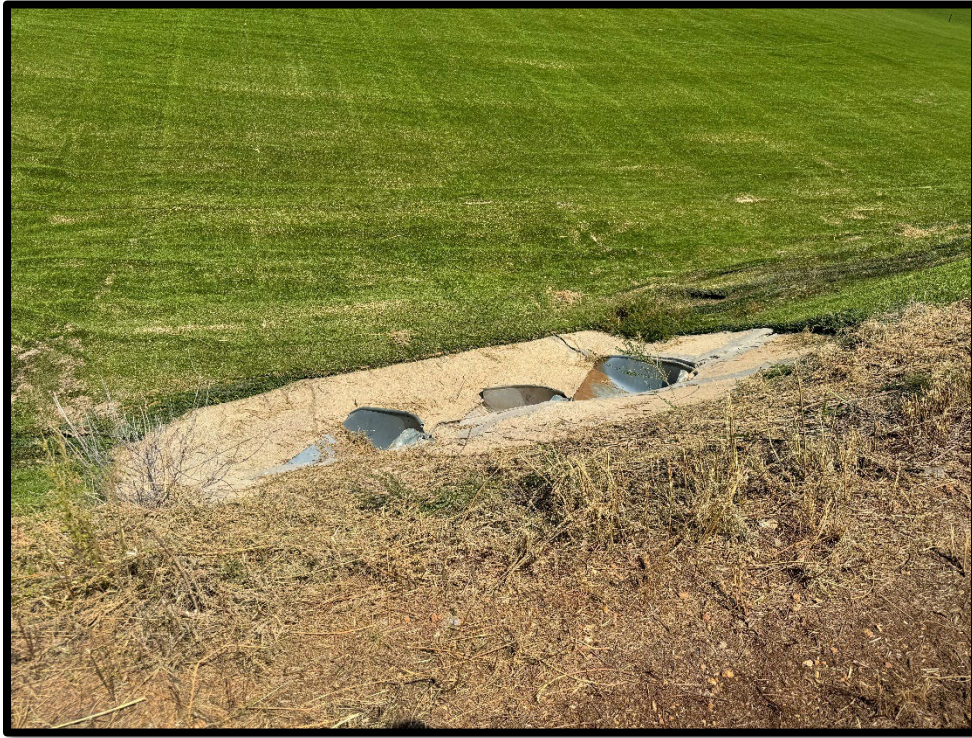
**Photograph 9:** View of woody vegetation removed from culvert.

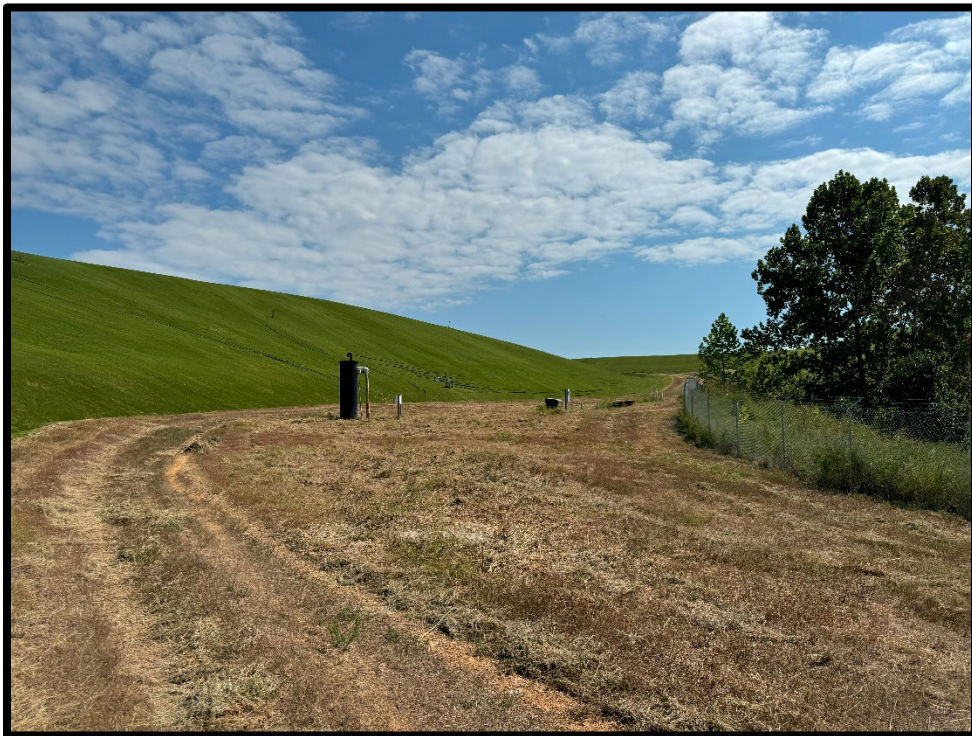
**Photograph 10:** View of cleared vegetation near LCS-3.

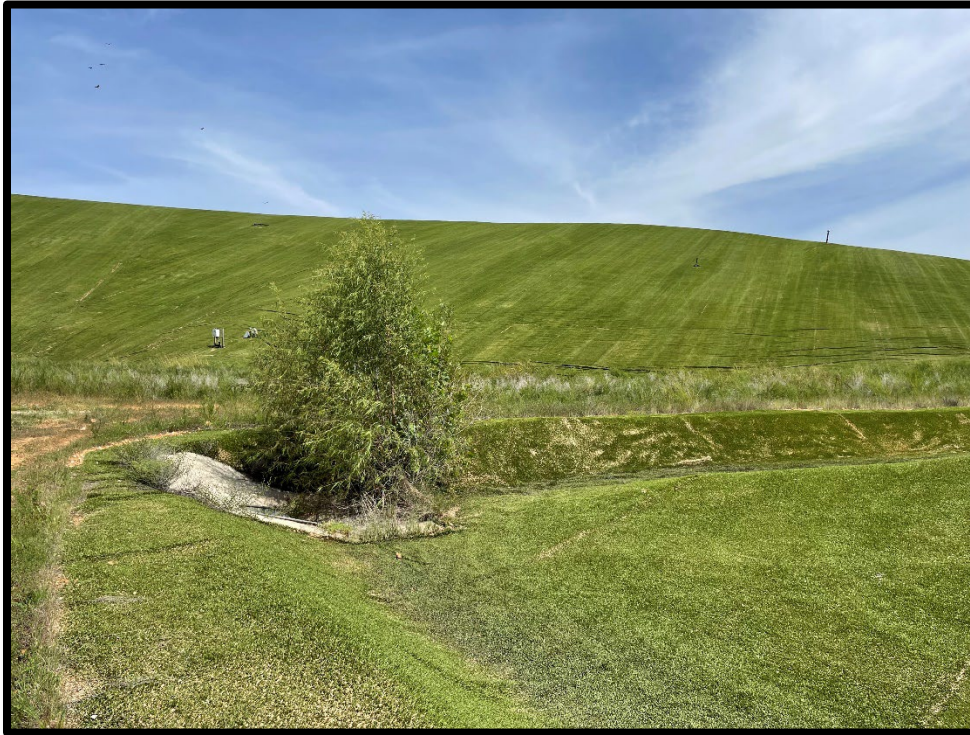
**Photograph 11:** View of woody vegetation near LCS-4 and LCS-5 pre-clearing.

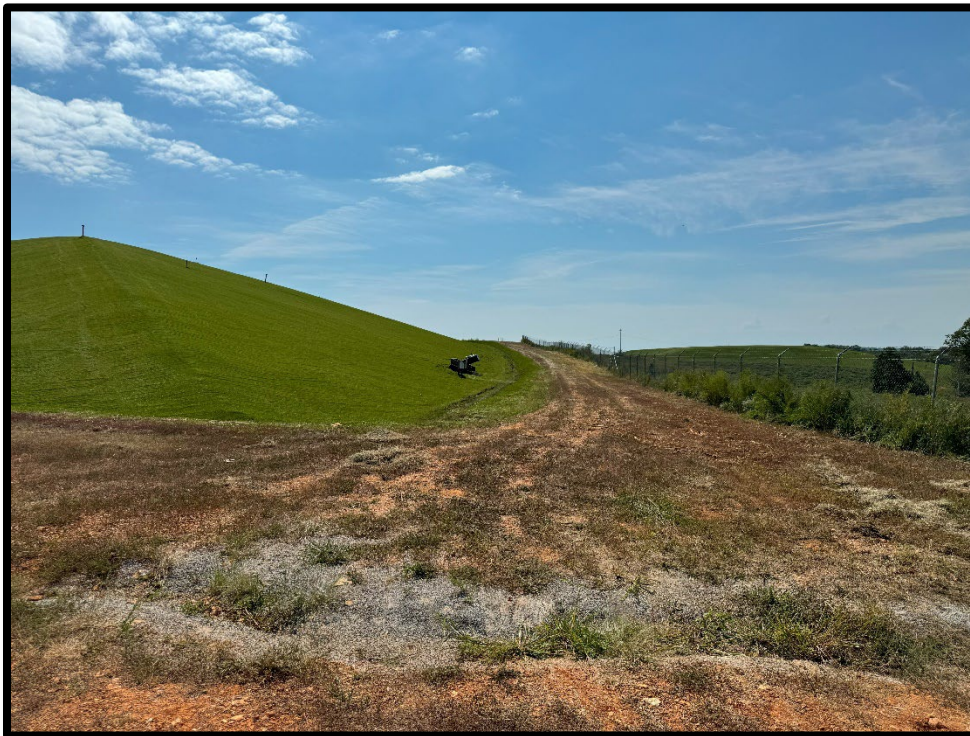
**Photograph 12:** View of woody vegetation near LCS-4 and LCS-5 post-clearing.

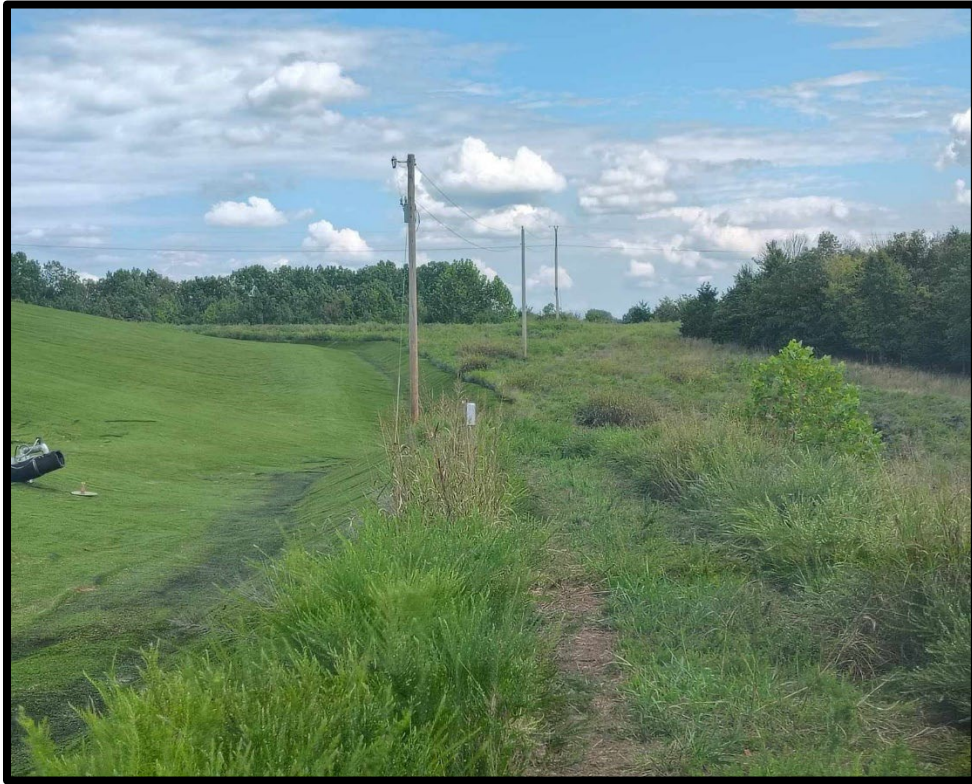
**Photograph 13:** View near LCS-9 pre-clearing.

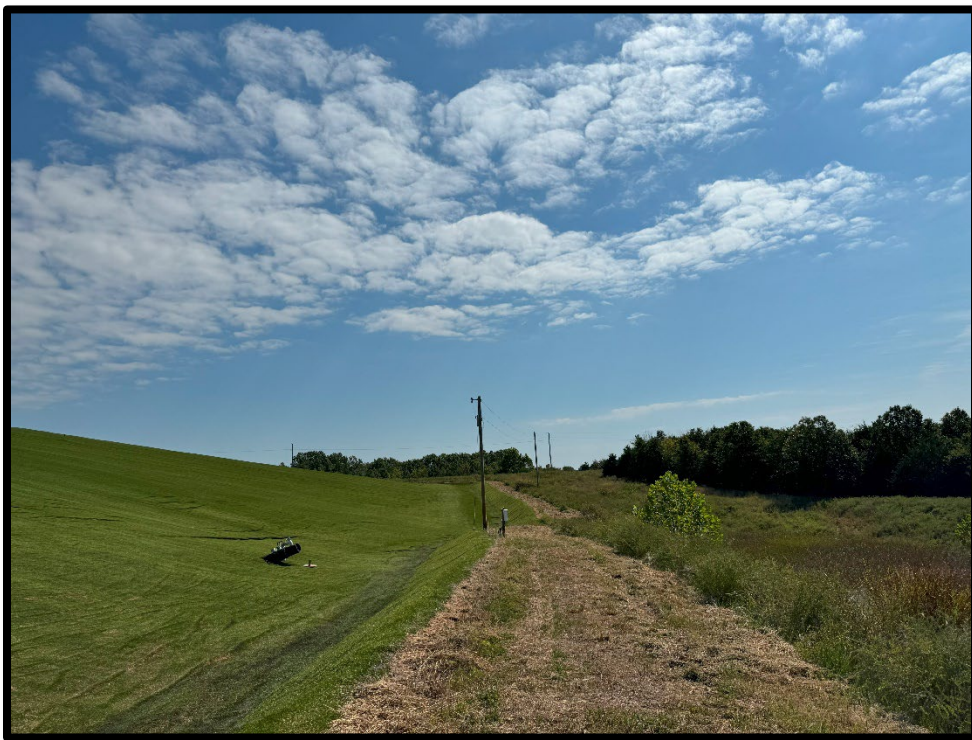
**Photograph 14:** View near LCS-9 post-clearing.

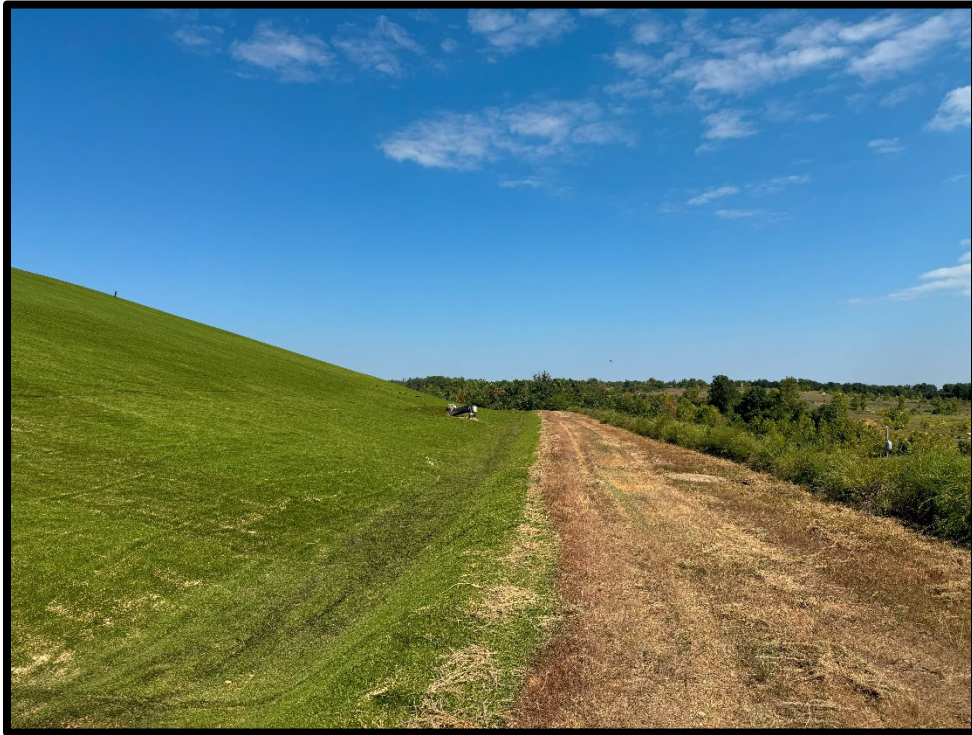
**Photograph 15:** View near LCS-8 post-clearing.

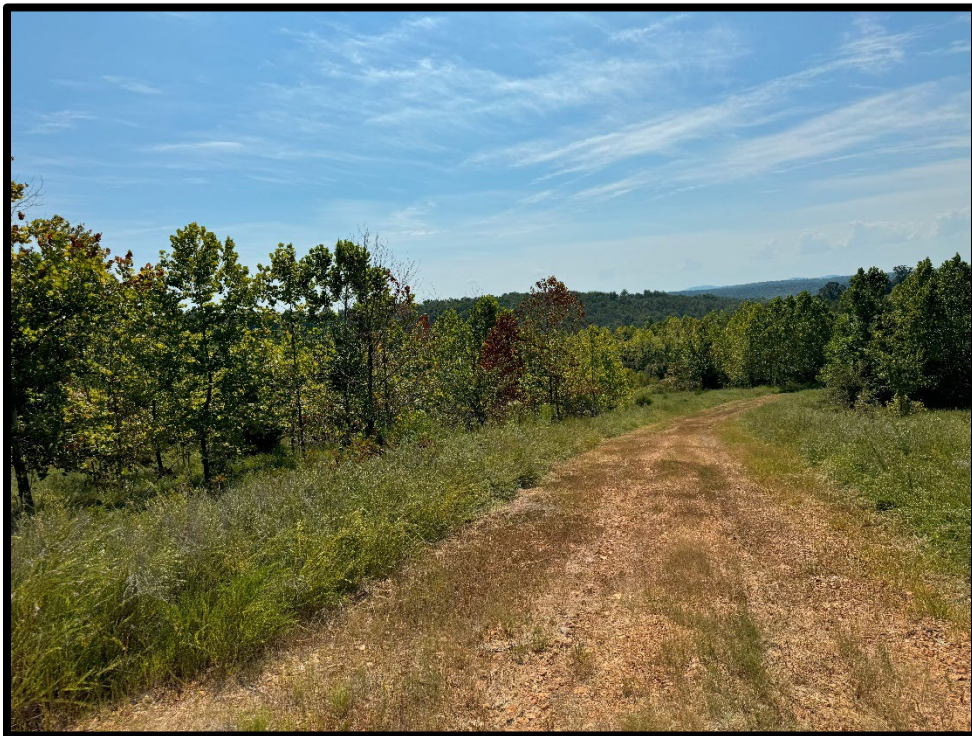
**Photograph 16:** View of access road to old landfill cell.

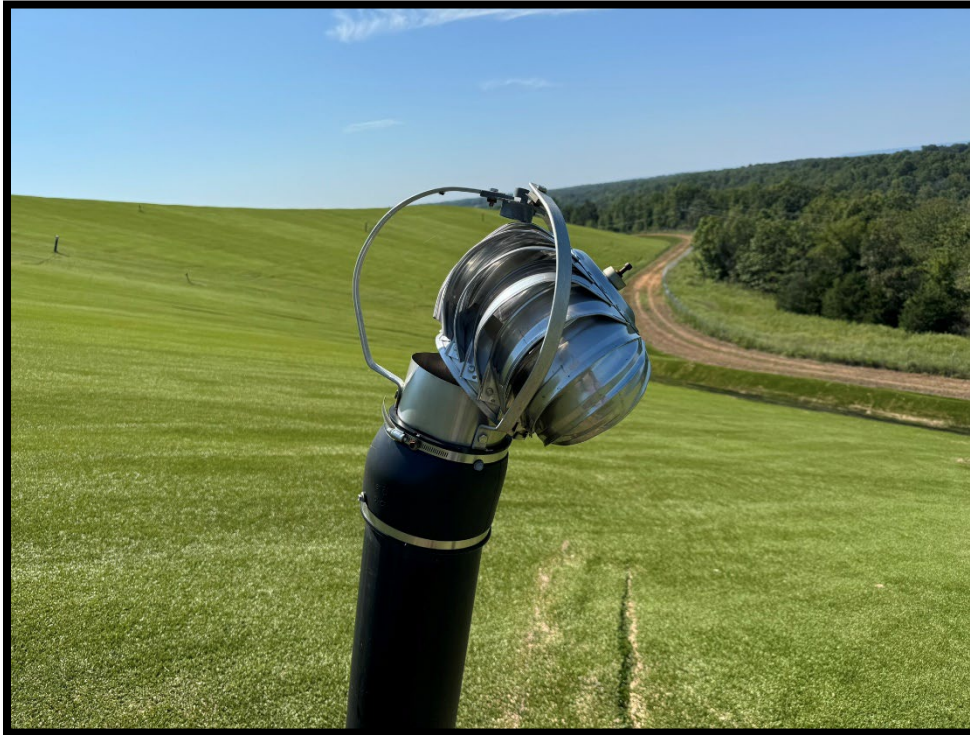
**Photograph 17:** View of damaged turbine vent on north side of Area 1-2 prior to repairs.

On October 16, 2024, Harbor visited the site to repair several turbine vents that had become damaged or detached. Three new turbine vents were re-installed on six-inch vent pipes near LCS-1, LCS-6, and LCS-8.

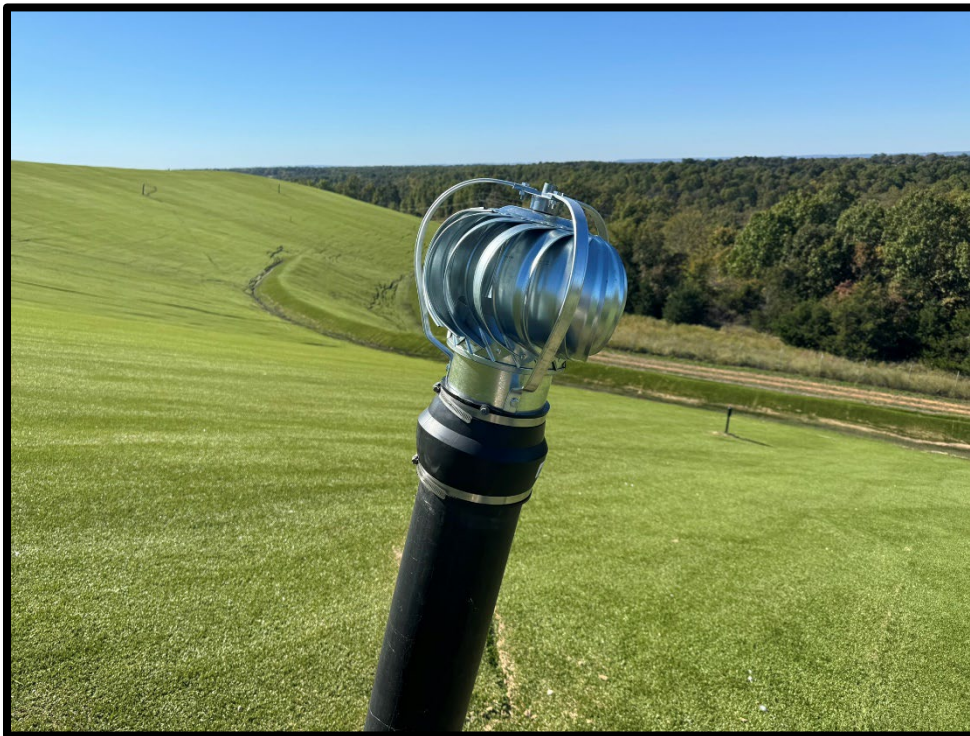
**Photograph 18:** View of turbine vent on north side of Area 1-2 after repairs.

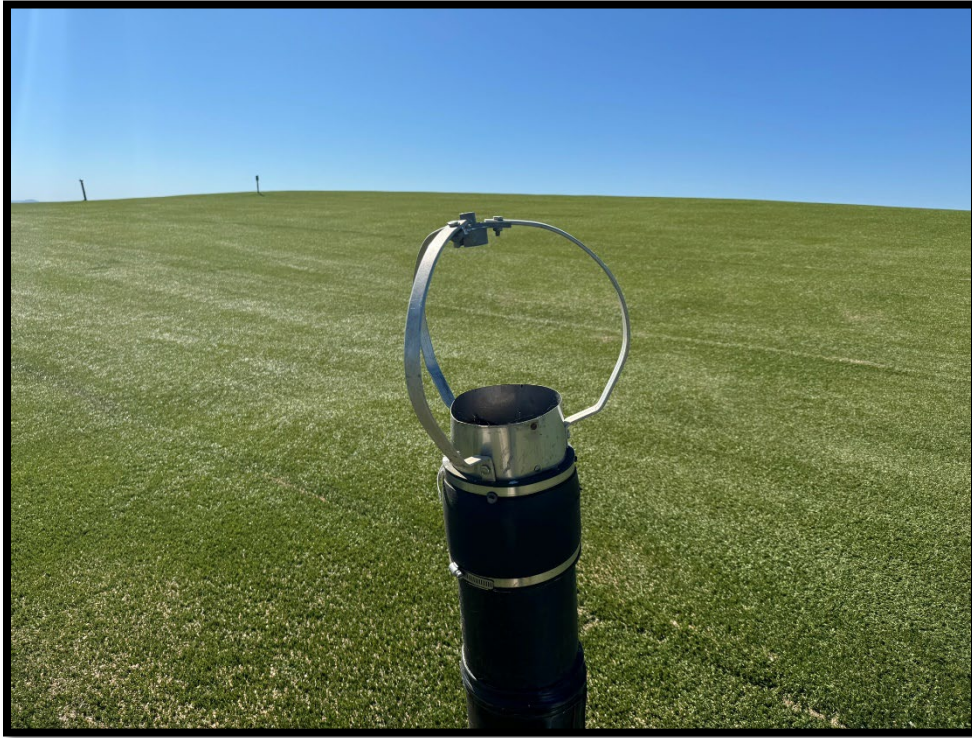
**Photograph 19:** View of damaged turbine vent near LCS-6 before repairs.

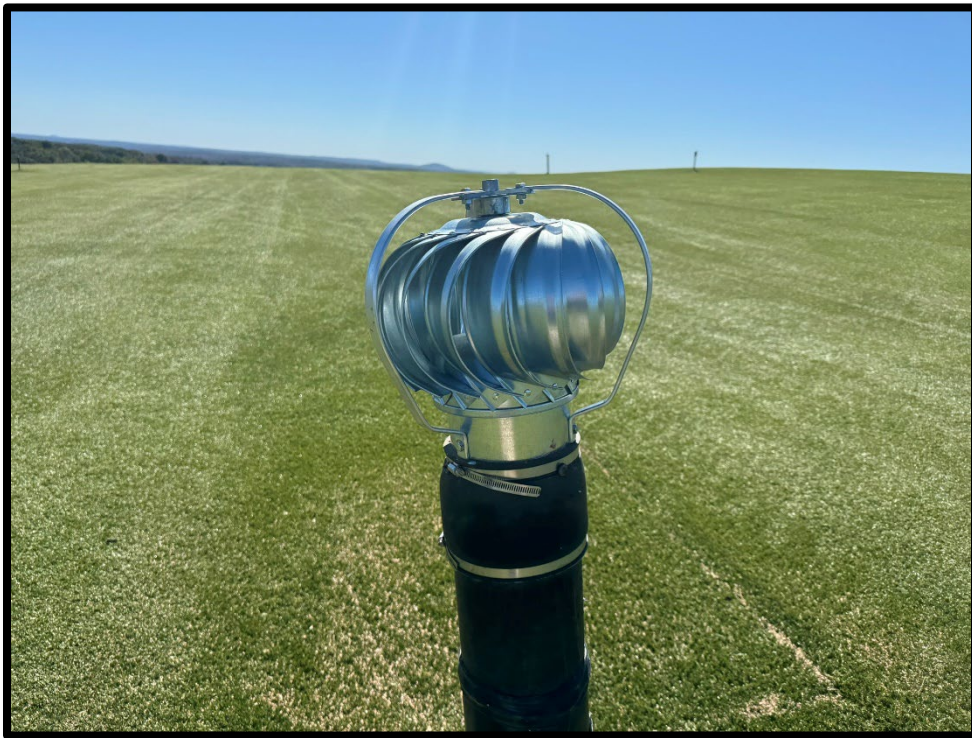
**Photograph 20:** View of turbine vent near LCS-6 after repairs.

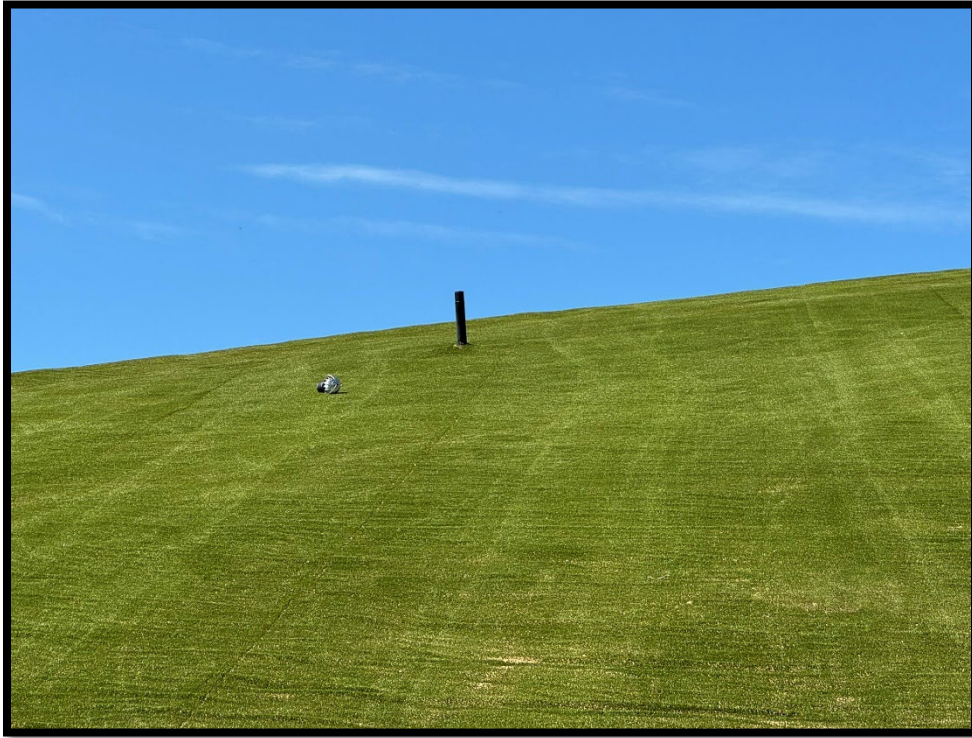
**Photograph 21:** View of damaged turbine vent near LCS-8 before repairs.

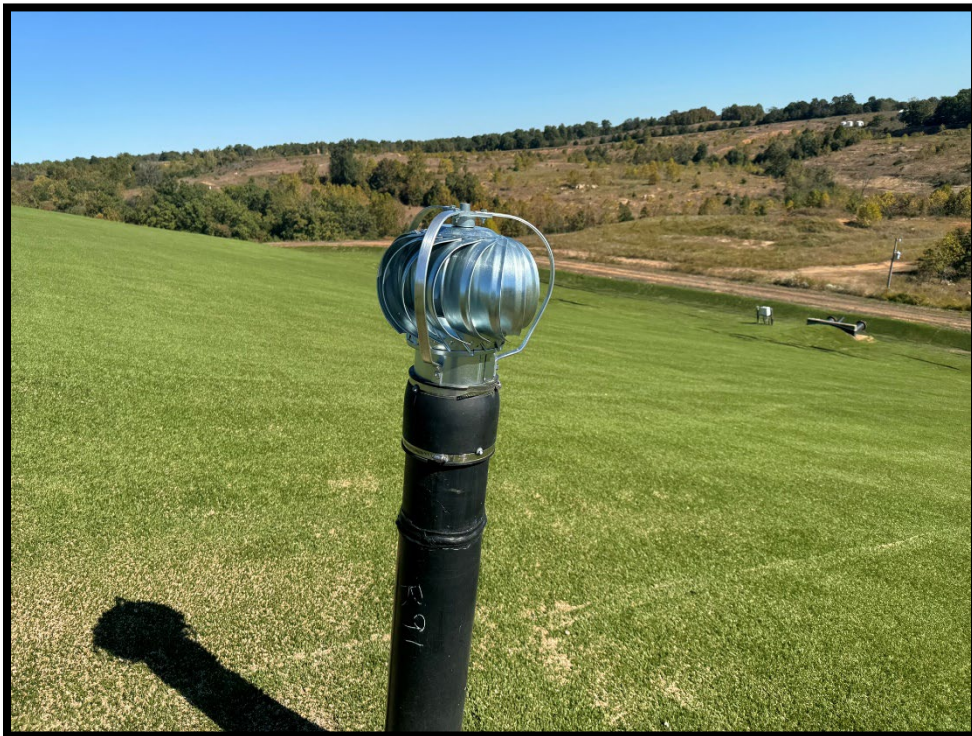
**Photograph 22:** View of turbine vent near LCS-8 after repairs.
